Inspection Report

Permit Number:	C0250005
Inspection Type:	COMPLETE
Inspection Date:	Tuesday, September 27, 2016
Start Date/Time:	9/27/2016 9:00:00 AM
End Date/Time:	9/28/2016 12:00:00 PM
Last Inspection:	Wednesday, August 31, 2016

Permittee: **ALTON COAL DEVELOPMENT LLC**
 Operator: **ALTON COAL DEVELOPMENT LLC**
 Site: **COAL HOLLOW**
 Address: **463 North 100 West, Suite 1, CEDAR CITY UT 84720**
 County: **KANE**
 Permit Type: **PERMANENT COAL PROGRAM**
 Permit Status: **ACTIVE**

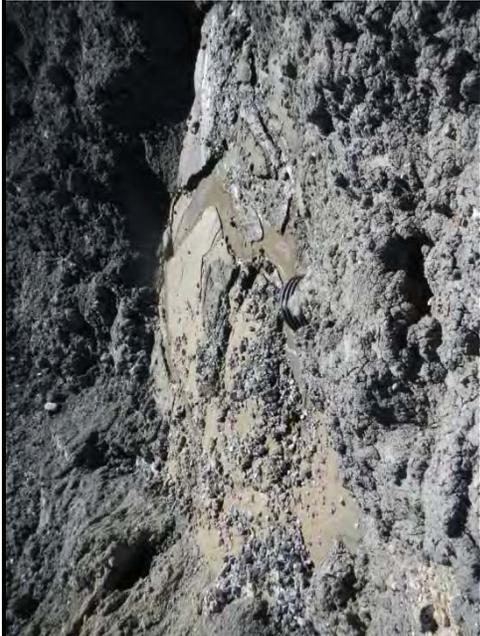
<p>PHOTO 13 Outlet of ditch P10-S03 geotextile remains riprap washed away</p>	<p>PHOTO 14 Pit 10 catch basin and inlet to P10-08</p>
