**Citation for Non-Compliance
Utah Coal Regulatory Program**

Inspection Report

Permit Number:	C0250005
Inspection Type:	COMPLETE
Inspection Date:	Tuesday, March 14, 2017
Start Date/Time:	3/14/2017 12:30:00 PM
End Date/Time:	3/15/2017 5:00:00 PM
Last Inspection:	Wednesday, February 22, 2017

Photo Attachment
Inspection Report #5803
March 14-15, 2017

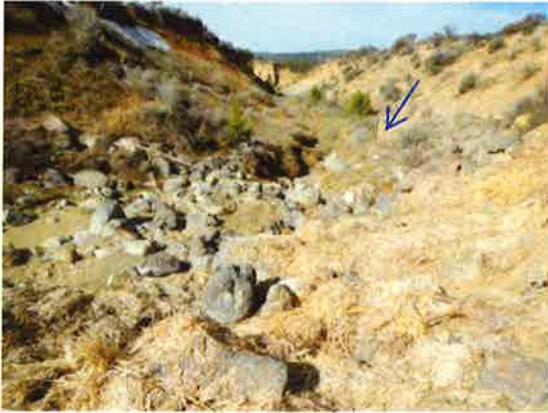
Transition Zone

Looking downstream at disturbed area boundary

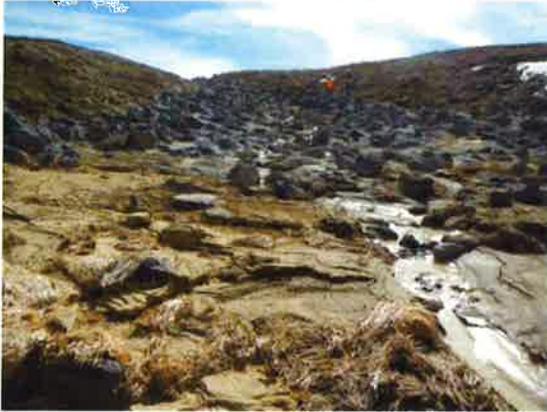
Looking upstream from disturbed boundary at "transition zone".

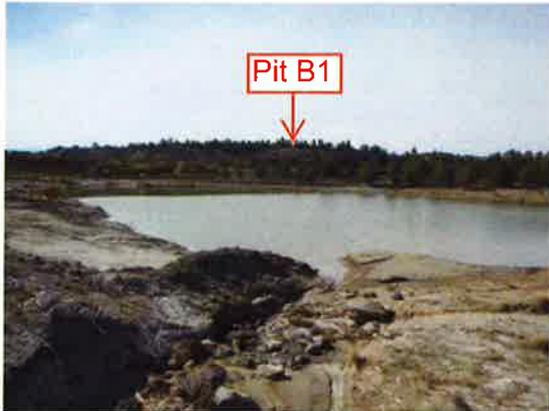
Looking S at Pond 3 and Pit B1 in distance

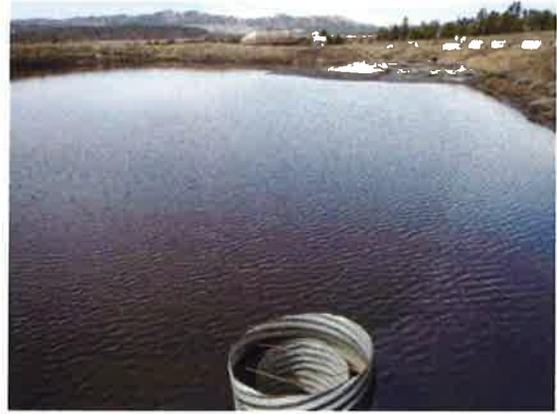
Pond 1

The operator has repaired structural damage to the primary spillways of Ponds 1, 1B, and 5. None of these ponds were discharging.

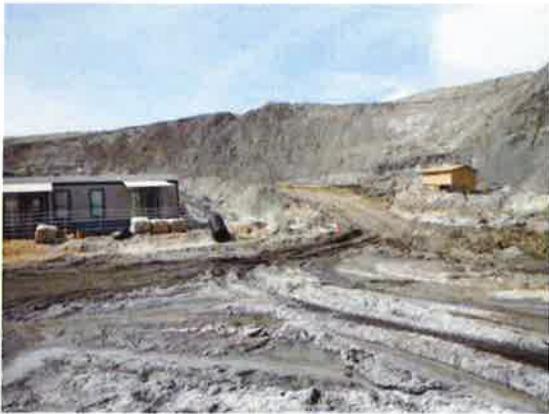
Primary haul road

The haul road is being maintained by scrapers, but is not yet restored to design standards. Culverts in the repair yard and along the haul road were unobstructed, except C11 which is more than 50% plugged with sediment. Mud on the haul road blocks the flow towards C16, but is not inside the culvert.
