Re: Joint Permit Application for repair of subsidence cracks on the East Fork of Box Canyon  
in Sevier County

**JOINT PERMIT APPLICATION FORM**  
**U.S. ARMY CORPS OF ENGINEERS - FOR SECTIONS 404 AND 10**  
**UTAH STATE ENGINEER'S OFFICE - FOR NATURAL STREAM CHANNELS**

Location: 038° 58' 50.3" N 111° 18' 18.1" W  
 Caption: Stream Alteration Permit - East Fork Box Canyon

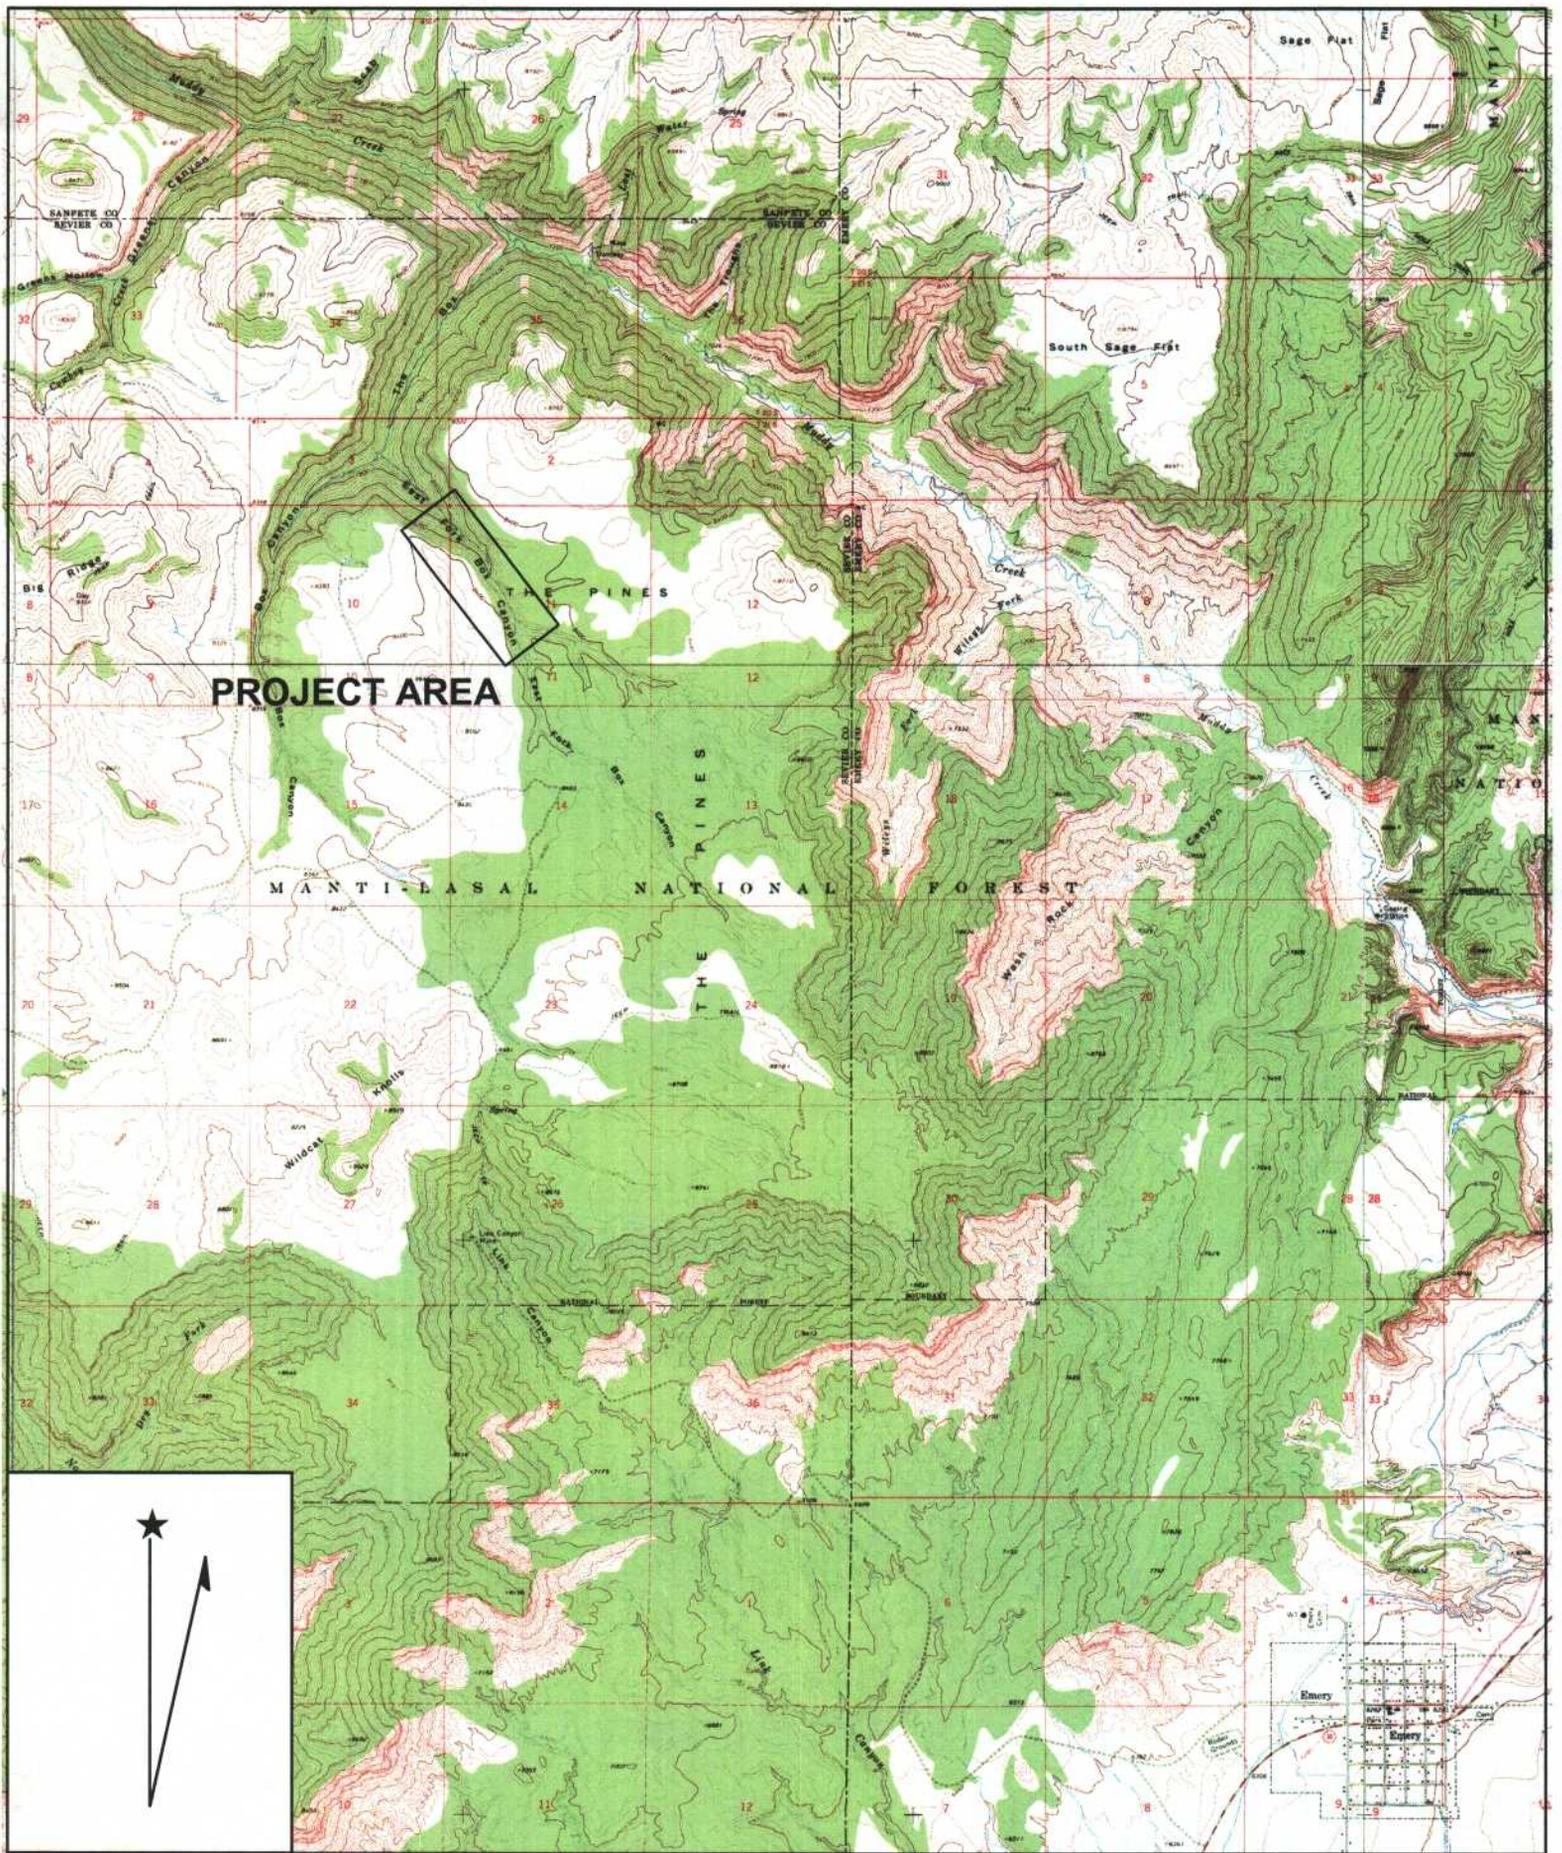
**PROJECT AREA**

Mining activity has occurred under this area resulting in small fracture and buckled zones where flow disappears for short distances and reappears down stream. The cracks will be repaired to ensure continuous flow of the stream.

- APPROXIMATE CRACK LOCATION
- SURVEYED CRACK LOCATION
- EFB MONITORING LOCATION
