2007 ANNUAL REPORT

CANYON FUEL COMPANY, LLC SUFCO MINE ACT/041/002

Re: 2007 Annual Report for Canyon Fuel Company LLC, SUFCO Mine
C/041/002, Sevier County, Utah

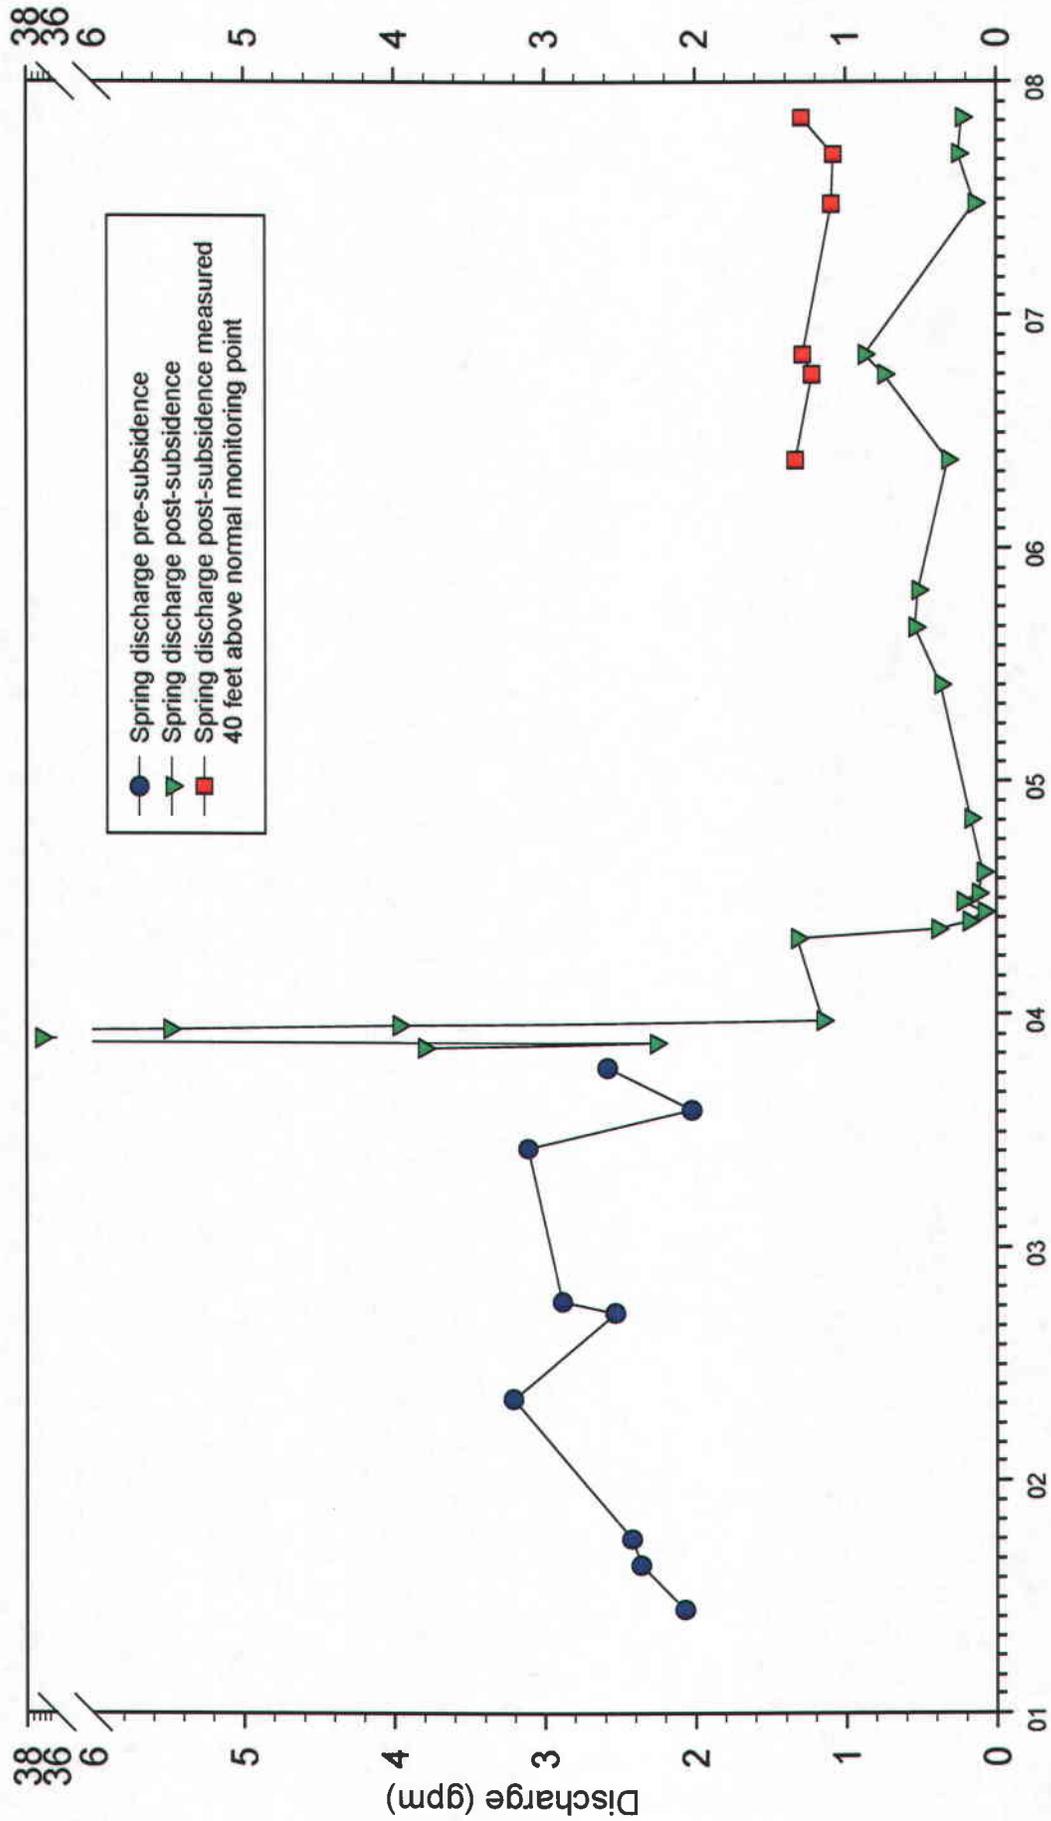
Figure 8 Discharge hydrograph for spring Pines 214.

Prior to the undermining and subsidence of the spring area, discharge from Pines 214 averaged about 2½ gpm (June 2001 through October 2003; Figure 8). Coincident with the undermining of the spring area, discharge from the spring surged to 37 gpm, then declined to as little as 0.08 gpm in June 2004 after mining in the area was complete. It is noteworthy that discharge from spring Pines 214 increased steadily from 0.09 gpm in August 2004 to 0.87 gpm in October 2006. The fact that groundwater discharge continues to occur from the groundwater system supporting the spring indicates that the Castlegate Sandstone groundwater system continues to operate (i.e. groundwater in the Castlegate has not been dewatered or diverted into deep horizons). Discharge from Pines 214 continued during 2007, although the discharge rate from the spring was somewhat lower than that measured in 2005 and 2006 (Figure 8). The lower discharge measured during 2007 is likely a result of the prevailing drought conditions during the year. It should be noted that the established historical monitoring point for Pines 214 is situated immediately below a sandstone ledge several tens of feet below the spring discharge location. Subsequent to the undermining of the spring area, the sandstone ledge over which the spring discharge flows before reaching the monitoring station was cracked. Consequently, some of the spring discharge is diverted into the bedrock or colluvial sediments immediately upstream of the monitoring point and this discharge is not included in the discharge value reported to the Division of Oil, Gas and Mining for spring Pines 214 (this discharge likely flows diffusely into the East Fork stream

channel about 30 feet below the monitoring point). For the purpose of obtaining a more representative spring discharge measurement, discharge from Pines 214 has also been measured immediately above the sandstone ledge (about 40 feet higher in the drainage) since 2006. It is apparent in Figure 8 that the discharge from Pines 214 measured during drought conditions in 2007 is approaching that of pre-mining levels.

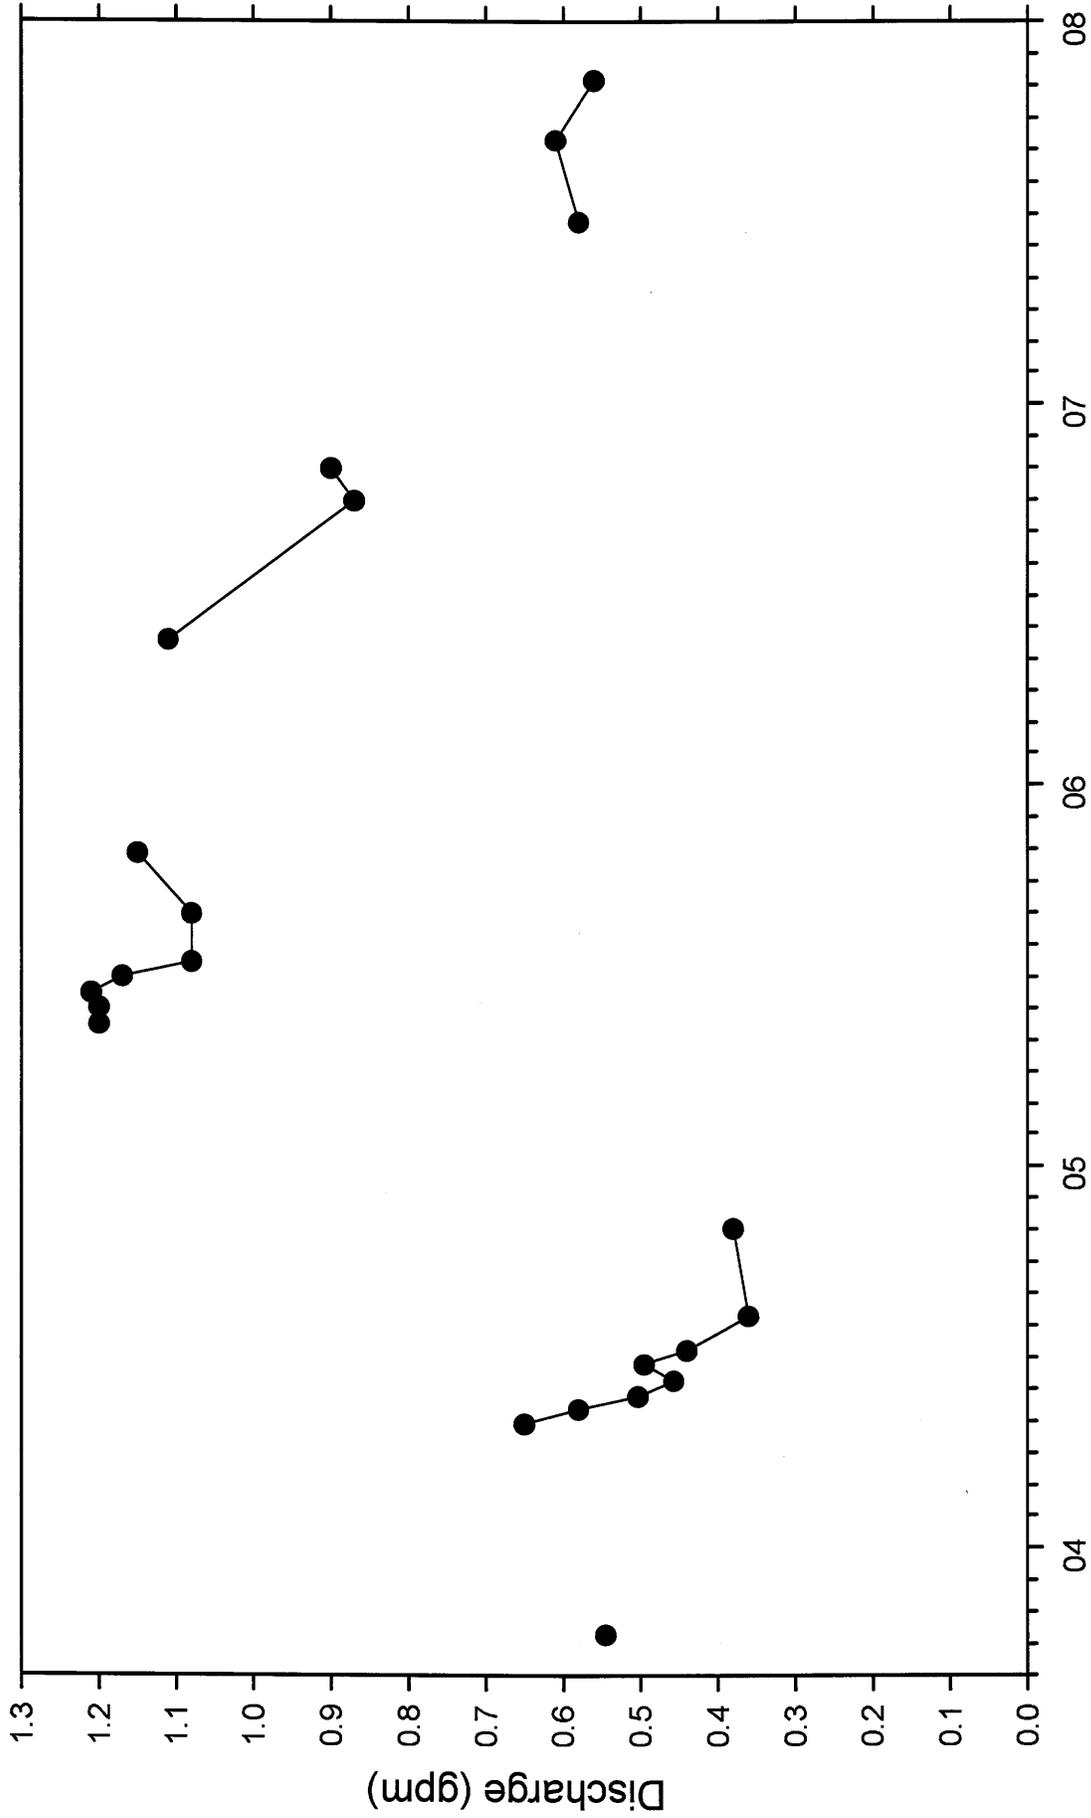
Figure 9 Discharge hydrograph for EFB-8 spring.

Discharge from spring EFB-8, which also discharges from the Castlegate Sandstone has not been detrimentally affected by mining-induced subsidence and continued during 2007 to discharge at rates consistent with those measured prior to the undermining and subsidence of the spring area. (Figure 9).
