2009 ANNUAL REPORT			Page 2

On July 15, 2009, the Pines Tract Area was visited by Keith W. Zobell (Environmental Specialist), Mike Davis (Mining Engineer for Canyon Fuel Company, SUFCO Mine), and Leland Roberts (Environmental Engineer for Canyon Fuel Company, SUFCO Mine). The purpose of this trip was to revisit all of the original photographic points that have been established and to retake photographs at each of the sites and to determine the general vegetative growth, plant vigor, and plant condition at each of the established photographic sites. These sites are revisited each year at approximately the same date each year, so as to reduce any possible seasonal variations. Photographs of each site are identified and included in this report.

LINK CANYON MINE PORTAL VEGETATION STUDY

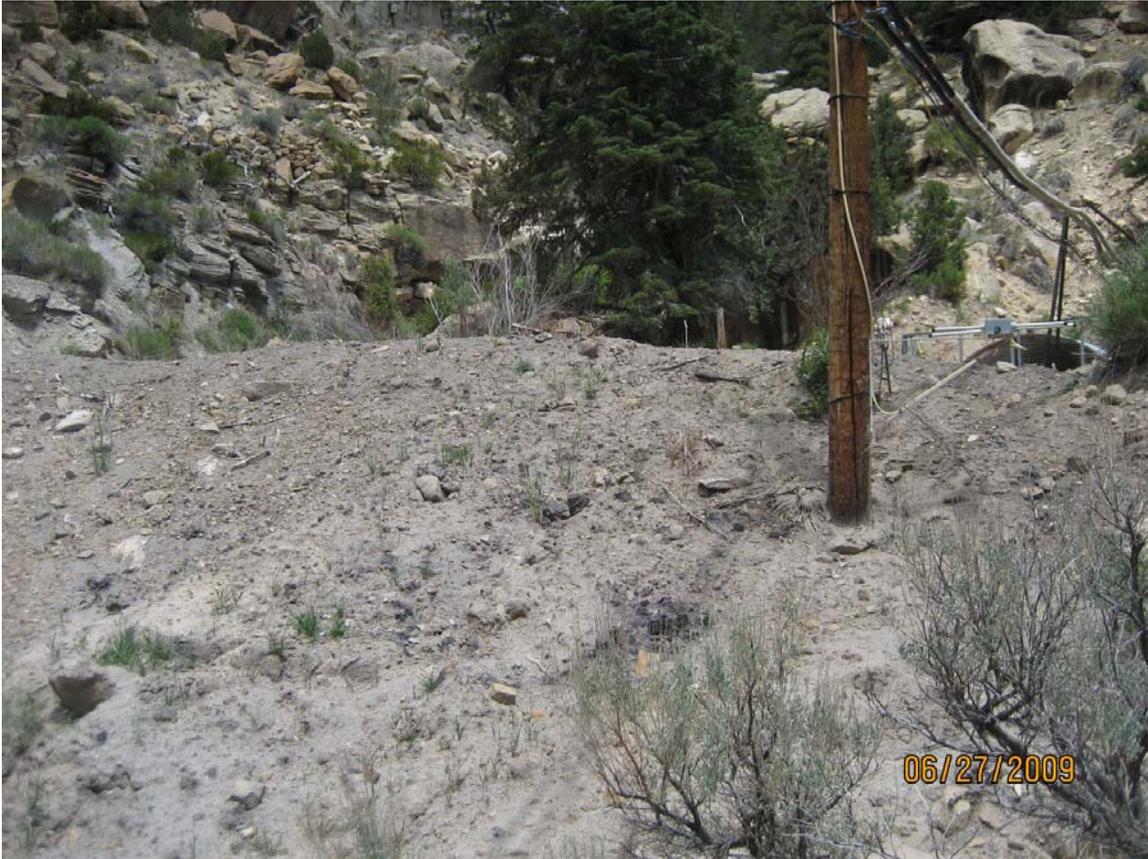
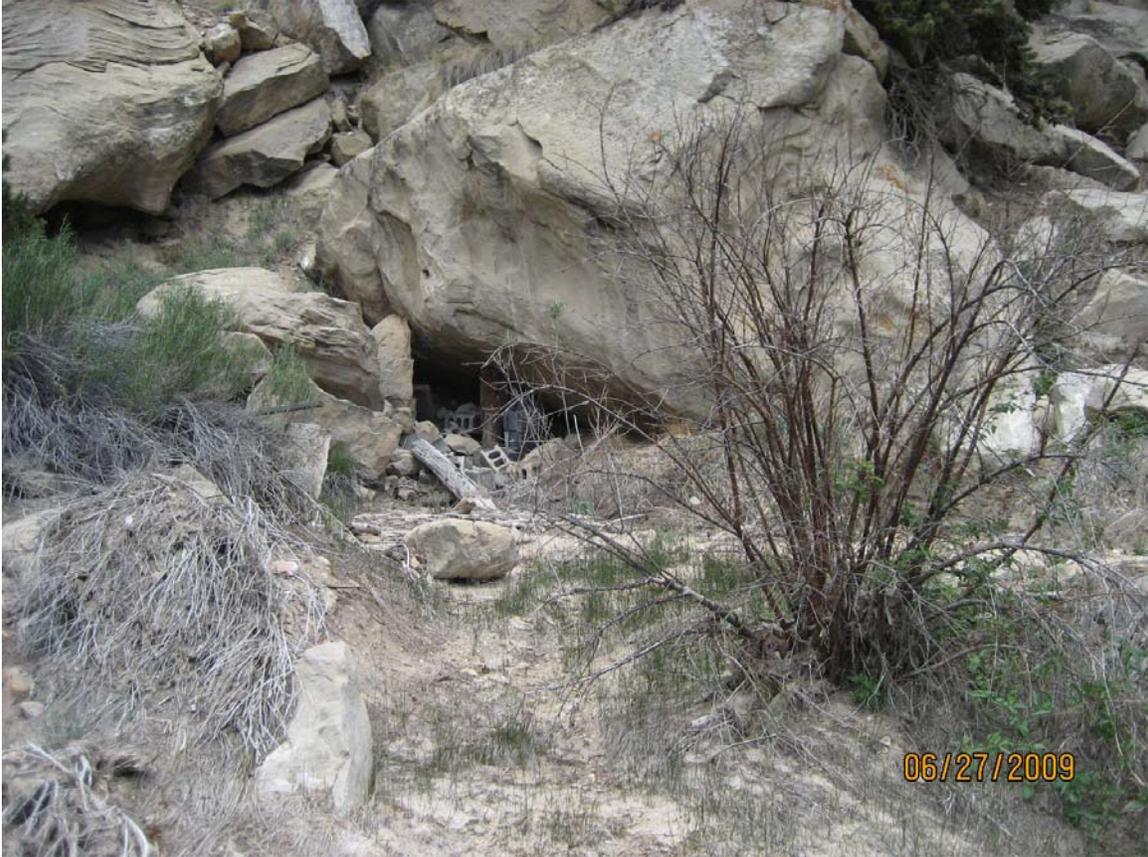
Link Canyon East Portal Photo Point

There is no water discharging from this portal and there is no evidence that there has been any this spring. The wiregrass (*Juncus balticus*) is starting to recover from last years flood. The wiregrass area has approximately 50% ground cover with 8-9 inches of new growth. Only one branch of the Dogwood bush (*Cornus stolonifera*) is still alive. However there are numerous sprouts coming up from the base of the bush with 4-5 inches of new growth. The Clematis (*Clematis liquisticifolia*) is just starting to grow with 3-4 inches of new growth. The Rabbitbrush (*Chrysothamnus nauseosus*) has 3-4 inches of new growth. There is no evidence of any Bluegrass plants. There some Cheatgrass (*Bromus tectorum*) growing on the site. Both sites continue to be very dry.
