INTERUPTION OF FLOW – SOUTH FORK OF QUITCHUPAH CREEK

Area Undermined: Dec 2013 - Jan 2014

Per commitments in Sufco's approved "Monitoring and Mitigation Plan for Undermining the South Fork of Quitchupah 2R2S Block "A" and 3R2S Block "B". We have prepared a summary report describing recent monitoring and subsequent mitigation activities.

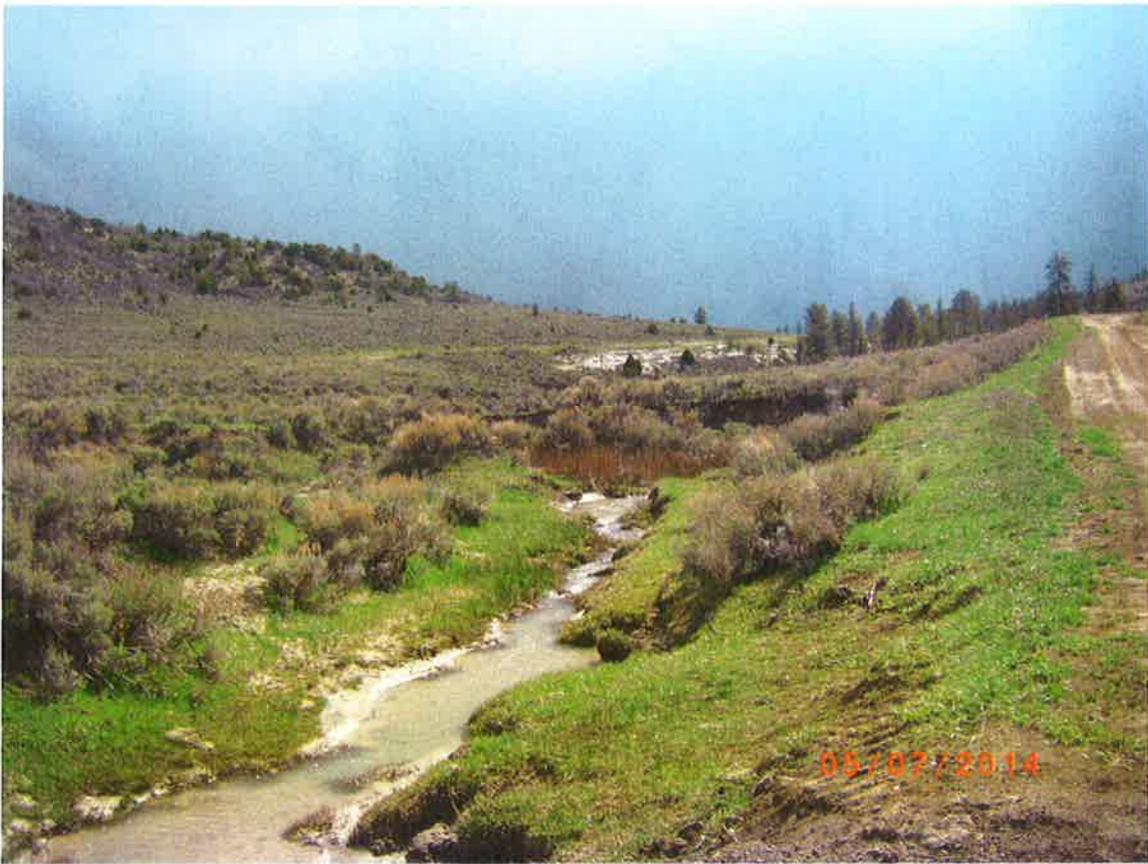
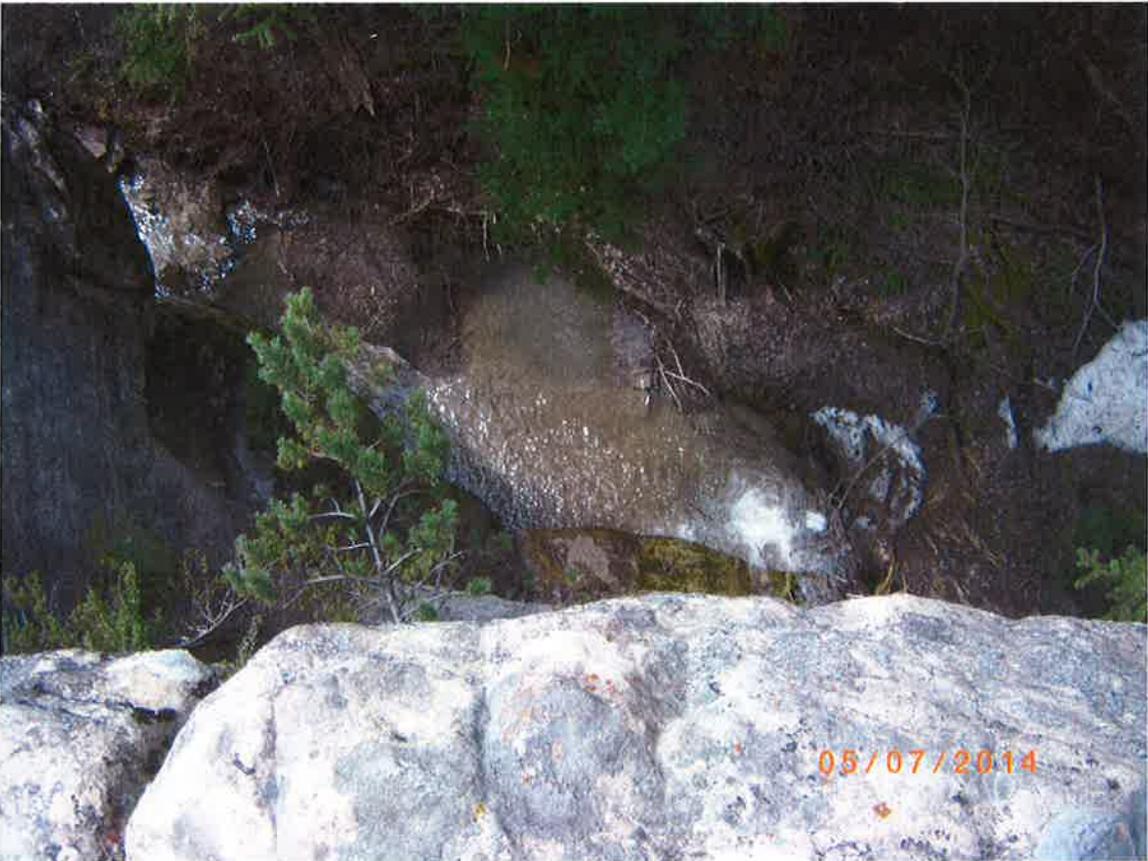
Water
flowing
fine

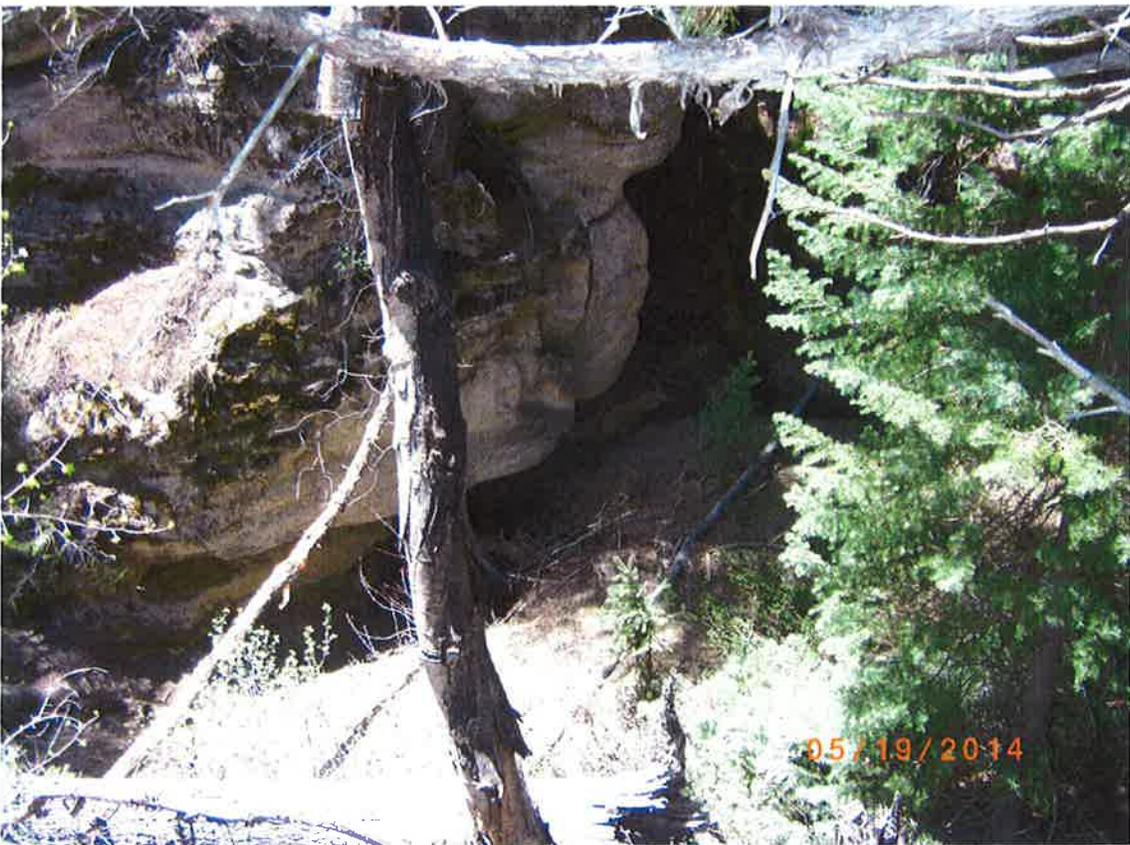
May 20 - The water was bypassing the area where the cracks had been repaired (with native material) and proceeding downstream.

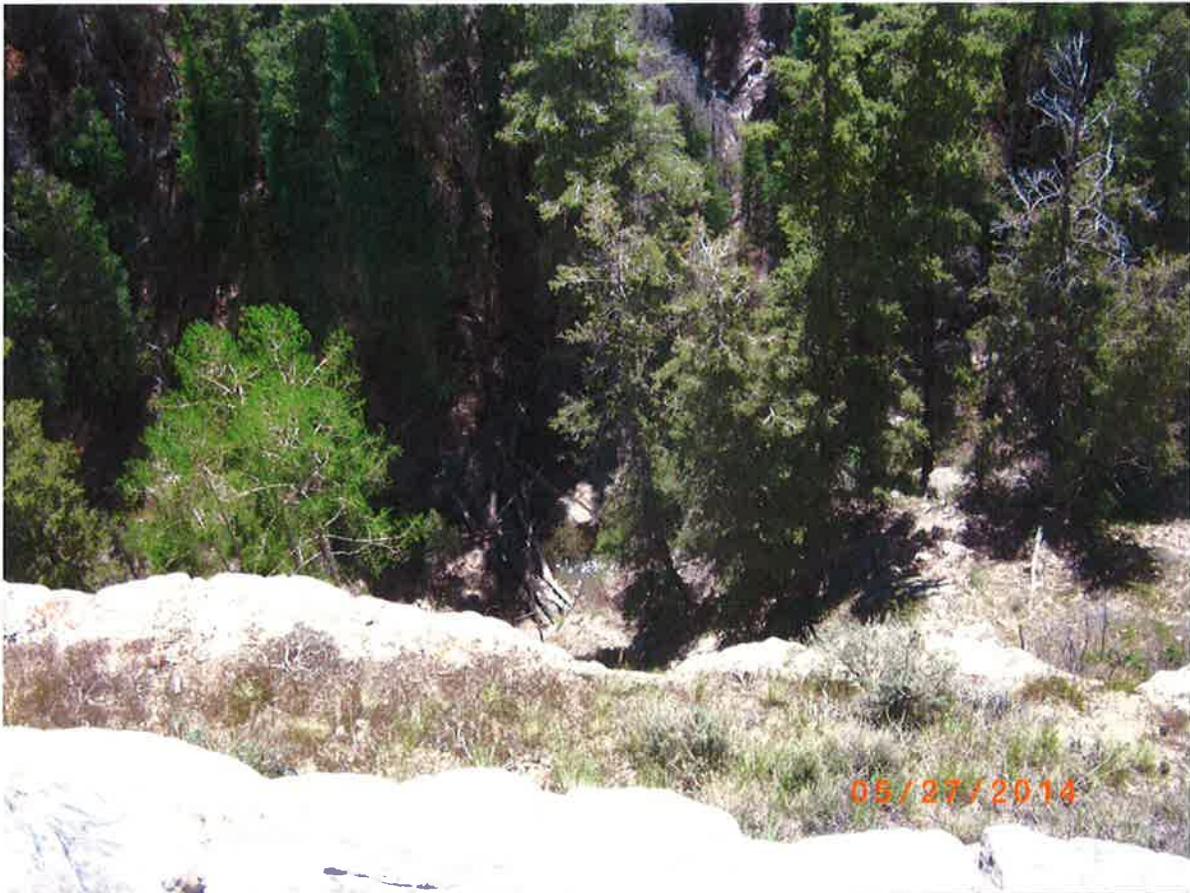
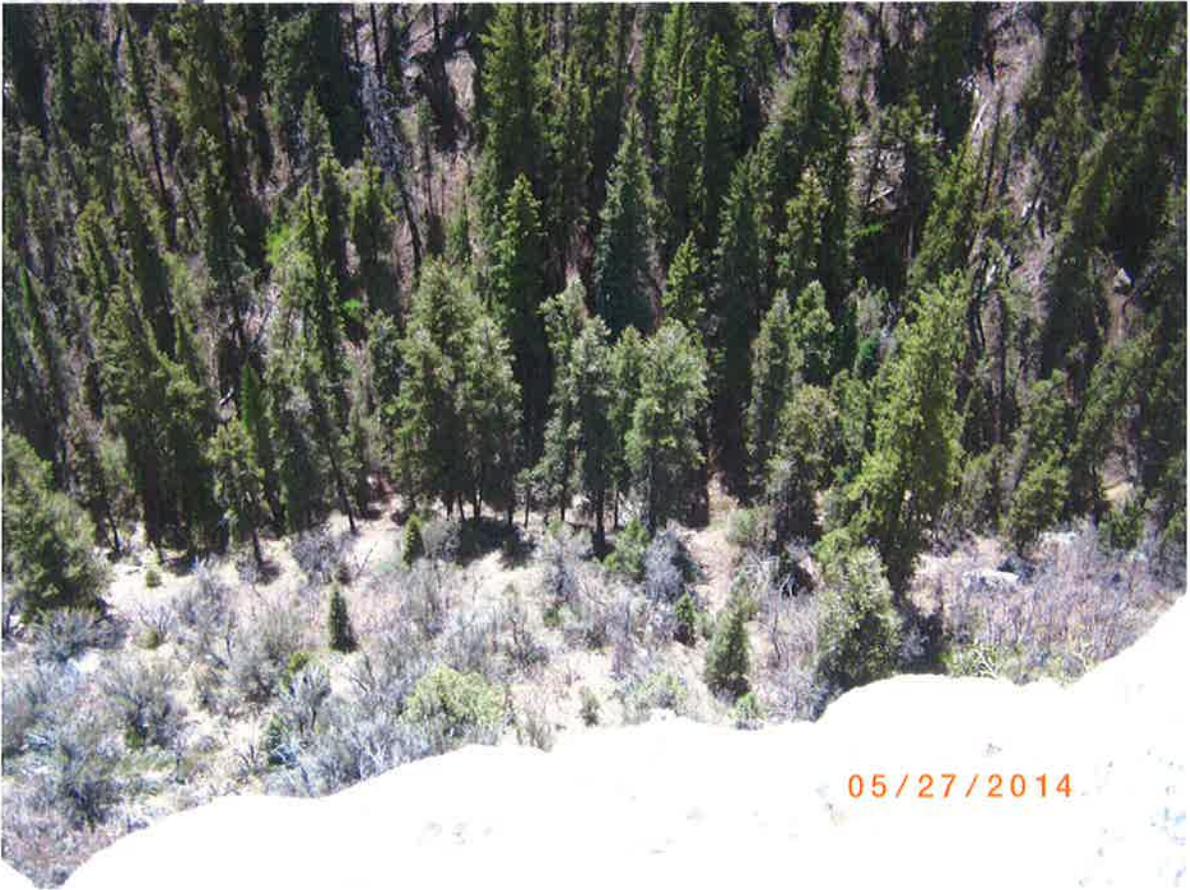
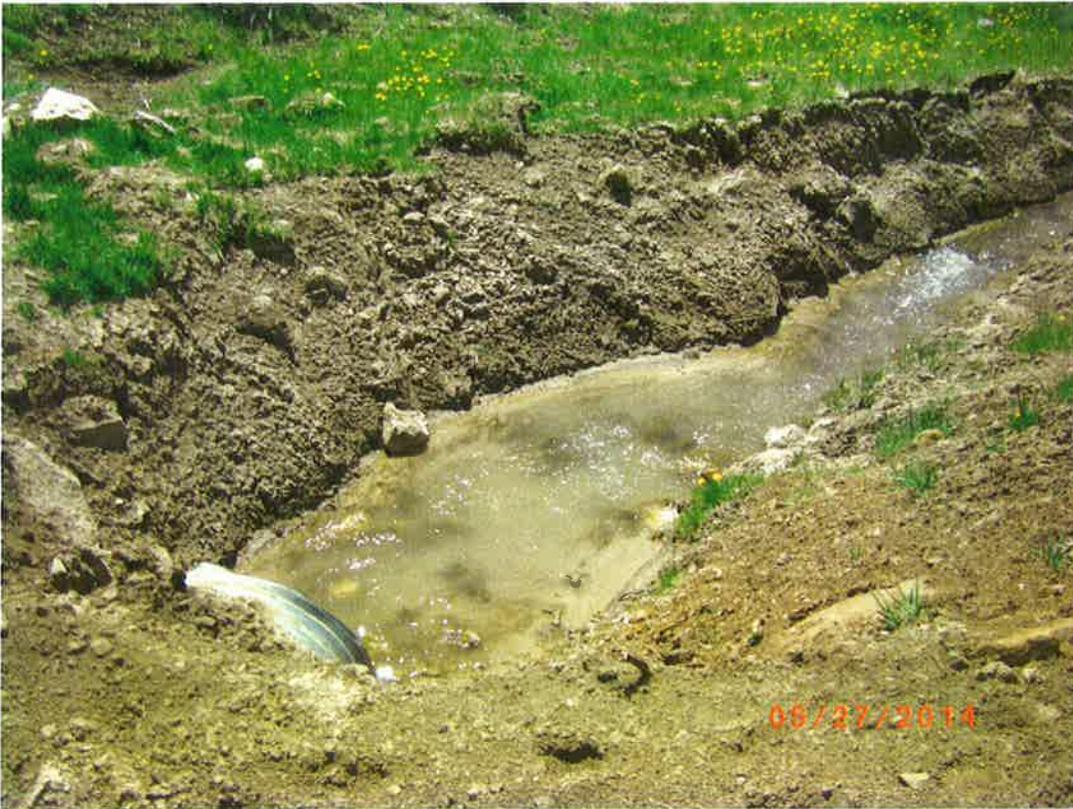
May 29 - The creek was observed to be flowing from monitoring point 006A to the confluence of the North and South Forks of Quitcupah Creek. Estimated flow was +/- 300 gpm at about 200 yards downstream from monitoring point 006A. On May 28th flow at 006C was measured at 276 gpm and at 006D was 321 gpm. Additional flow measurements by Petersen Hydrologic, LLC are scheduled for June 10th.
