Subject: Request for solid and hazardous waste determination, Wellington Prep Plant, Wellington, Utah

Investigation of the Chemical Characteristics of Material in The Coarse Refuse Pile at the Price River Terminal, LLC Wellington Prep Plant, Carbon County, Utah

31 March 2014

Price River Terminal, LLC
Wellington, Utah

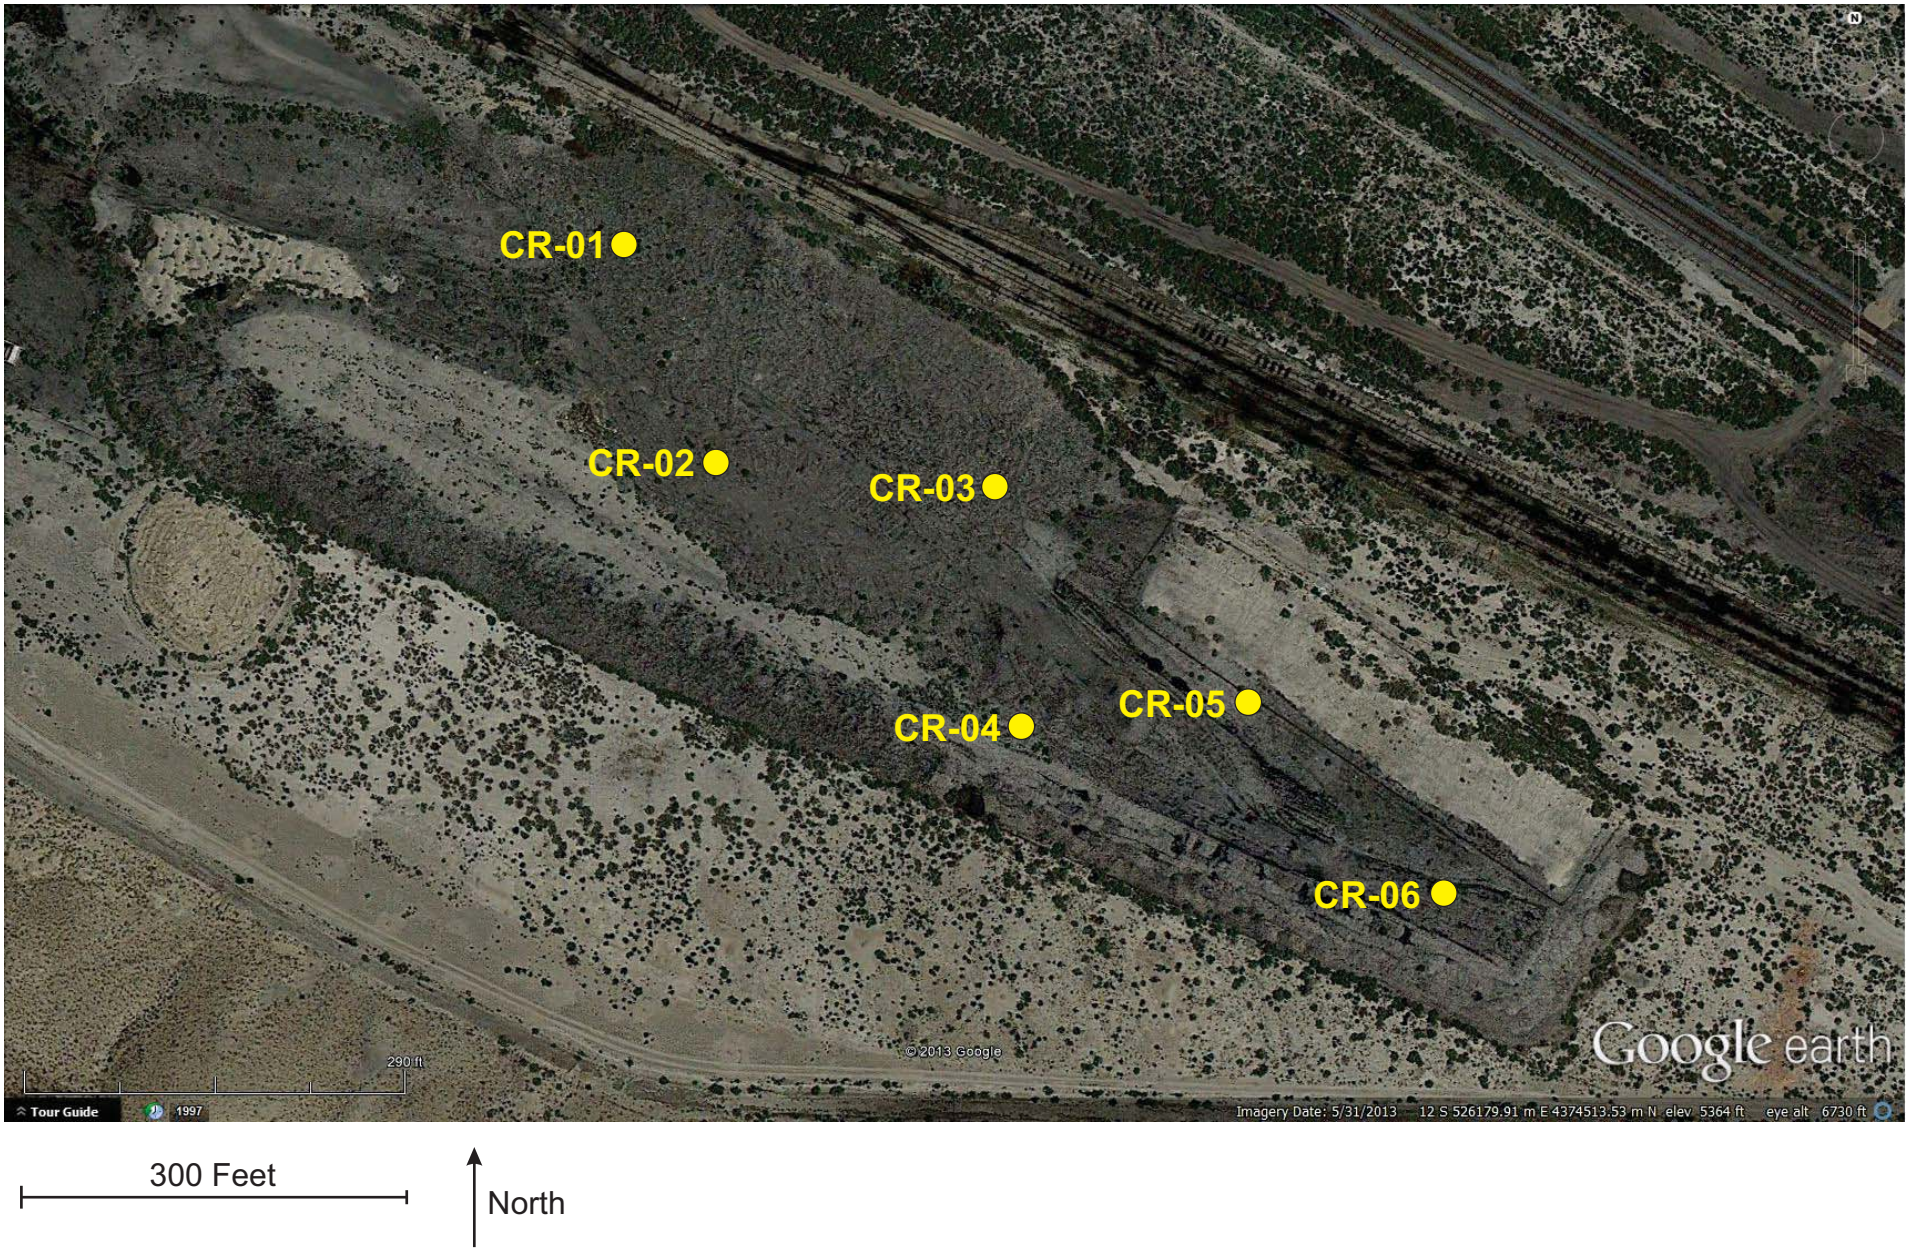
Figure 2 Location of the Coarse Refuse Pile at the Wellington Prep Plant site (oblique image view).

The long axis of the Coarse Refuse Pile trends in a northwest to southeast direction and is about 1,400 feet in length (Figure 2). The width is variable and ranges from about 300 to 400 feet. The footprint of the pile encompasses approximately 10.0 acres. The surface topography of the Coarse Refuse Pile is somewhat irregular. The height of the pile has not been measured, but based on visual observations it was estimated to be in the range of about 20 to 40 feet in most locations.
