**Re: Permit Renewal Application, White Oak Mining and Construction, Inc.
 White Oak Mine, ACT/007/001-RN99, Folder #2, Carbon County, Utah**

WHITE OAK COMPLEX - DISTURBED
3-D VIEW

FIGURE
R-12

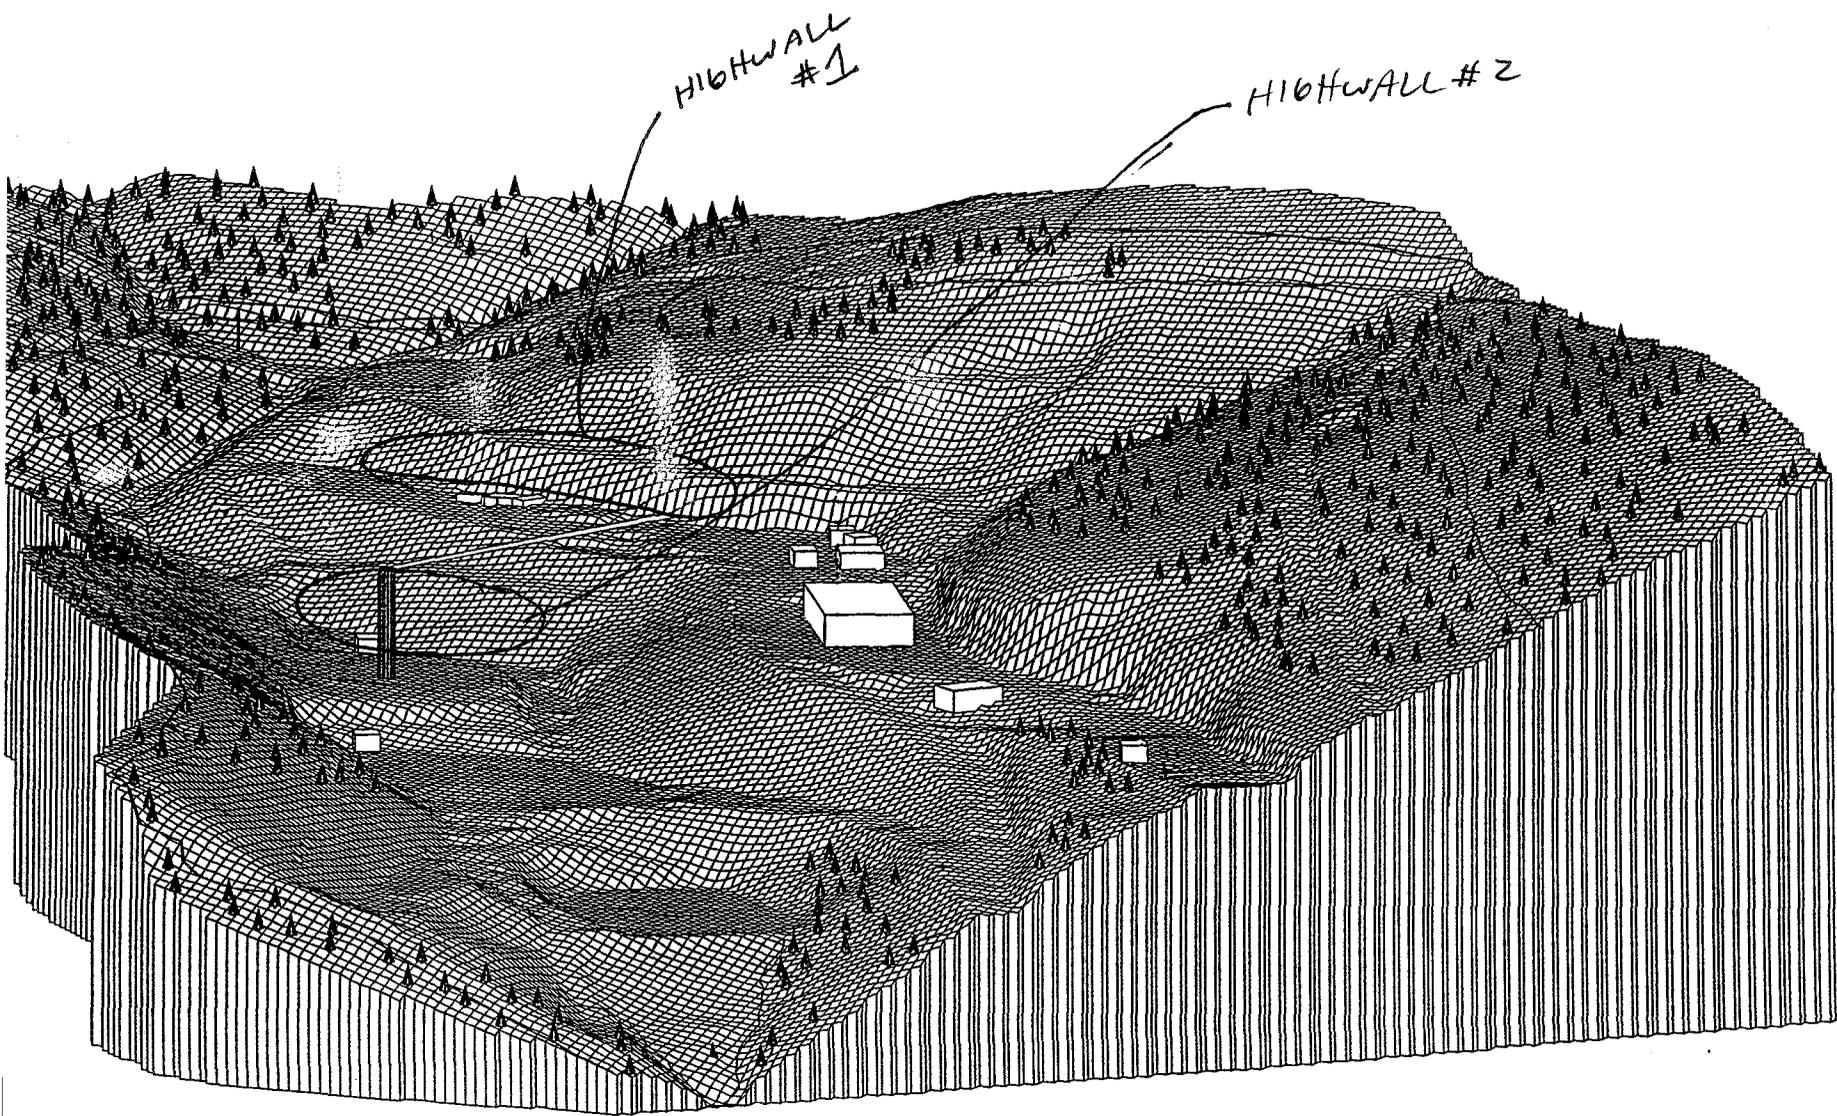
HIGHWALL #1 REMAINING AFTER RECLAMATION

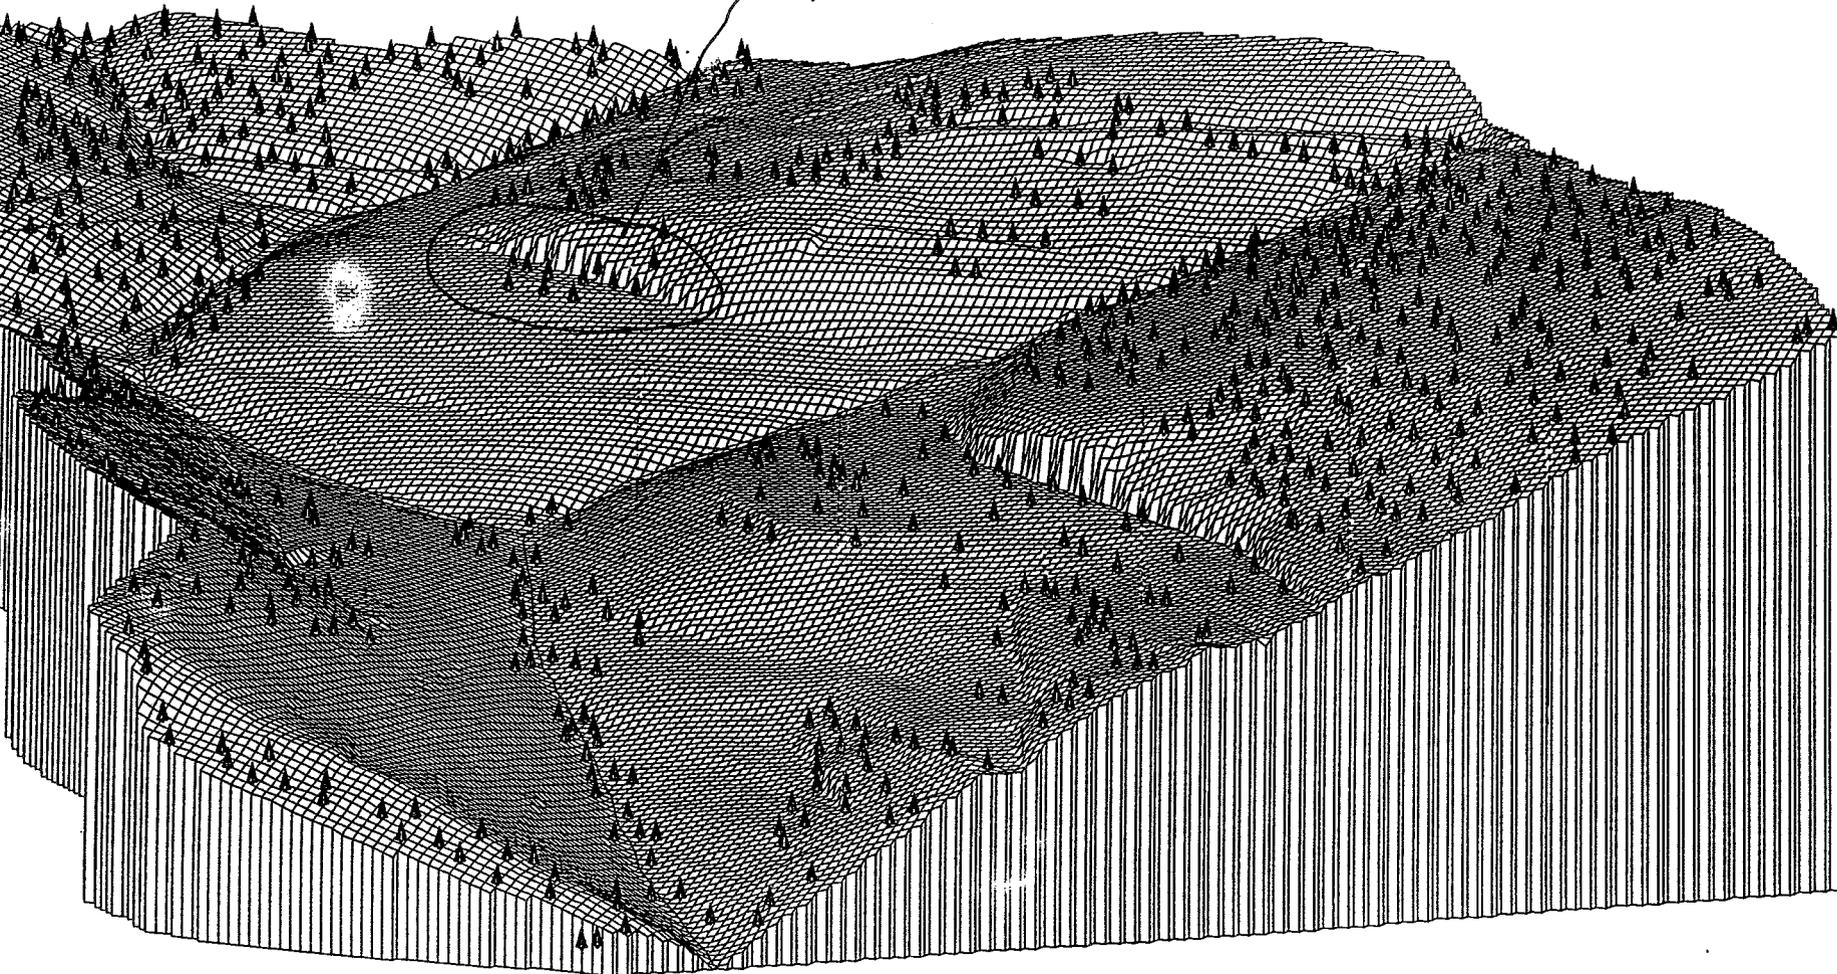
WHITE OAK COMPLEX - RECLAIMED
3-D VIEW

In order to develop reclamation contouring and associated volumes, both existing and future reclaimed contours have been entered into AUTOCAD for the entire disturbed area. Cut and fill volumes associated with reclamation activities were then developed utilizing Engineering Data Systems (EDS) software. Since soils which will be removed are not native undisturbed soils, but were placed during mine development, it was recommended by a professional geotechnical engineer that a compaction factor of 5% be added to the calculation of all cut materials. Calculations shown in Appendix R2 reflect this recommendation.
