Re: Resource Recovery and Protection Plan (R2P2) Modification, Early Recovery of 3rd Left Longwall Panel, Starpoint #2 Mine

On December 13, 1995, the Bureau of Land Management (BLM) received from Cyprus Plateau, a notice that the 3rd Left longwall panel was shortened by 180 feet to allow the safe extraction of the machinery due to adverse ground conditions. The subject area is in the Wattis Seam on Federal coal lease U-64263.

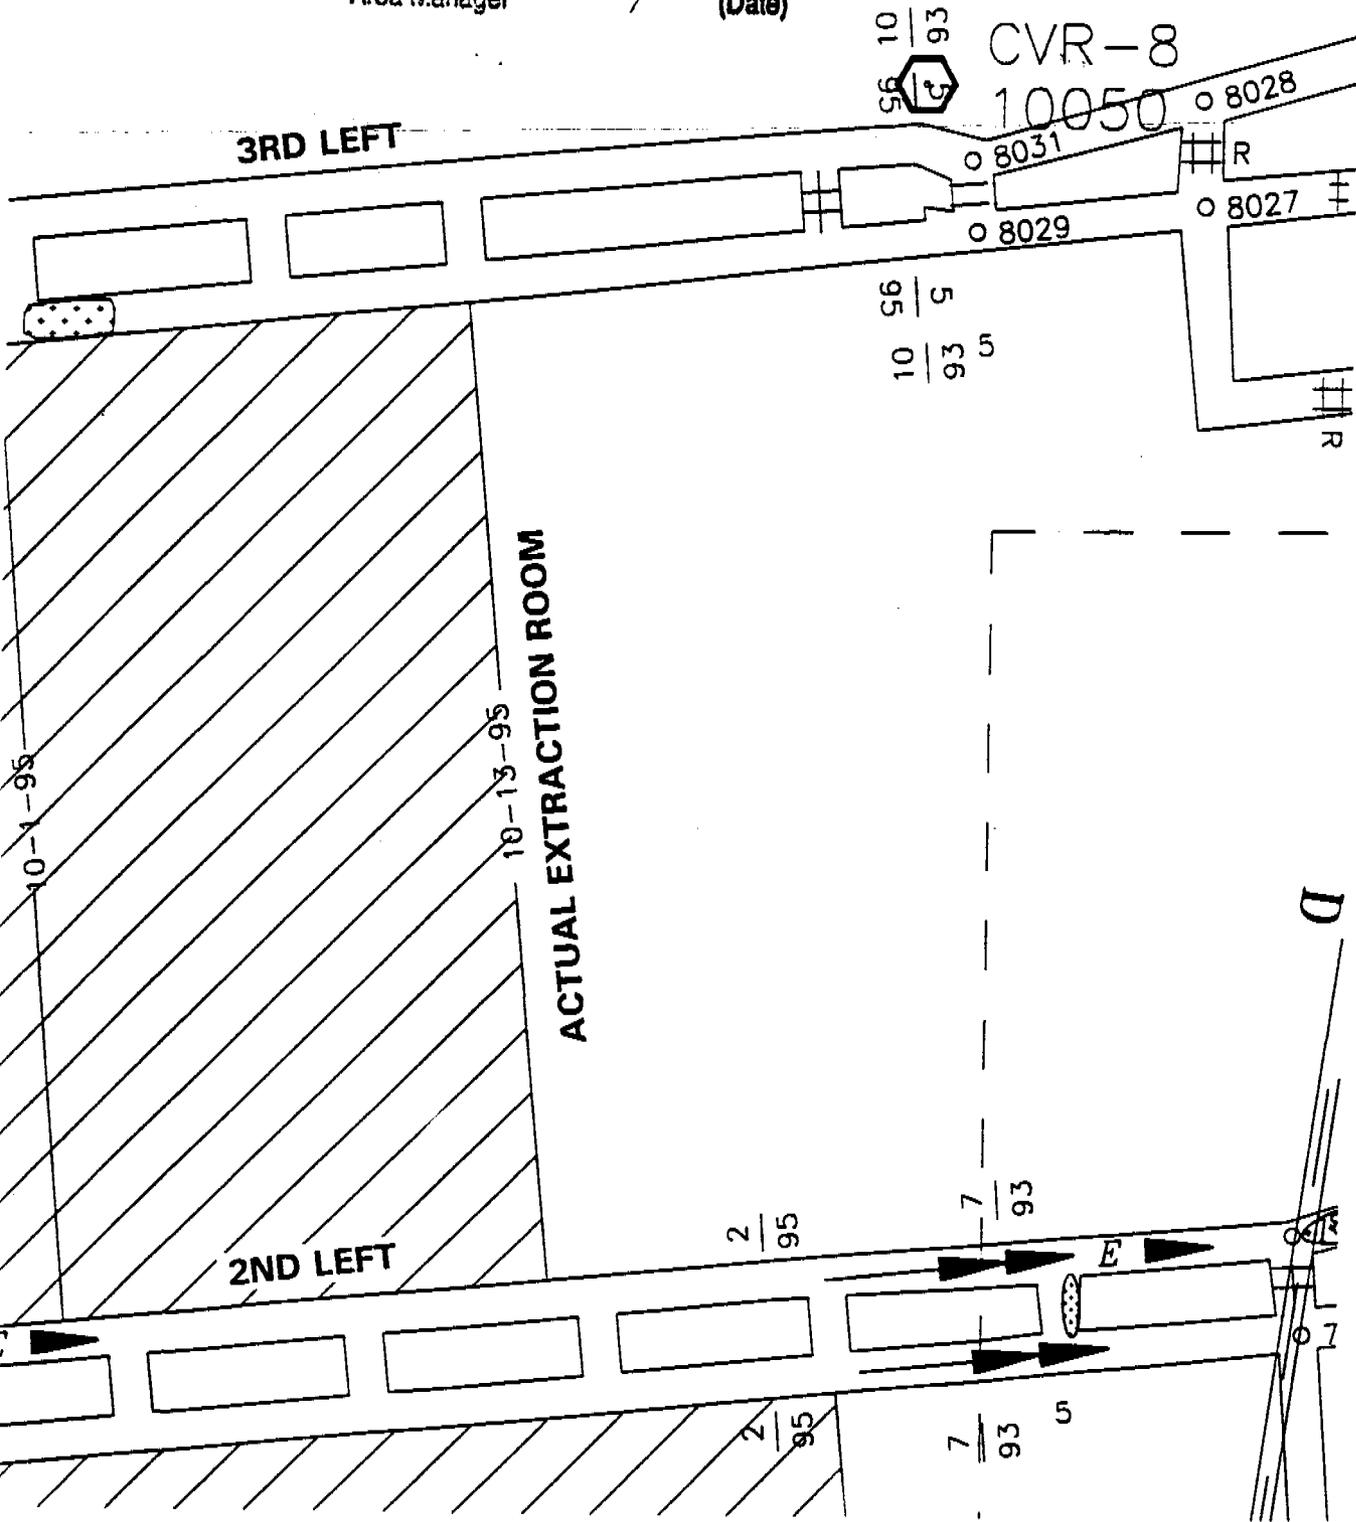
The BLM has determined that the proposed modification to the R2P2 is in compliance with the Mineral Leasing Act of 1920, as amended, the regulations at 43 CFR 3480, the lease terms and conditions, and will achieve maximum economic recovery of the Federal coal. Cyprus's decision to extract the longwall at crosscut 7 from the 3rd Left panel was unauthorized at the time, but BLM agrees with the action. A copy of the approved mine map is enclosed.

MINOR MODIFICATION TO
MINING PLAN APPROVED BY
BUREAU OF LAND MANAGEMENT
Recommended By:

Cyprus states poor roof conditions along the margins of a sandstone channel were encountered that forced the early extraction of the longwall at crosscut 7 instead of crosscut 5 in the 3rd Left headgate entries. Loose roof rock associated with the channel margin extended along the headgate entries and a large cave buried the stage loader. These unsafe conditions necessitated the move of the longwall. Cyprus, of their own accord, notified BLM personnel that they had moved the longwall without first notifying the BLM. According to Cyprus, this was an oversight, as key officials who deal regularly with the BLM were absent. The letter for formal approval was sent later.
