Re: Updated Cumulative Hydrologic Impact Assessment (CHIA), Gentry Mountain, Hiawatha Coal Company, Hiawatha Mine, C/007/0011, Outgoing File

- Figure 1: **Hiawatha Mine Discharge: Upper Tie Fork and Graben Goose**
- Figure 1a: **Hiawatha Mine Discharge at Mohrland**
- Figure 2: **Hiawatha Mine Discharge: Graben Goose & Bear Canyon Springs**

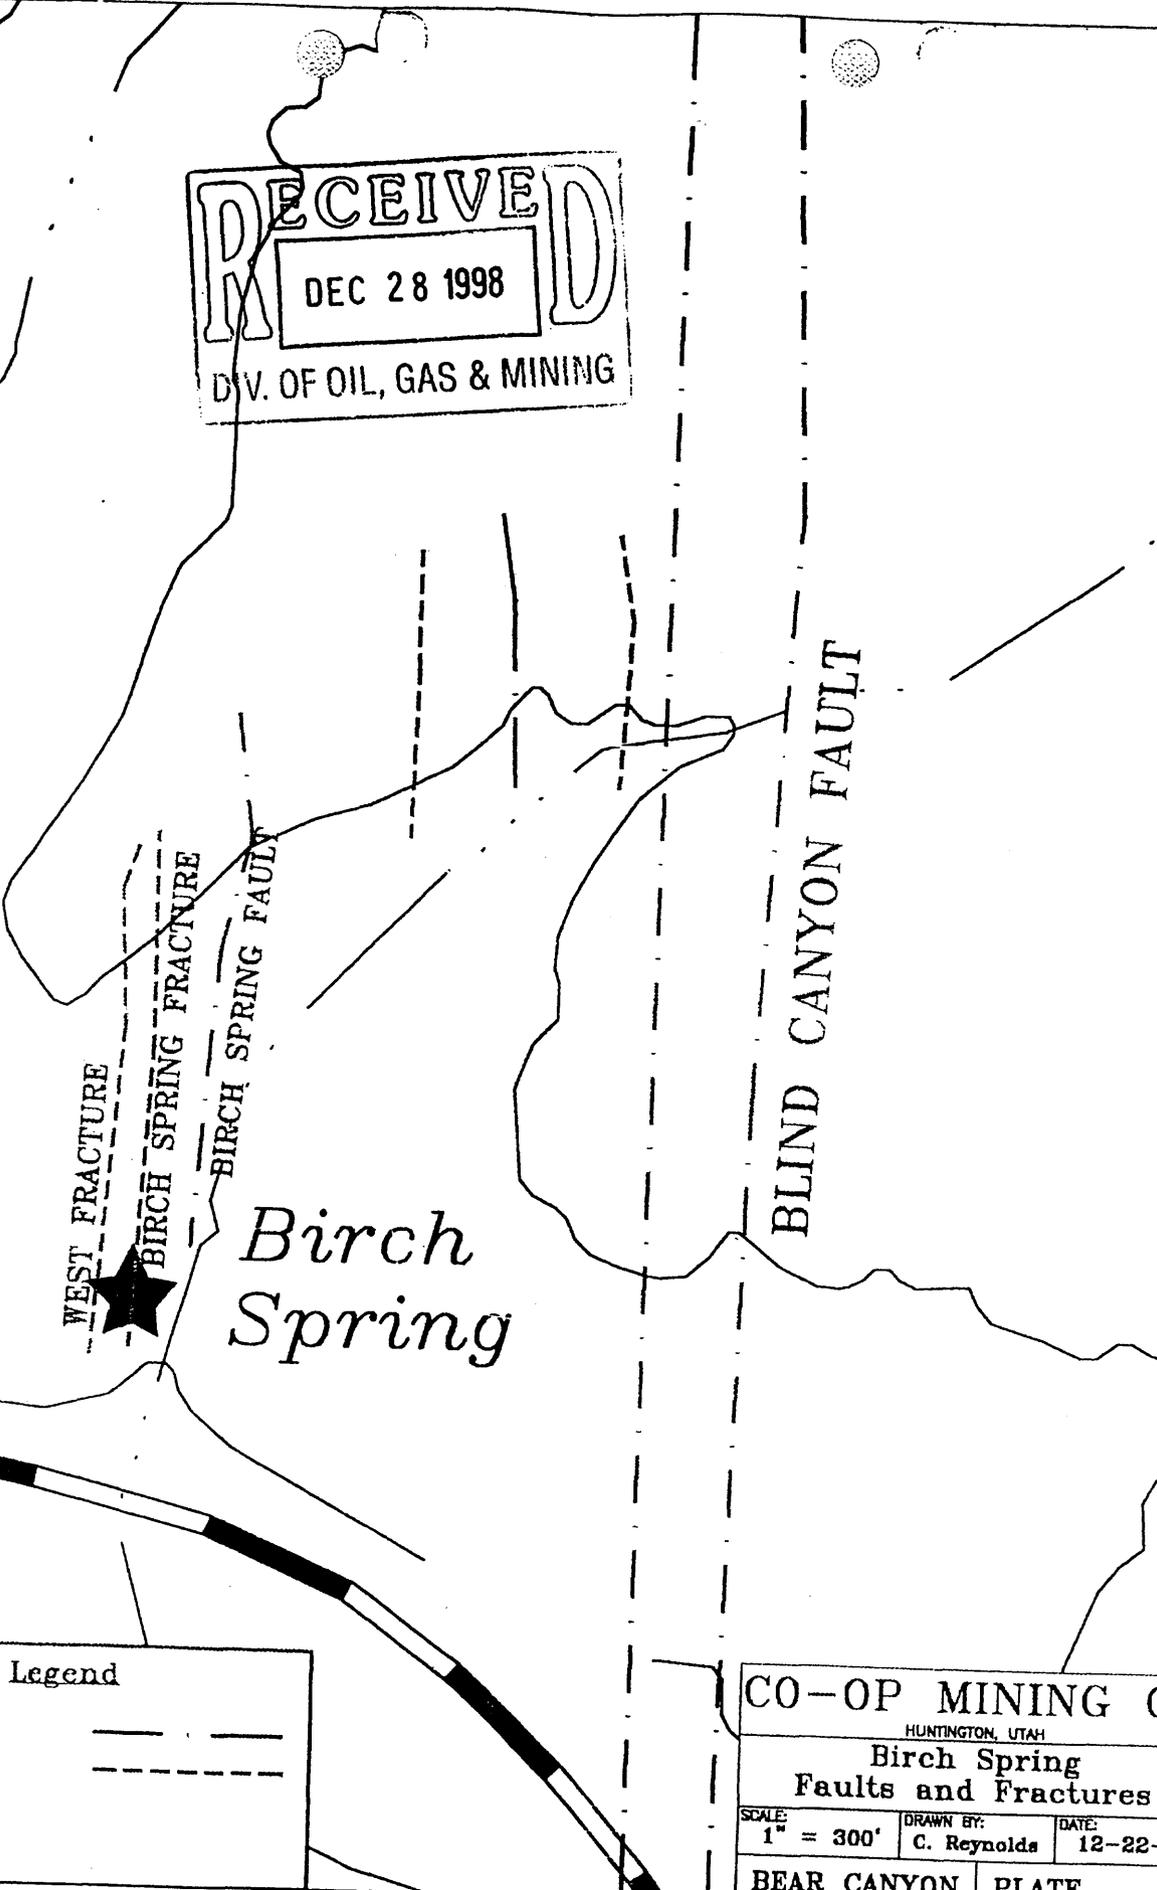
CO-OP MINING CO.		
HUNTINGTON, UTAH		
Birch Spring Faults and Fractures		
SCALE: 1" = 300'	DRAWN BY: C. Reynolds	DATE: 12-22-98
BEAR CANYON		PLATE

WEST FRACTURE

BIRCH SPRING FRACTURE

BLIND CANYON FAULT

Legend	
FAULT	— — — — —
FRACTURE	- - - - -

The survey included identifying the faults and fractures associated with and adjacent to Birch Spring. The survey began at Birch Spring. Birch Spring No. 1 and 2 sources flow from the South joint of a double fracture. A significant fracture was also identified 20 feet West of the Birch Spring fracture. A fault was observed East of Birch Spring having at least three points of offset totaling approximately 15 feet. These three geologic structures were then tracked simultaneously to the North.

During the survey, additional faults and fractures were identified East of these three structures. Two additional fractures and one additional small fault was observed East of Birch Spring and West of the Blind Canyon Fault. The total distance across this area was approximately 600 feet, with each structure being separated by what appeared to be competent blocks of formation with no significant fracturing, some as wide as 50'.

The two fractures and the fault surrounding Birch Spring were mapped Northward to the Ridge between the Birch Spring drainage and Blind Canyon (approximately 1,000 ft). The lack of outcrop prevented following the fractures beyond this point.

The attached map delineates the fractures which were mapped in relation to the Blind Canyon fault and the Spring. From the mapping, it appeared that the joints and fractures have good continuity and may conduct water horizontally in a North/South direction and vertically. Vertical conductivity, however, could potentially be limited by the shale layers, which appear to heal the fractures within the shale formations. None of the fractures converge with the Blind Canyon fault in the vicinity of Birch Spring, and no apparent flow paths were observed to facilitate East/West movement of water from the Blind Canyon Fault to Birch Spring. The fracture system could allow local recharge from precipitation and snowmelt into Birch Spring, which may be enhanced by surficial fractures and/or restricted by shale layers.

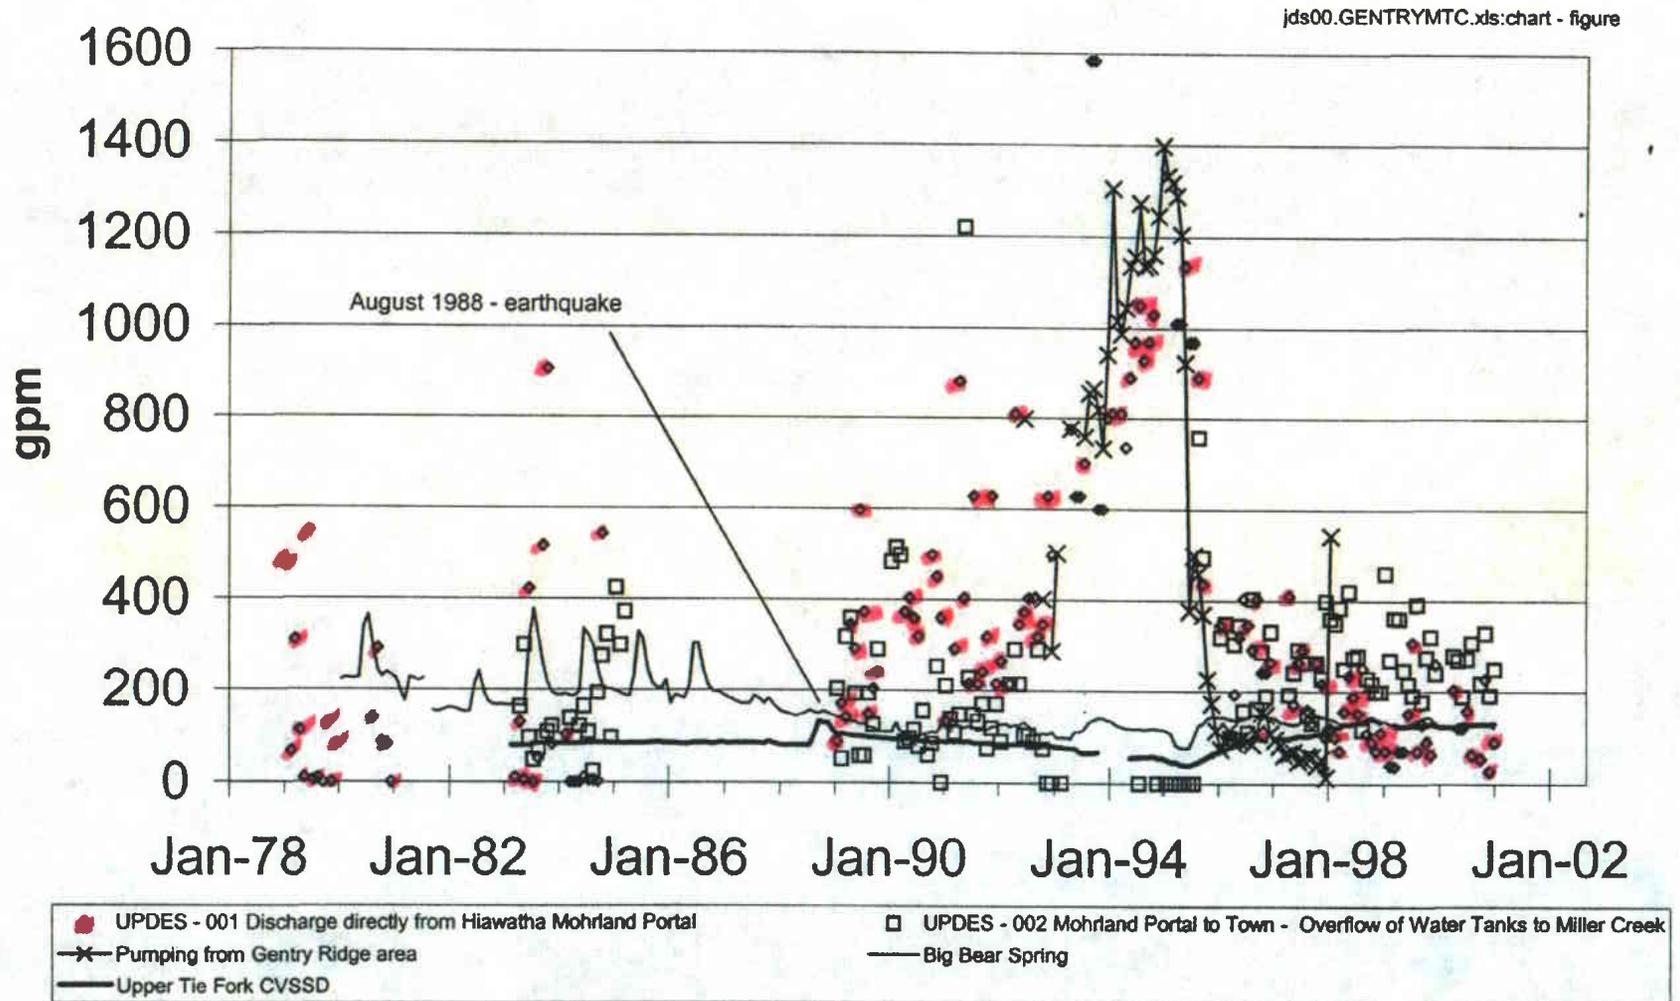
Figure 1

Starpoint Pumping - Hiawatha Discharge

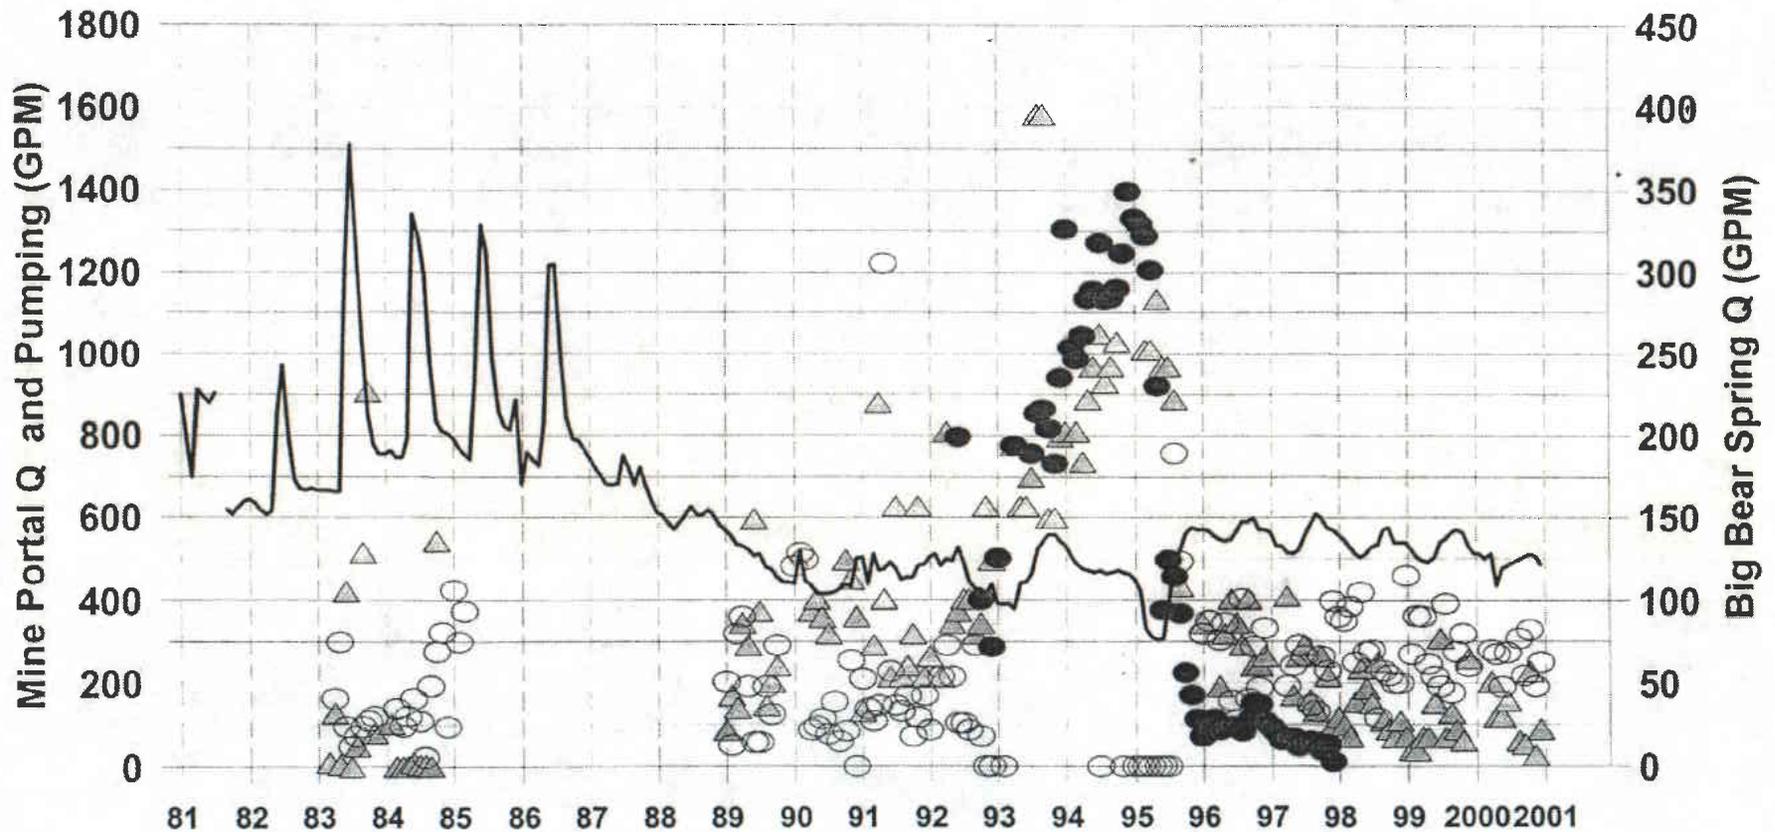
Figure 2

Hiawatha Mine Discharge

Graben Goose and Bear Canyon Springs

△ Moreland Portal UPDES-001

○ Mine Q to Miller Creek UPDES-002

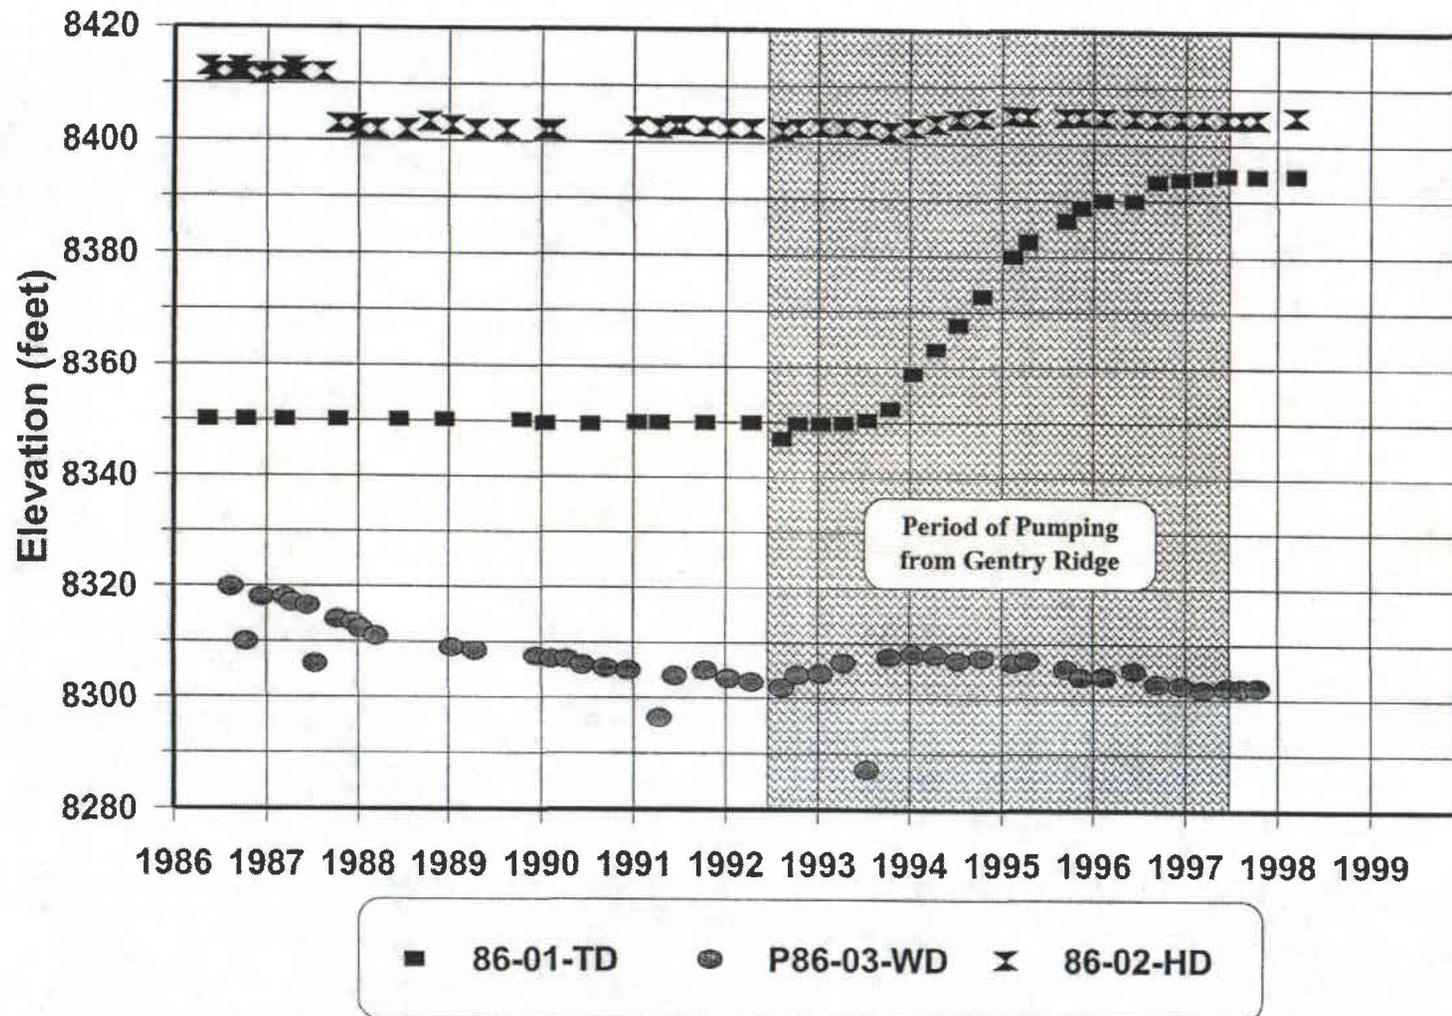
Figure 3

Star Point Wells

East of The Bear Canyon Fault

New springs may have developed below Gentry Ridge along the coal outcrops southeast and down dip from the mine sumps and well P86-01-TD (Figure 3). Water was pumped across the Bear Canyon Graben from the west into Area 8 and the Mother Goose sump in the Third Seam (Map 3). In a field visit to the Hiawatha Mine in 1997, UDOGM personnel noted that a considerable amount of water was flowing from seeps above and along the coal outcrops in the South Fork of Right Fork of Miller Creek. If these seeps and springs resulted from the pumping operations at the Star Point Mine they would have been expected to diminish after pumping operations ceased. No seeps or spring surveys were conducted in this region during or following pumping operations, and there has been no follow-up visit by the Division.

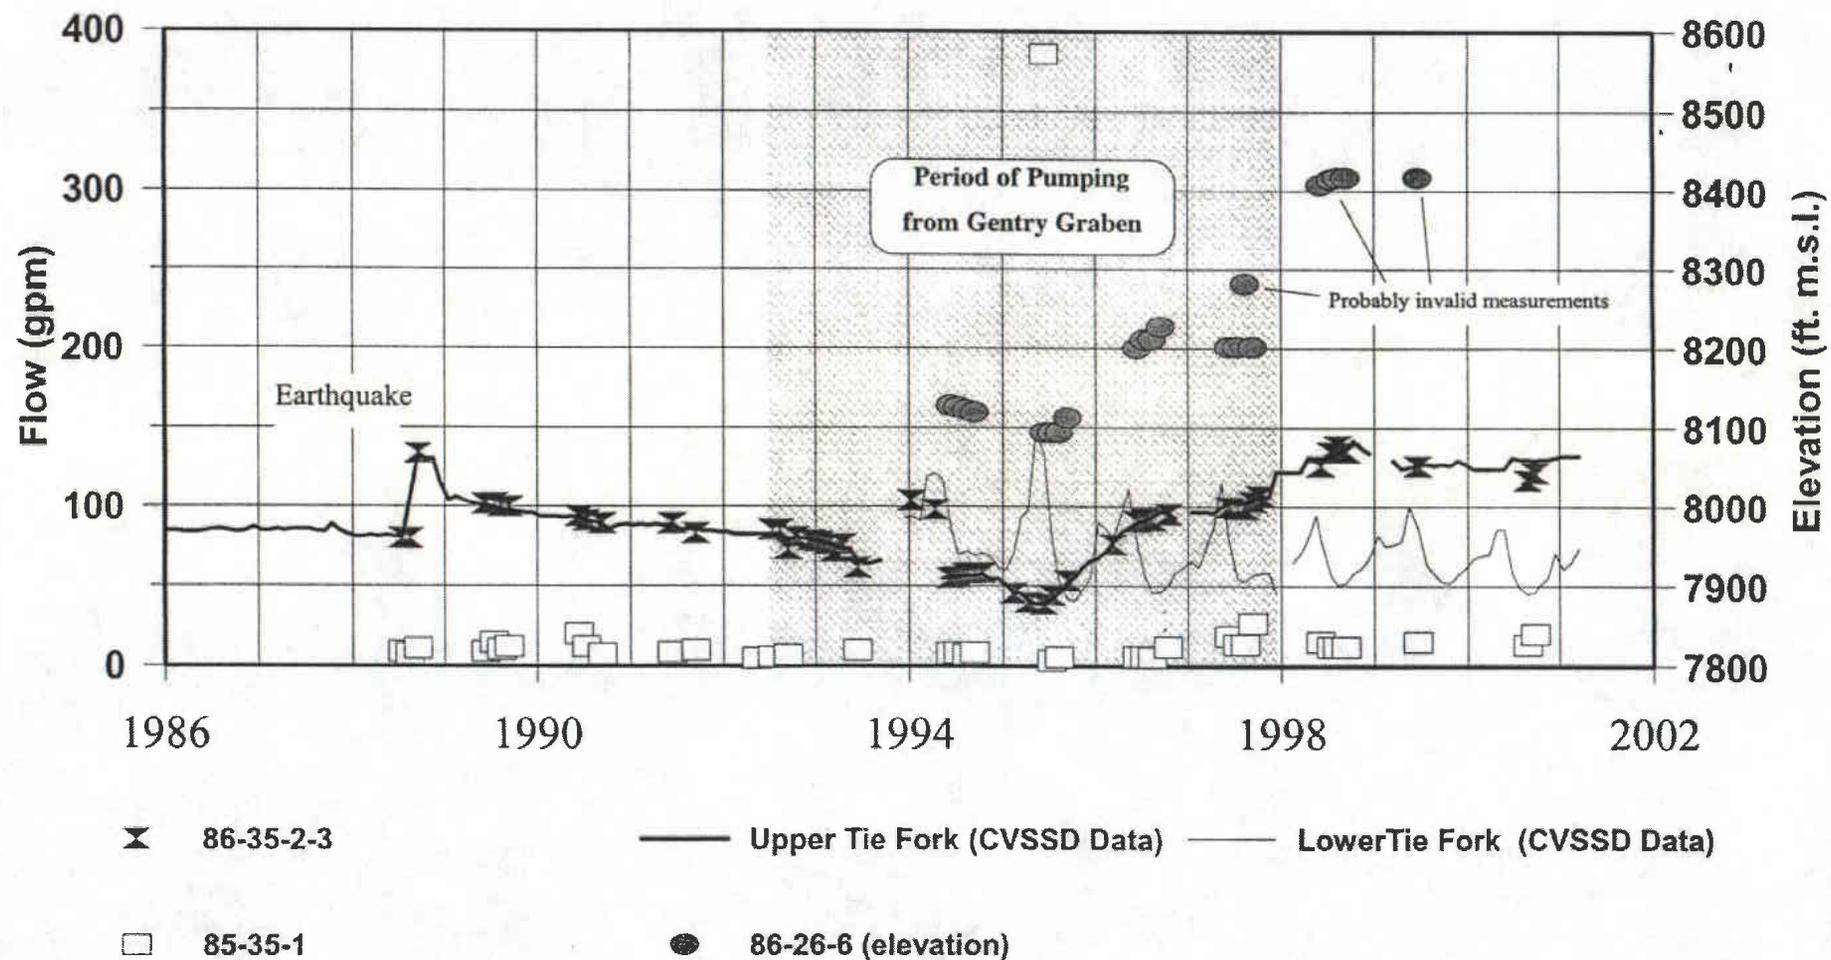
Figure 5

Tie Fork Wells and Related Monitoring Sites

Although Big Bear and Upper Tie Fork Springs had low flows recorded between April and June 1995, in May 1995 Lower Tie Fork had its highest recorded flow and the water level in well 85-35-1 spiked (Figure 5). All these extreme events occurred during dewatering of Gentry Ridge by the Star Point Mine. Lower Tie Fork Spring reached a low in October 1995, five months after the May peak. The 1995 lows at Little Bear and Upper Tie Fork can be simply explained by regional climatic influences, and at Big Bear by climate and maybe pumping at Star Point Mine, if a connection between the Pleasant Valley graben and Bear Canyon graben can be identified. Climate and pumping do not explain the peaks observed at Lower Tie Fork Spring and well 85-35-1. Lower Tie Fork Spring appears to respond independently from the other springs and it probably has a separate recharge zone.

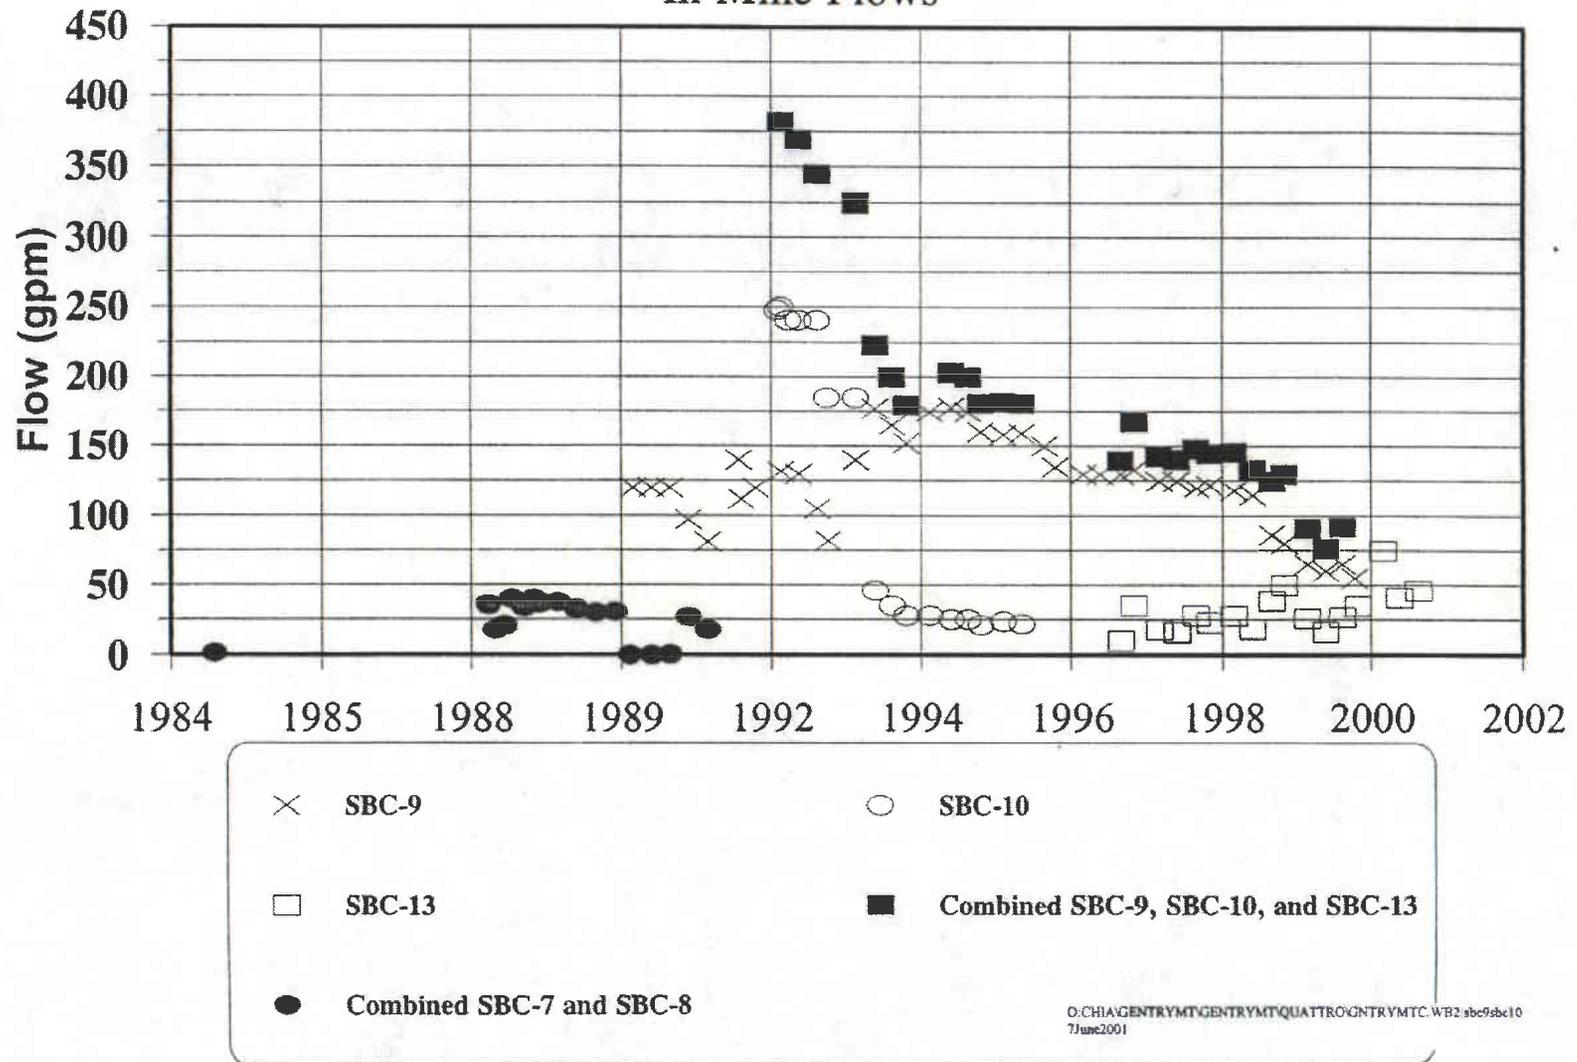
Figure 6

Bear Canyon Mine

In-Mine Flows

SBC-10 area began discharging from the gob at SBC-13: SBC-13 averages 30 gpm, and flow appears to be increasing (Figure 6).

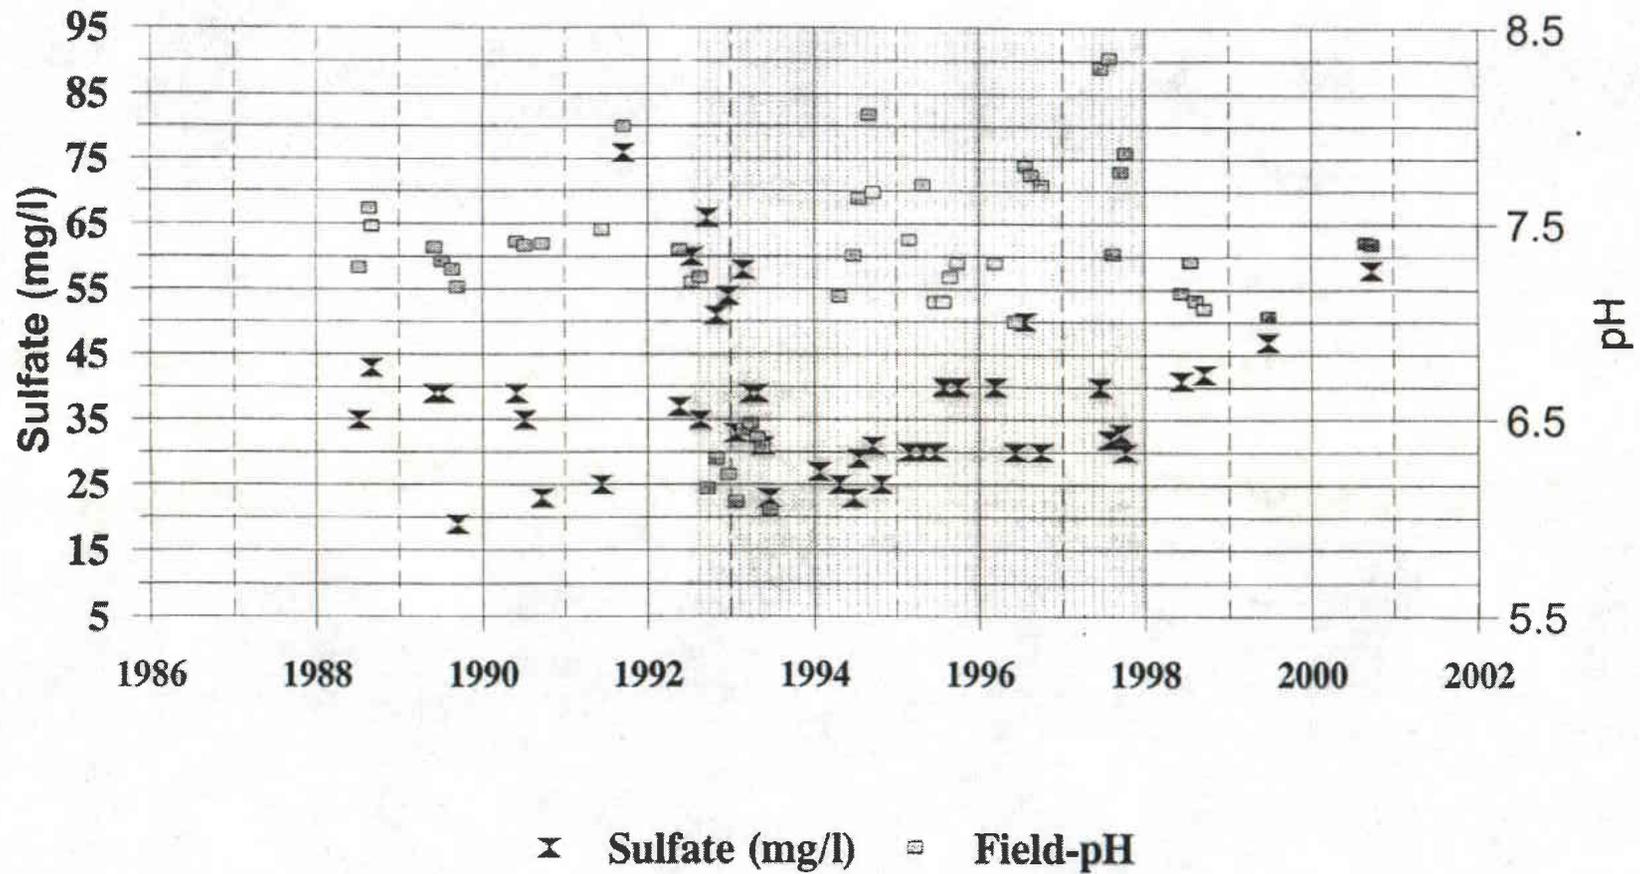
Figure 9

Sulfate and pH

Upper Tie Fork Well 86-35-2-3

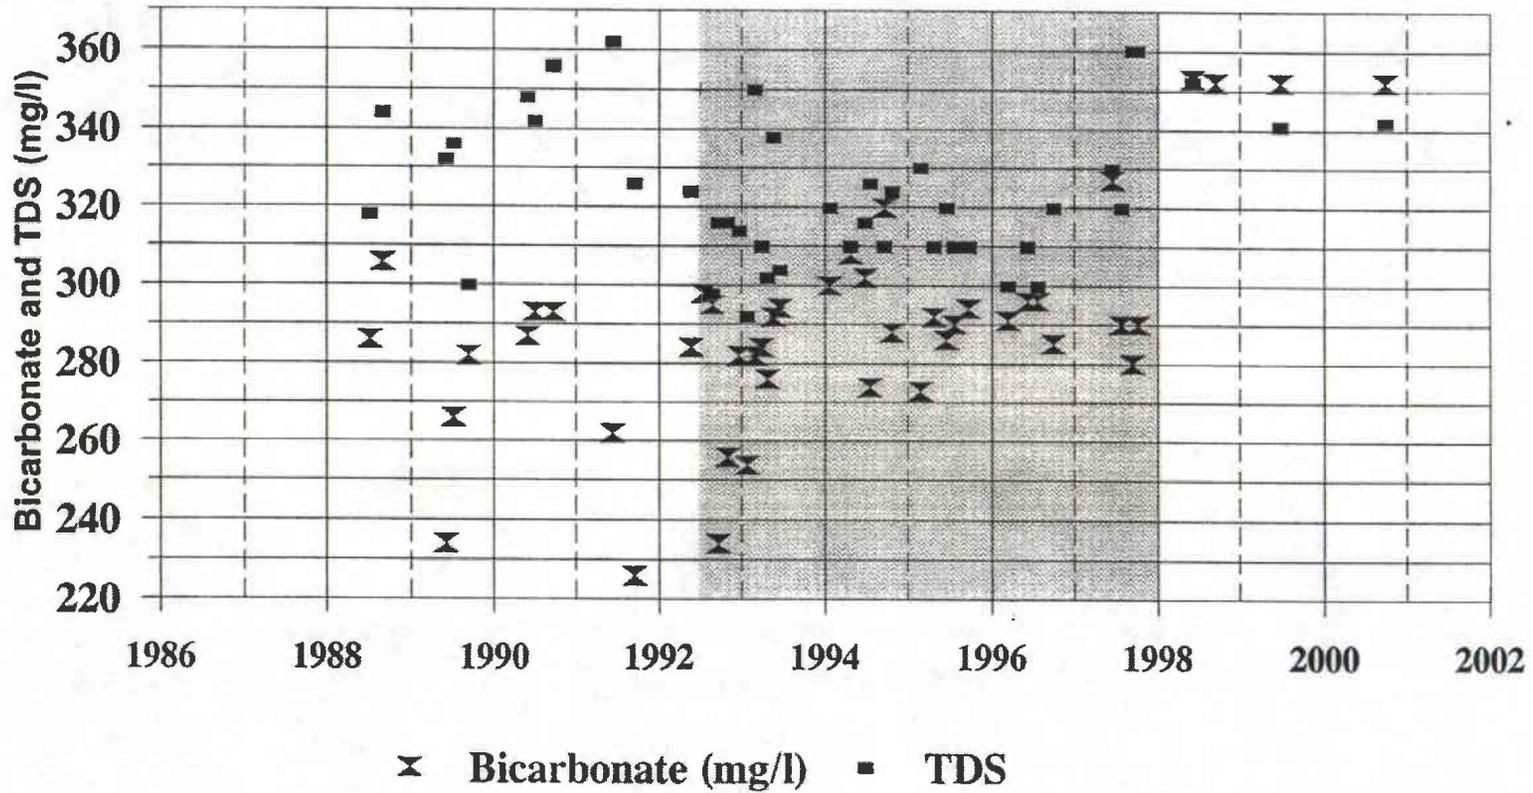
Figure 10

Bicarbonate and TDS

Upper Tie Fork Well 86-35-2-3

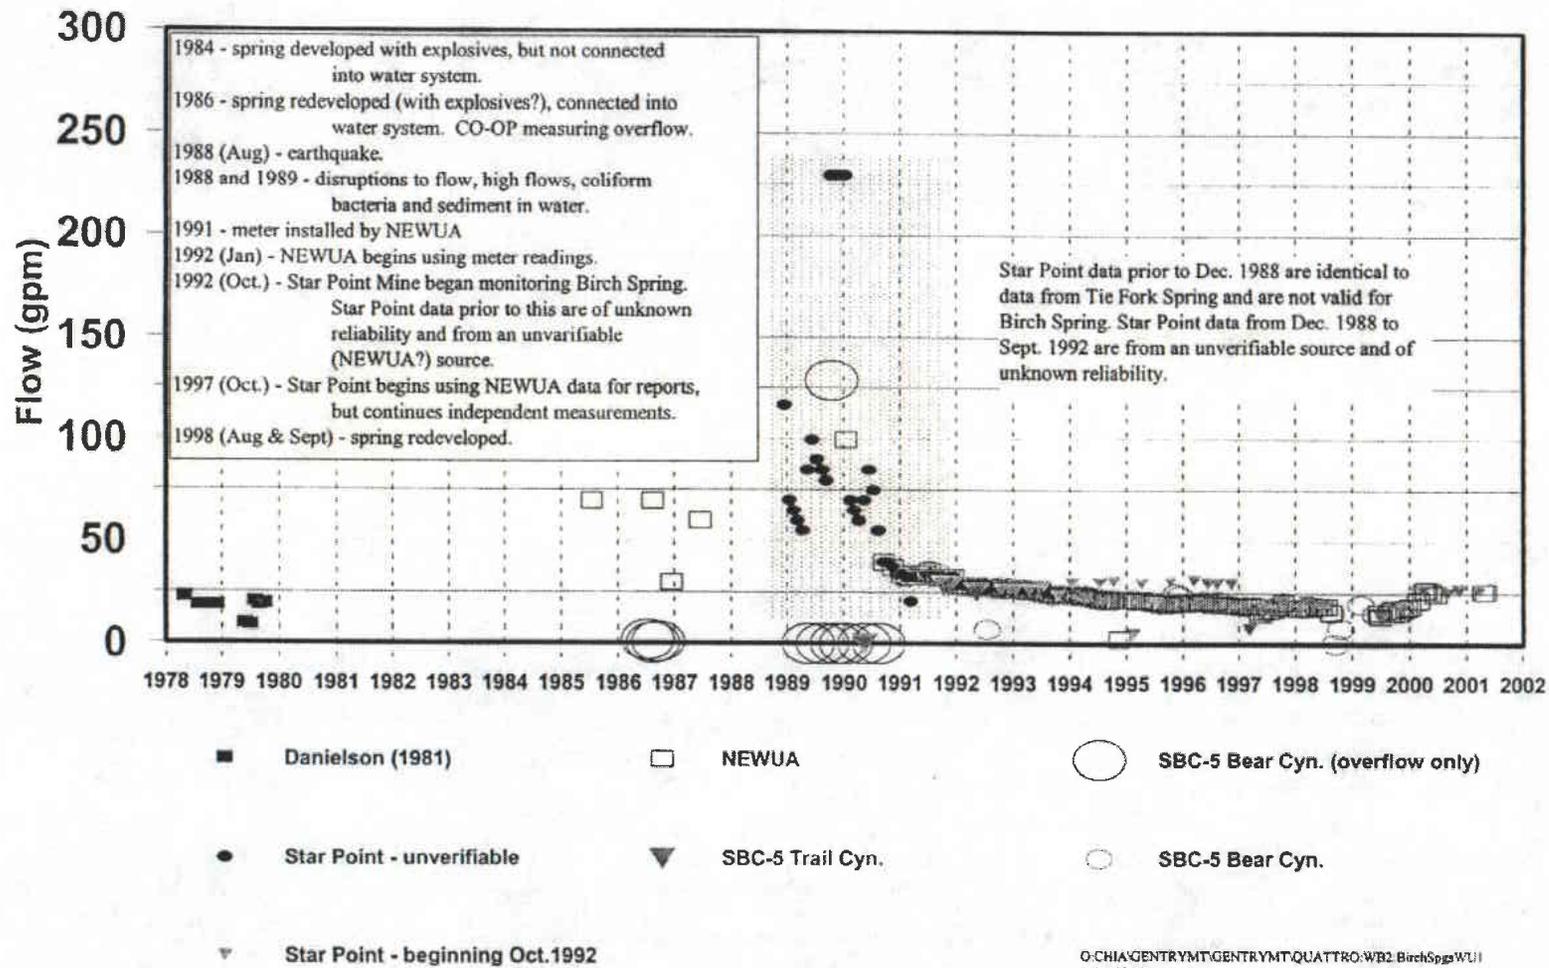
Figure 11a

Birch Spring Flow Combined Data Sources

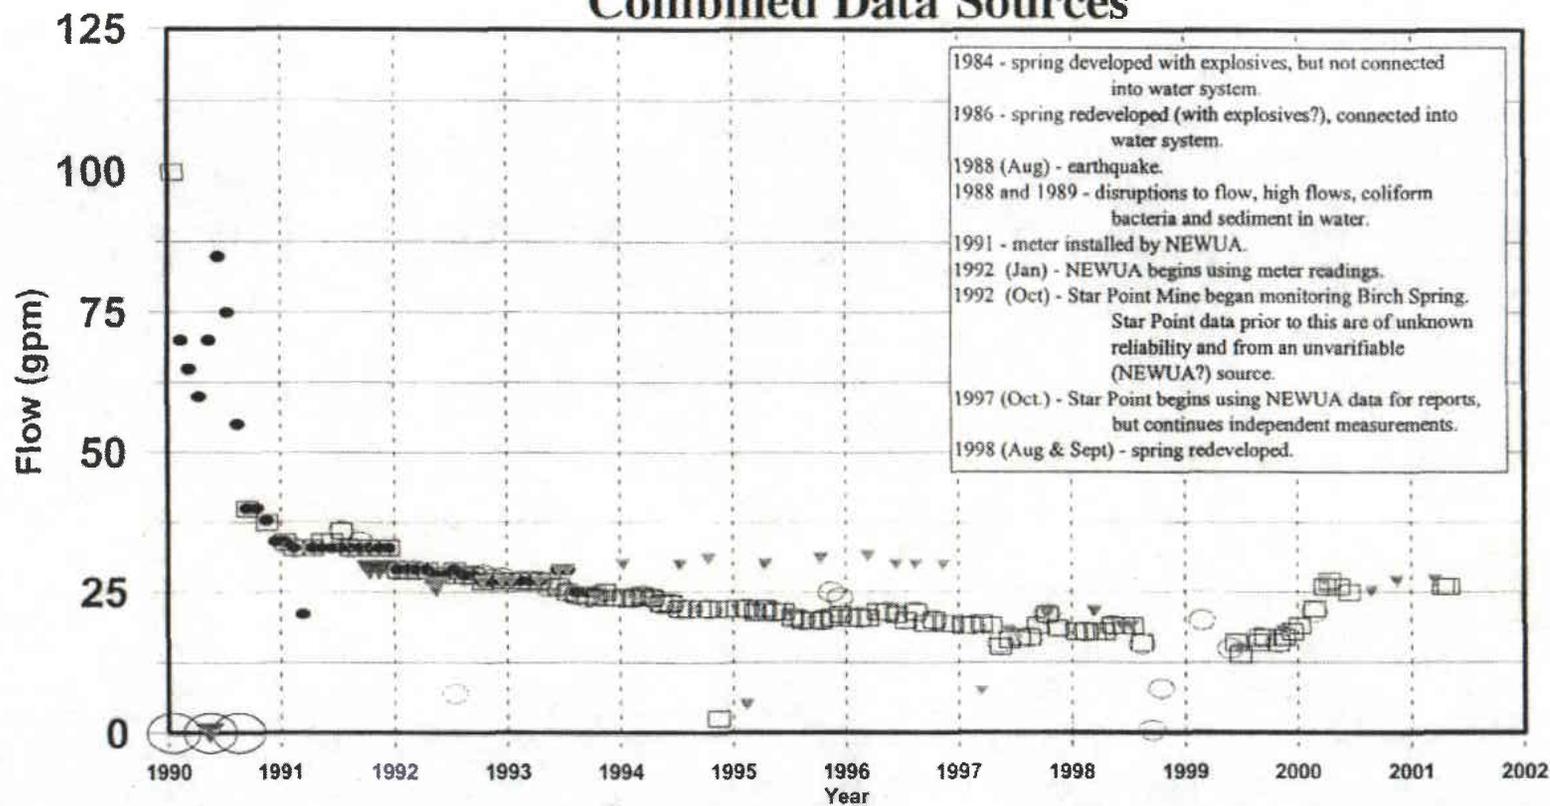
Figure 11b

Birch Spring Flow Combined Data Sources

□ NEWUA

○ SBC-5 Bear Cyn. (overflow only)

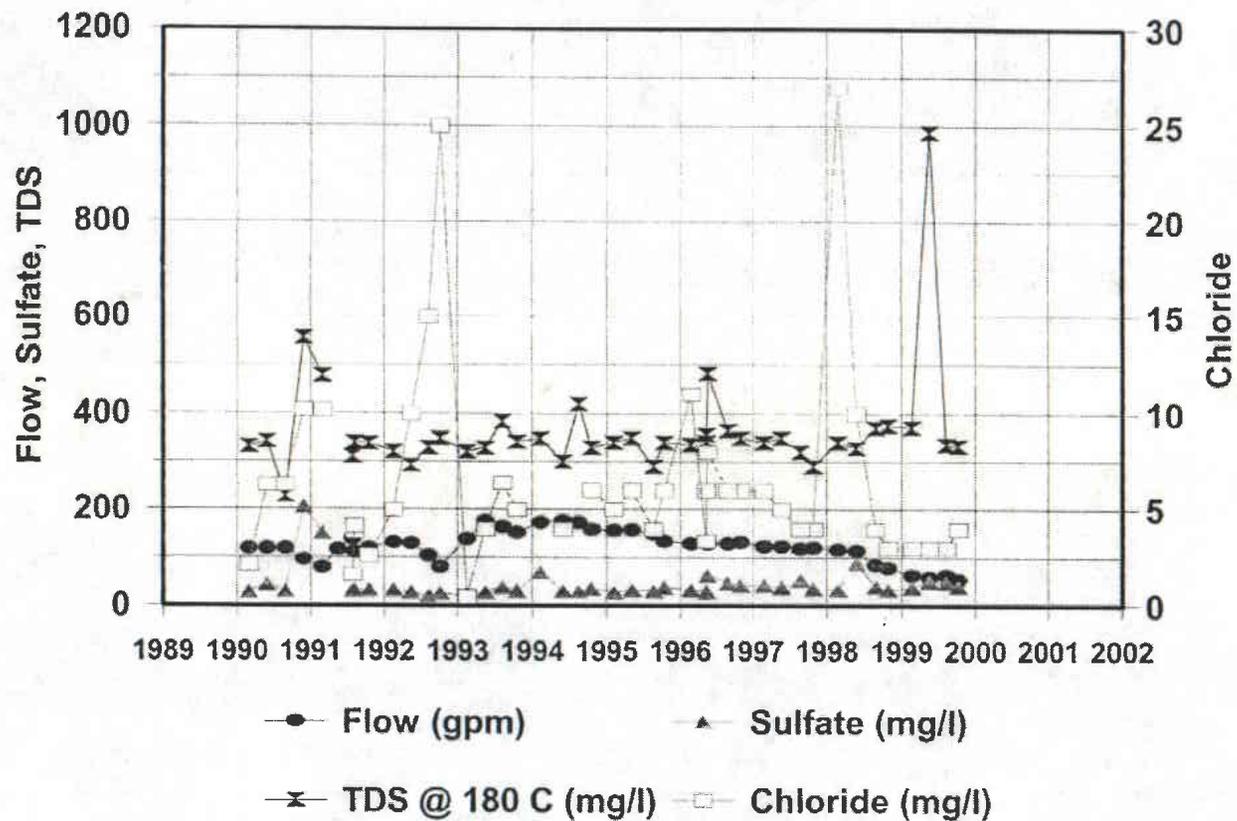
Figure 12

Chemistry of SBC-9 Sand Channel

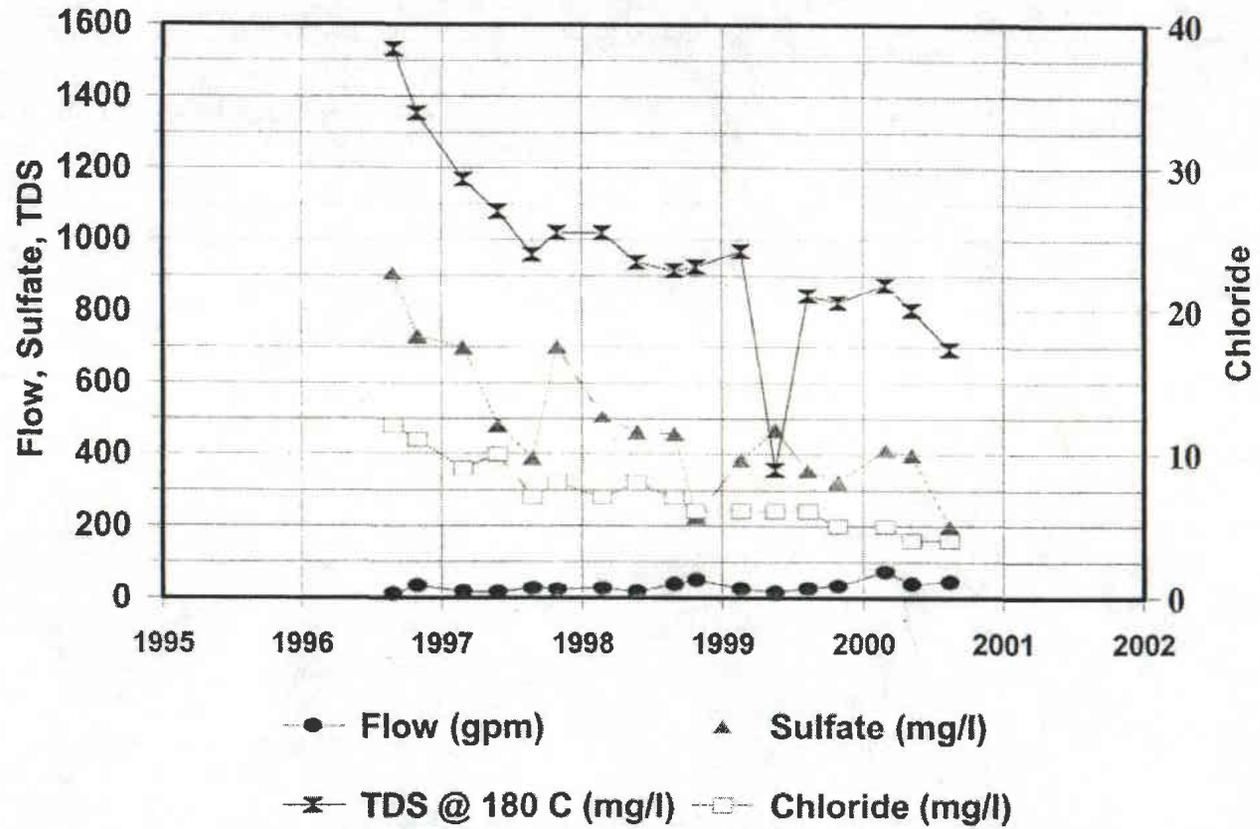
Figure 13b

Chemistry of SBC-13

Sand Channel

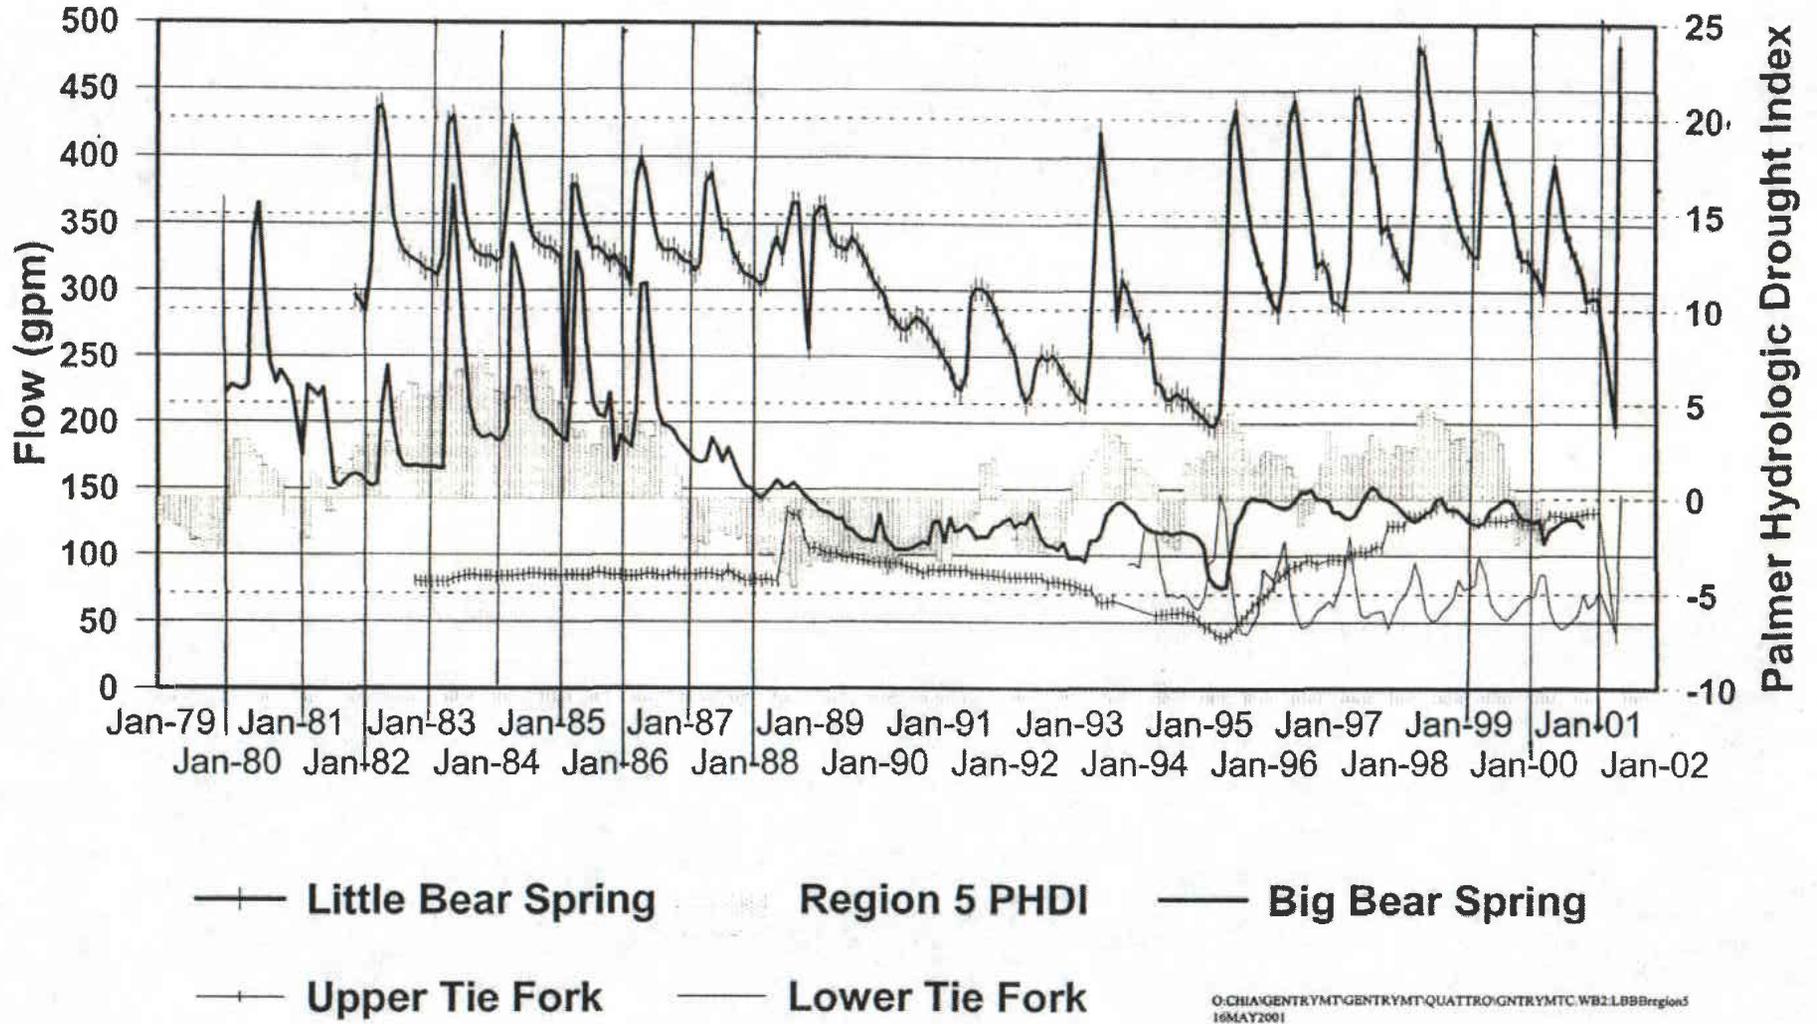
Figure 14a

Flow of Selected Springs and Region 5 PHDI

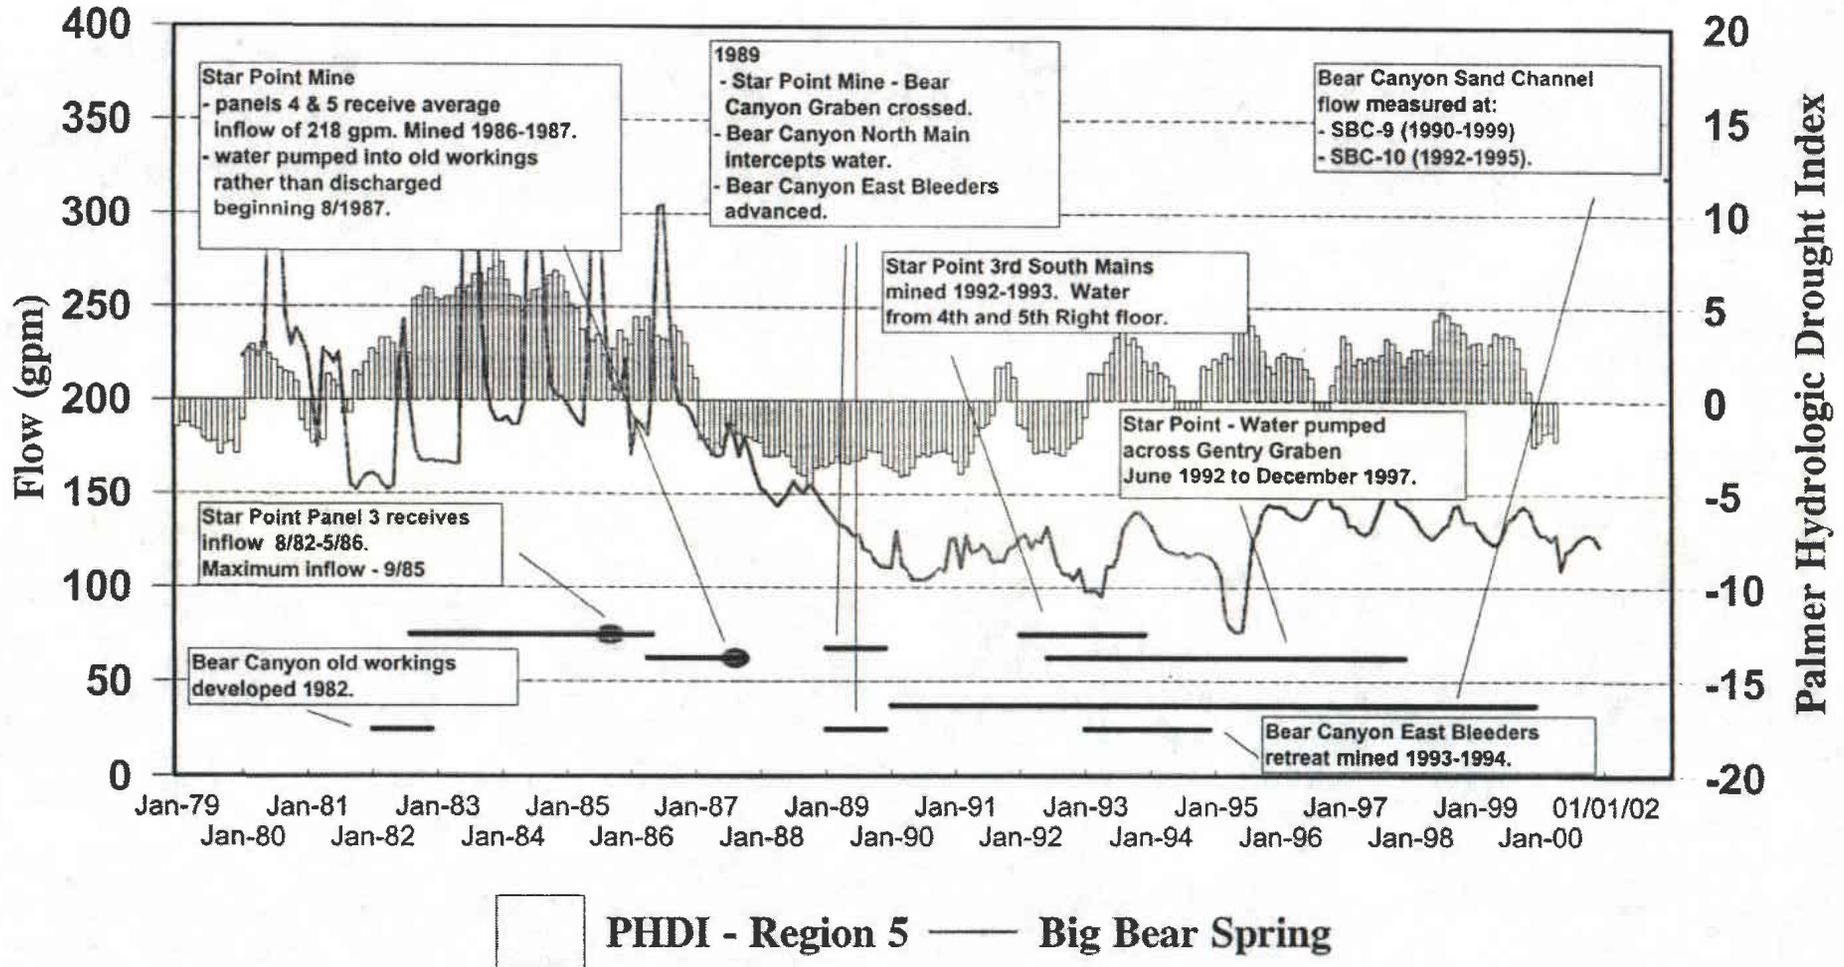
Figure 14b

Big Bear Spring, the PHDI, and Mine Water Interception
