Re: Updated Cumulative Hydrologic Impact Assessment (CHIA), Gentry Mountain, Hiawatha Coal Company, Hiawatha Mine, C/007/0011, Outgoing File

- Figure 1: **Hiawatha Mine Discharge: Upper Tie Fork and Graben Goose**
- Figure 1a: **Hiawatha Mine Discharge at Mohrland**
- Figure 2: **Hiawatha Mine Discharge: Graben Goose & Bear Canyon Springs**

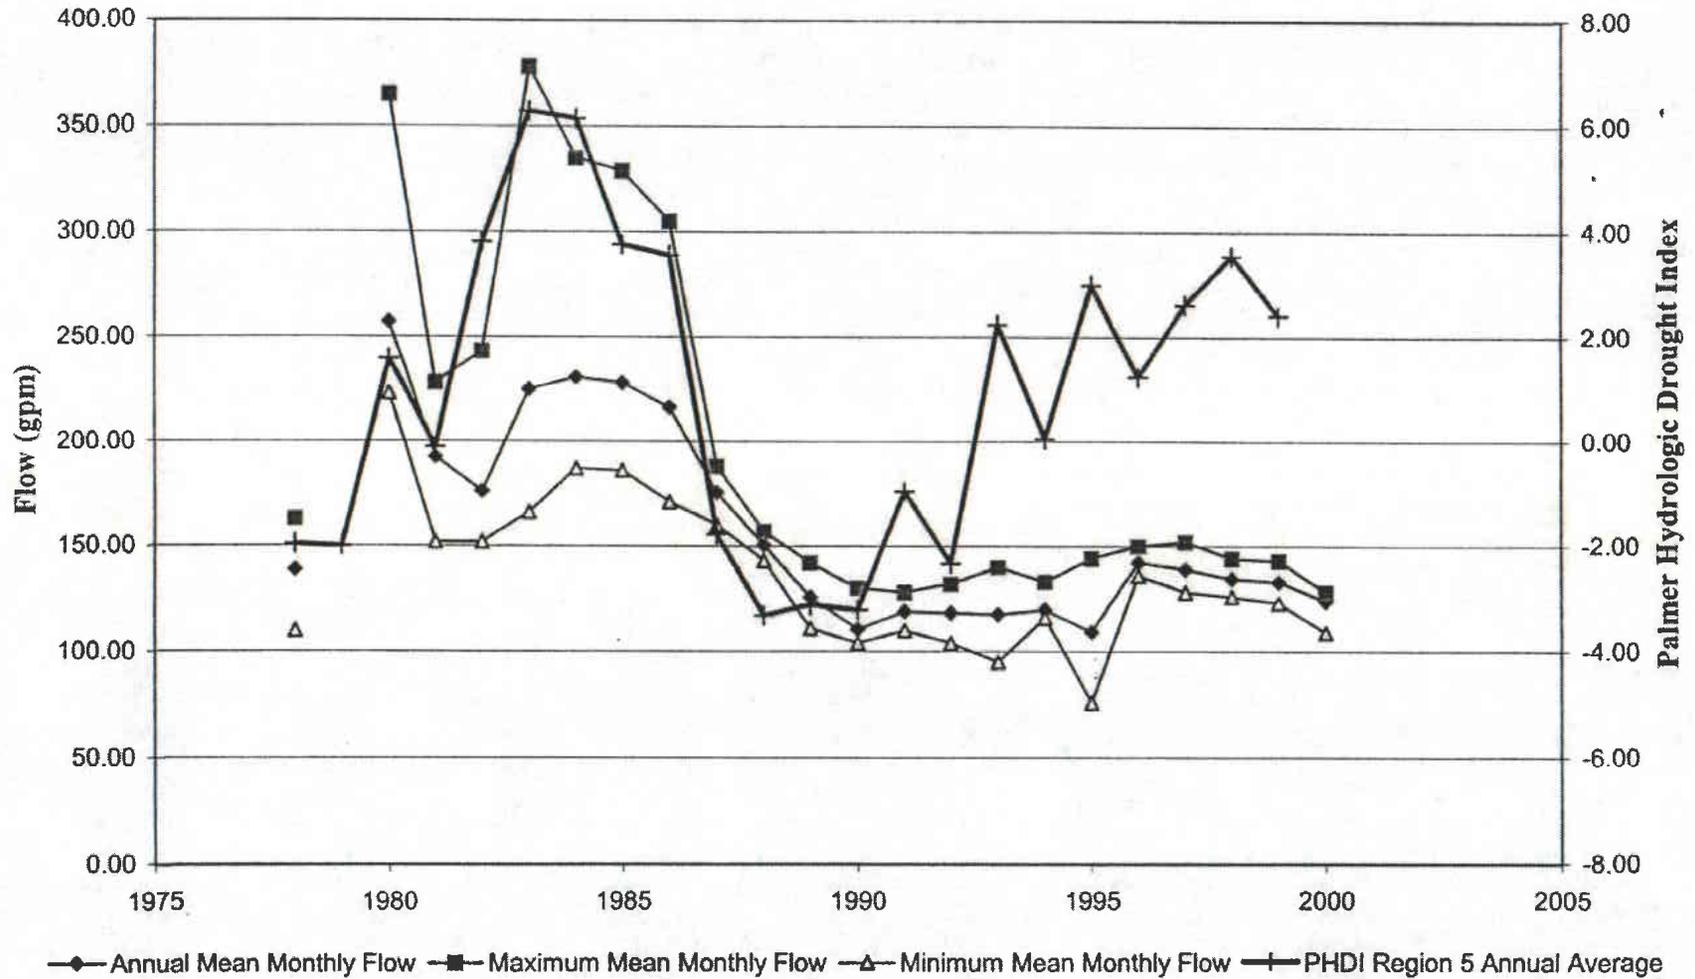
Figure 15

Big Bear Spring

Annual Flows

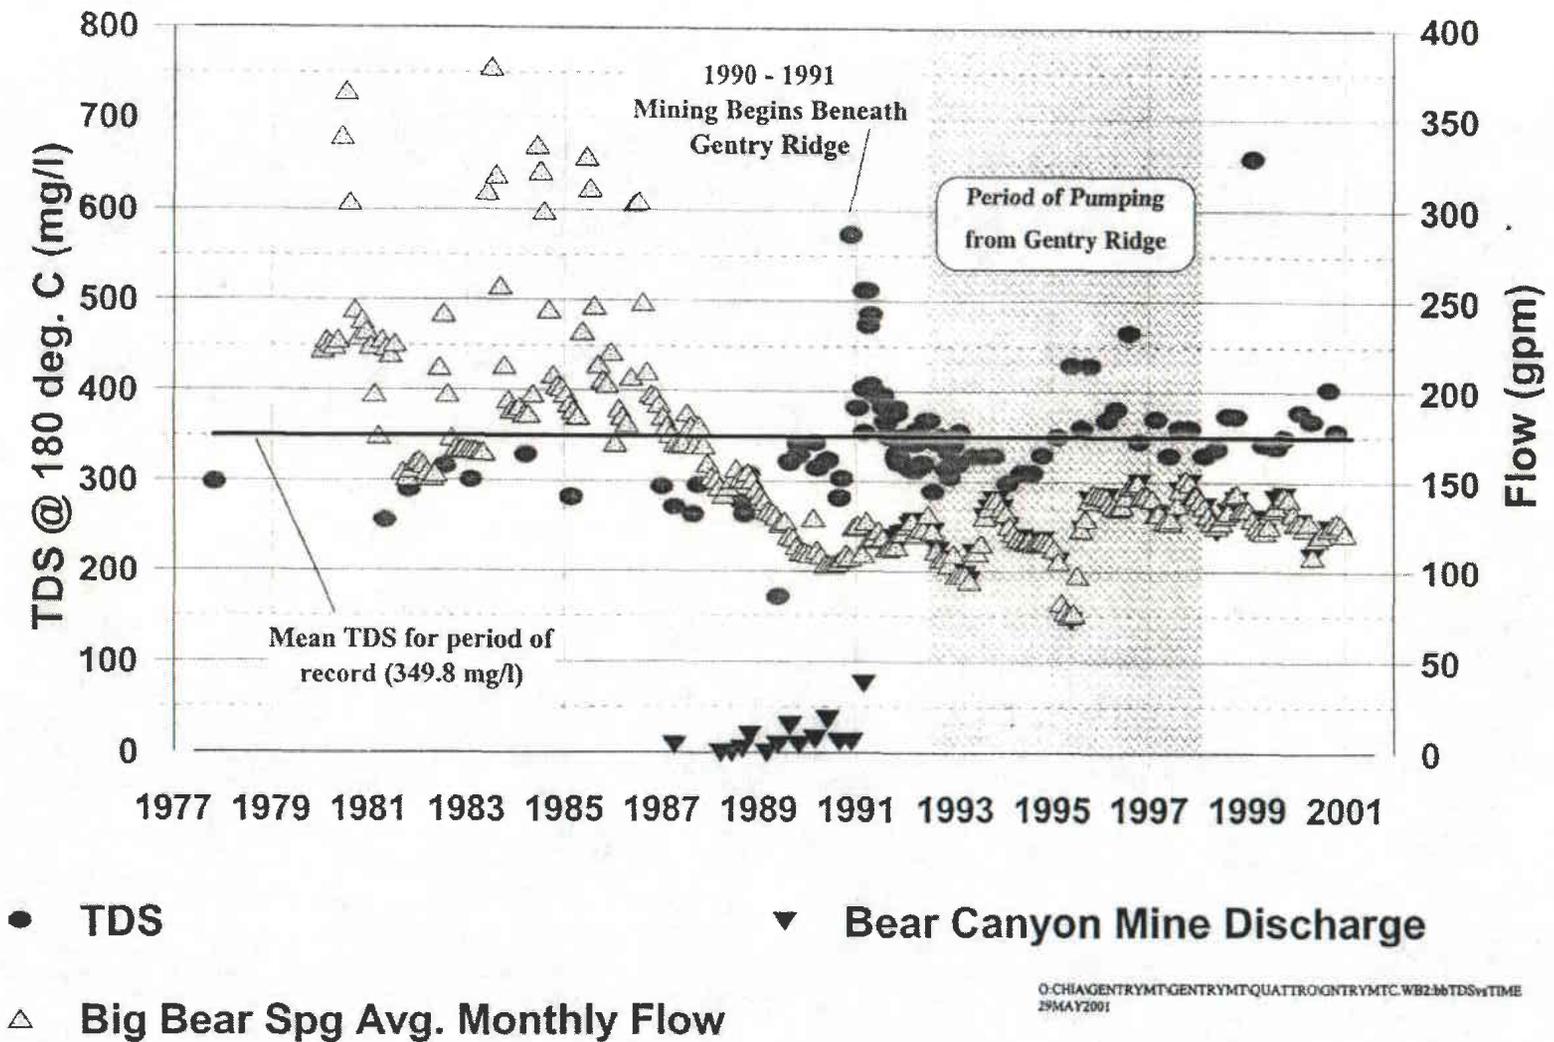
Figure 16a

Bear Canyon Mine: Big Bear Spring

Total Dissolved Solids (TDS) vs Time

The change in hydraulic conductivity in mined strata may change the residence time for water traveling through the system. Data from the Big Bear Spring show a slight increase in TDS with time (Figure 16a), but this is probably related more to decrease in flow than to changes in residence time caused by mining (Figure 16b). TDS was generally lower during the high flow period before 1988 (Table IV-6 - Note: TDS was not determined during the highest flows during this period). TDS was higher than average during 1990 - 1991 and 1995 - 1996. The 1990 - 1991 increase in TDS corresponds to when Star Point Mine began mining under Gentry Ridge, and also roughly corresponds to when Bear Canyon Mine began discharging water intercepted in the mine in 1987 and then increased discharge beginning in 1991. The 1995 increase corresponds to the period when flows at several springs were at their lowest due to drought and when pumping from the Gentry Ridge Horst across the Bear Canyon Graben reached its maximum average monthly flow (Figure 2). The high value in 1999 is an unexplained single-point anomaly, perhaps caused by lab or field error. No definitive conclusions can be drawn about the relationship between mining operations at the Star Point and Bear Canyon Mines and changes in TDS at Big Bear Spring, although some short-term increases do appear related to mining activities.

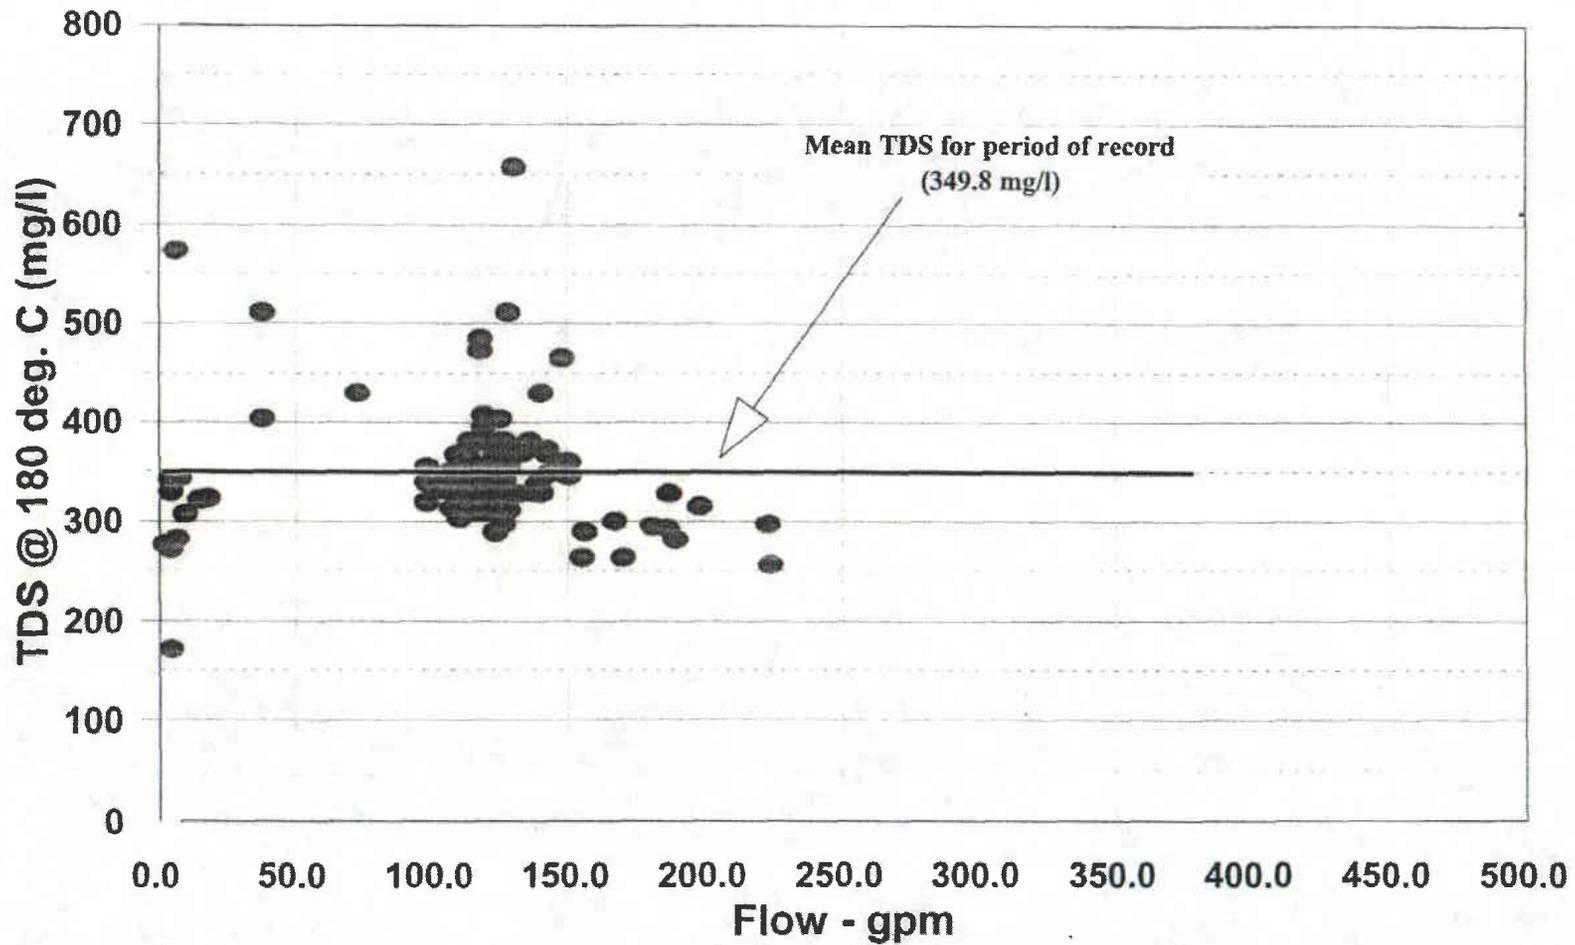
Figure 16b

Bear Canyon Mine: Big Bear Spring

Total Dissolved Solids (TDS) vs Flow

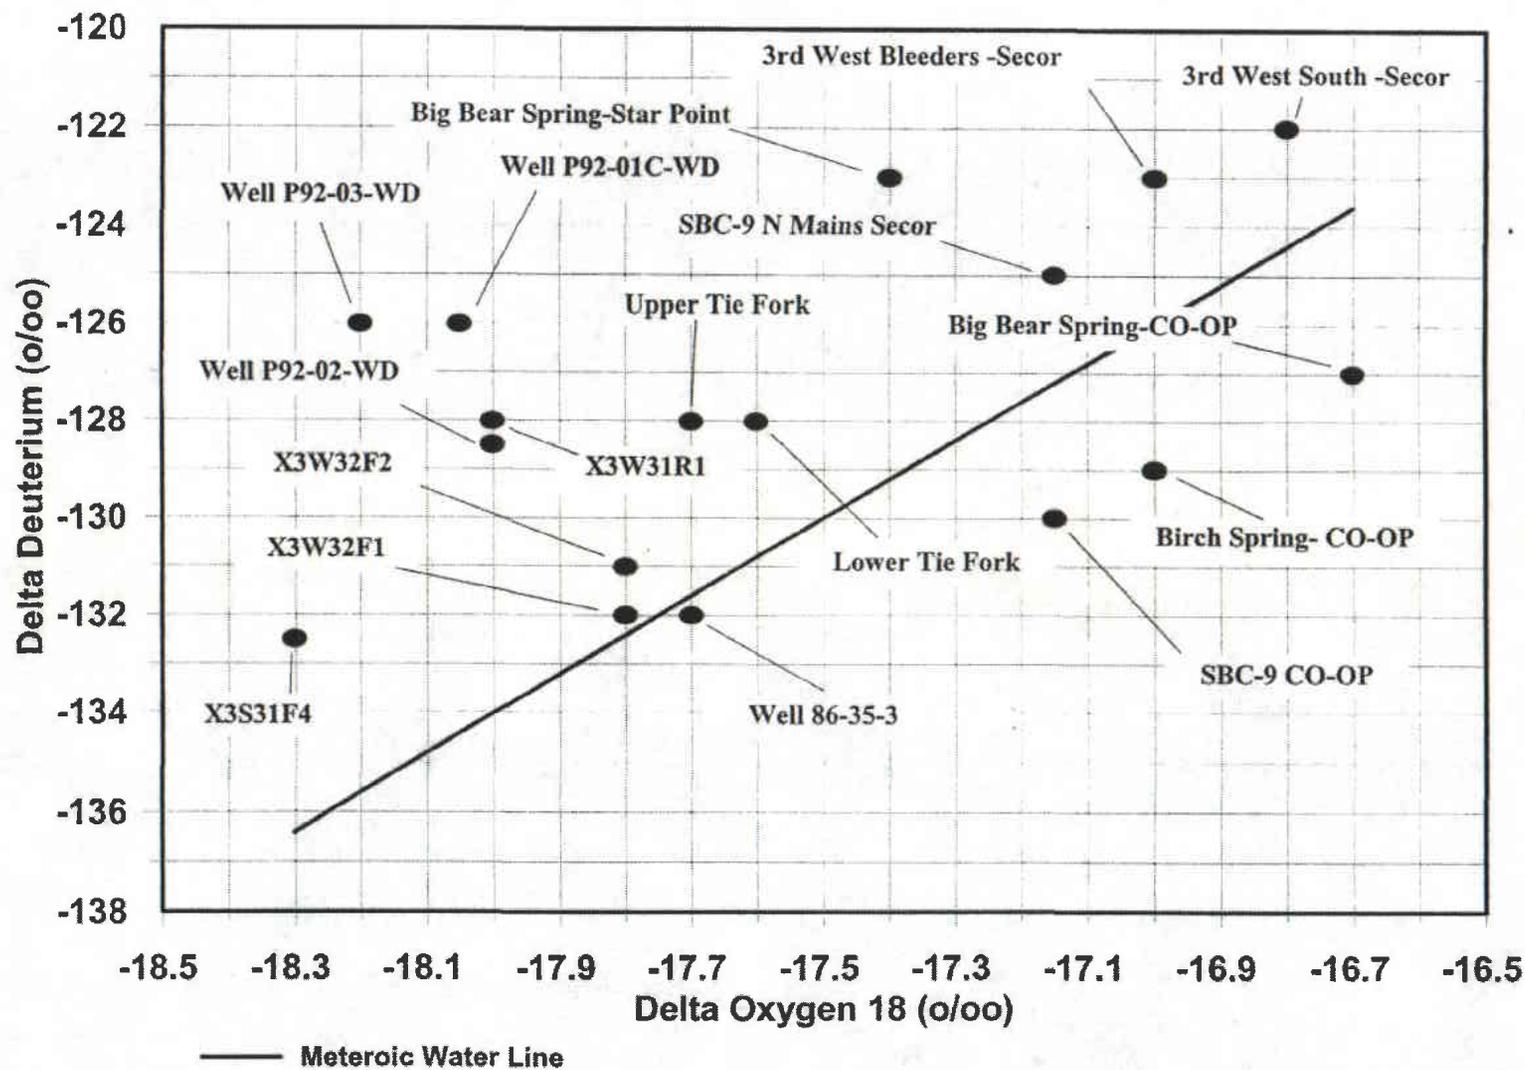
Figure 17

Meteoric Water Line

Deuterium and Oxygen 18

The data presented by Bear Canyon and Star Point Mines show that Big Bear Spring water differs in oxygen and hydrogen isotopic-ratios in relation to the Meteoric Water Line (Figure 17). Big Bear Spring data plot below the Meteoric Water Line for the sample presented by Co-Op in 1995 and the data plot above the water line for the sample obtained by Star Point prior to 1991.

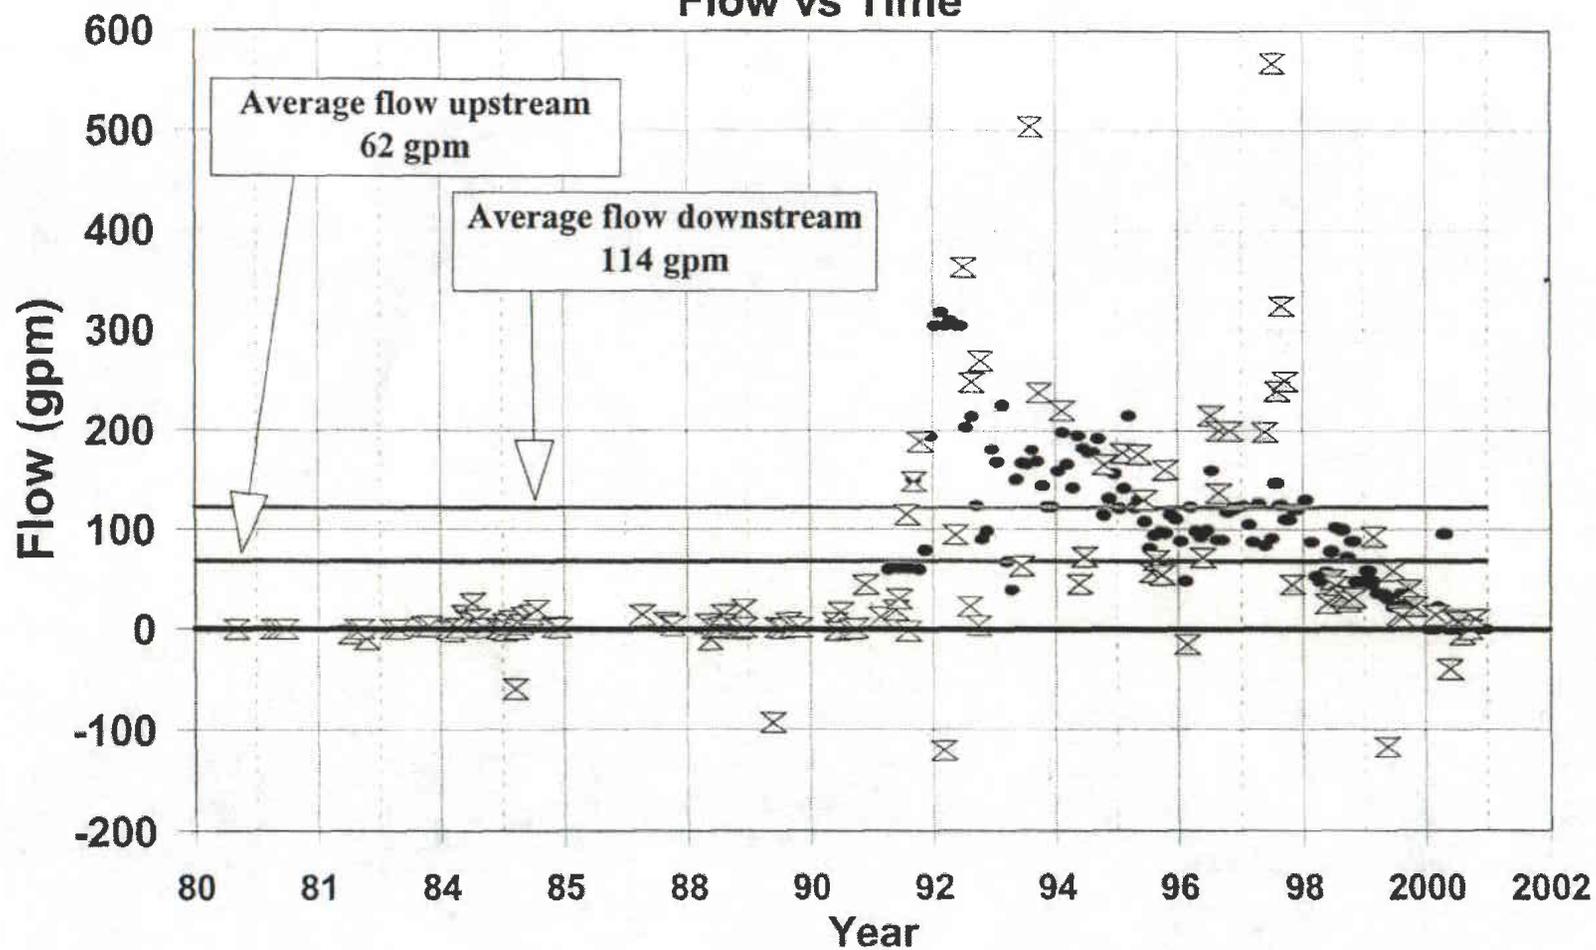
Bear Canyon Mine & Bear Creek Flows

Flow vs Time

• Mine Water Q: Monthly Average × BC-2 minus BC-1

Figure 18 shows the difference between flows recorded in Bear Creek at BC-1 above the Bear Canyon Mine and BC-2 below the mine. It also shows the discharge from UTG04006-004, the Bear Canyon Mine-water discharge point. Before significant discharge from the mine began, flows above and below the mine were similar. The larger flow downstream at BC-2 from 1991 through 1999 can be attributed to the Bear Canyon Mine discharge.
