CHAPTER III

RECLAMATION PLAN

3.1 Introduction

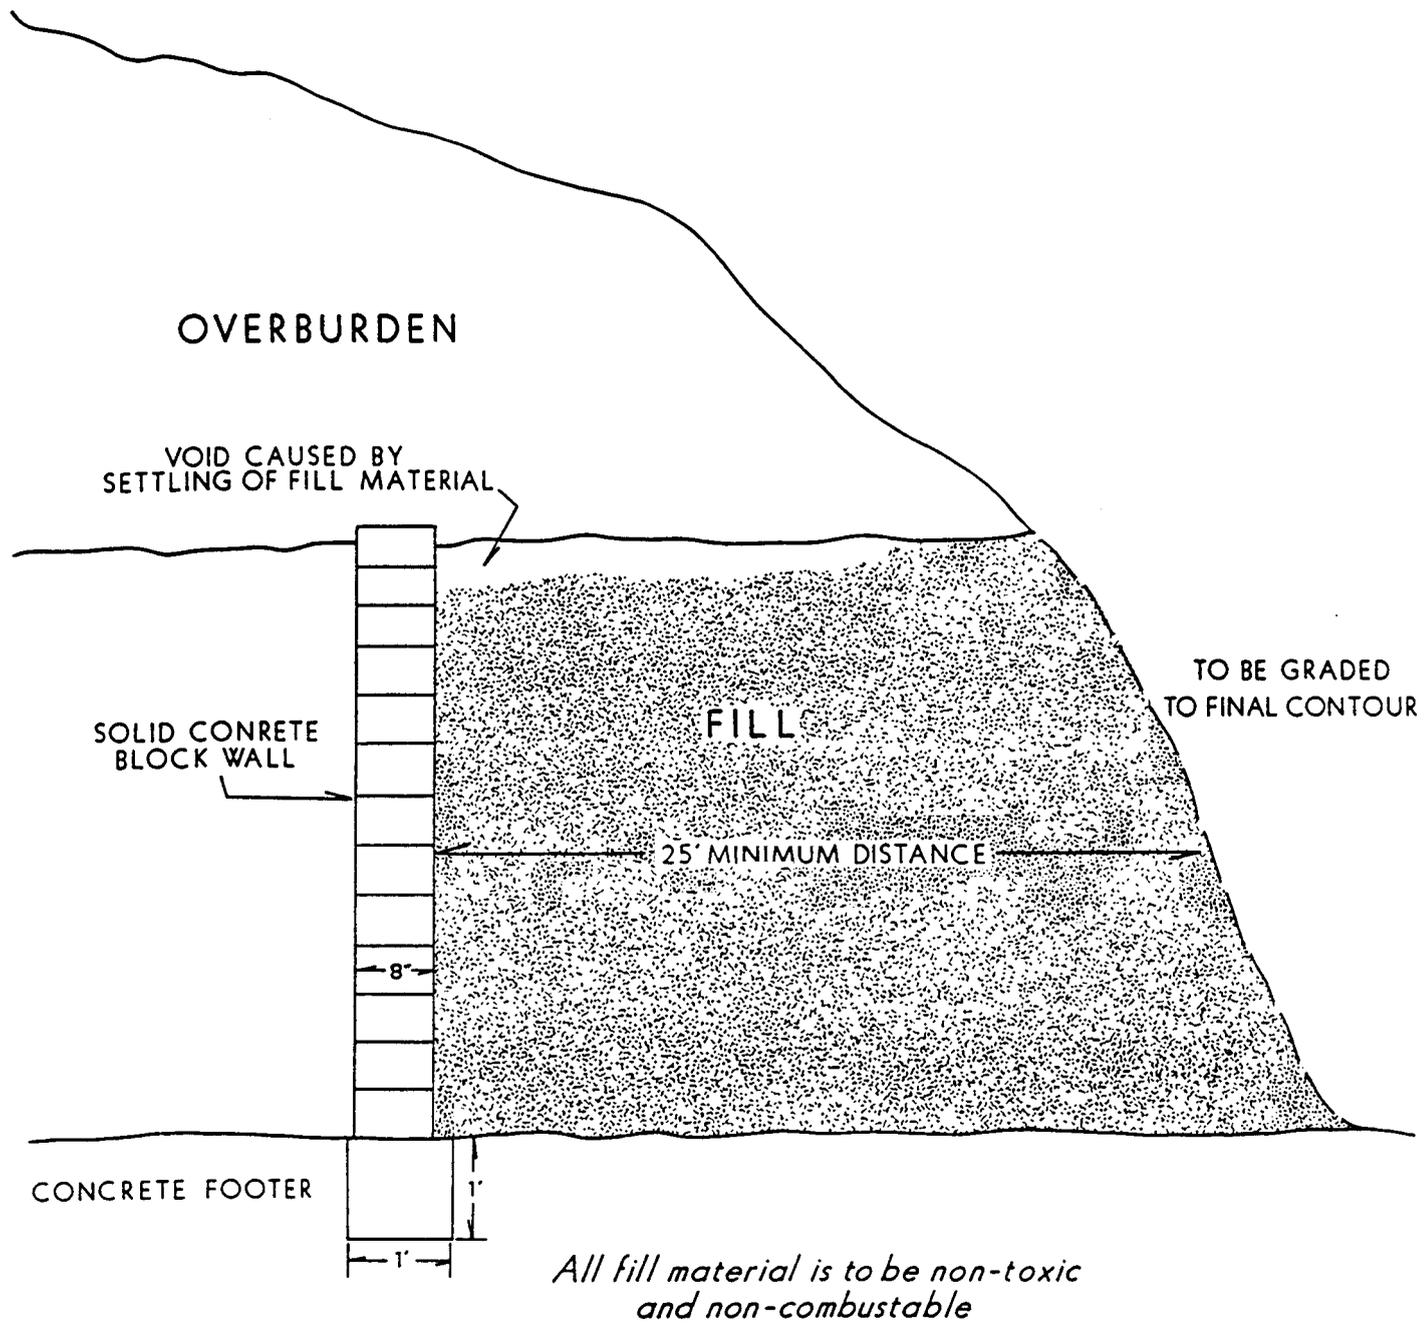
Figure 4.6.2-1 Typical Final Reclamation Portal Seal

TYPICAL CROSS SECTION OF MINE PORTAL SEALS

All portals have already been closed with a solid block masonry wall which is suitable for permanent reclamation. All portals with the exception of the Lila Canyon east and west portals will be backfilled and revegetated during reclamation. Figure 4.6.2-1 shows a typical portal section which has been sealed and backfilled.

Slope or drift openings required to be sealed shall be sealed with solid, substantial, noncombustible material such as concrete blocks, bricks, or tile and shall be completely filled with noncombustible material for a distance of at least 25 feet into such openings in accordance with CFR 75.1711-2. Figure 4.6.2-1 shows a typical portal reclaimed after sealing and backfilling.

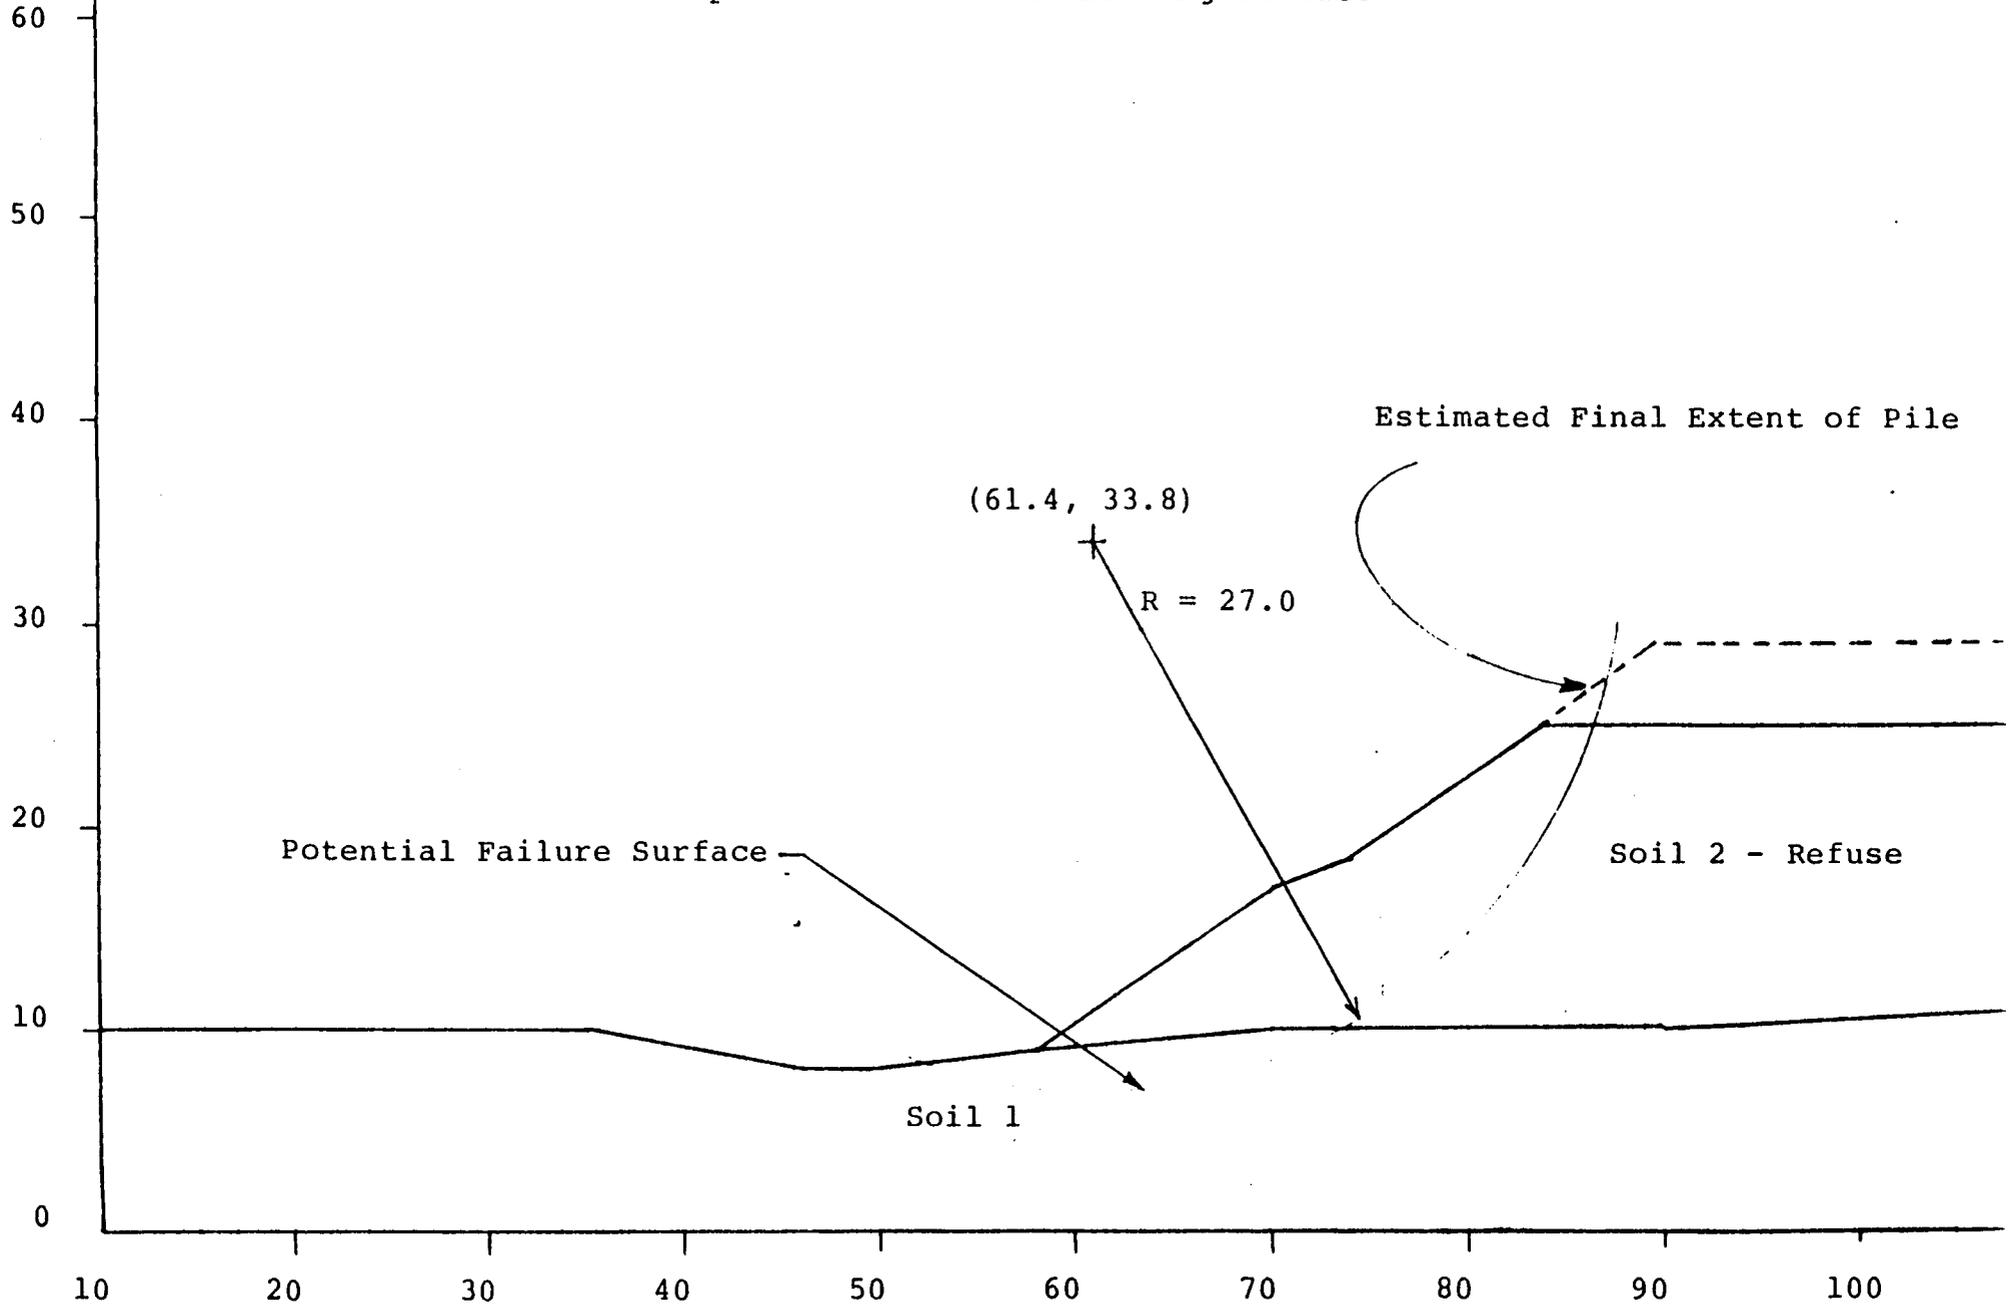
Road Junction. refuse Pile
Geneva Mine
Cross - Section Case 1
West Slope of Section A-A'-Drawing C3-1208

The three slopes evaluated have minimum safety factors in excess of 1.5.

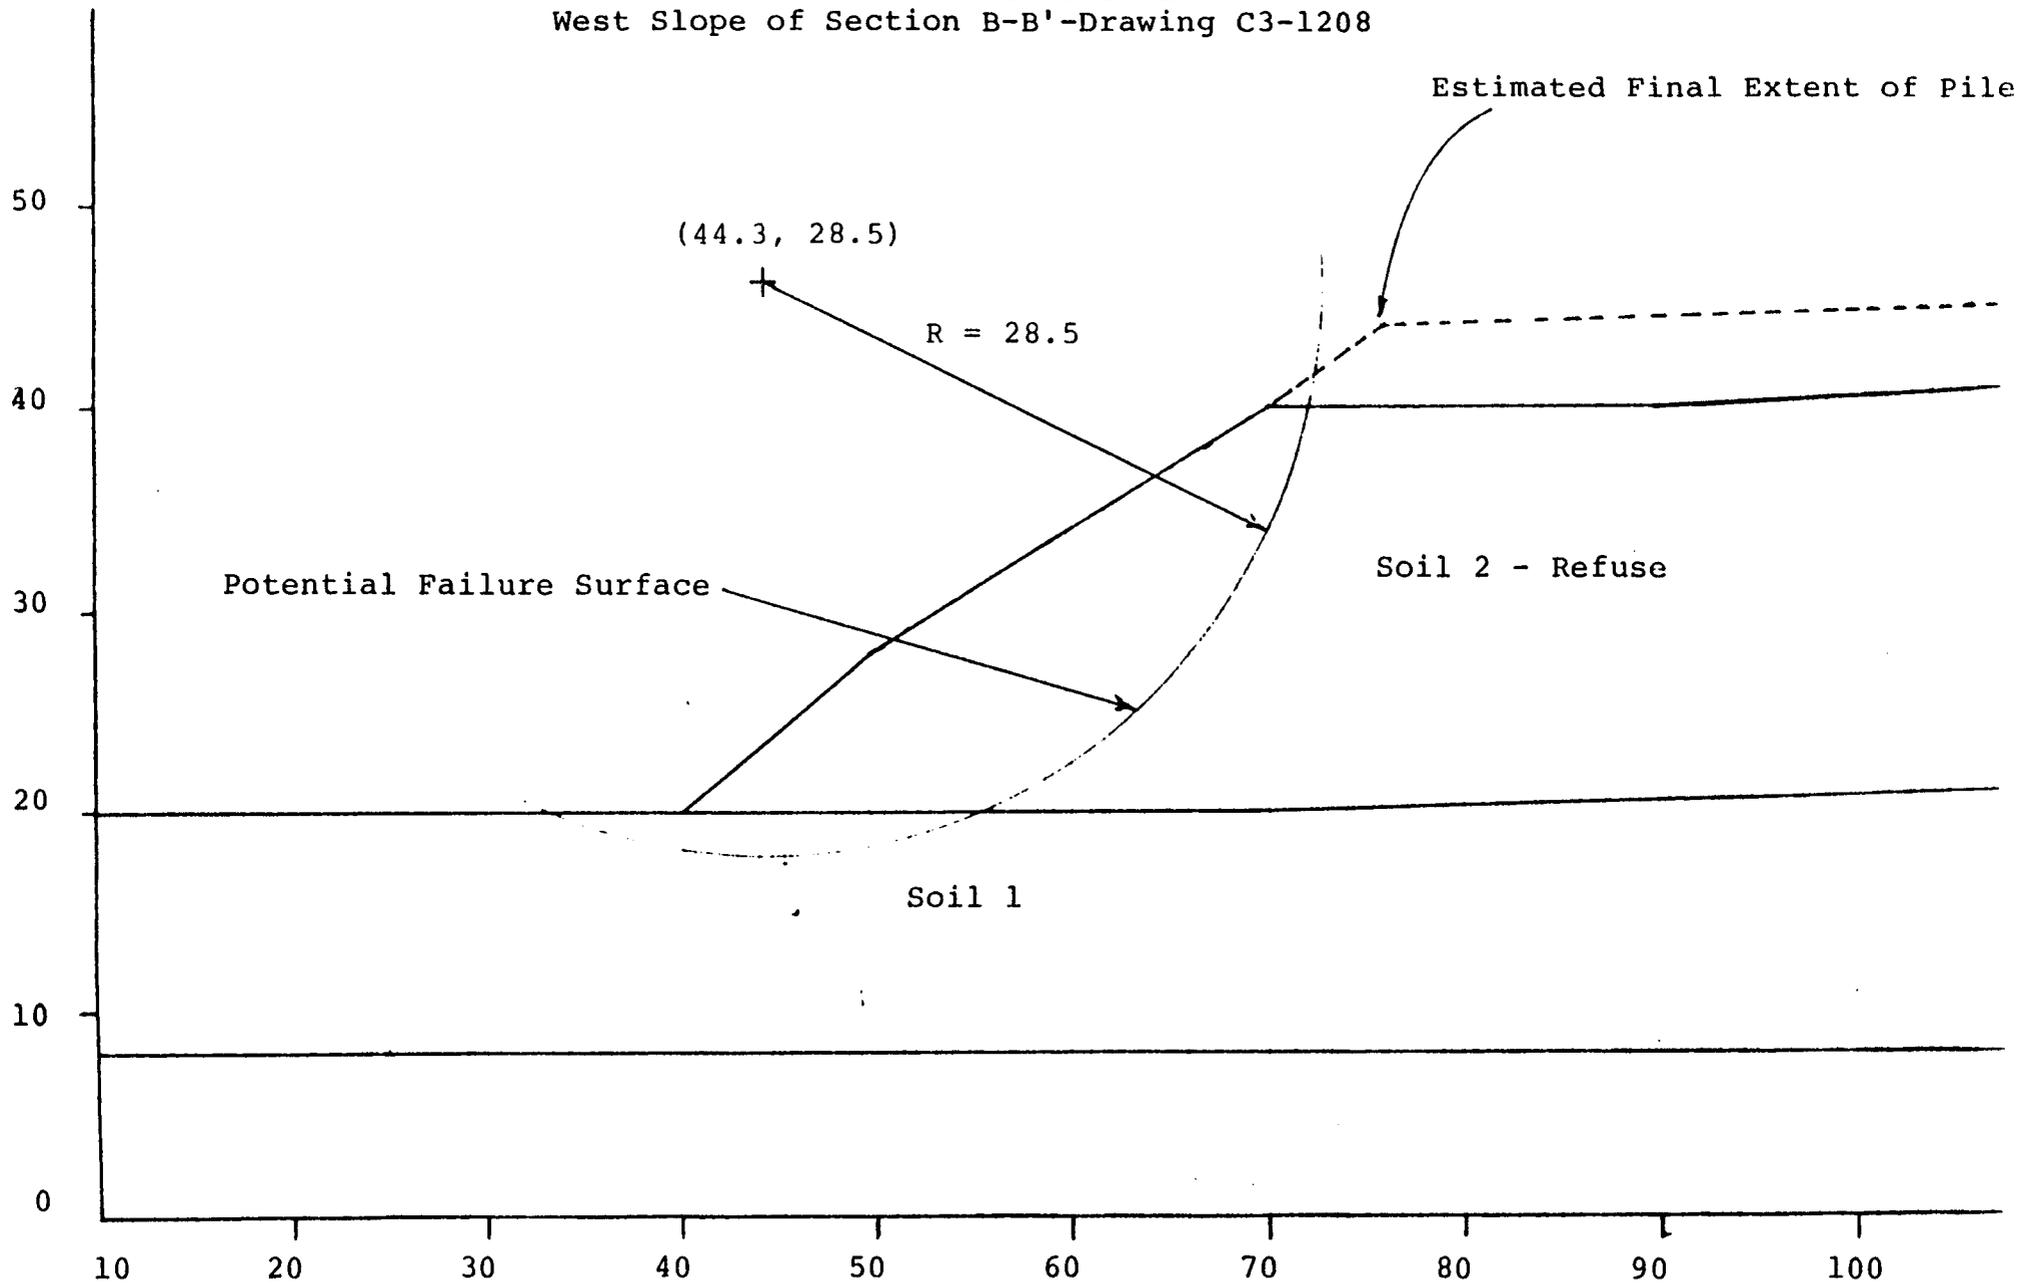
Road Junction Refuse Pile
Geneva Mine
Cross - Section Case 2
West Slope of Section B-B'-Drawing C3-1208

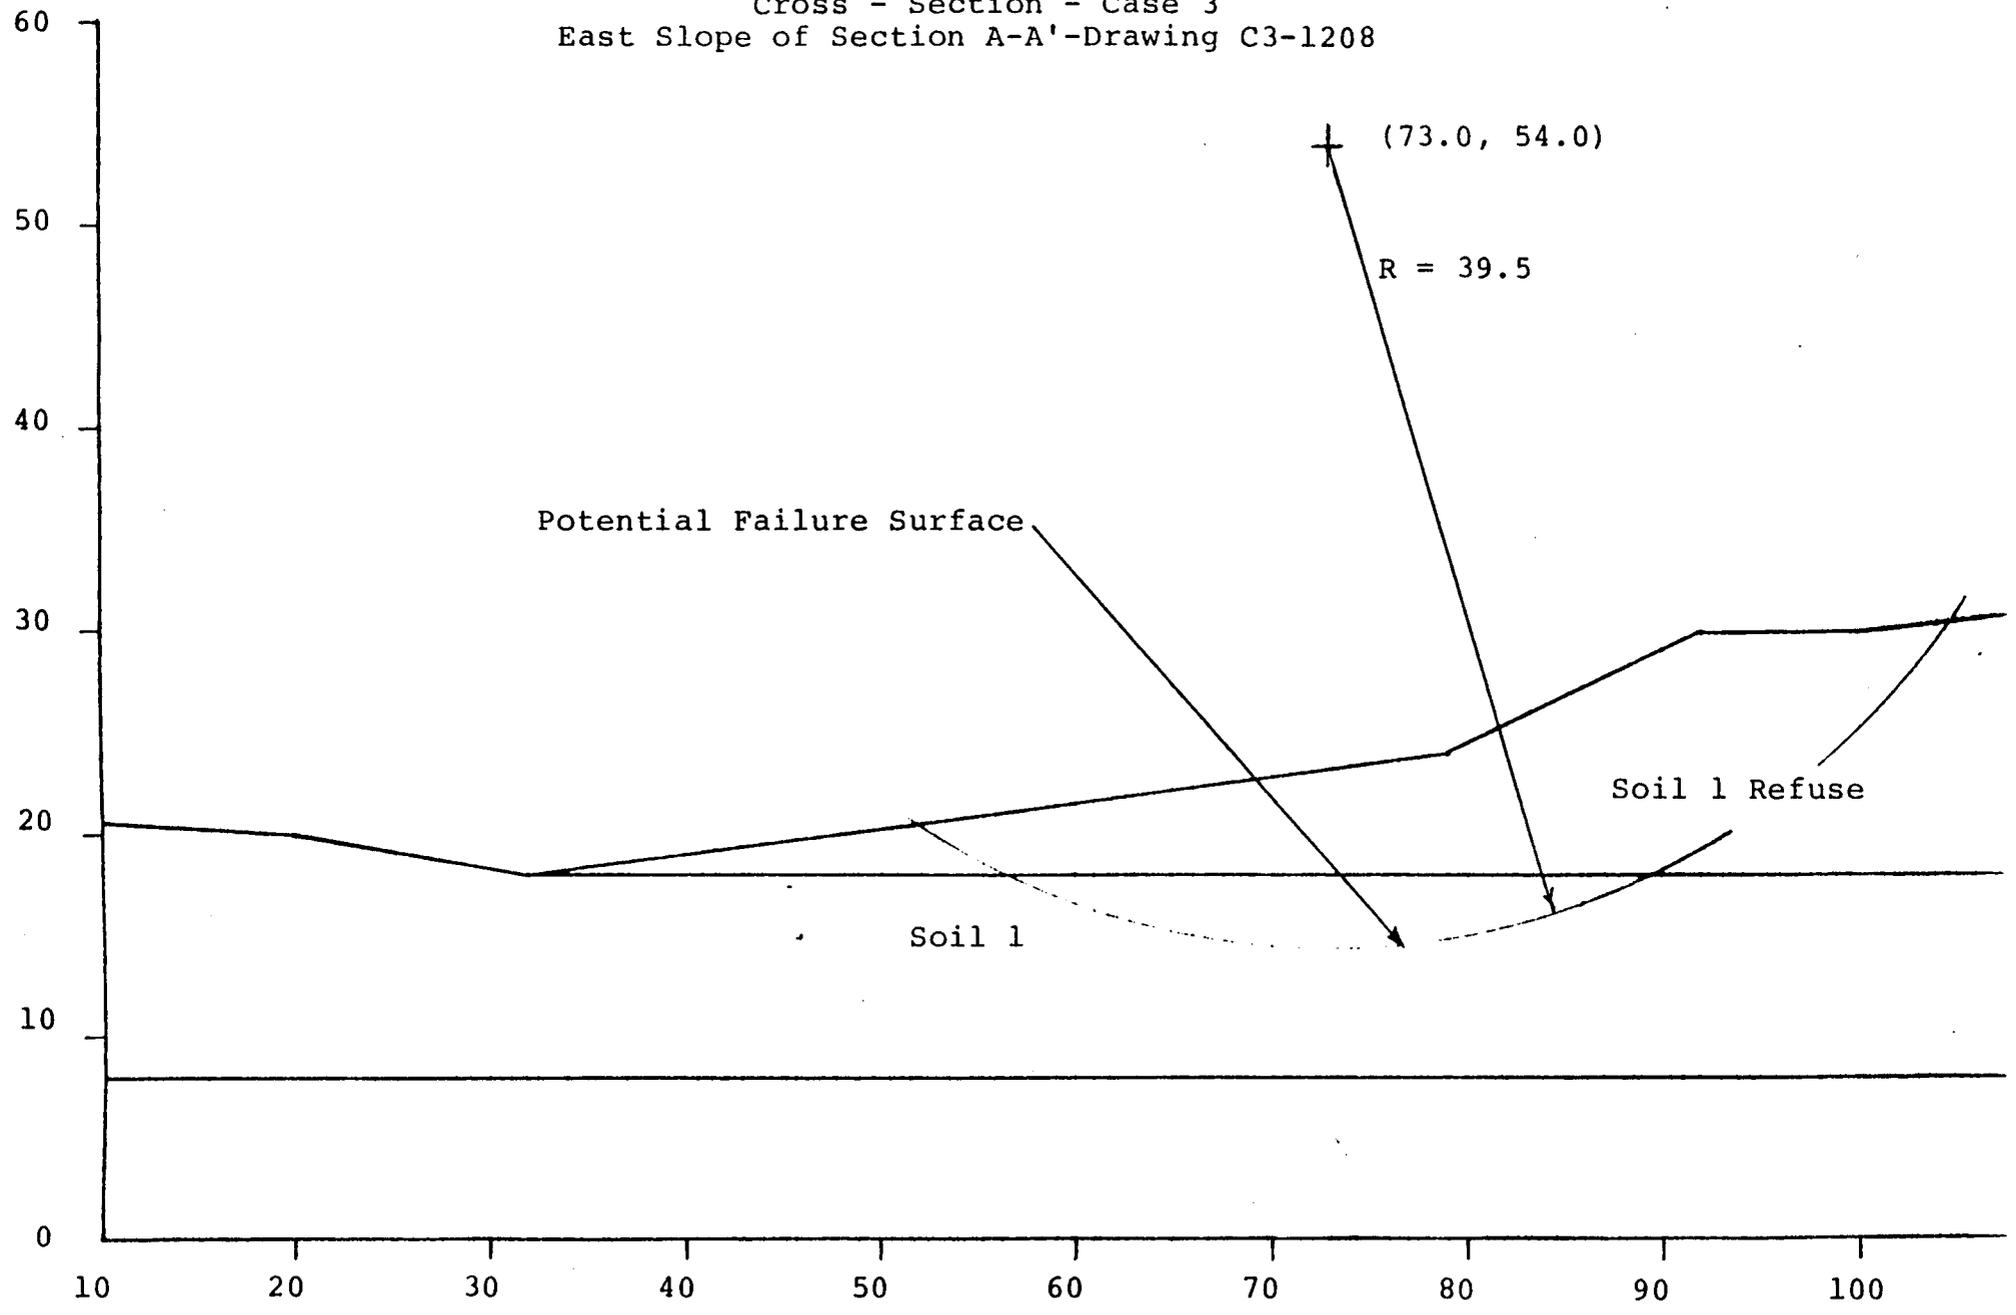
Road Junction Refuse Pile
Geneva Mine
Cross - Section - Case 3
East Slope of Section A-A'-Drawing C3-1208

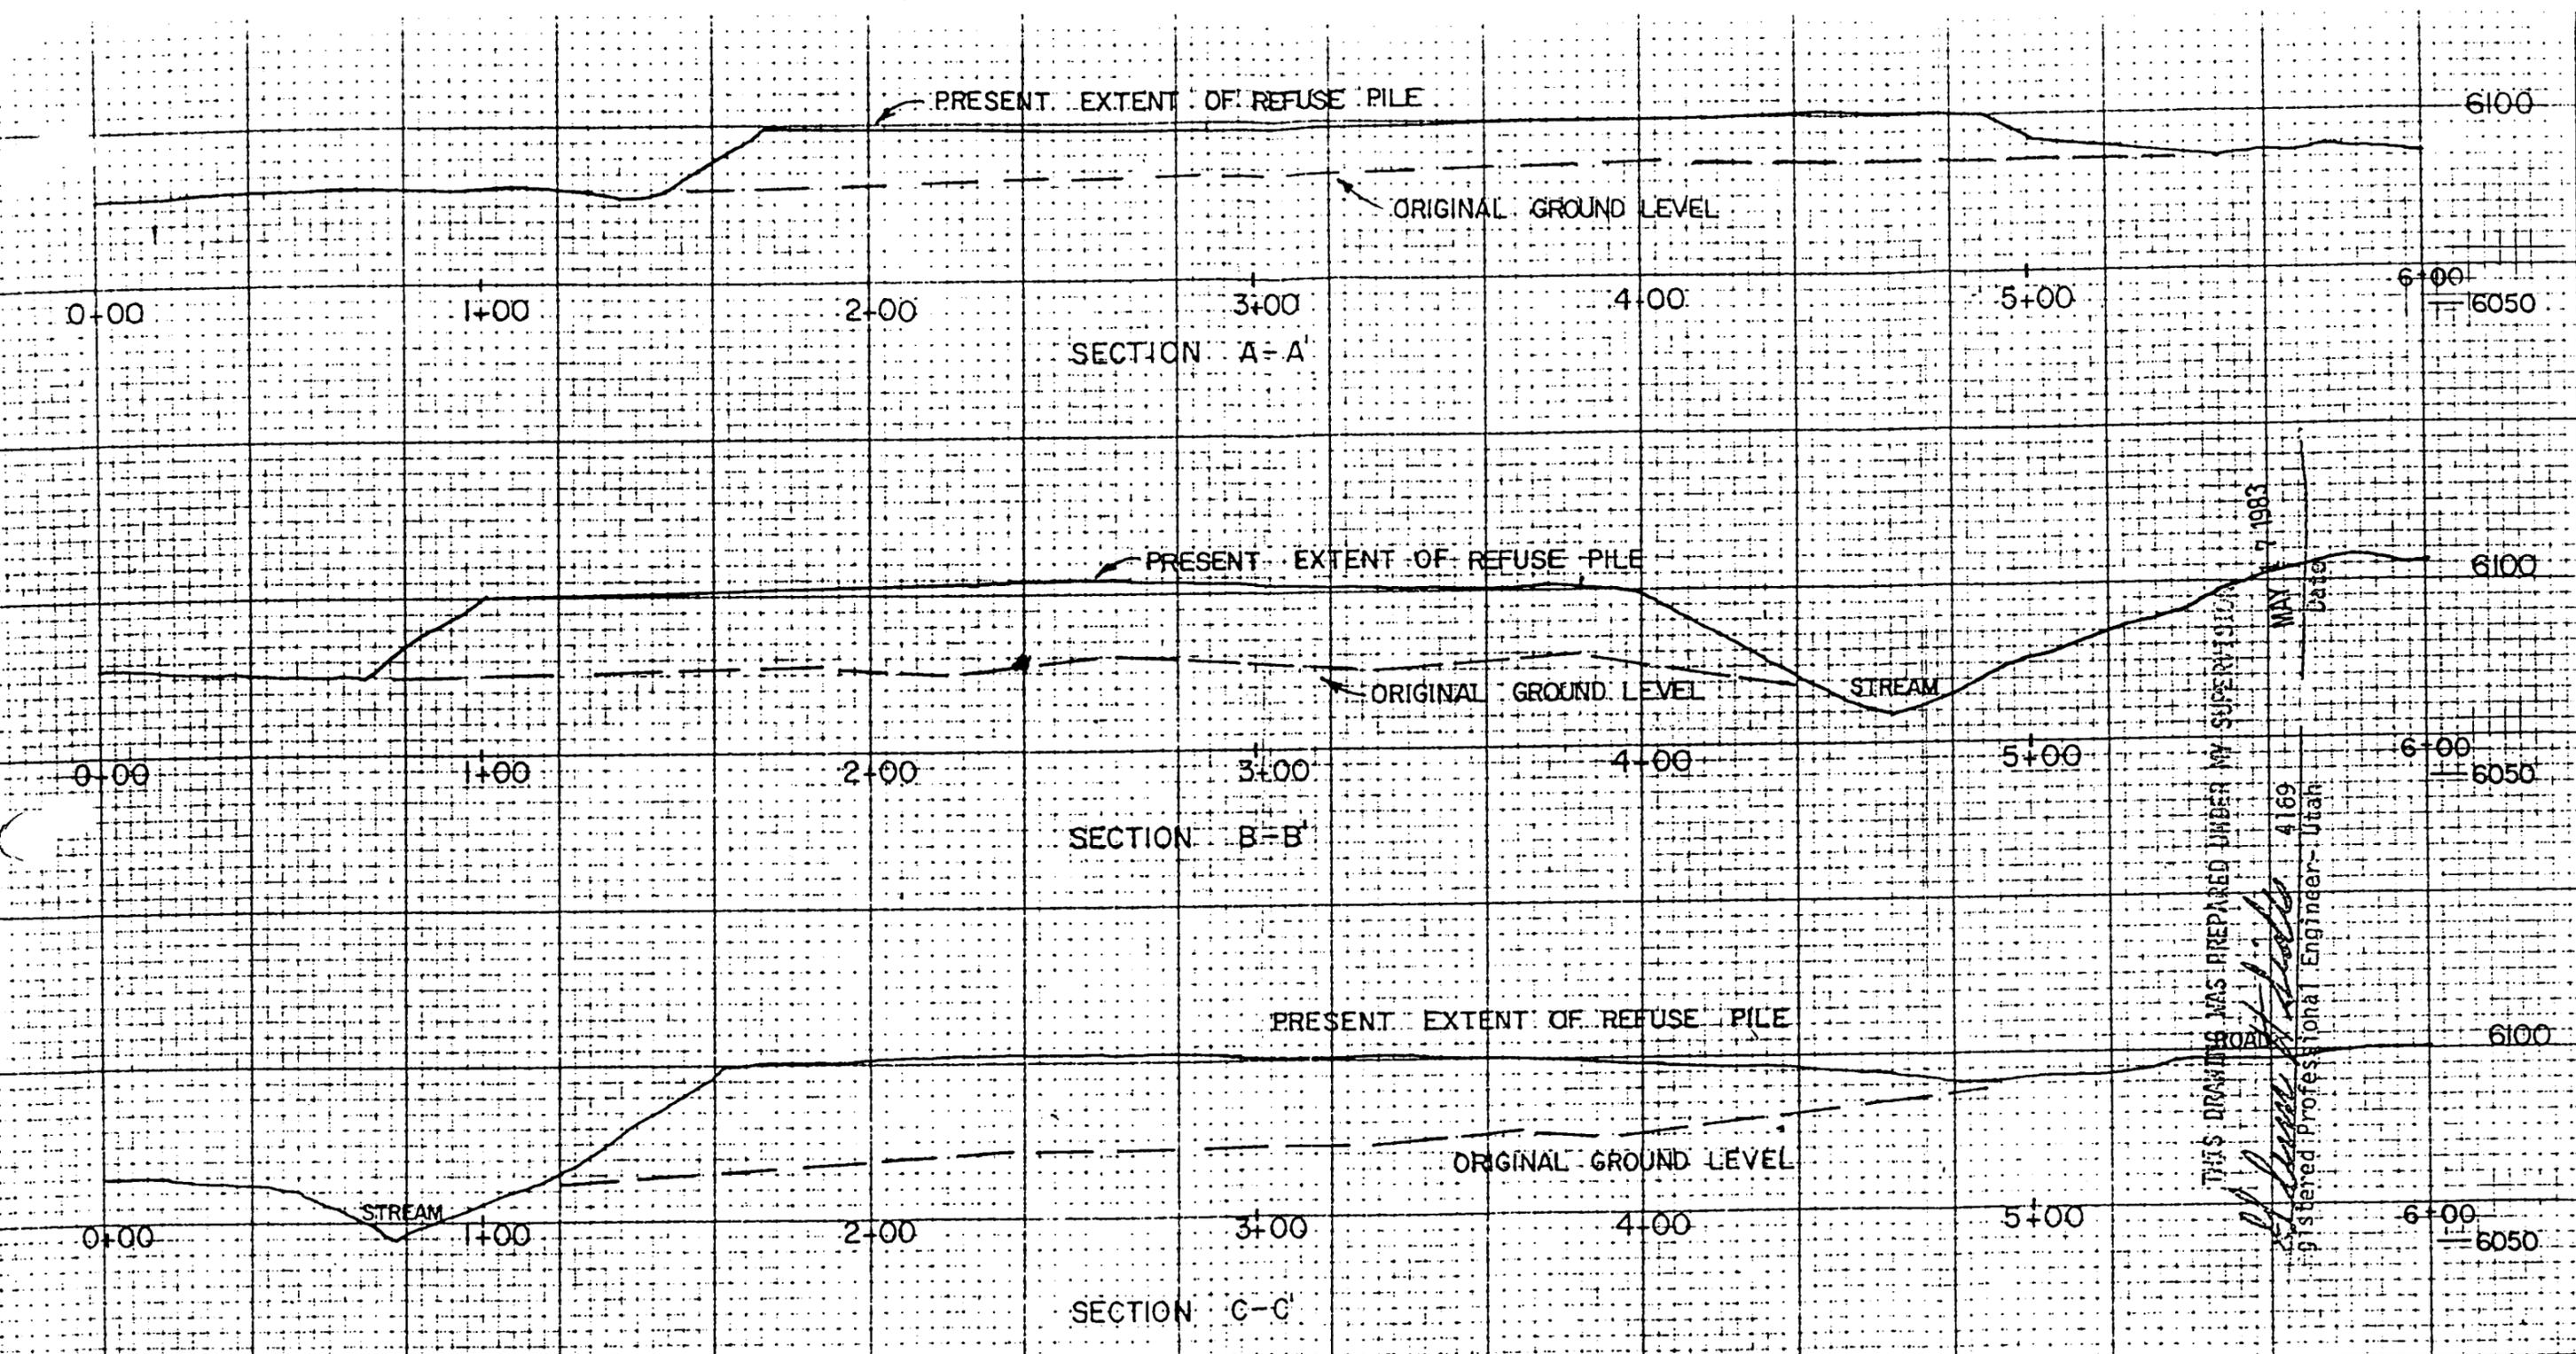
WESTERN DISTRICT-COAL	
	EAST CARBON, UTAH -	
GENEVA MINE		
ROAD JUNCTION REFUSE DUMP		
Ref. Dwg. F3-171		
DRAWN:	APPROVED:	
R.M.C. 2-18-81	G.H.S. 2-18-81	
SCALE: 1" = 40' HORZ.	C3-1208	
1" = 40' VERT.

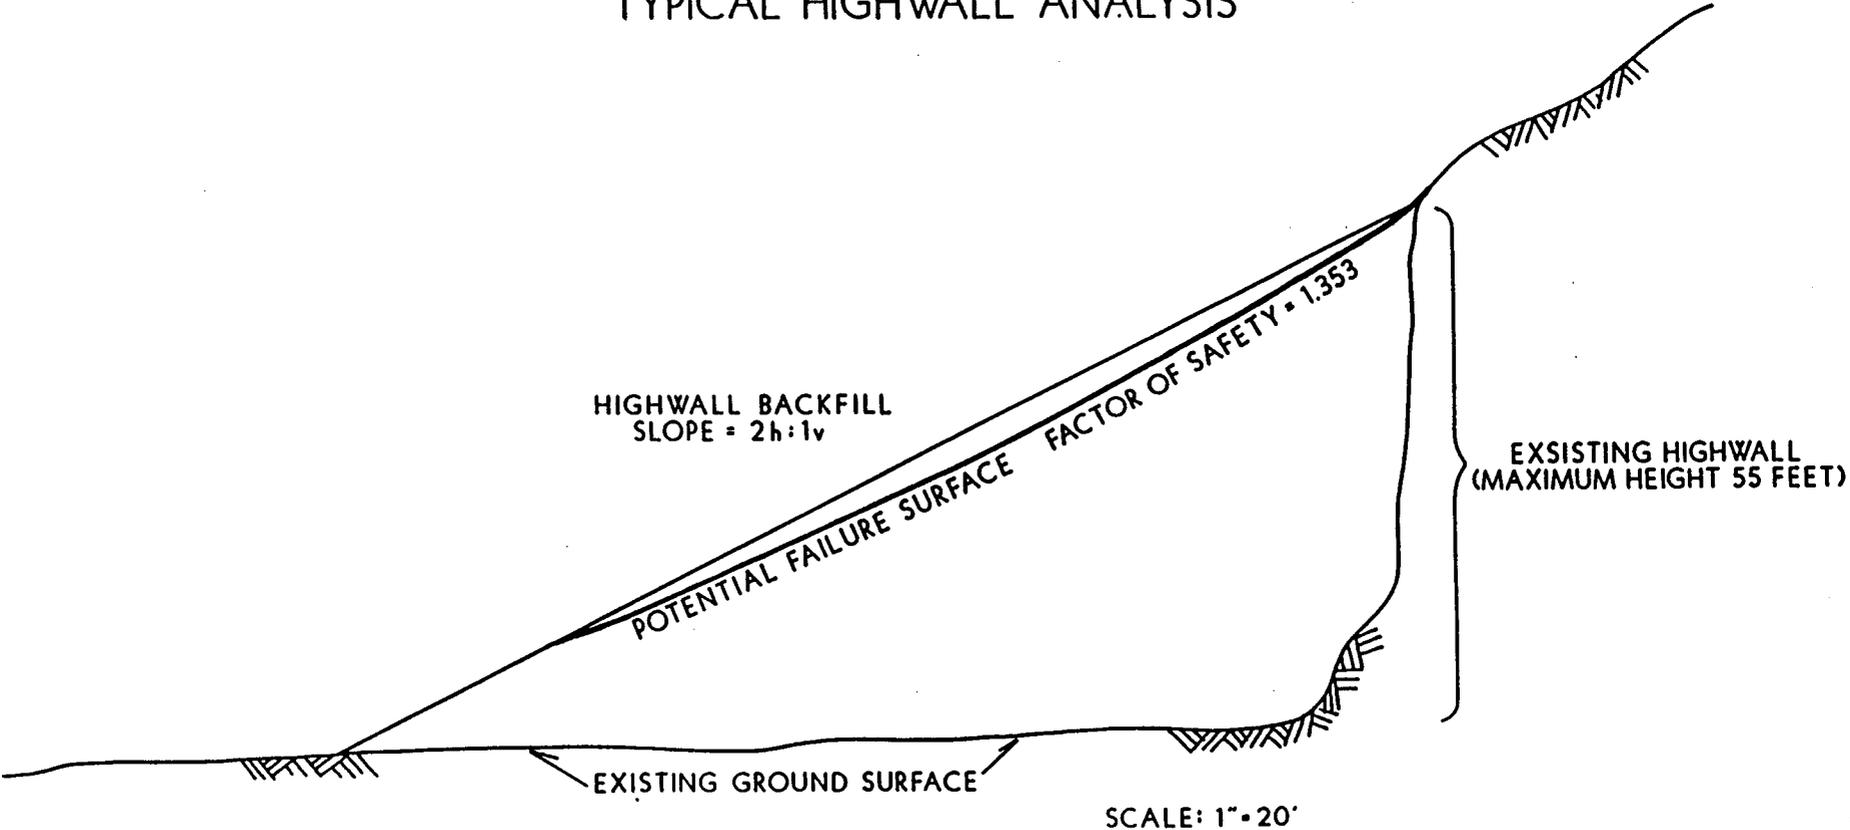
Appendix IV-2
Figure 1

SLOPE STABILITY ANALYSIS
TYPICAL HIGHWALL ANALYSIS

The slope stability has been evaluated using the simplified Janbu method of slices (Janbu and others, 1956). A computer program has been used to generate potential failure surfaces and calculate the factor of safety for each surface (Geoslope, 1985). One hundred potential failure surfaces have been considered for each highwall backfill and for each regraded slope. Included in computer printouts at the end of the report are descriptions of the surfaces with the ten lowest factors of safety for each analysis. Appendix IV-2 Figures 1 and 2 show the typical highwall backfill, and the typical regraded slope in cross section, and the potential failure surface with the lowest factor of safety.

Stability analysis reveal factors of safety of 1.353 for the highwall backfill and 1.906 for the regraded slopes in the mine facilities area. These factors of safety are for the potential failure surface with the lowest factor of safety. These failure surfaces are shown in Appendix IV-2 Figures 1 and 2.

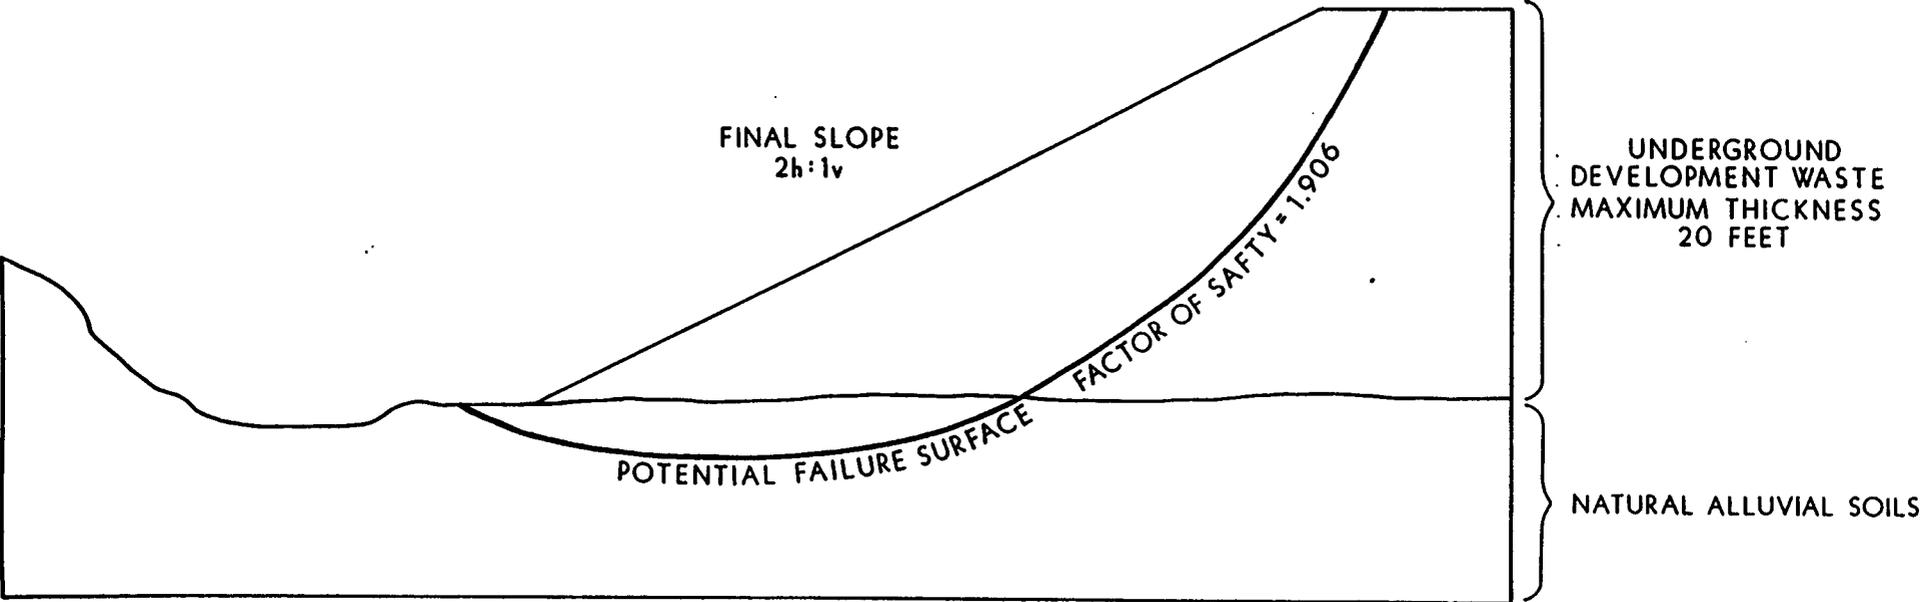
Appendix IV-2
Figure 2

SLOPE STABILITY ANALYSIS
TYPICAL MINE FACILITIES CROSS SECTION

SCALE 1" = 10'

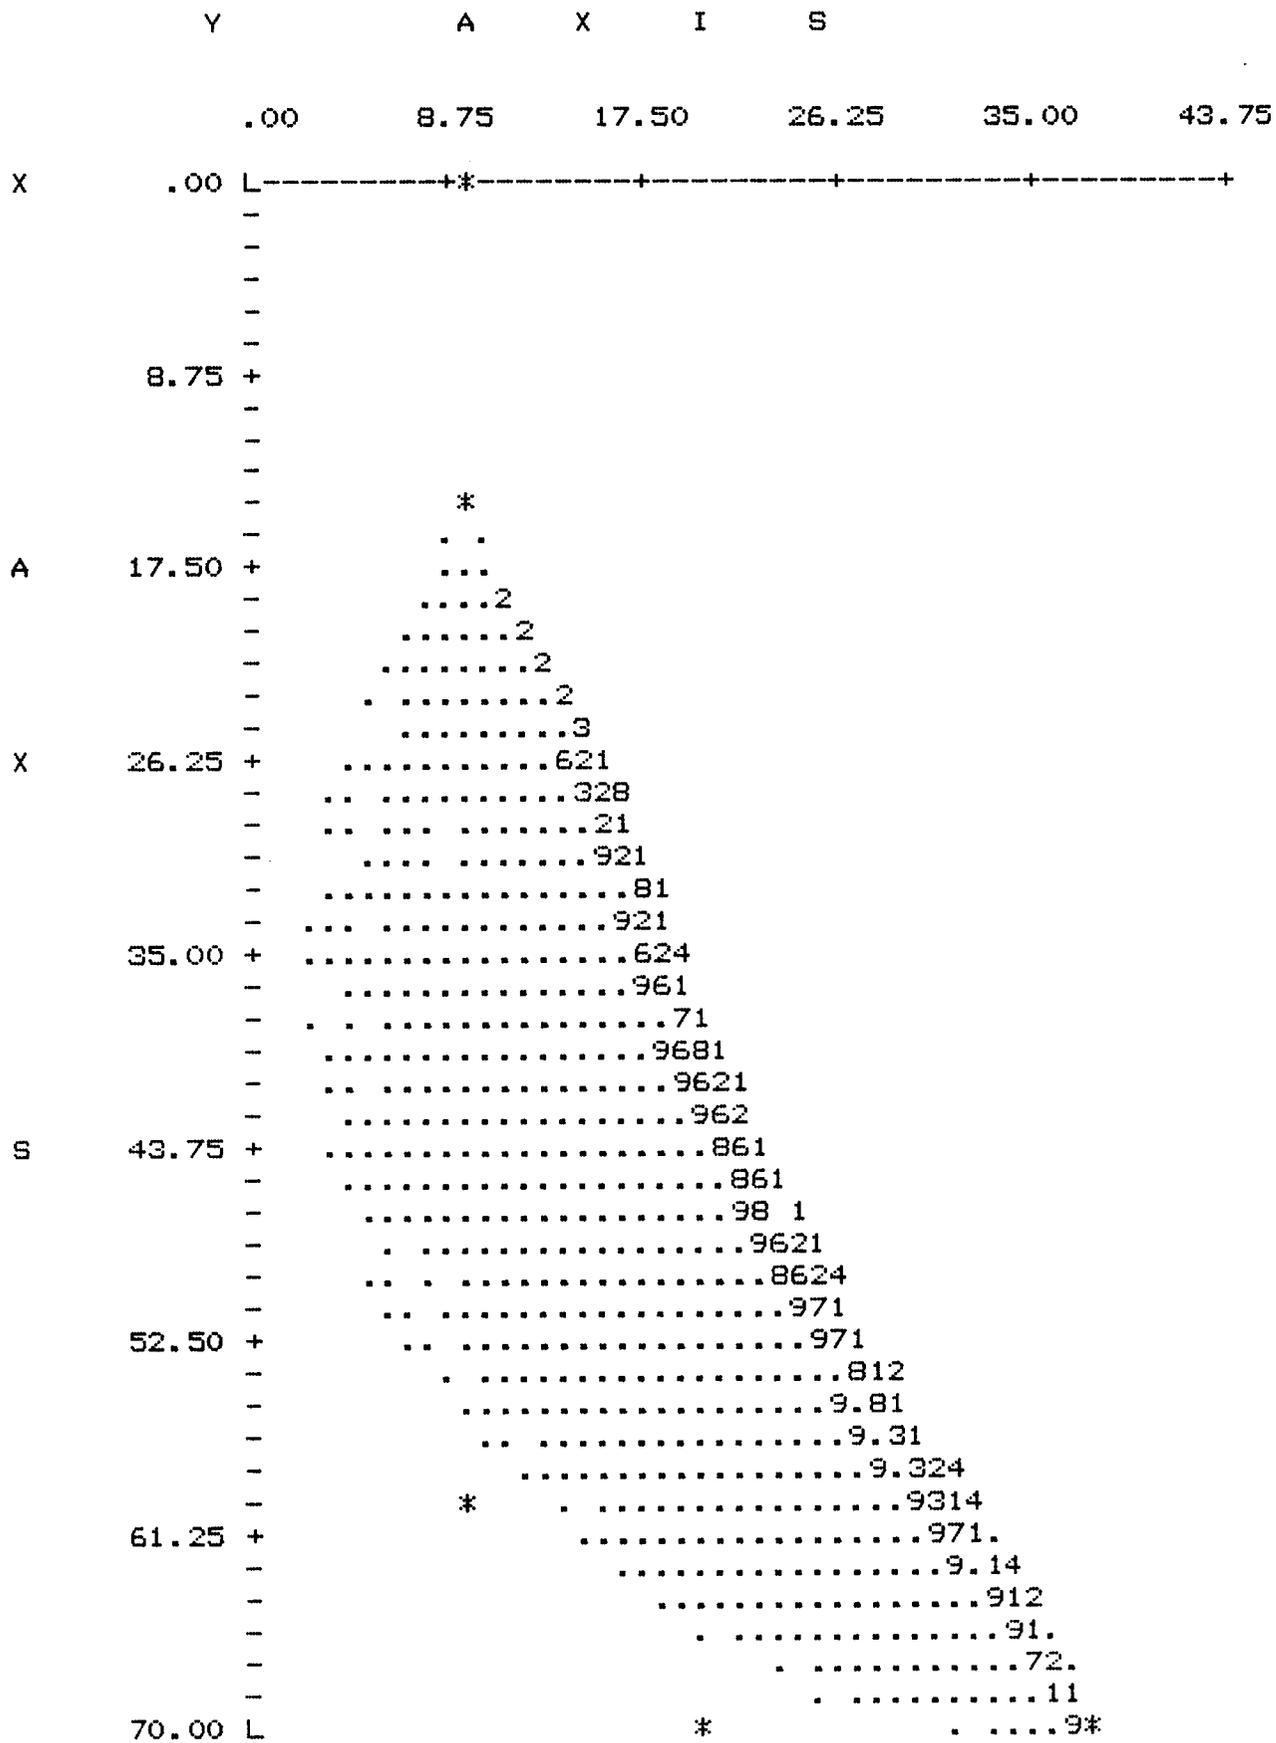
SAFETY FACTOR = 1.379

POINT NO.	X-SURF	Y-SURF	ALPHA (DEG)
1	30.00	17.50	10.82
2	31.96	17.88	12.56
3	33.92	18.31	14.29
4	35.86	18.80	16.03
5	37.78	19.36	17.76
6	39.68	19.97	19.50
7	41.57	20.63	21.24
8	43.43	21.36	22.97
9	45.27	22.14	24.71
10	47.09	22.98	26.45
11	48.88	23.87	28.18
12	50.64	24.81	29.92
13	52.38	25.81	31.65
14	54.08	26.86	33.39
15	55.75	27.96	35.13
16	57.39	29.11	36.86
17	58.99	30.31	38.60
18	60.55	31.56	40.33
19	62.07	32.85	42.07
20	63.56	34.19	43.81
21	63.75	34.37

SOIL TYPE NO.	TOTAL UNIT WT.	SATURATED UNIT WT.	COHESION INTERCEPT	FRICTION ANGLE (DEG)	PORE PRESSURE PARAMETER	PRESSURE CONSTANT	PIEZOMETRIC SURFACE NO.
1	90.0	90.0	.0	30.0	.00	.0	1
2	85.0	85.0	144.0	35.0	.00	.0	1

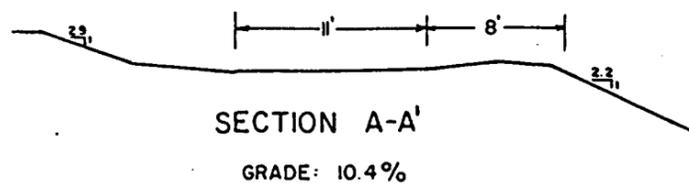
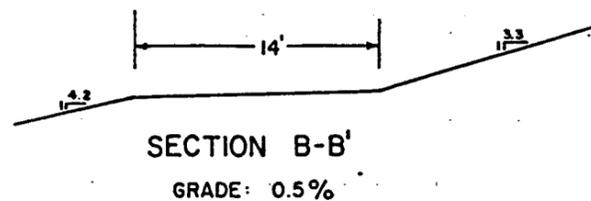
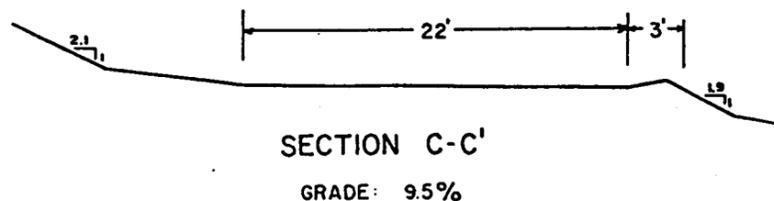
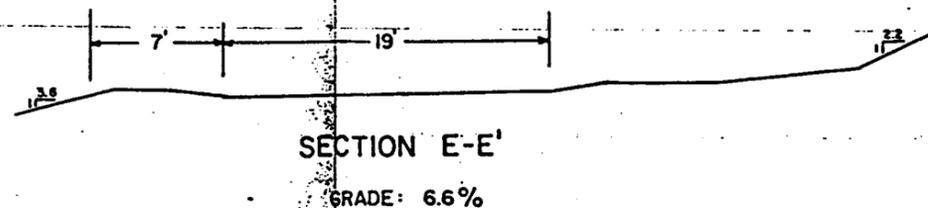
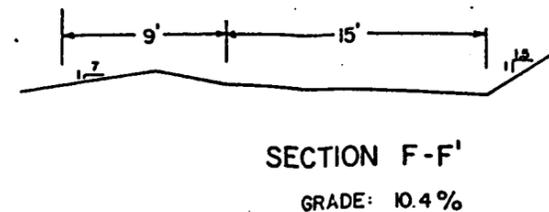
C3-1282
Sheet 1 of 3

GENEVA COAL MINE
ROAD CROSS-SECTIONS

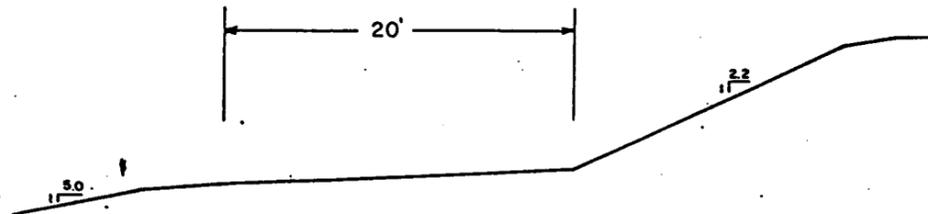
SECTION M-M'
GRADE: 8.6%
