## Table of Contents

**Probable Hydrologic  
Consequences Determination**

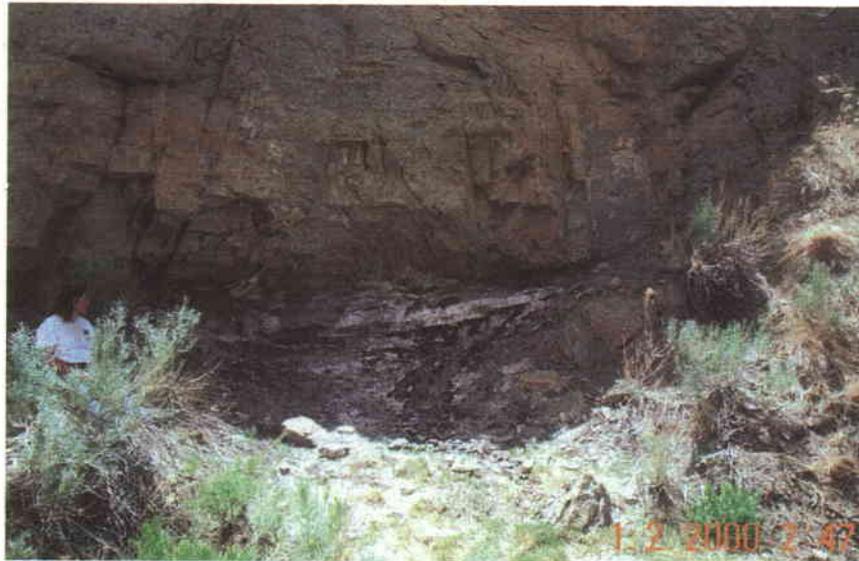
## L-16-G Little Stink

**Location:** Located in what has recently been named Stinky Spring Canyon by the Operator. The seep is located approximately .25 miles to the West of the permit area and within the Central Graben. The seep is located at the top of the Mancos Shale approximately 600 feet below the coal seam in a highly faulted area at an elevation of 5840 feet. The stream reach is intermittent by definition but is ephemeral acting (See Appendix 7-7 & Plate 7-4). The drainage above and below this monitoring location flows only as a result of spring run-off or storm events.

**General:** Due to its location, outside the permit area, outside the limit of subsidence, within the Central Graben, and being 600 feet below the coal seam, there is no potential for Lila Canyon Mine to negatively impact this spring or recharge sources. This location is used heavily by Rocky Mountain Bighorn Sheep; however, no evidence of the sheep using the poor quality water has been documented. The permittee has never observed amphibians at or near this location.

L-16-G and L-17-G are seeps being monitored in Stinky Spring Canyon. ~~These two seeps appear to be an important source of water for Bighorn sheep specifically in the early spring.~~ have been observed within the canyon but have never been observed drinking the water.

These springs are located within the Central Graben, which is a block that has been downdropped between 145 and 250 feet relative to the adjacent bedrock. They occur near the contact between the Mancos Shale and the overlying Blackhawk Formation. The fractured nature of the bedrock along the edges of the Central Graben, as a result of the faulting, likely are the limits of the areal extent of the recharge or source area to the springs. The low-permeability of the surrounding Mancos Shale likely isolate the graben block from groundwater in the surrounding bedrock. Thus, the recharge to the springs is likely limited to the area of the consolidated graben block.

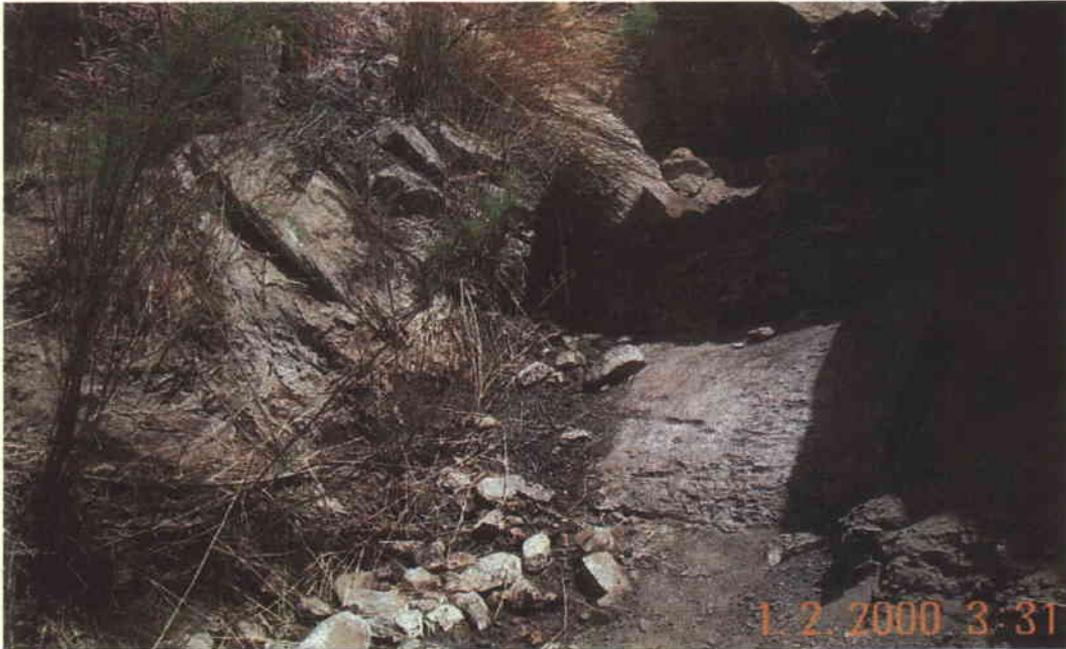
## L-17-G Big Stink

- Location:** Located in what has recently been named Stinky Spring Canyon. -The seep is located approximately .25 miles to the West of the permit area, .1 mile above L-16-S, and within the Central Graben.- The seep is located at the top of the Mancos Shale approximately 500 feet below the coal seam in a highly faulted area at an elevation of 5920 feet. -The stream reach is intermittent by definition but is ephemeral acting (See Appendix 7-7 & Plate 7-4).- The drainage above and below this monitoring location flows only as a result of spring run-off or storm events.

- General:** Due to its location, outside the permit area, outside the limit of subsidence, and being 500 feet below the coal seam, there is no potential for Lila Canyon Mine to negatively impact this spring or recharge sources. This location is used heavily by Rocky Mountain Bighorn Sheep; however, no evidence of the sheep drinking the poor quality water has been documented. The permittee has never observed amphibians at or near this location.
