**Horse Canyon Extension  
Lila Canyon Mine**

**Chapter 6  
Geology**

# Volume 5 of 7

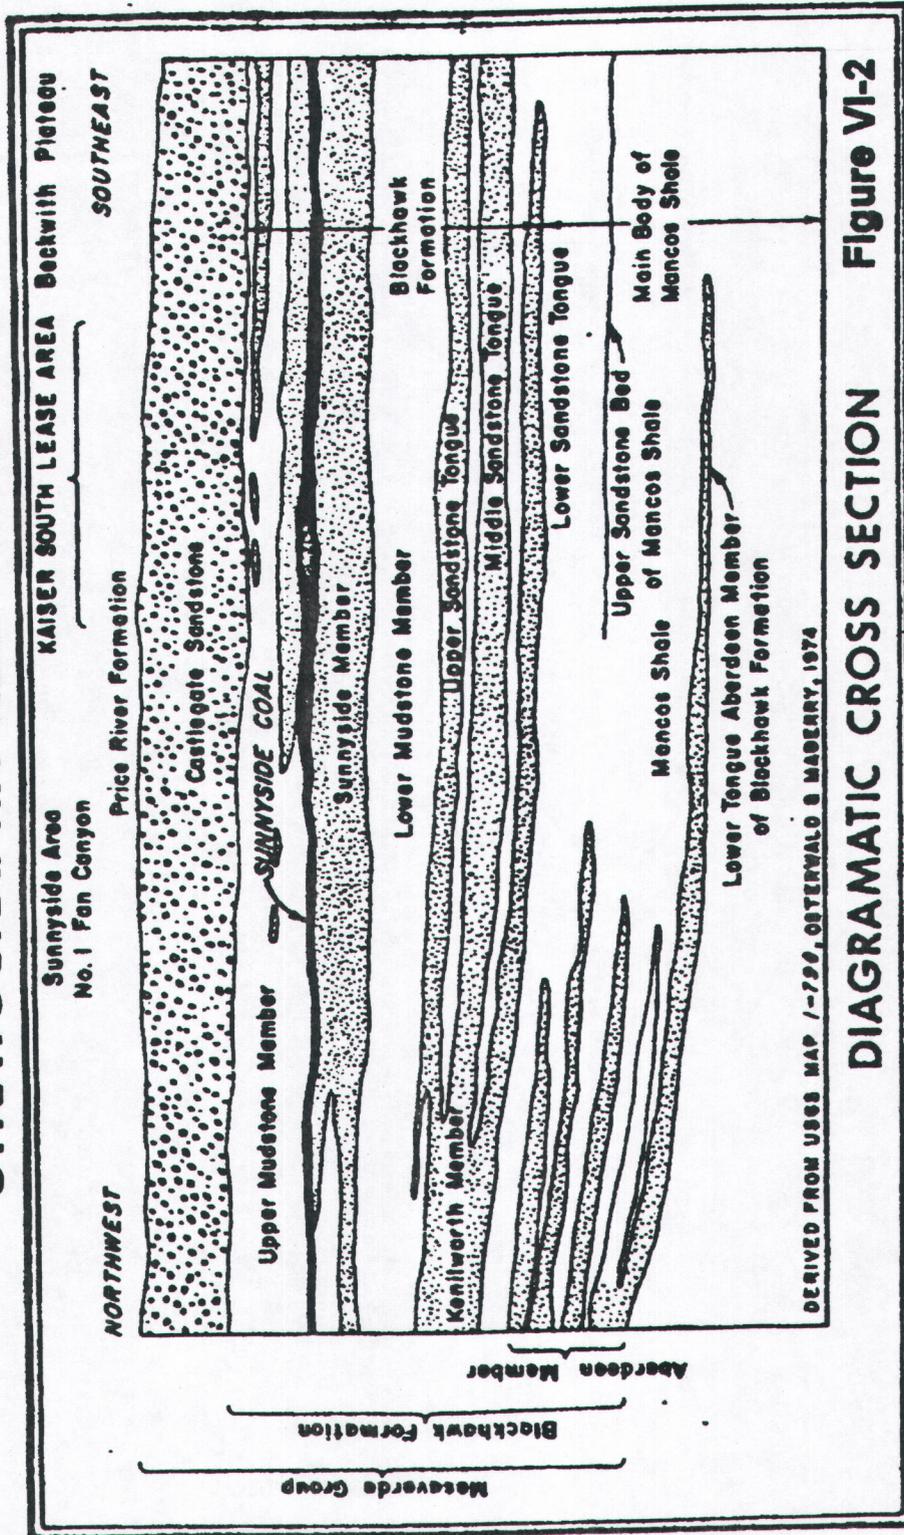
Figure VI-2

# STRATIGRAPHIC RELATIONSHIPS

DIAGRAMATIC CROSS SECTION

Osterwald and Mayberry (1974) divide the Blackhawk Formation into the following two members (See Figure 6-2): the Lower Mudstone Member and Kenilworth Member, 150 to 300 feet thick; and the Upper Mudstone and Sunnyside Member, 150 to 350 feet thick.

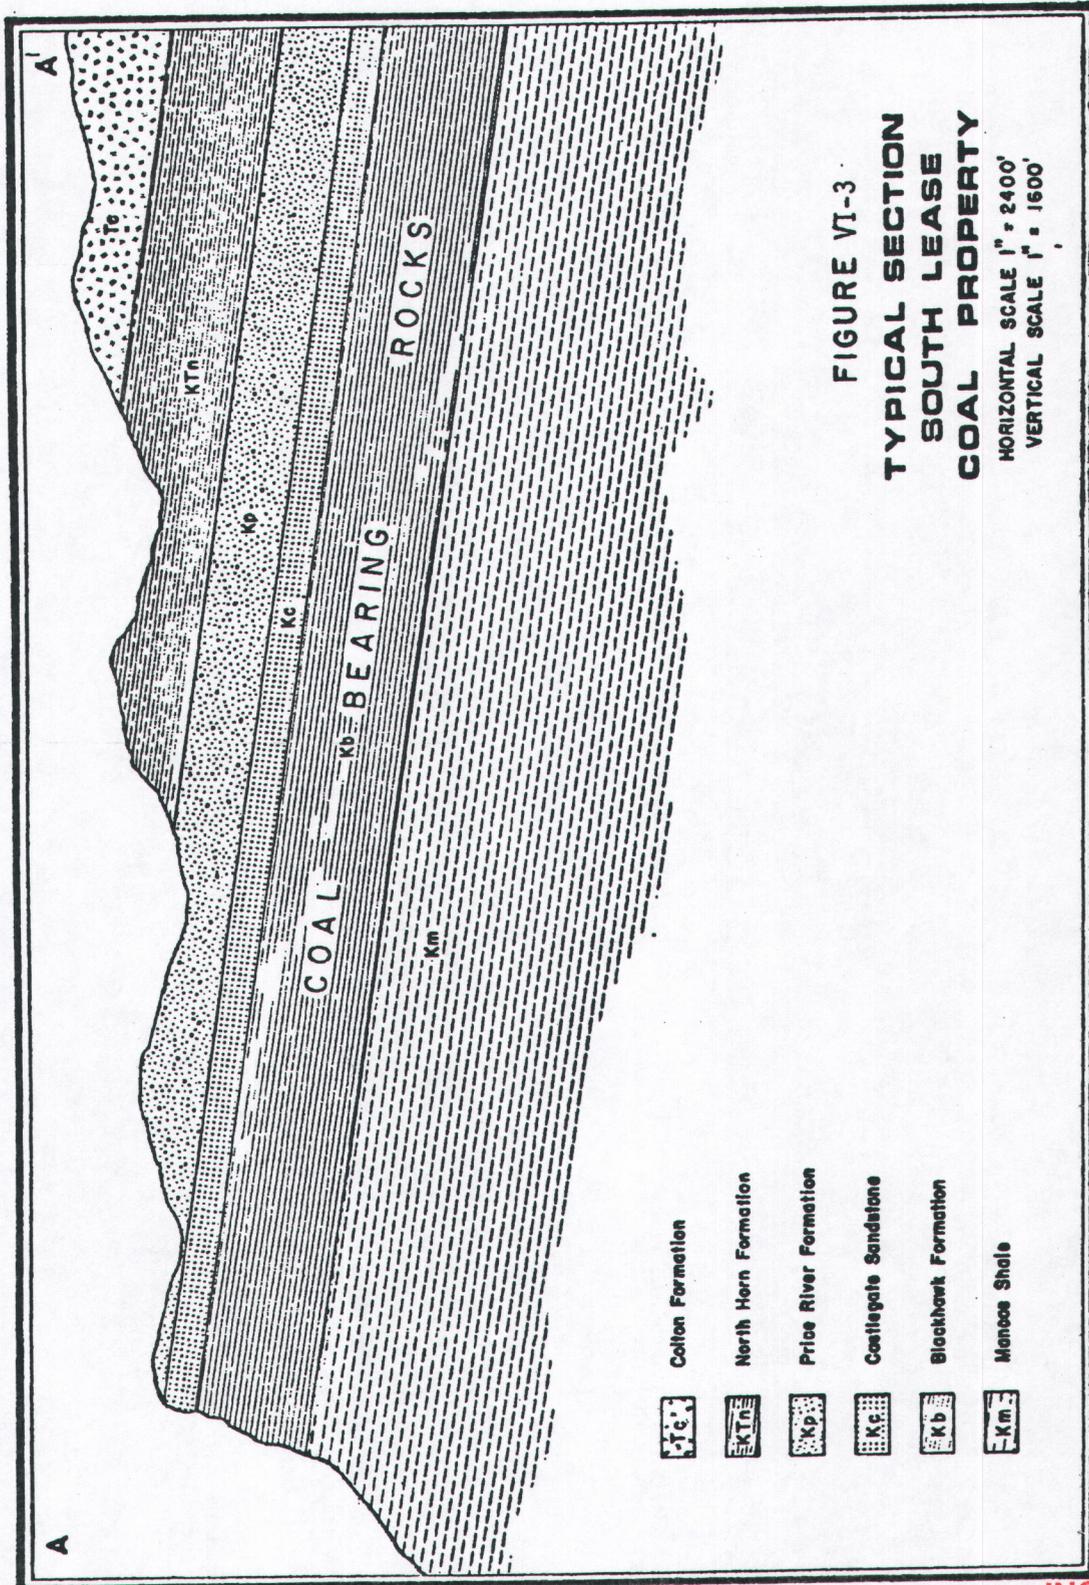
FIGURE VI-3  
TYPICAL SECTION  
SOUTH LEASE  
COAL PROPERTY

HORIZONTAL SCALE 1" = 2400'  
VERTICAL SCALE 1" = 1600'

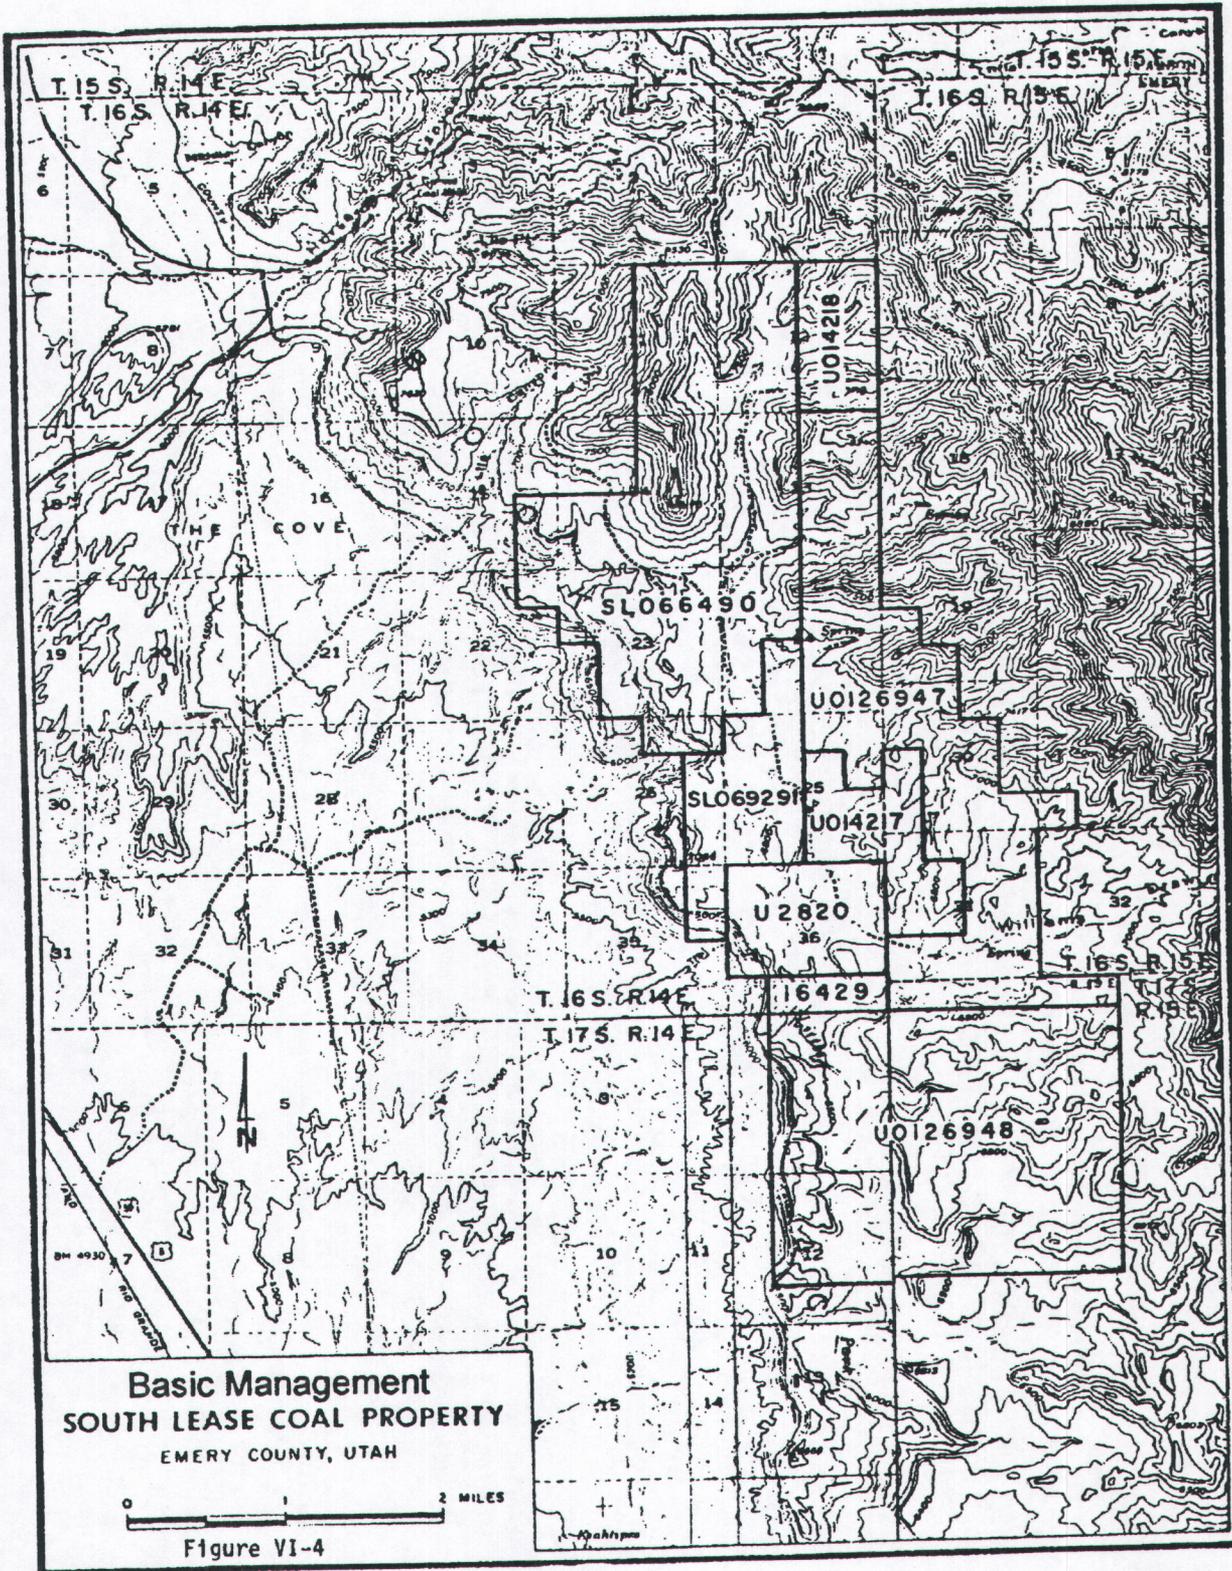
Basic Management  
SOUTH LEASE COAL PROPERTY  
EMERY COUNTY, UTAH  
0 1 2 MILES  
Figure VI-4

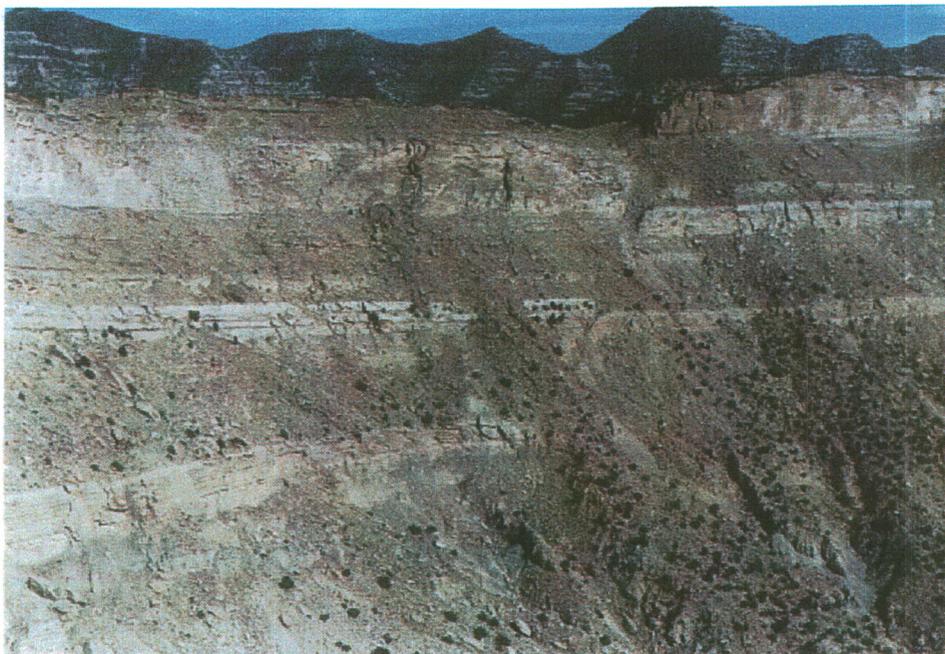
**Williams Draw Fault**

Major South Lease Faults					
Fault	Strike	Range of dips	Displacement (in feet)		
			West	Middle	East
North Lila Canyon	N10°E	S70°	13	42	?
Middle Lila Canyon	N7°E	S70°	8	10	?
South Lila Canyon	N89°E	N60°	17	25	?
Entry	S85°E	S55-30°	0	50	0
Cliffs Graben	Apparently does not extend into the Lease				
Central Graben Auxiliary	N87°E	S87-60°	205	0	?
Central Graben Main	N82°E	N52-77°	145	50	40
Williams Draw	S88°E	N56-68°	195	125	50
South Boundary	S84°E	S81-78°	72	45	15

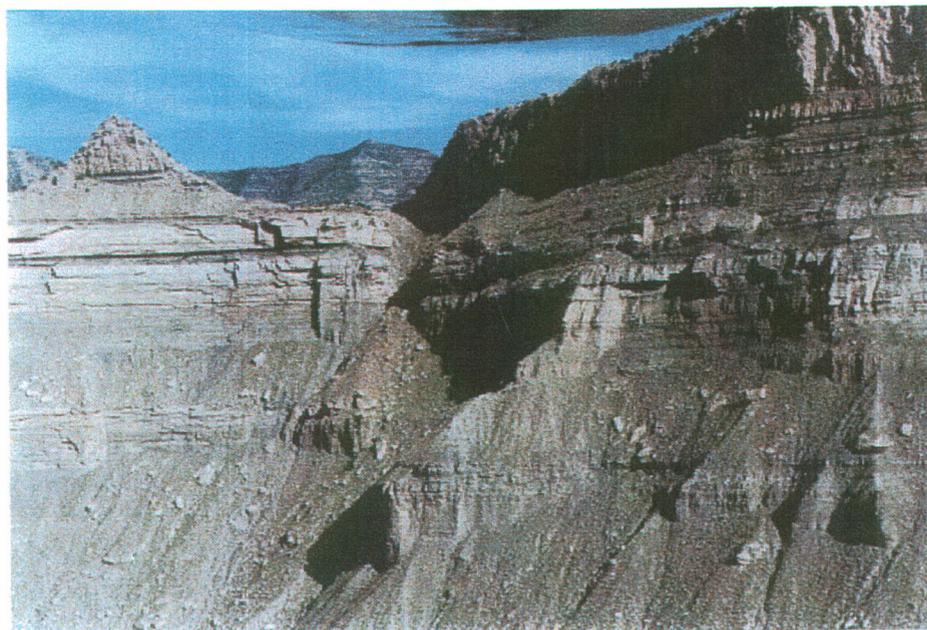
**South Boundary Fault**

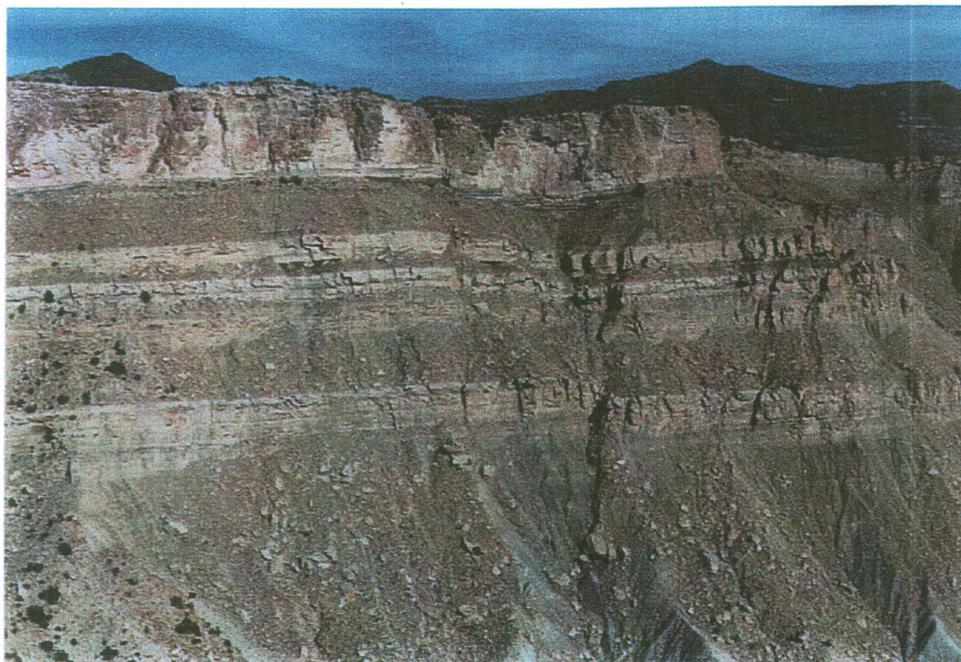
**Cliffs Graben**

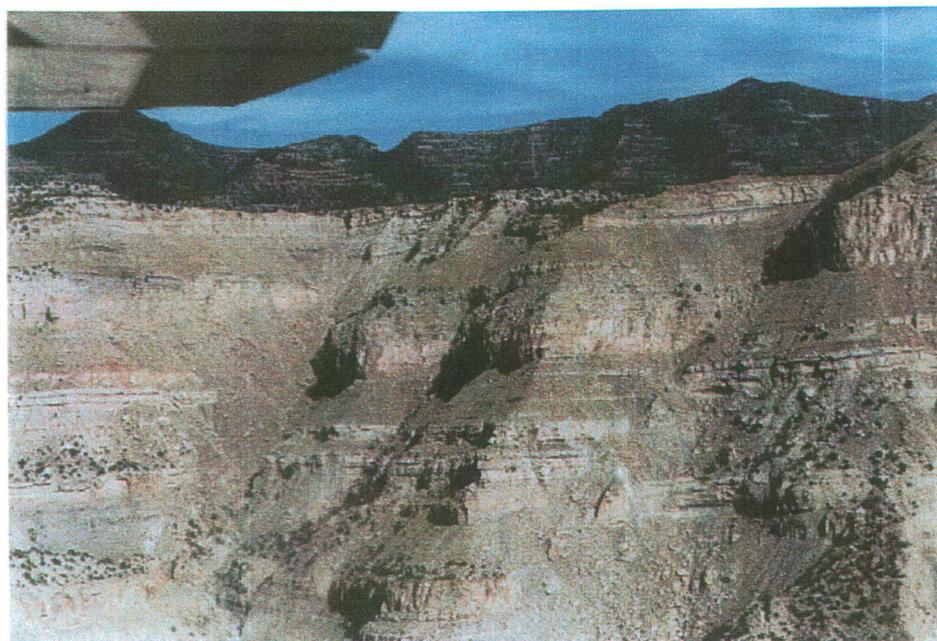
**Central Graben**

The fault set defining the Central Graben disrupts the coal from the outcrop down-dip for approximately 5,000 feet. The possible complex nature of the structure in this block, due to secondary faulting and fracturing, may affect recovery of the coal.

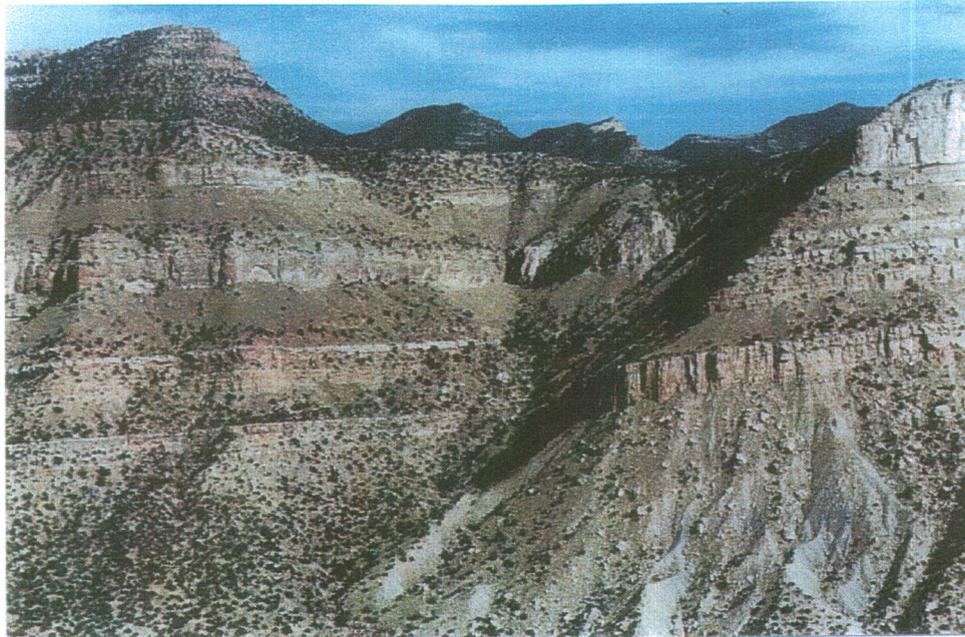
**Entry Fault** Near Lila Canyon Portals

In addition to the drilling, an exploration test entry was driven 6,080 feet into the property from U.S. Steel's Geneva Mine. A total of 120,000 tons of coal was extracted from the workings and used for coke-making. The entry was terminated when a fault having a displacement of approximately 50 feet was encountered. The entry was sealed after roof falls in the Geneva Mine made these entries inaccessible. The Horse Canyon mine is now sealed as well. Geological, analytical, and mining data were acquired.

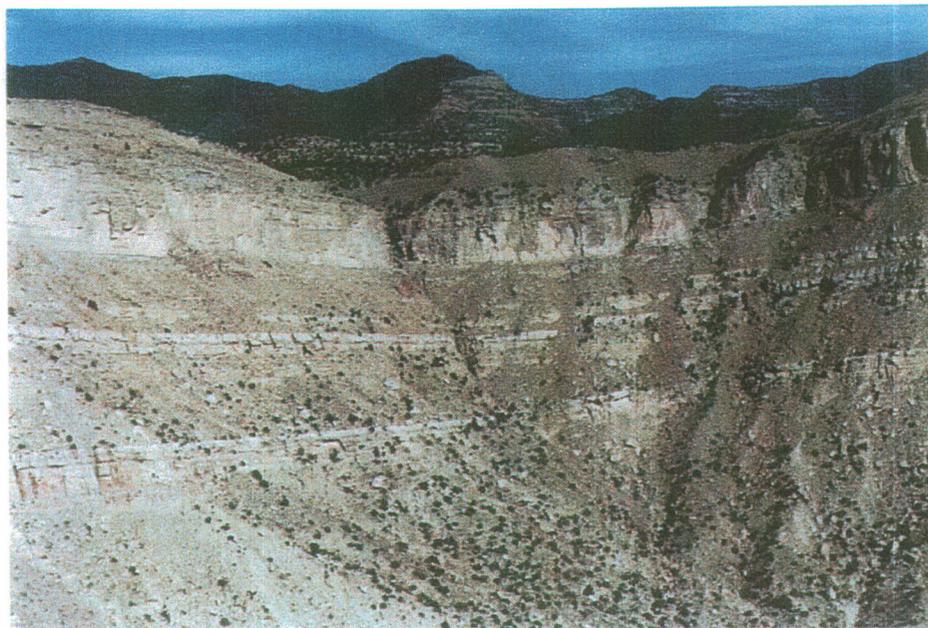
**No-Name** South of Entry Fault
