2014 Annual Report Deficiencies; Lila Canyon Mine Task ID #4801

In response to the 2014 Annual Report Review for Lila Canyon Mine, C/007/0013 Task ID #4801:

**UTAHAMERICAN ENERGY, INC.
LILA CANYON MINE**

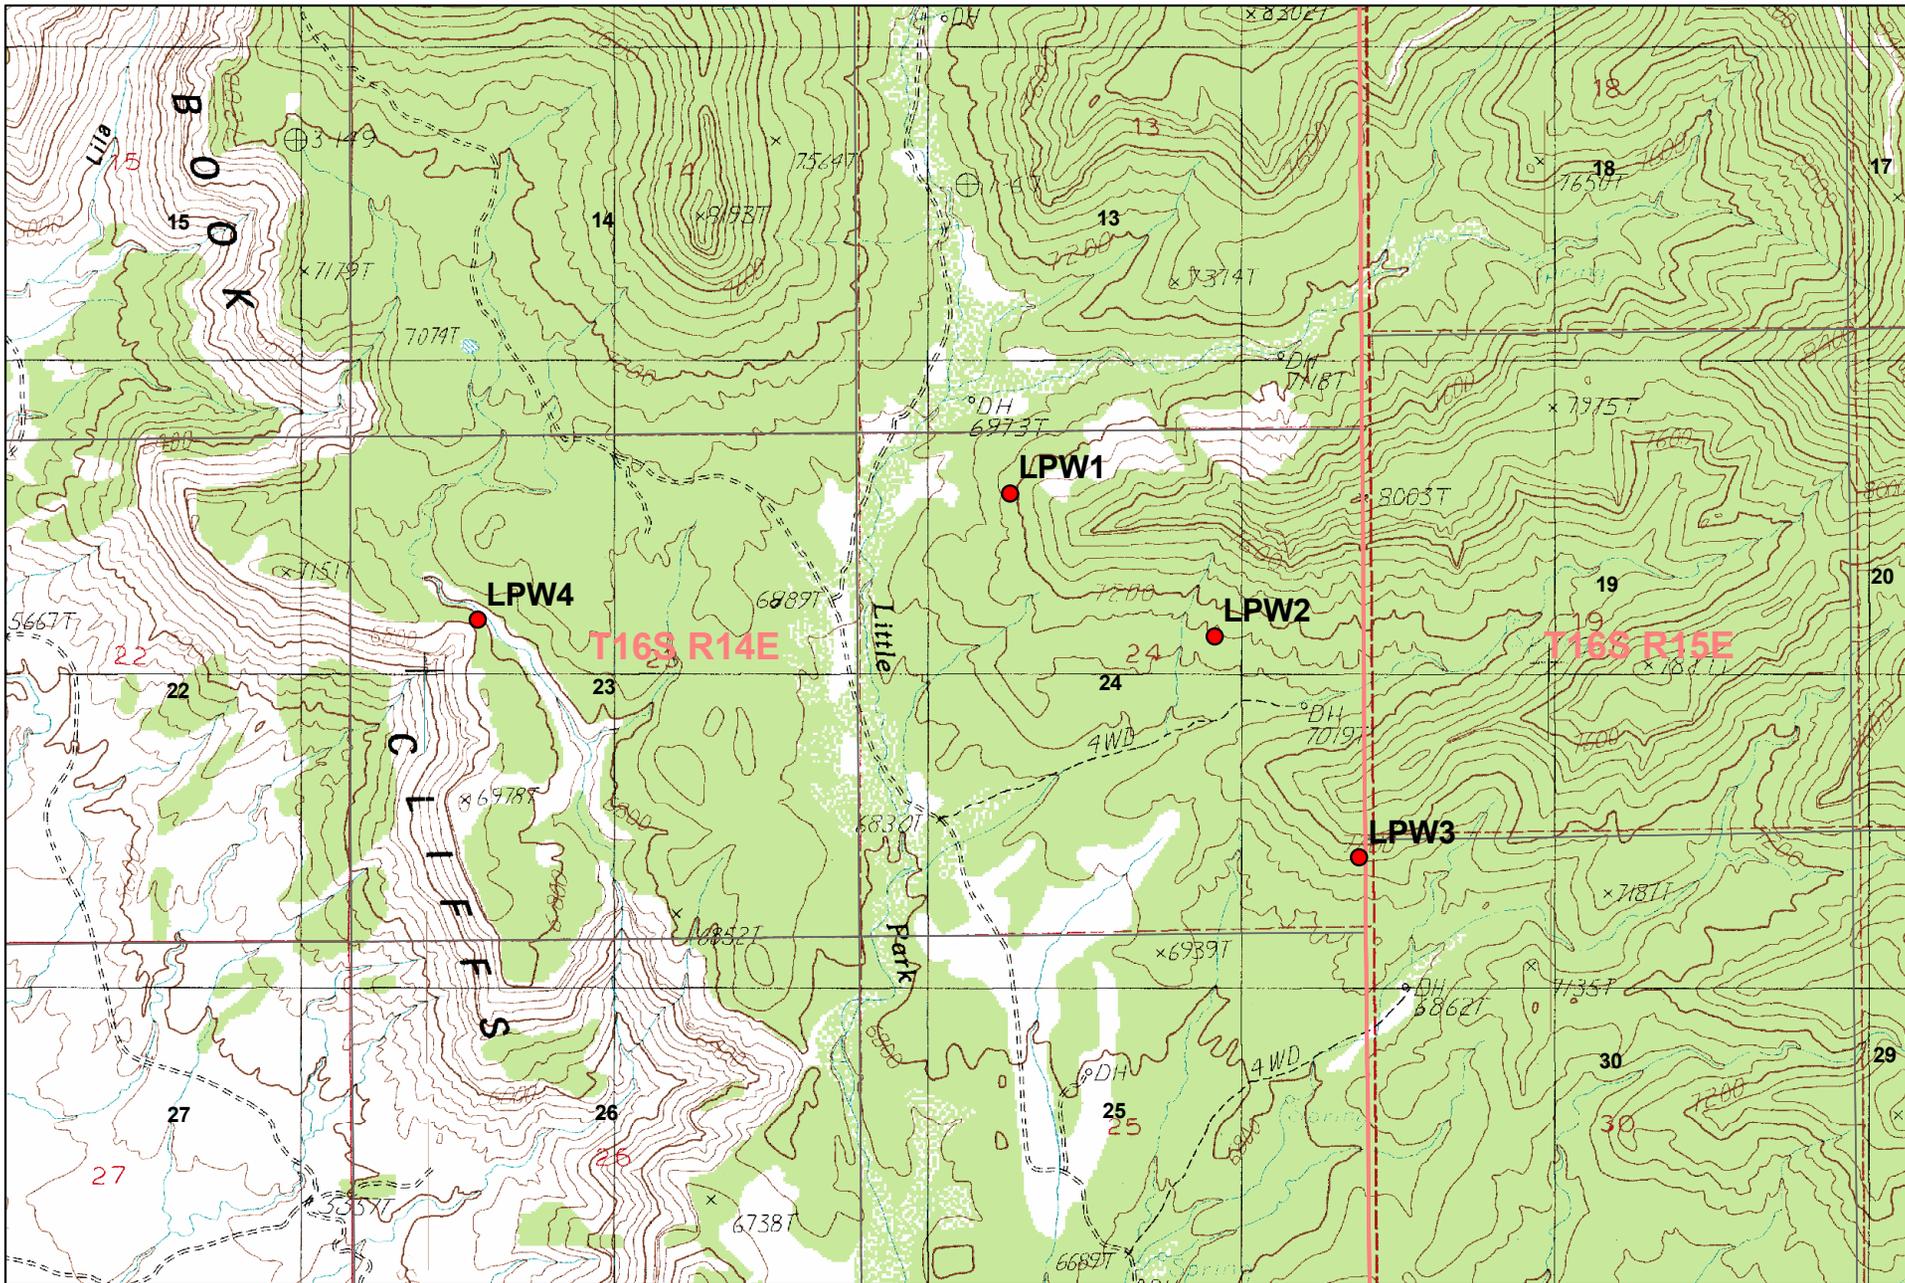
Plate 1

Along with the inventory forms (Attachment 1), each call point surveyed was plotted on a map for further review and association with existing maps of potential owl use and breeding habitat (Plate 1).
