State of Utah  
DEPARTMENT OF NATURAL RESOURCES  
DIVISION OF OIL, GAS AND MINING

Re: Approval of Reclamation Plans, Mountain Coal Company, Gordon Creek 2, 7, & 8 Mines, ACT/007/016, Folder #3, Carbon County, Utah

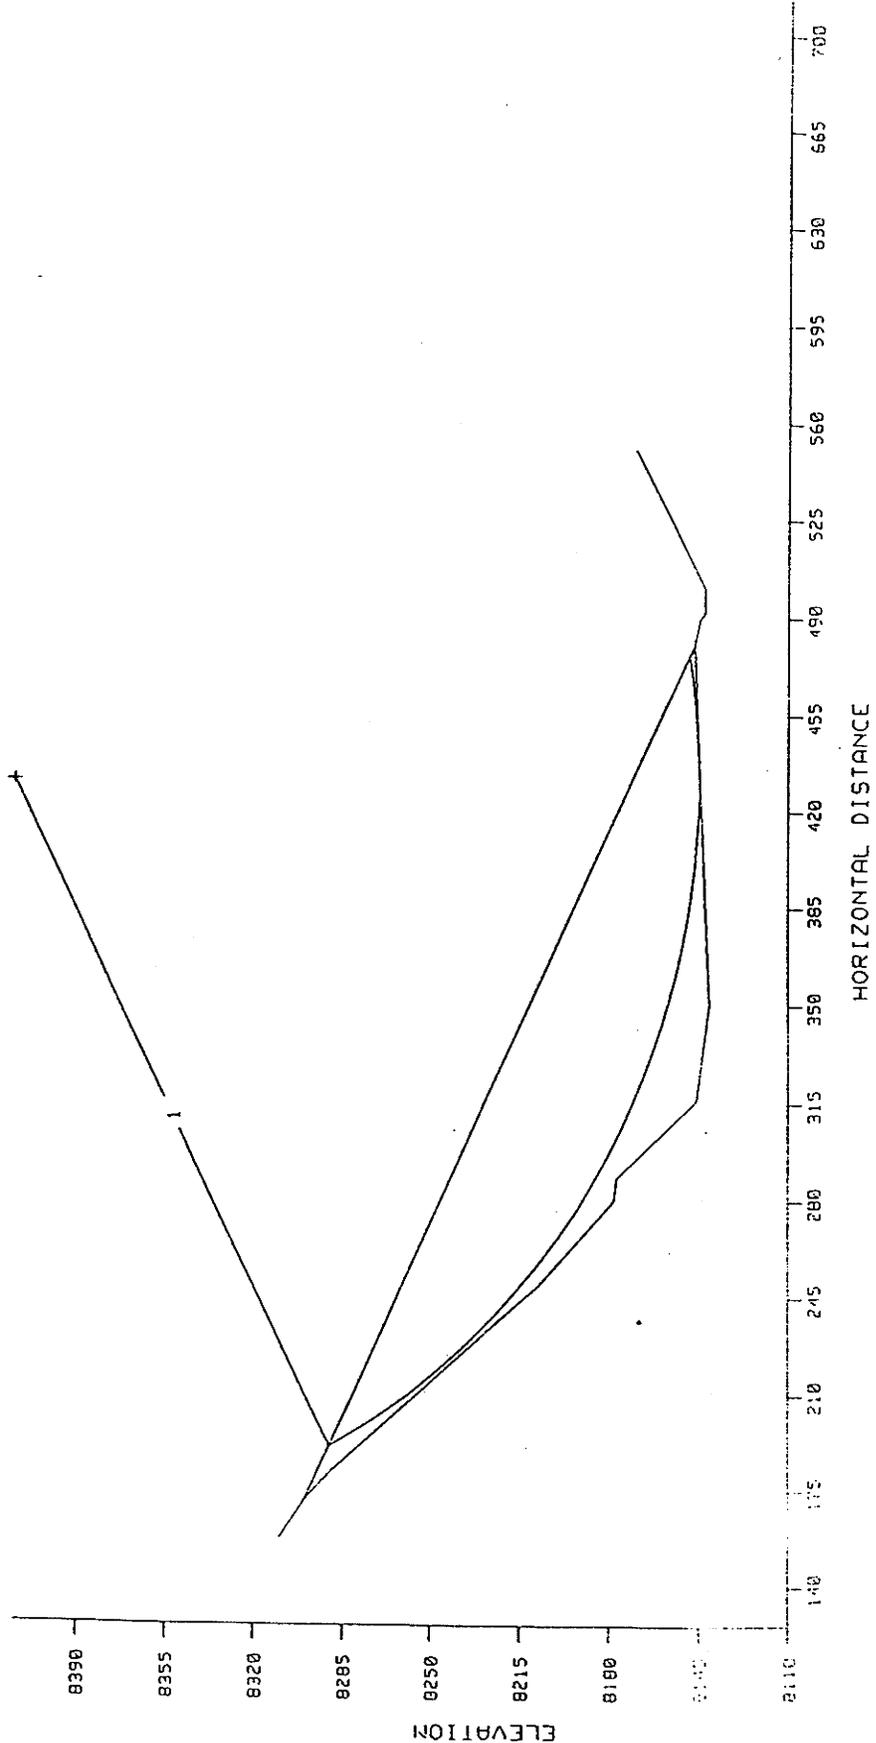
COMPLETE SLOPE CROSS SECTION SHOWN

CIRCLE	X	Y	RADIUS	FS
1	430.0	8415.0	270.0	1.20
