United States Department of the Interior

BUREAU OF LAND MANAGEMENT

RE: Soldier Canyon Mine Resource Recovery and Protection Plan (R2P2) Modification, Main East Area of the Sunnyside Seam

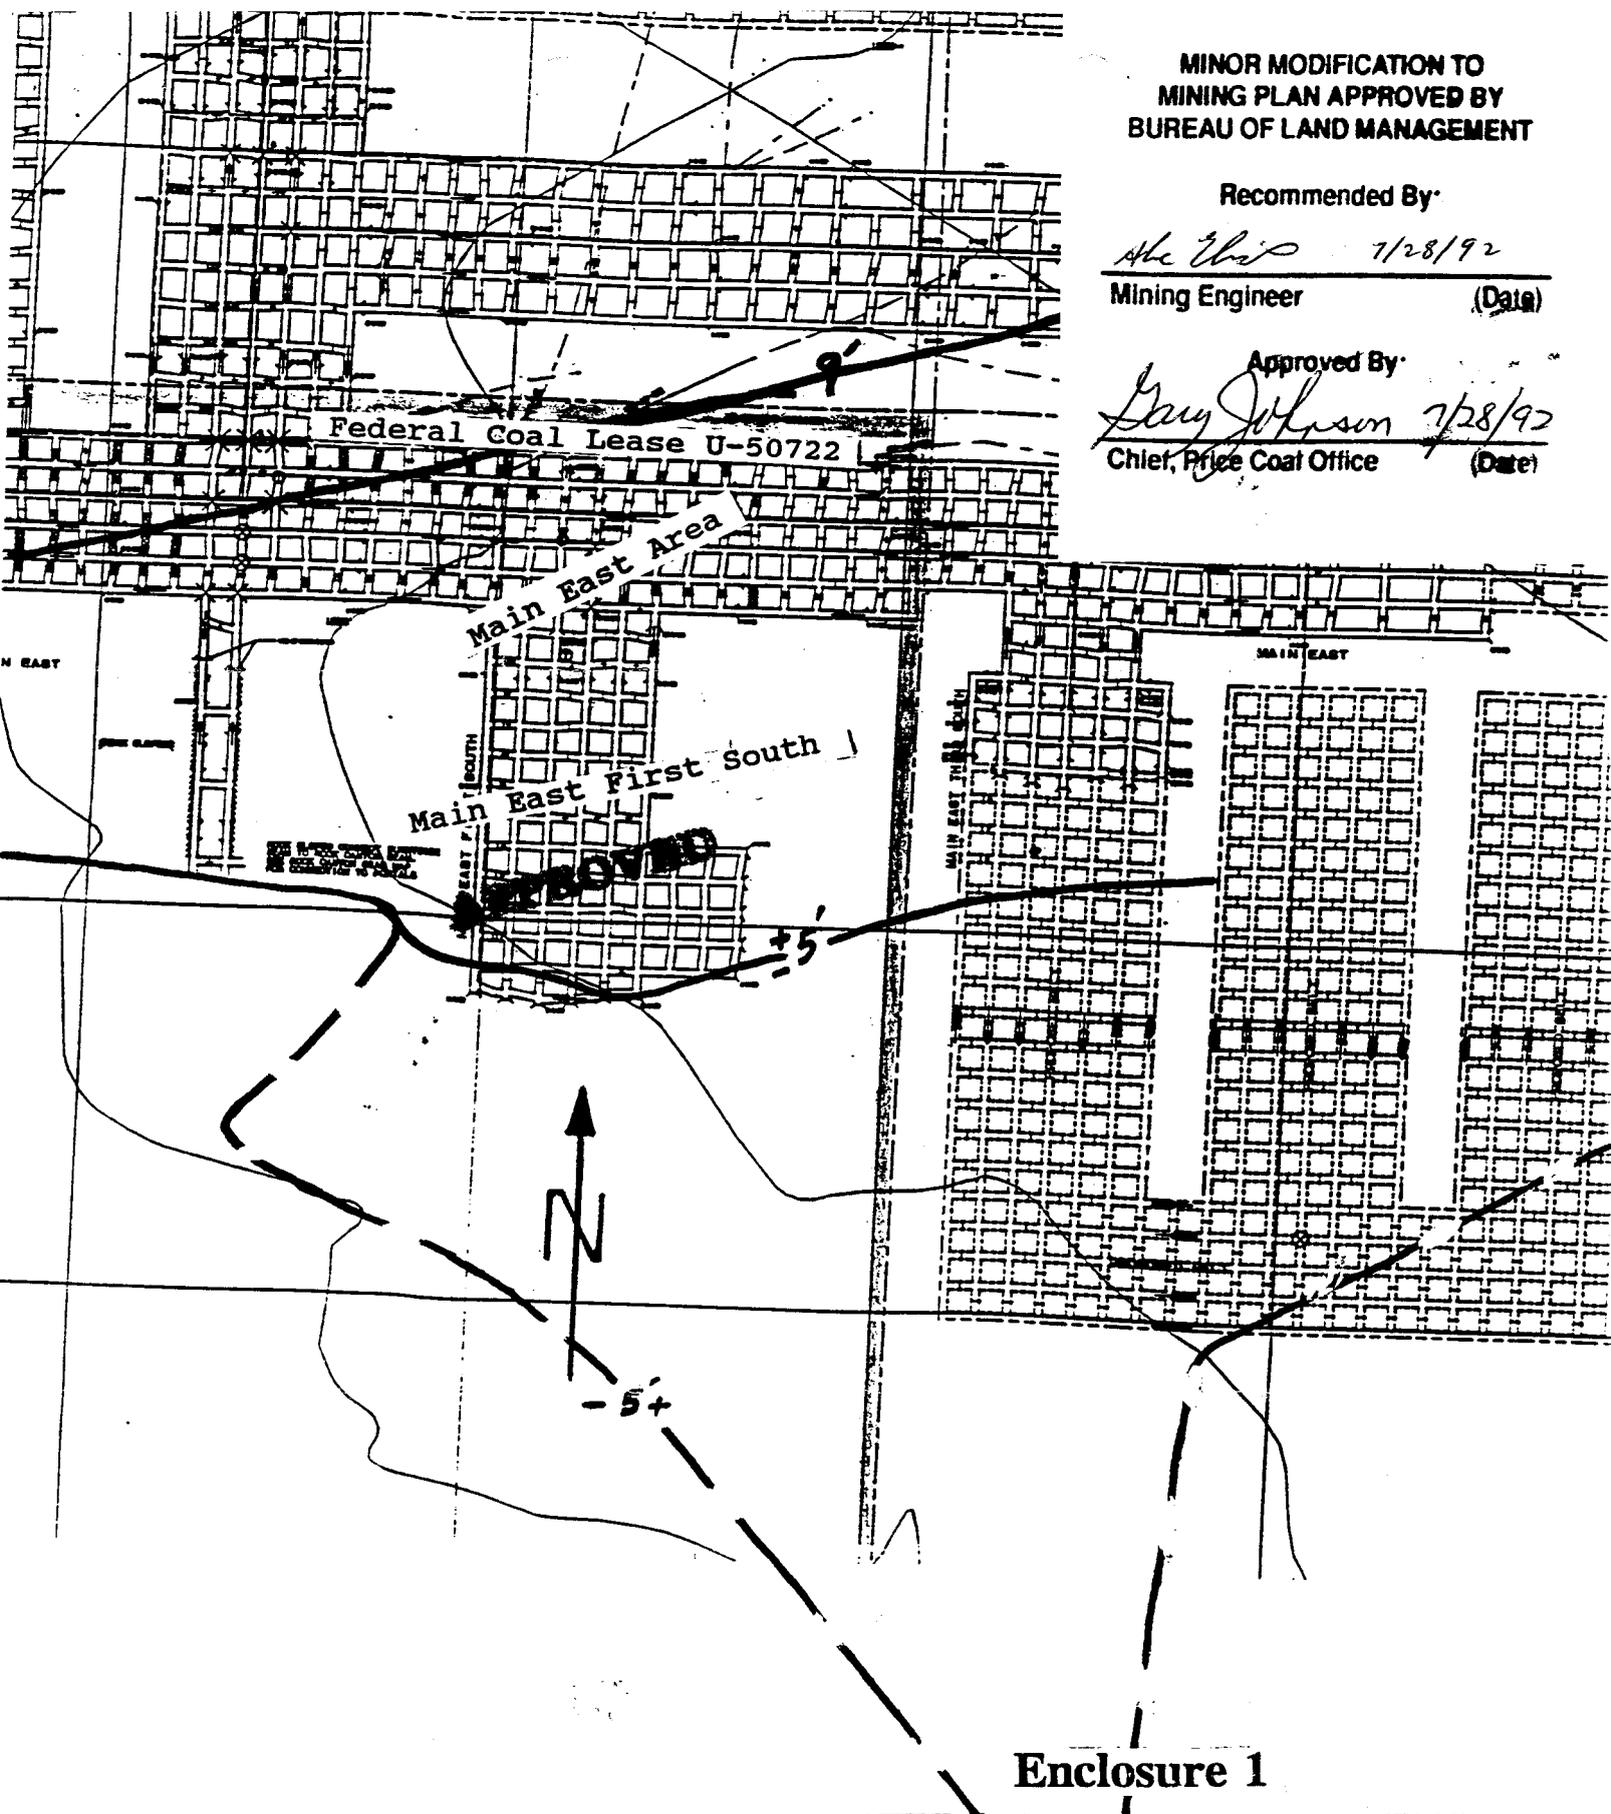
Enclosure 1
SOLDIER CREEK COAL COMPANY
SOLDIER CANYON MINE
SUNNYSIDE SEAM
MAIN EAST AREA

SCCC's approved mining plan was to recover the developed pillars in the Main East area of the Sunnyside Seam (see enclosure 1), then recover the previously developed pillars in the underlying Rock Canyon Seam (see enclosure 2). Soldier Creek is now proposing to change this plan and begin pillar retreat mining in the Fifth East area of the Rock Canyon Seam. Recovery of the pillars in the Sunnyside Seam will be delayed and addressed appropriately in future mine planning. The company is in the market for sale and any future mine plan changes will depend on the new buyer.

By overlaying the maps of the two seams, the BLM has verified that the Main East First South section of the Sunnyside Seam is located approximately over the center of the underlying Fifth East area of the Rock Canyon Seam. An analysis of available drill logs shows an average interburden of 145 feet between the seams with a sandstone content of 53 percent in this area of the mine.

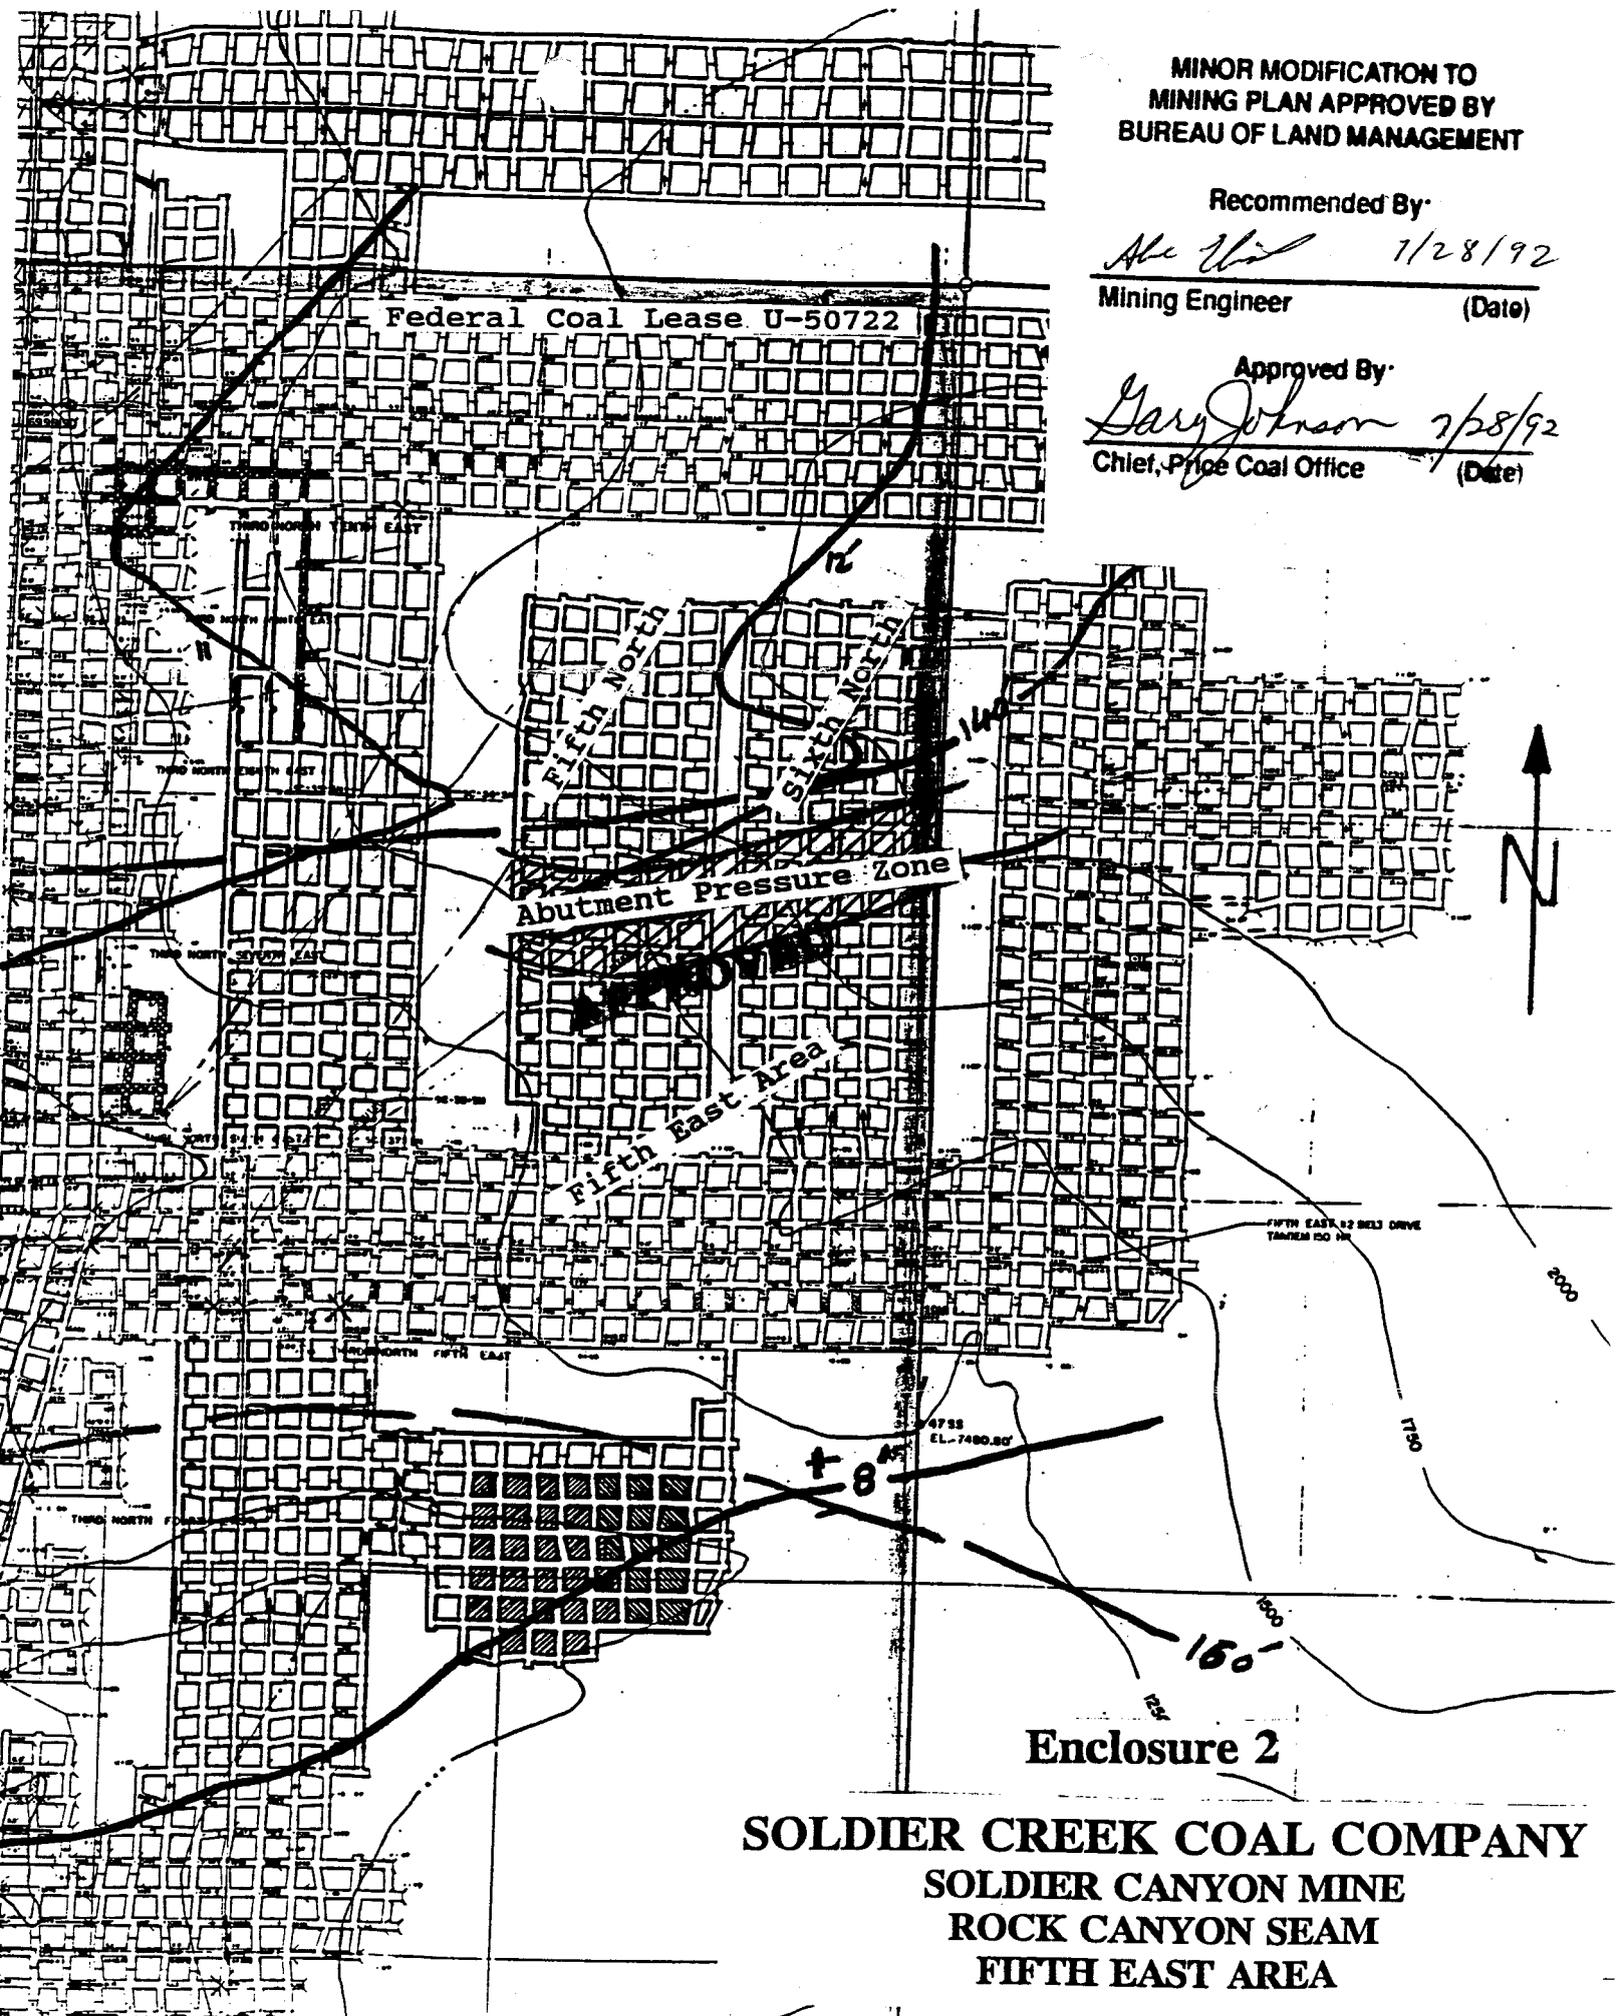
Enclosure 2

SOLDIER CREEK COAL COMPANY
SOLDIER CANYON MINE
ROCK CANYON SEAM
FIFTH EAST AREA

According to SCCC, pillaring the Sunnyside Seam first would transfer abutment pressures into the center of the underlying Fifth East area of the Rock Canyon Seam causing a significant loss of coal reserves (see enclosure 2). The interburden, which is approximately 150 feet thick and contains over 40 feet of sandstone, is expected to minimize any adverse affects on the Sunnyside Seam by mining the underlying Rock Canyon Seam in advance.
