**BLUE BLAZE COAL CO.
P.O. Box 784
Price, Utah 84501
Ph. 801-472-3786**

FIGURE 1. GEOLOGY AND PROPOSED MONITORING WELL LOCATIONS

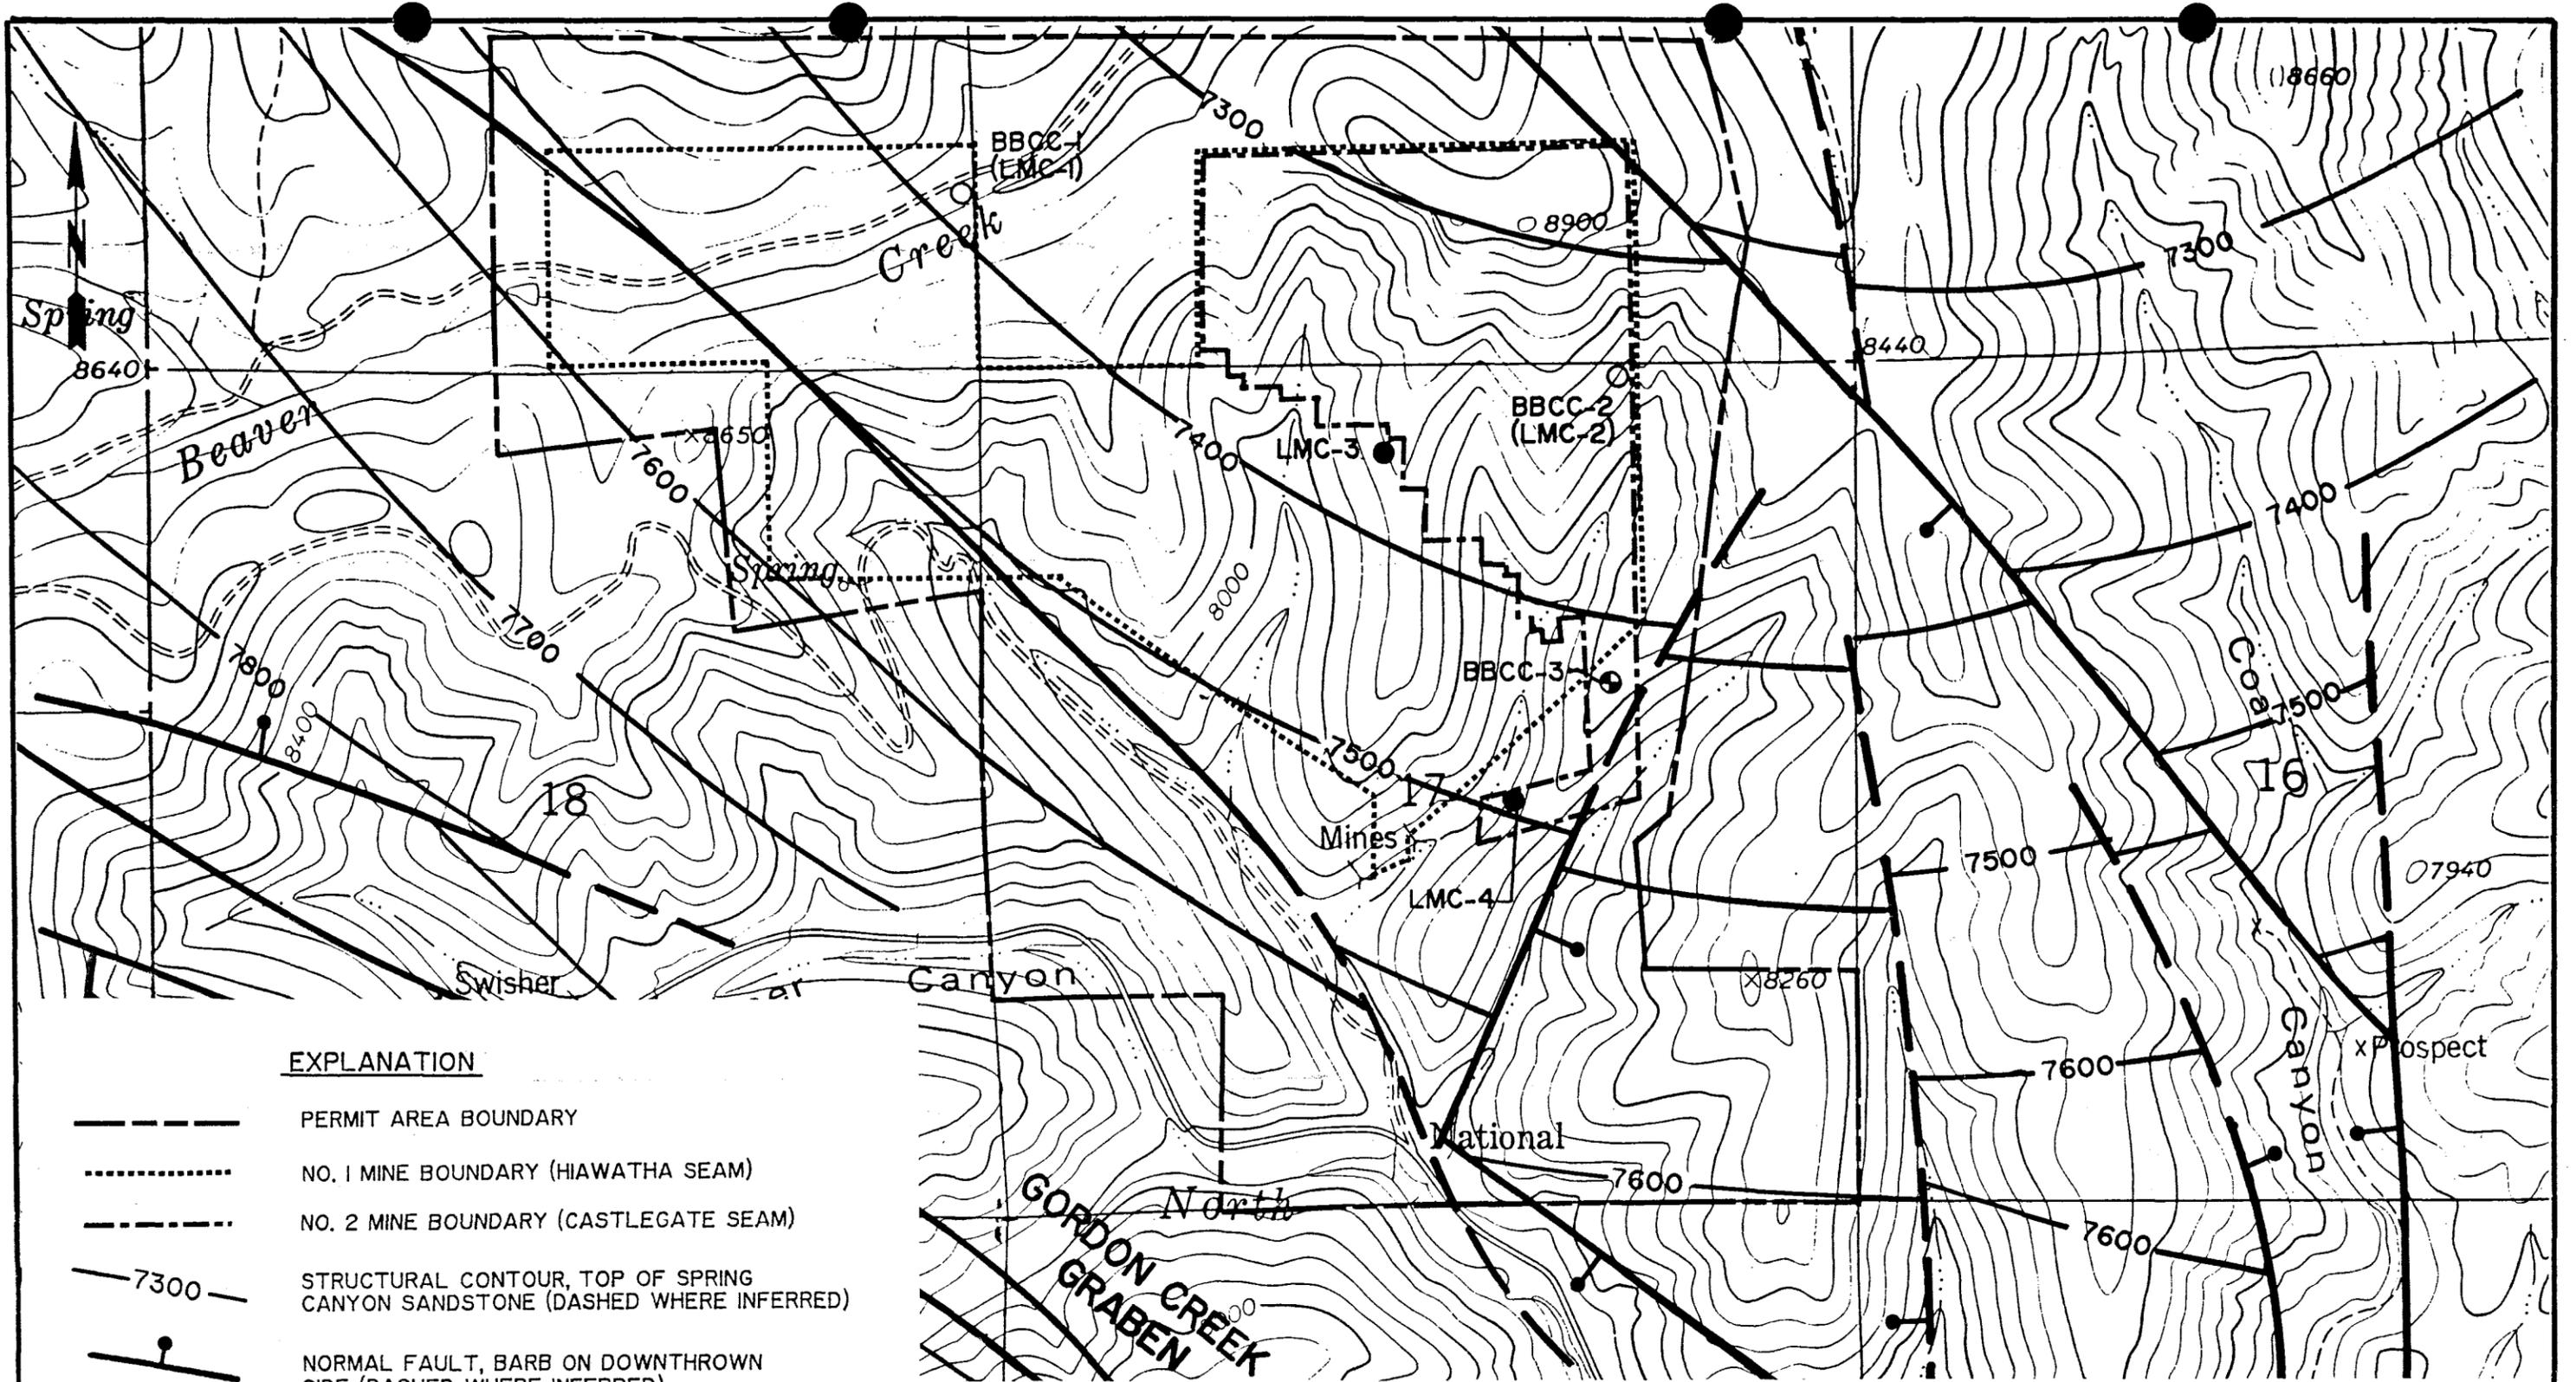
- PERMIT AREA BOUNDARY
- NO. 1 MINE BOUNDARY (HIAWATHA SEAM)
- - - - NO. 2 MINE BOUNDARY (CASTLEGATE SEAM)
- 7300 - STRUCTURAL CONTOUR, TOP OF SPRING CANYON SANDSTONE (DASHED WHERE INFERRED)
- ┆ NORMAL FAULT, BARB ON DOWNTHROWN SIDE (DASHED WHERE INFERRED)
- EXISTING DRILL HOLE (TO BE MONITORED AS IS)
- EXISTING DRILL HOLE (TO BE DEEPEMED AND CONVERTED TO MONITORING WELL)
- ⊕ PROPOSED IN-MINE MONITORING WELL

GEOLOGY FROM HANSEN (1988)

Figure 1 shows structural contours and surface fracture locations as obtained from Hansen (1988). Assuming a groundwater flow direction that is similar to the structural dip, the location of BBCC-3 should allow adequate triangulation with BBCC-1 and BBCC-2 to permit delineation of the potentiometric surface of the Star Point Sandstone within the mine areas. If necessary, the location of BBCC-3 will be revised northward a short distance to ensure that the well is placed on the same side as BBCC-1 and BBCC-2 of the major fault systems defining the No. 1 Mine boundaries. This will allow better correlation between the three wells.
