ROADS

DEVELOPMENT WASTE

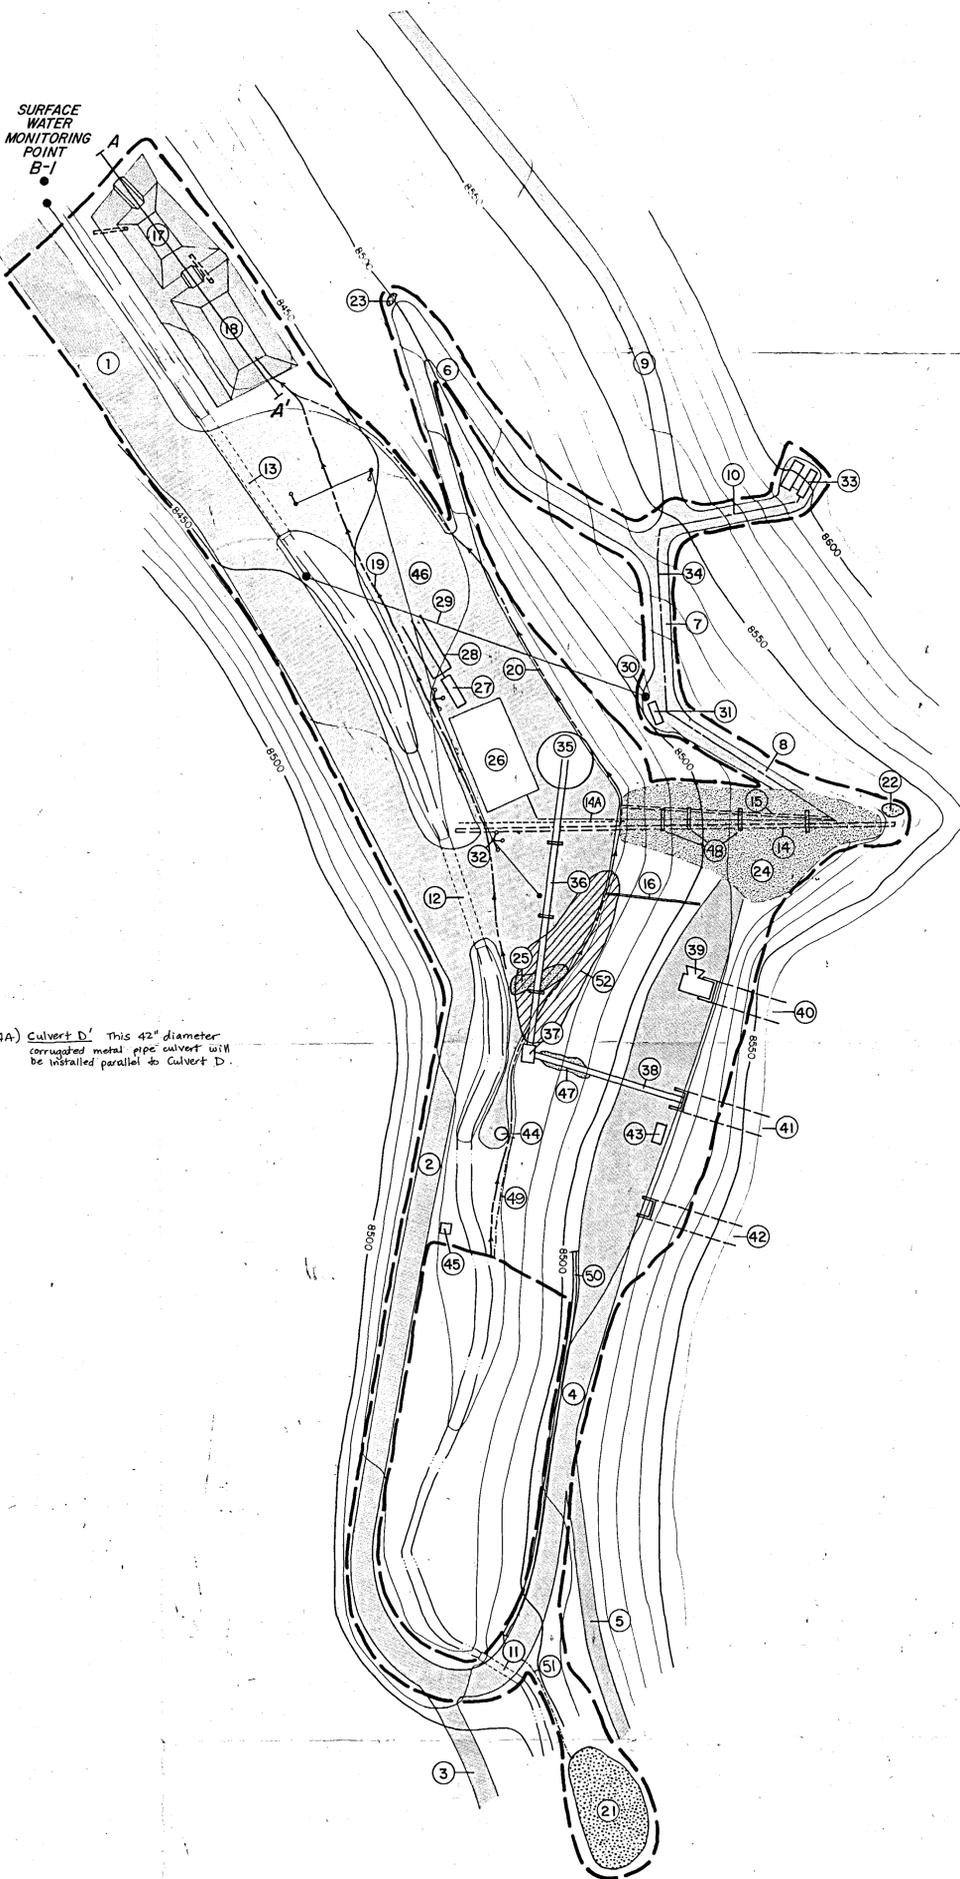
14A) Culvert D' This 42" diameter corrugated metal pipe culvert will be installed parallel to Culvert D.

- DISTURBED AREA BOUNDARY
- ▨ ROADS & BENCH AREAS
- ▩ MINE DEVELOPMENT WASTE
- ▧ TOPSOIL STOCKPILE
- ▦ SEDIMENT POND STRUCTURE

- 1) **Main Haul/Access Road**
This road provides access to the site from the Town of Clear Creek and will remain following reclamation work. The iron gate at the mine entrance will remain so Jack Otani can lock the site to prevent unauthorized entrance. The sign at the entrance should be removed or re-identified as to now belonging to Jack Otani.

- 2) **Improved Access Road**
This road was improved during mining activities to provide access not only up Mud Creek but also to the upper portal bench. This road will remain following reclamation activities to serve as continuing access up Mud Creek.

- 3) **Existing Mud Creek Road**
This road is the original Mud Creek road which exists now in its original condition. It will remain.
- 4) **Portal Access Road**
This road provided access from the lower bench to the mine entries. It will be re-constructed, scarified, mulched, and seeded as part of reclamation activities.

- 5) **Exploration Road**
This road was constructed for some previous exploration by drilling work. It has been reclaimed. No additional work is necessary.

- 6) **General Access Road**
This road provides access to the substation, powerline transformer pole, culinary and fire protection water storage tanks, and for some former exploration work. This road will remain following reclamation activities. The road surface will be scarified and the culinary re-established.

- 24) **Mine Development Waste Pile**
This pile contains approximately 4,000 cubic yards of mine development waste which was removed from the underground mine during operations. This material will be used to seal the underground entries on the portal bench.

- 25) **Small Development Waste Pile**
This pile contains approximately 200 cubic yards of mine development waste. This material will be placed on the portal bench with the remainder of the mine development waste.

- STRUCTURES
- 26) **Office, Bath House & Shop**
This structure will remain after reclamation activities for use by Jack Otani.
 - 27) **Septic Tank**
This structure will remain for future use.
