**2001 Annual Report**  
**Savage Coal Terminal**

Re: Annual Report for 2001  
Savage Coal Terminal  
C/007/022  
Carbon County, Utah

**SAVAGE INDUSTRIES, INC.**  
**2001 ANNUAL POND INSPECTION REPORT**

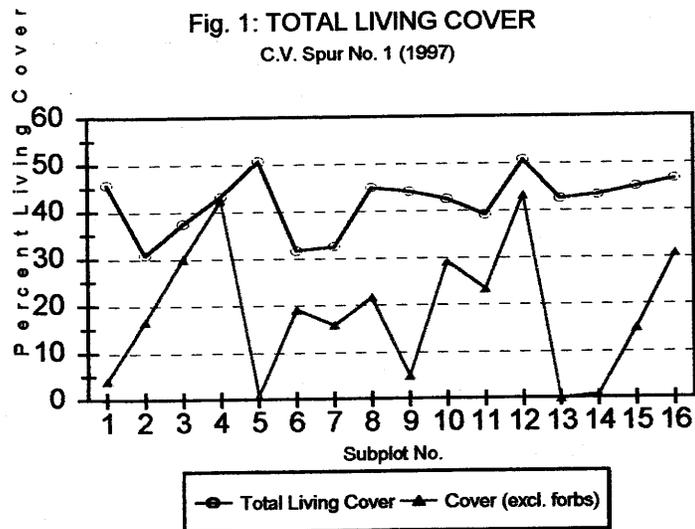
Figure 1 graphically illustrates the total cover – with and without the weedy species.

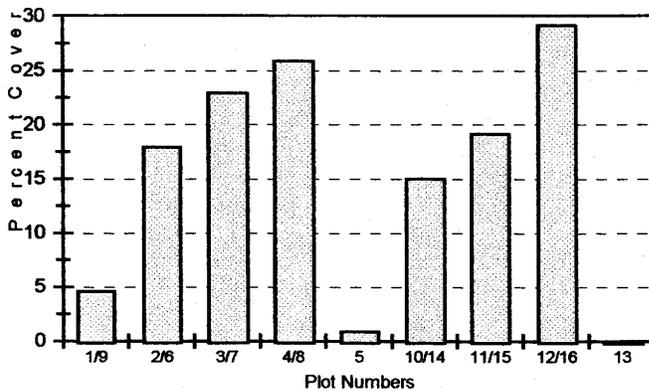
Fig. 2: MEAN COVER OF EACH TREATMENT  
C.V. Spur No 1 (1997)

The mean cover values of each treatment is shown on Figure 2.

Conversely, the subplots that performed with the least success for living cover were the subplots that had 6 inches of soil with no coal refuse added (Subplots 1/9, 5 & 13).

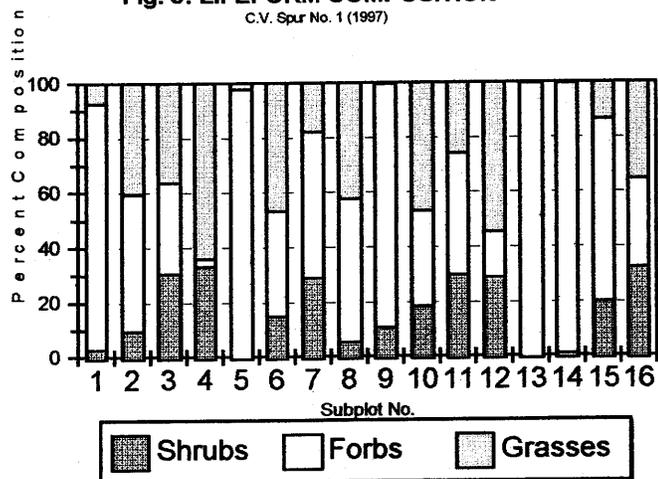
Fig. 3: LIFEFORM COMPOSITION  
C.V. Spur No. 1 (1997)

Lifeform or species composition has also been graphically shown for each subplot for comparison. This provides the reviewer with information about the relative

cover proportion of shrubs, forbs and grasses. The graph is shown on Figure 3, but weedy species were included with the forbs.

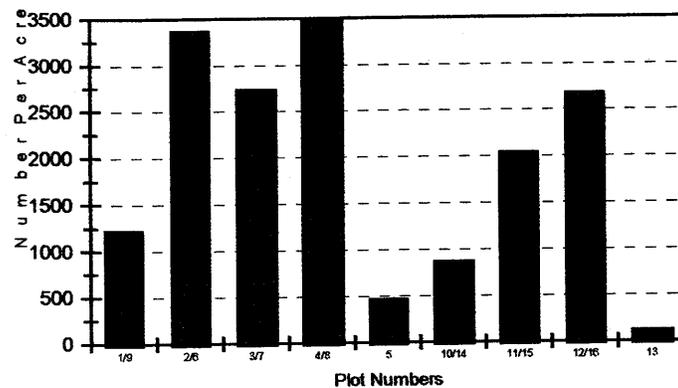
Fig. 4: MEAN DENSITY OF EACH TREATMENT  
C.V. Spur No. 1 (1997)

Like the cover data described above, woody species density was also combined by treatments and shown on Figure 4. Woody species density also revealed interesting results and patterns. If one considers the subplots with the

(Subplots 5, 13, & 1/9).
