Subject: Phase I Bond Release, Plateau Mining Corporation, Willow Creek Mine, Crandall Canyon Surface Facilities, C/007/0038, Task ID #3453

# APPLICATION FOR COAL PERMIT PROCESSING

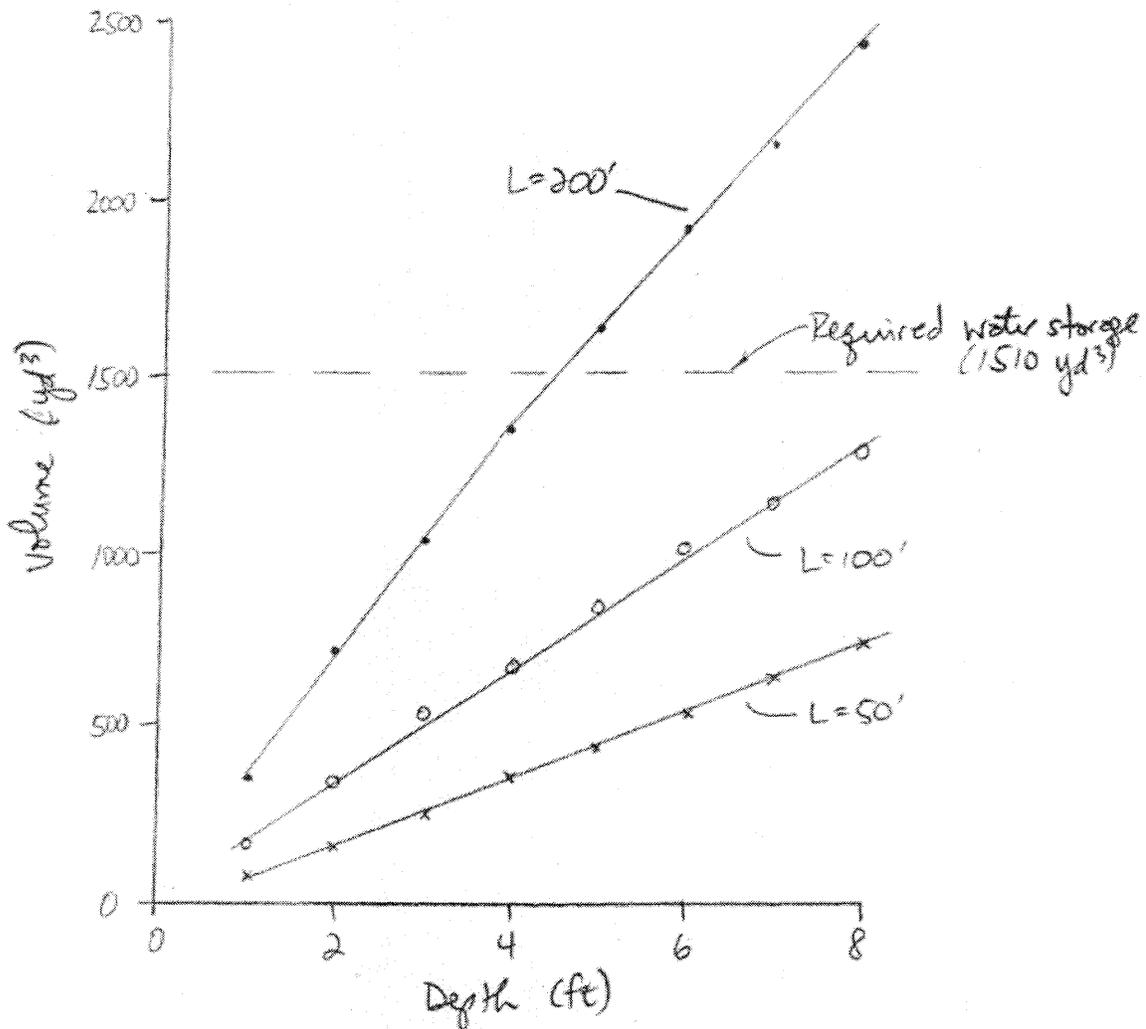
Pond Stage-Capacity Curves

At  $L = 200'$ , required water storage occurs at  $d = 4.5'$ .

For pond constructed at 6' depth (i.e., 1.5' freeboard);

Depth (ft)	BW (ft)	Cumulative Volume		Actual Volumes (Total)					
		Thru Length (ft <sup>3</sup> /ft of L)	Ends (ft <sup>3</sup> )	For L=50'		For L=100'		For L=200'	
				(ft <sup>3</sup> )	(yd <sup>3</sup> )	(ft <sup>3</sup> )	(yd <sup>3</sup> )	(ft <sup>3</sup> )	(yd <sup>3</sup> )
1	47	48.5	75.0	2500	92.6	4925	182	9775	362
2	44	94.0	300.0	5000	185	9700	359	19,100	707
3	41	136.5	675.0	7500	278	14,325	531	27,975	1040
4	38	176.0	1200.0	10,000	370	18,800	696	36,400	1350
5	35	212.5	1875.0	12,500	463	23,125	856	44,375	1640
6	32	246.0	2700.0	15,000	556	27,300	1010	51,900	1920
7	29	276.5	3675.0	17,500	648	31,325	1160	58,975	2180
8	26	304.0	4800.0	20,000	741	35,200	1300	65,600	2430

Note: L = bottom length of pond
