COAL SYSTEMS, Inc.

Re: J. B. King Mine
ACT/015/002, Folder #7

Attached are two sets of items prepared for abatement of violation NOV N84-2-18-2 resulting from an inspection of the mine site August 30, 1984. Areas of concern, and actions taken are as follows:

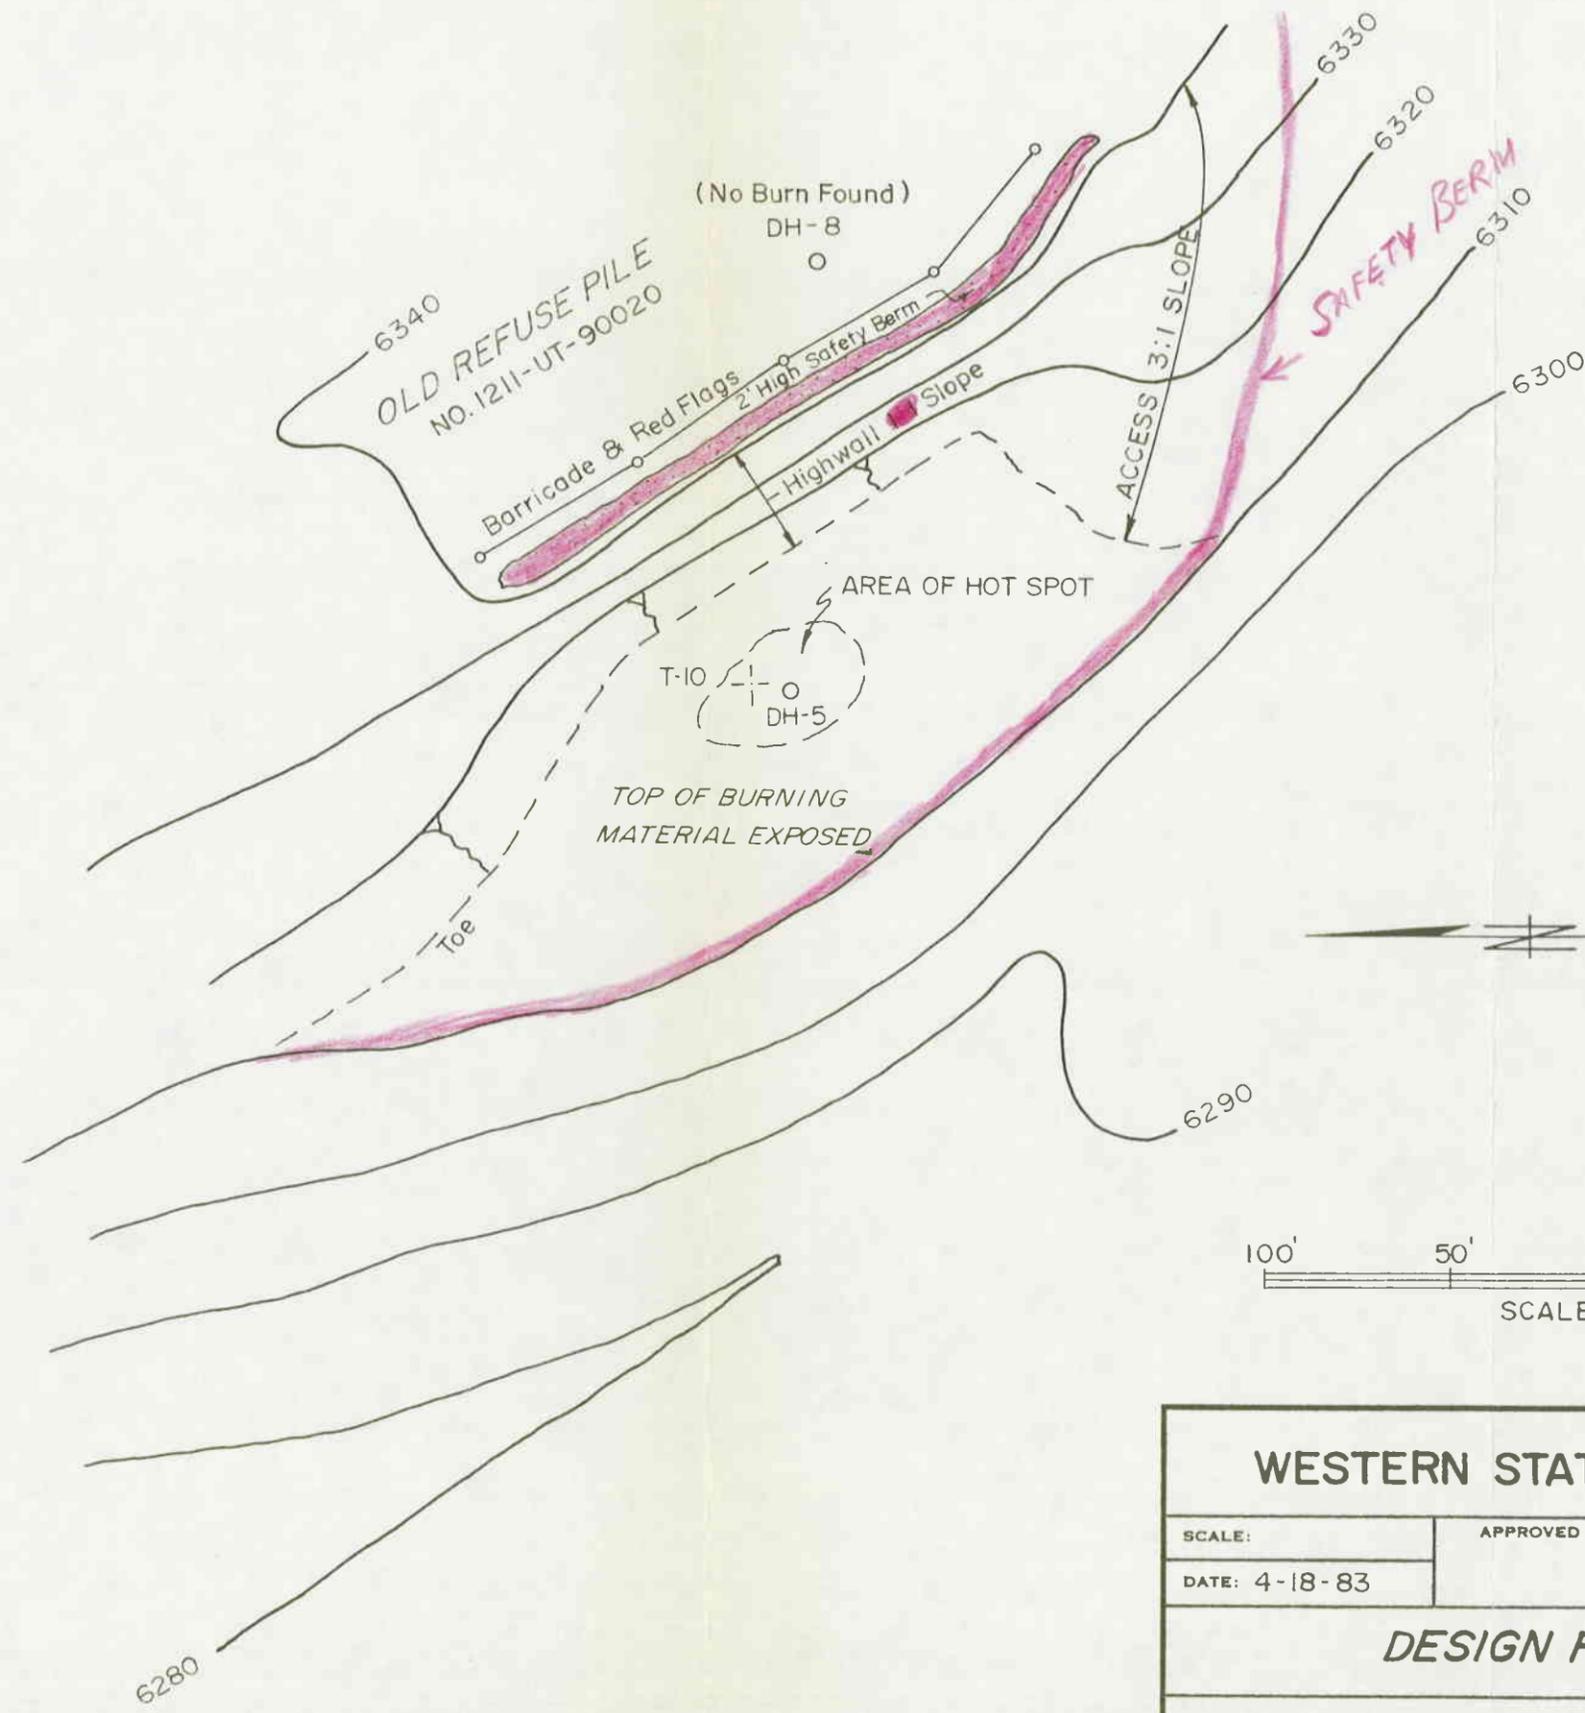
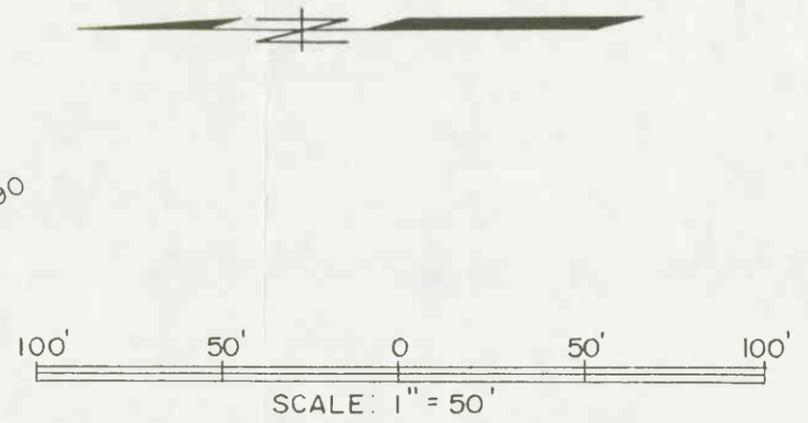
WESTERN STATES MINERALS CORP.		
SCALE:	APPROVED BY: D.A.S.	DRAWN BY:
DATE: 4-18-83		REVISED:
DESIGN FOR EXCAVATION		
COAL SYSTEMS, INC. - S.L.C., UTAH		DRAWING NUMBER 4050-2

NOTE:
 HIGHWALL SLOPE
 1 1/2' H to 1' V
