**State of Utah**  
 DEPARTMENT OF NATURAL RESOURCES  
 DIVISION OF OIL, GAS AND MINING

RE: Longwall Underground Meeting, PacifiCorp, Trail Mountain Mine, ACT/015/009, Folder #2, Emery County, Utah

Goal of Meeting: To confirm and validate noncoal waste items abandoned in the mine, items removed from under ground, and pending items that are needed and will be removed later.

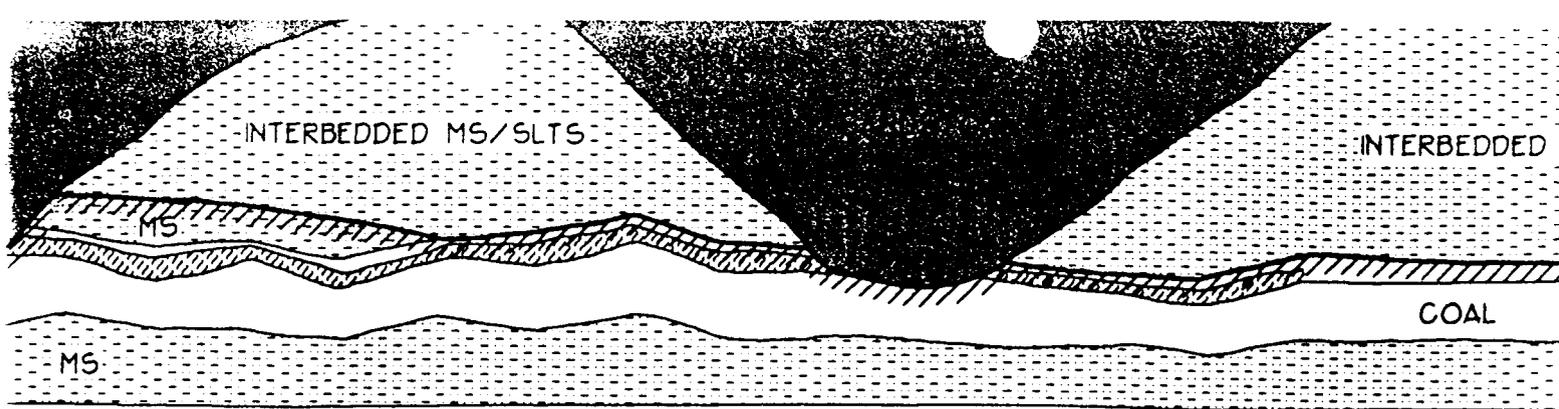
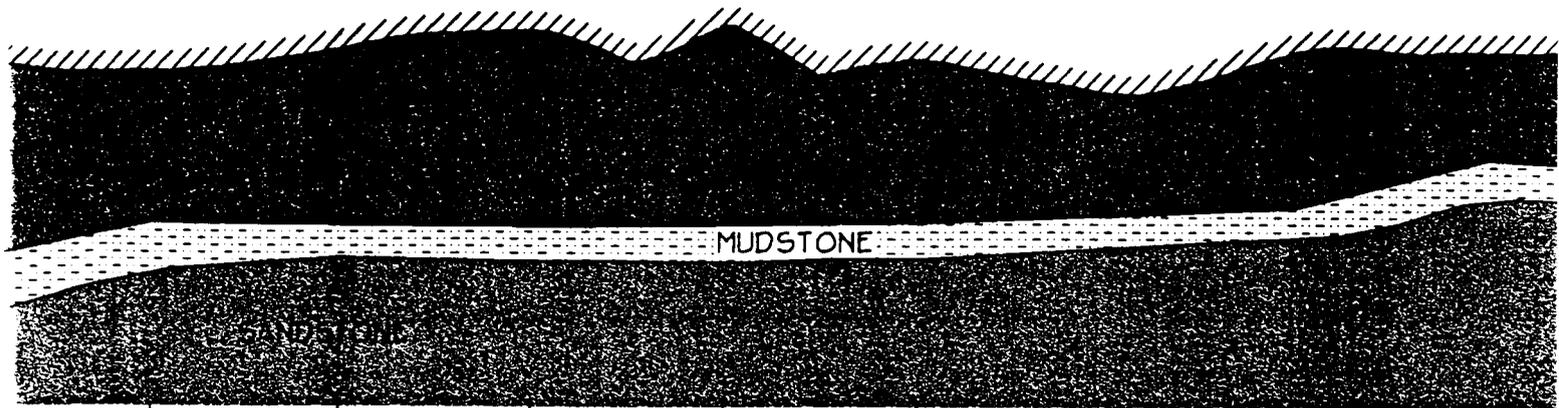
Headgate Profile

42	40	38	36	34	32	30	28
2.0	1.6	2.0	1.8	1.8	1.6	1.8	1.6
9.0		9.2		9.2		8.7	7.5
42.0	39.4	37.2	35.2	31.0	33.5	35.4	35.0
