The mining method used in most of the mine is room and pillar with partial pillar removal. Full extraction mining (planned subsidence) is proposed at Emery only in the First South panel, as noted on Plate V-5. As a result, any subsidence outside of the First South panel area would fall into the unplanned category. Figure 1 pg. 28 shows the partial pillar splitting diagram employed underground. This layout is the result of past experience as well as state and federal regulations pertaining to roof control and ventilation. All pillar splitting will be approved by MSHA. A pillar split diagram specific to full extraction is provided in Figure 2 (page 29).

**1st SOUTH FULL EXTRACTION
WILDLIFE**

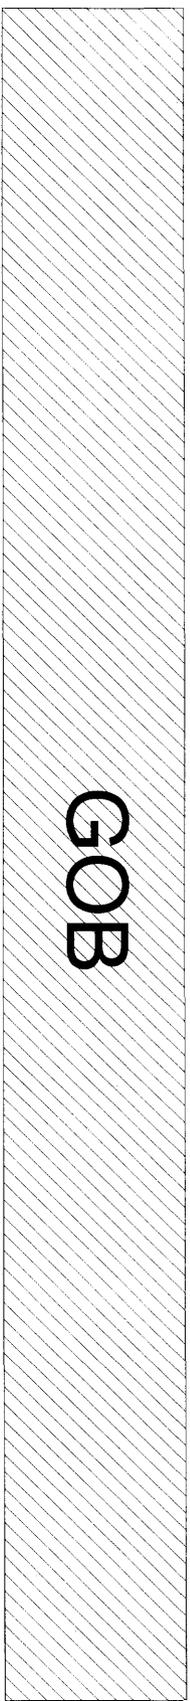
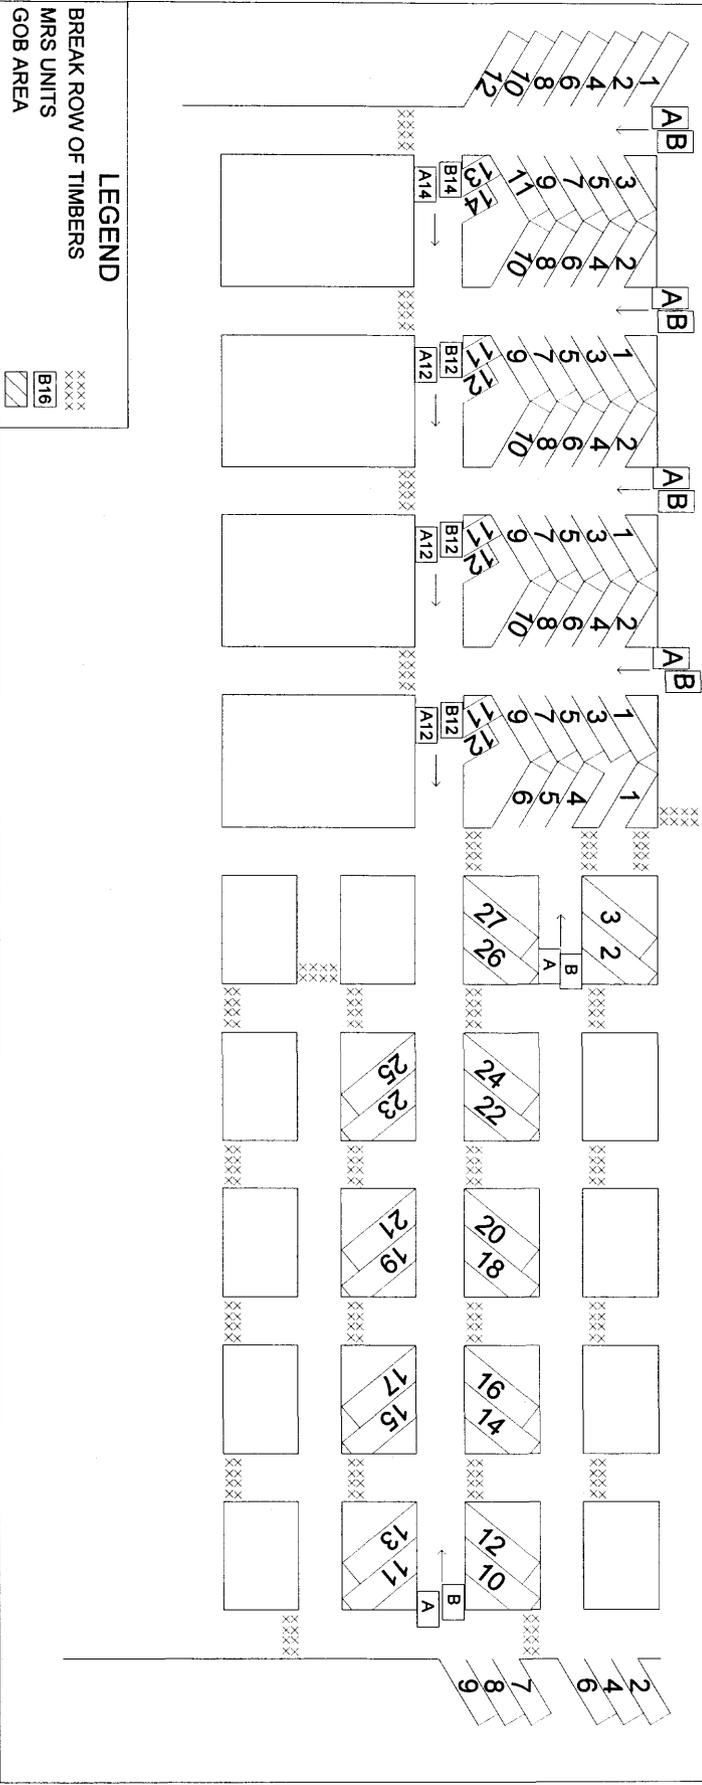
**Figure 2: Full Extraction with 2 MRS Units for Supplemental Support
Mirror Image Applies**

A breaker row may consist of either:

- two MRS units, or
- two rows of posts on a maximum spacing of four feet (4'), or
- two cribs
