RE: RESPONSE TO INITIAL COMPLETENESS REVIEW COMMENTS, RILDA CANYON LEASE TRACTS, PACIFICORP, DEER CREEK MINE, ACT/015/018, FOLDER #2, EMERY COUNTY, UTAH

PROBABLE HYDROLOGIC CONSEQUENCES (PHC) REVIEW, PACIFICORP, DES BEE DOVE MINE, ACT/015/017, DEER CREEK MINE, ACT/015/018 (INCLUDING THE PROPOSED RILDA CANYON LEASE TRACT), COTTONWOOD/WILBERG MINE, ACT/015/019, FOLDER #2, EMERY COUNTY, UTAH

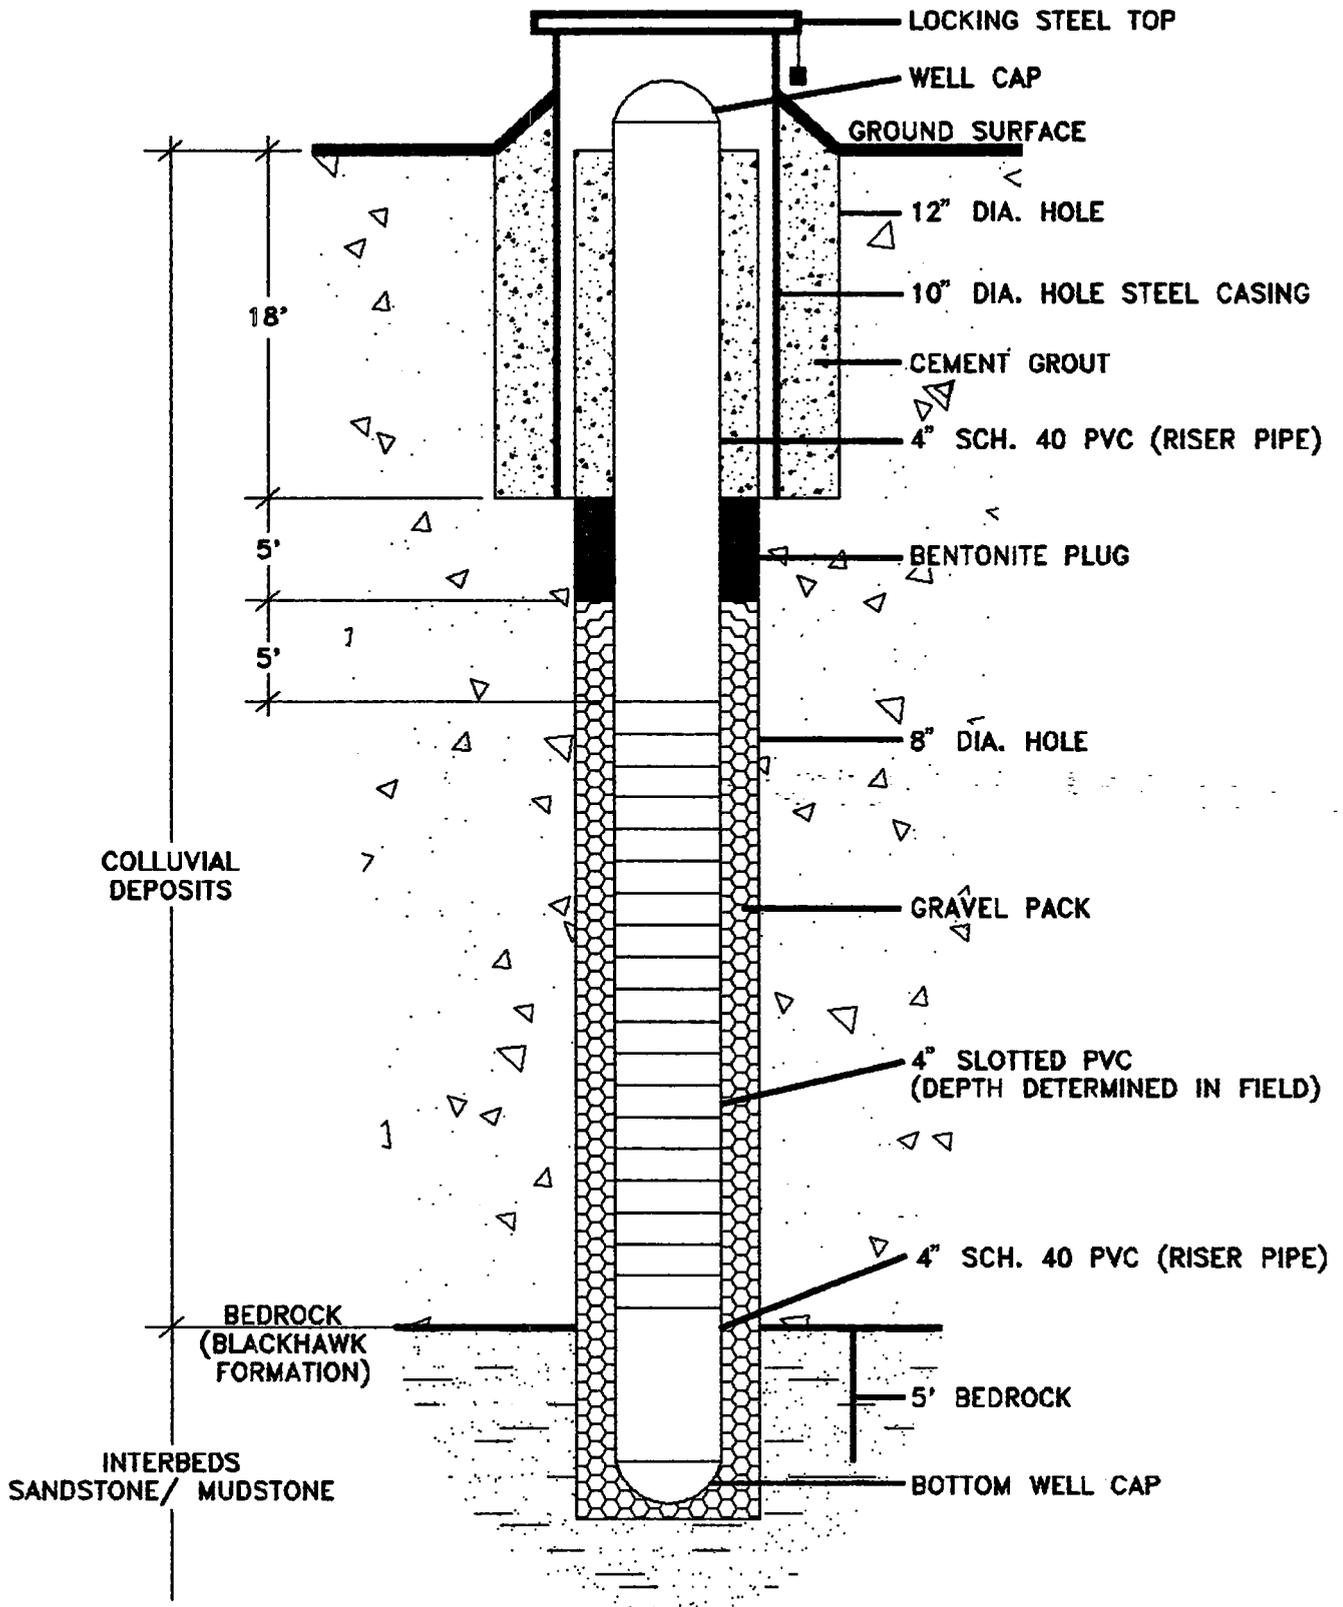
COTTONWOOD CANYON WELL DESIGN - COLLUVIAL DEPOSITS FIGURE 1

1. Only approved drilling additives will be used.
2. Hole will jetted after completion until quality stabilizes.

(See Figures 1 and 2)
