BUREAU OF LAND MANAGEMENT

Re: Deer Creek Mine Resource Recovery and Protection Plan (R2P2); Minor Modification Request, Proposed Relocation for the 4th North Mains off the 10th West Mains, North Rilda Canyon Reserve Access

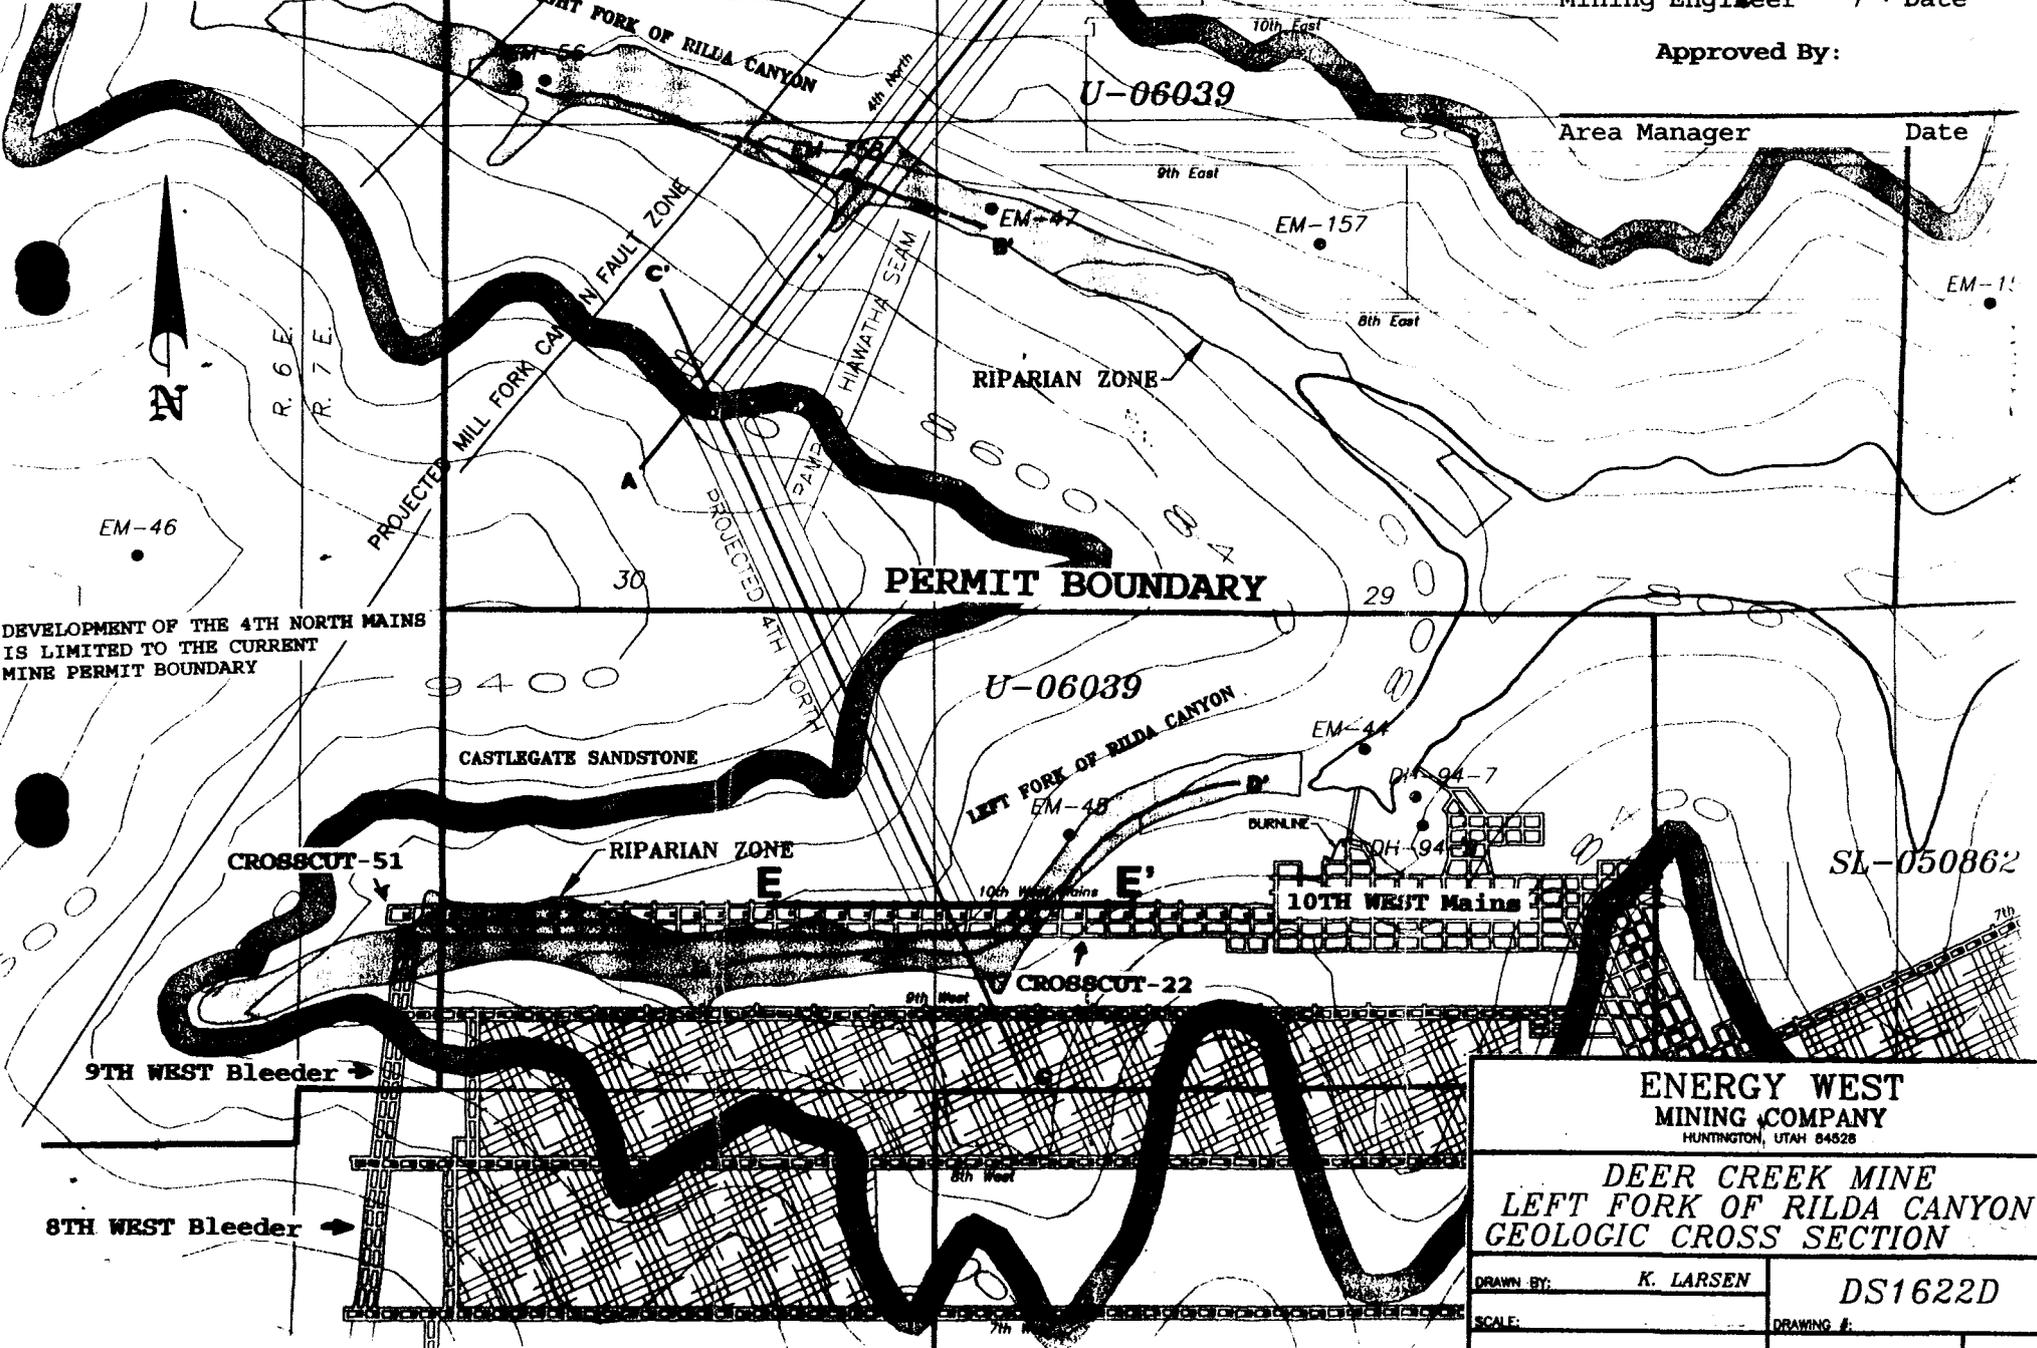
ENERGY WEST MINING COMPANY <small>HUNTINGTON, UTAH 84528</small>	
DEER CREEK MINE LEFT FORK OF RILDA CANYON GEOLOGIC CROSS SECTION	
DRAWN BY: K. LARSEN	DS1622D
SCALE: _____	DRAWING #: _____
DATE: NOVEMBER 13, 1996	SHEET 1 OF 1 REV. _____

DEVELOPMENT OF THE 4TH NORTH MAINS
IS LIMITED TO THE CURRENT
MINE PERMIT BOUNDARY

PacifiCorp's request relocates the 4th North Mains from between crosscuts 45 and 48 to between crosscuts 27 and 30 (proposed location) on 10th West. The initial development from the proposed location will be in a northwest direction for approximately 3000 feet, and then shift to a northeast direction and run parallel to the Mill Fork fault, as indicated in the approved R2P2. Accordingly, the proposed development is also limited to the **current mine permit boundary** (Enclosure 2).

by the westward development of the 10th West Mains. In August 1995, the 10th West development advanced under the canyon bottom (left fork of Rilda Canyon) and mined parallel to the canyon bottom for approximately 3600 feet (from crosscuts 22 to crosscut 50). In this area, coal seam thickness ranges from 11 feet near crosscut 22, with 7 to 8 feet of recoverable coal at crosscut 50 and overburden depth ranging from 200 to 800 feet, respectively. However, with the existing poor floor conditions (immediate floor 1.0 ft. mudstone split underlain by a thin (less than 0.5 ft.) coal rider) in 10th West, the termination of the 9th West gateroads due to insufficient coal seam thickness (less than 5 ft.) 500 feet south of 10th West and the projected convergence of the Mill Fork fault on the 10th West Mains, the development was halted at crosscut 51.
