CAPITAL PROJECT REQUEST (C.P.R.)

Project Title: Cottonwood Canyon Fan Reclamation		
Project Number: 45-9411	Budgeted: Reclamation Fund	C.E.R. Number:

COTTONWOOD CANYON FAN RECLAMATION

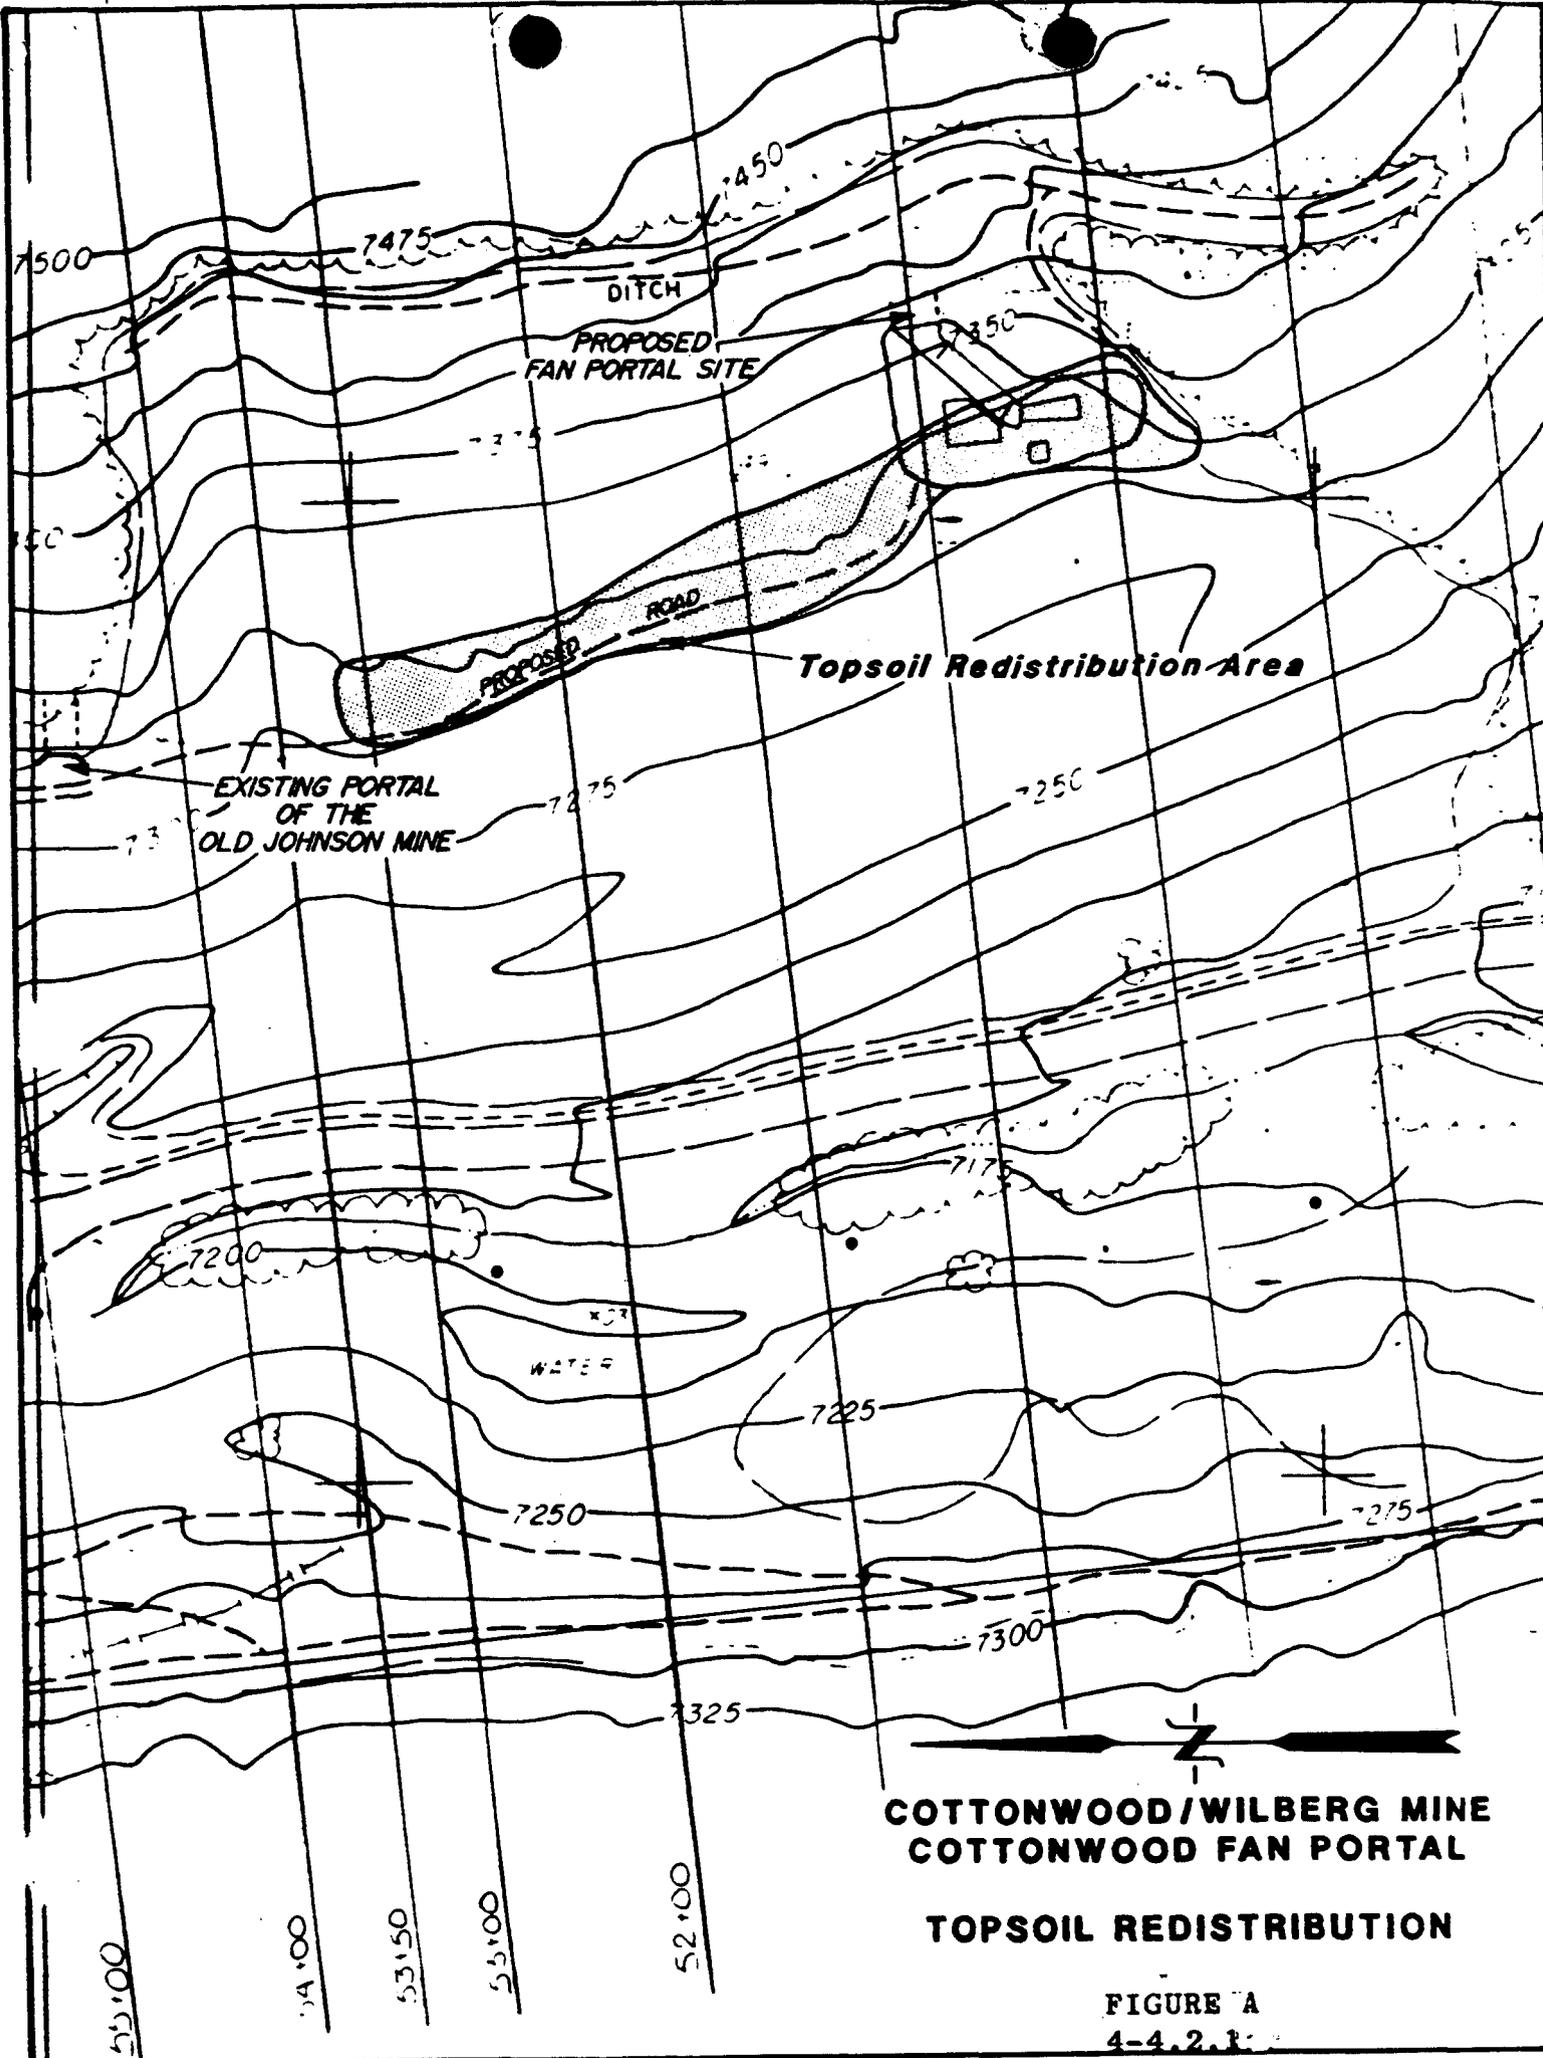
FIGURE A

**COTTONWOOD/WILBERG MINE
COTTONWOOD FAN PORTAL**

TOPSOIL REDISTRIBUTION

Backfilling of the coal seam will require 5930 cubic yards of subsoil and 930 cubic yards of topsoil to accomplish the design goals. The existing subsoil stockpile contains 7960 cubic yards and the topsoil pile contains 990 cubic yards. Excess subsoil materials will be used to restore the pre-existing Johnson Mine access road in accordance with UMC 817.176. This will require an additional 1750 cubic yards of material. Any remaining soil will be distributed over the areas where the soil stockpiles were located and reclaimed according to the revegetation plan, page 4-27.

Refer to Utah Power and Light Mining Division Drawings Cottonwood Fan Portal Topography Cross-Section, CM-10406-CP and Reclamation Cross-Sections, CM-10813-CP, (Maps 4-6 and 4-7), and Figure A page 4-4.2.1, for details.
