PACIFICORP

COTTONWOOD MINE
C/015/019

ANNUAL REPORT
2000

COTTONWOOD/WILBERG

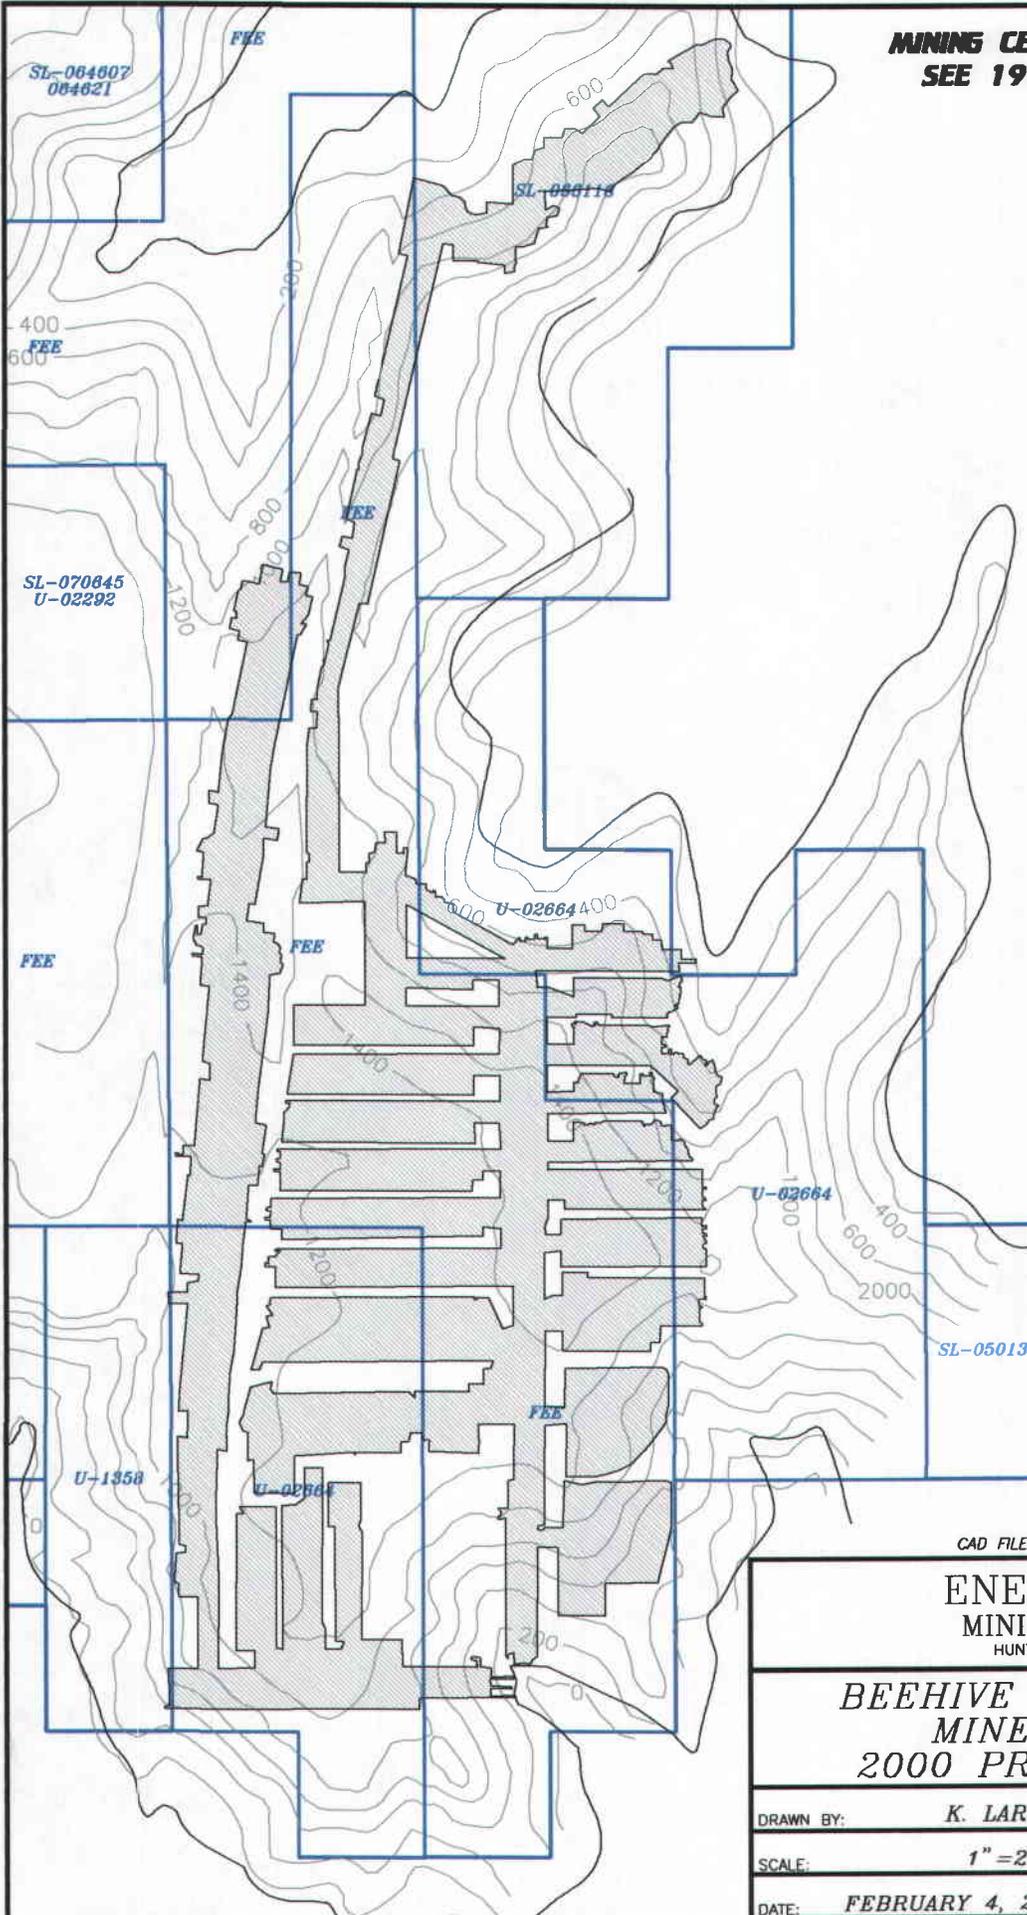
MINE PRODUCTION MAPS
2000

**MINING CEASED FEBRUARY 1987
SEE 1997 PRODUCTION MAP**

DRAWN BY:	K. LARSEN	DRAWING #:
SCALE:	1" = 2000'	SHEET	1 OF 1
DATE:	FEBRUARY 4, 2000	REV.	___

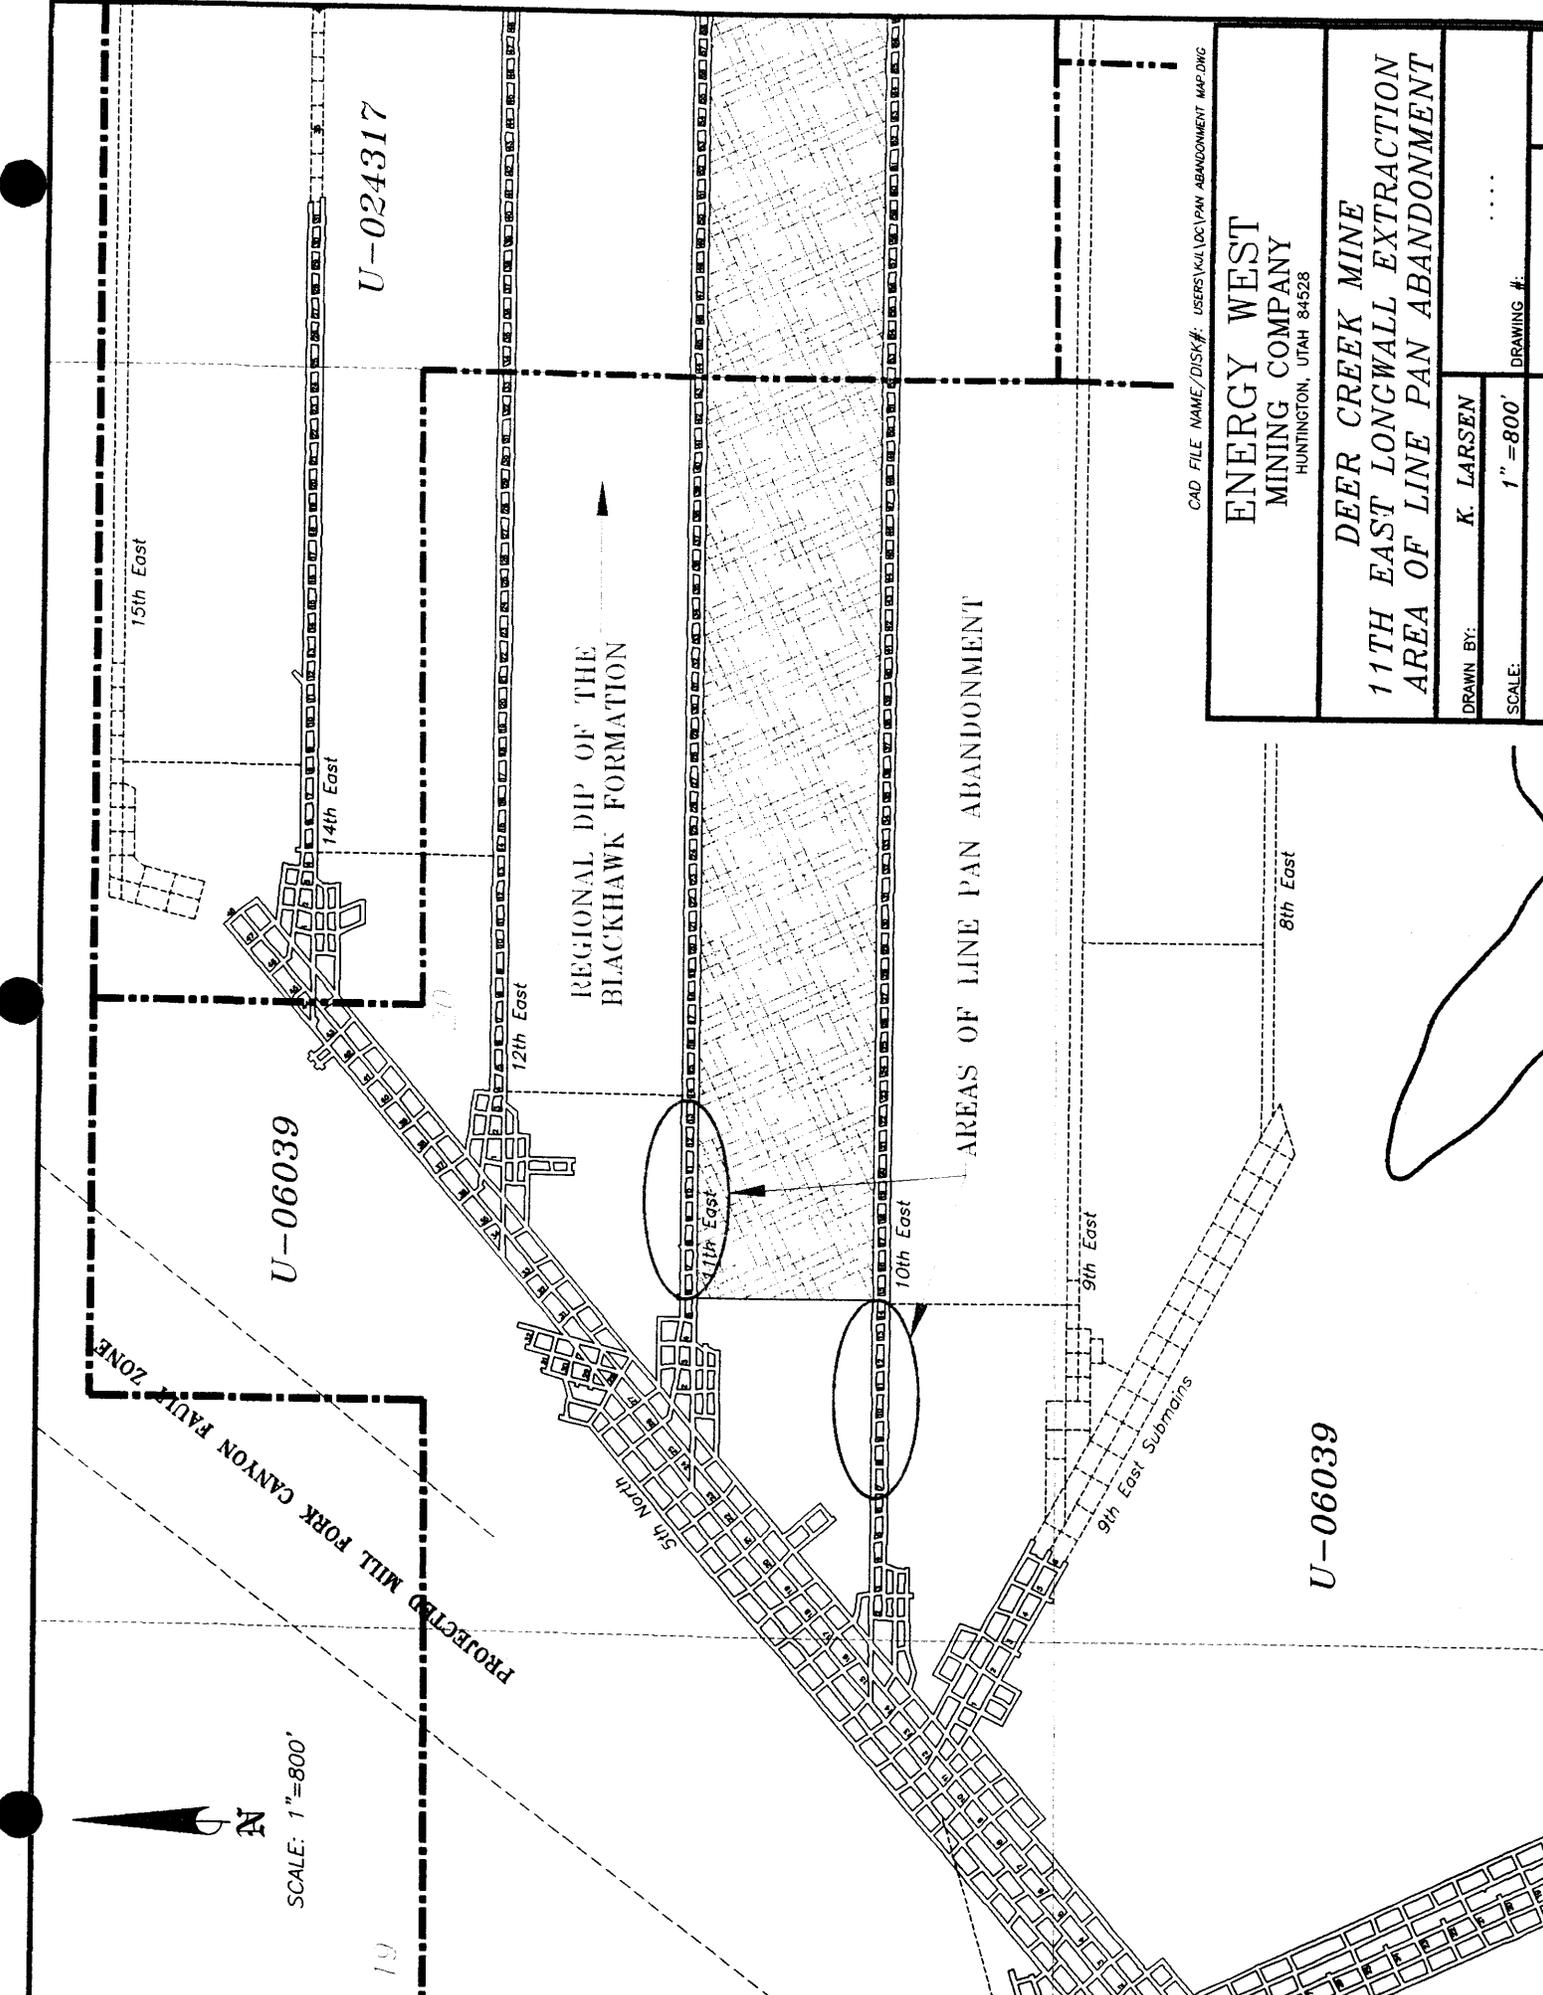
CAD FILE NAME/DISK#: USERS\KULDC\LPAN ABANDONMENT.MAP.DWG

**ENERGY WEST
MINING COMPANY**
HUNTINGTON, UTAH 84528
