Subject: Phase II and III Bond Release, Energy West Mining Company, Cottonwood/Wilberg Mine, Cottonwood Fan Portal, Miller Canyon Portals, C/015/0019, Task IDs # 3594, #3600, Outgoing File

Cottonwood/ Wilberg Mine
Energy West Mining Company
Technical Analysis
October 5, 2010

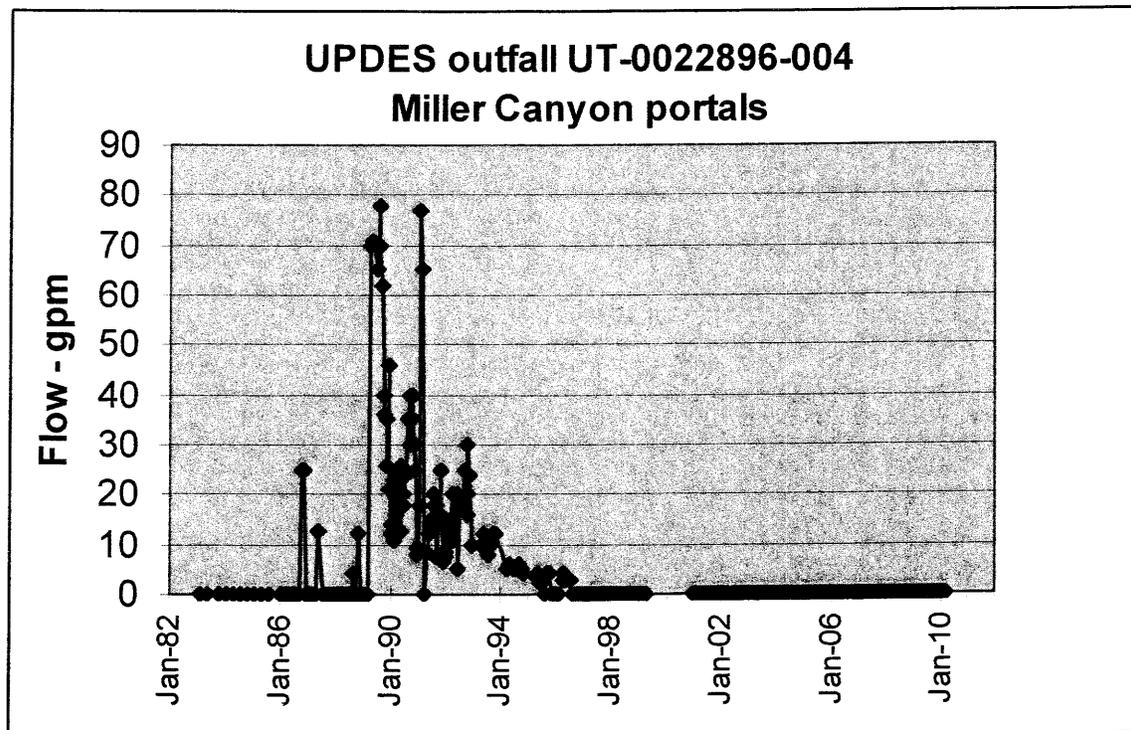
During the June 1999 reclamation, the Permittee utilized six-inch rock material to create French drains to facilitate drainage from the breakout portals. The Permittee also removed the 2-inch water monitoring pipe during the 1999 reclamation. The monitoring point for outfall UT-0022896-004 remains near the mouth of Miller Canyon. Discharge from the breakout portal area, along with other seepage from the canyon, does not reach this monitoring point because of infiltration and evapotranspiration along the canyon floor. No flow attributable to portal discharge has been reported since July 1966. This bond release application does not amend the monitoring plan and monitoring of outfall -004 will continue.
