SIGNIFICANT PERMIT REVISION APPROVAL Copy Form

Bank Seam Road Revision

PERMIT NUMBER: ACT/015/025

MINE: Bear Canyon

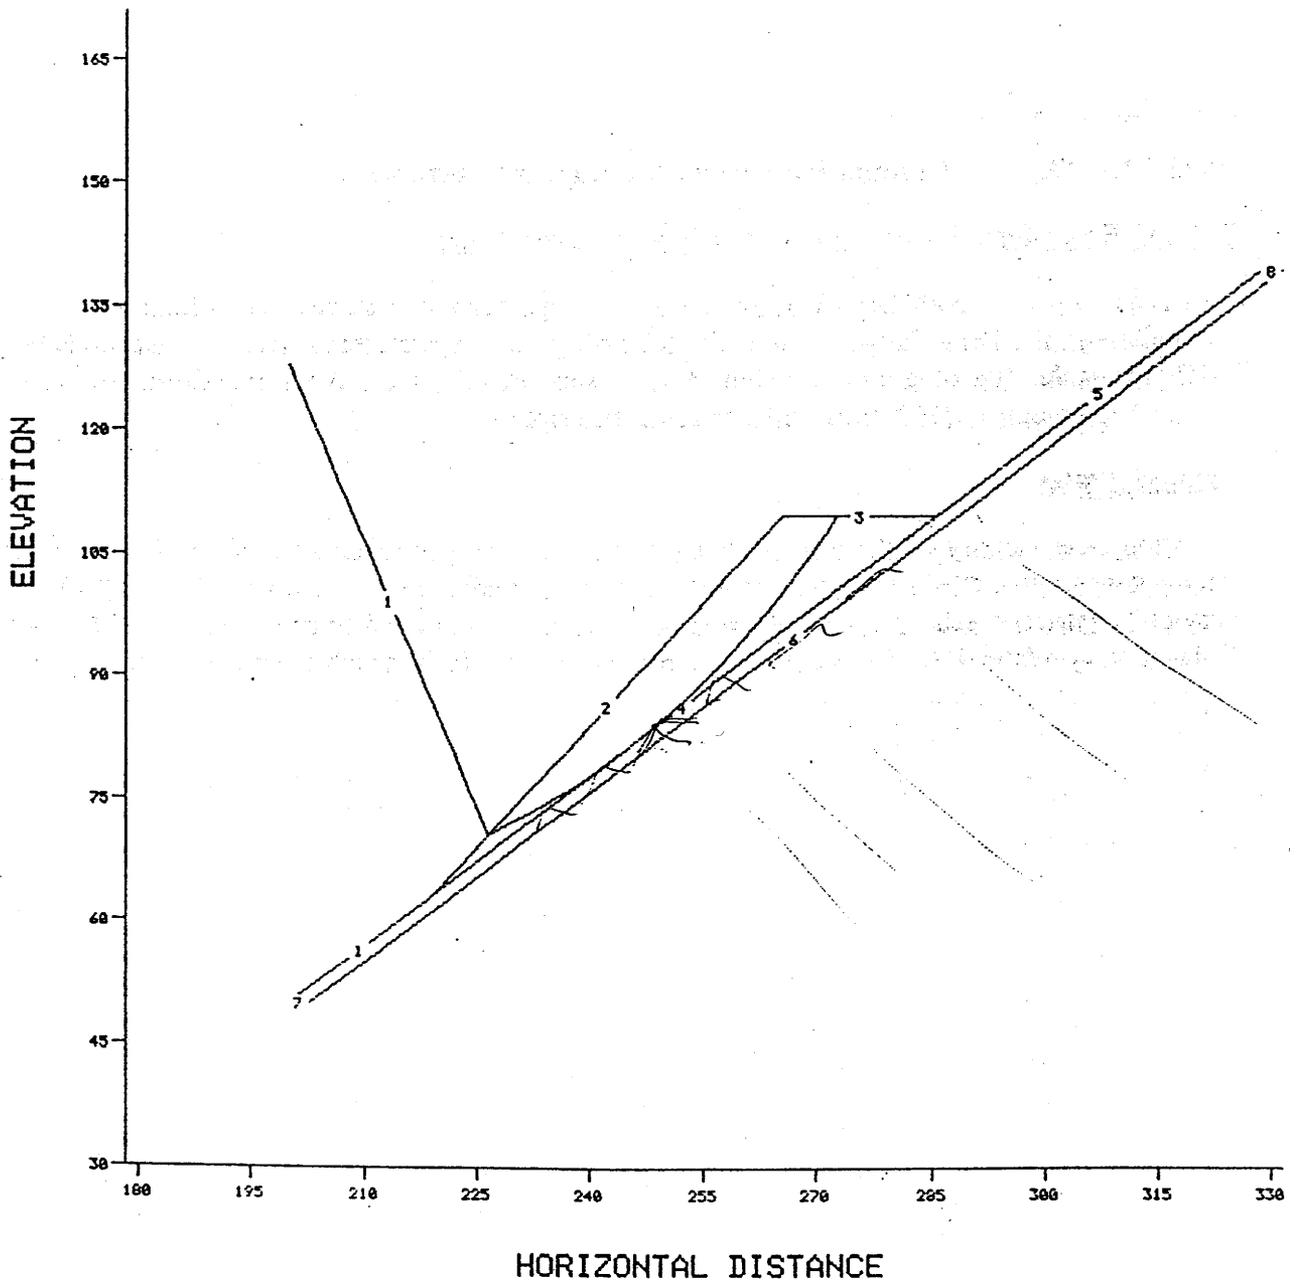
COMPLETE SLOPE CROSS SECTION

CIRCLE	X	Y	RADIUS	FS
1	179.0	173.5	113.2	1.31

Using the data provided by Dames & Moore, the Division performed its own computer analysis of the stability of the operational road slopes. This analysis indicated the presence of a potential circular failure surface, with a safety factor of less than the required 1.3, which extends from the top of the fill into the native material and again emerges near the toe of the fill. Dames & Moore explained, both in telephone conversations with this writer and in a July 12, 1994 letter to the Division, that this failure surface, though indicated as a possibility by the Division's analysis, is very improbable for two reasons. First, even though the model, for simplicity, assumes a depth to a planar bedrock surface of 6 feet, in reality the surface material ranges from 0 to 3 feet in thickness and the bedrock surface is stepped and rough and often even exposed at the surface. This means that any failure through the native material would cut through bedrock--a very unlikely occurrence. Second, Dames & Moore's experience indicates that, in situations like that of the Tank Seam Access Road where fill is placed and compacted atop native material, any failures which occur almost always occur in the fill or along the boundary between the fill and the native material and rarely extend into the native material. This writer's experience also indicates that this is the case.
