## TECHNICAL ANALYSIS

Tank Seam Road  
Co-Op Mining Company  
Bear Canyon Mine  
ACT/015/025

July 20, 1994

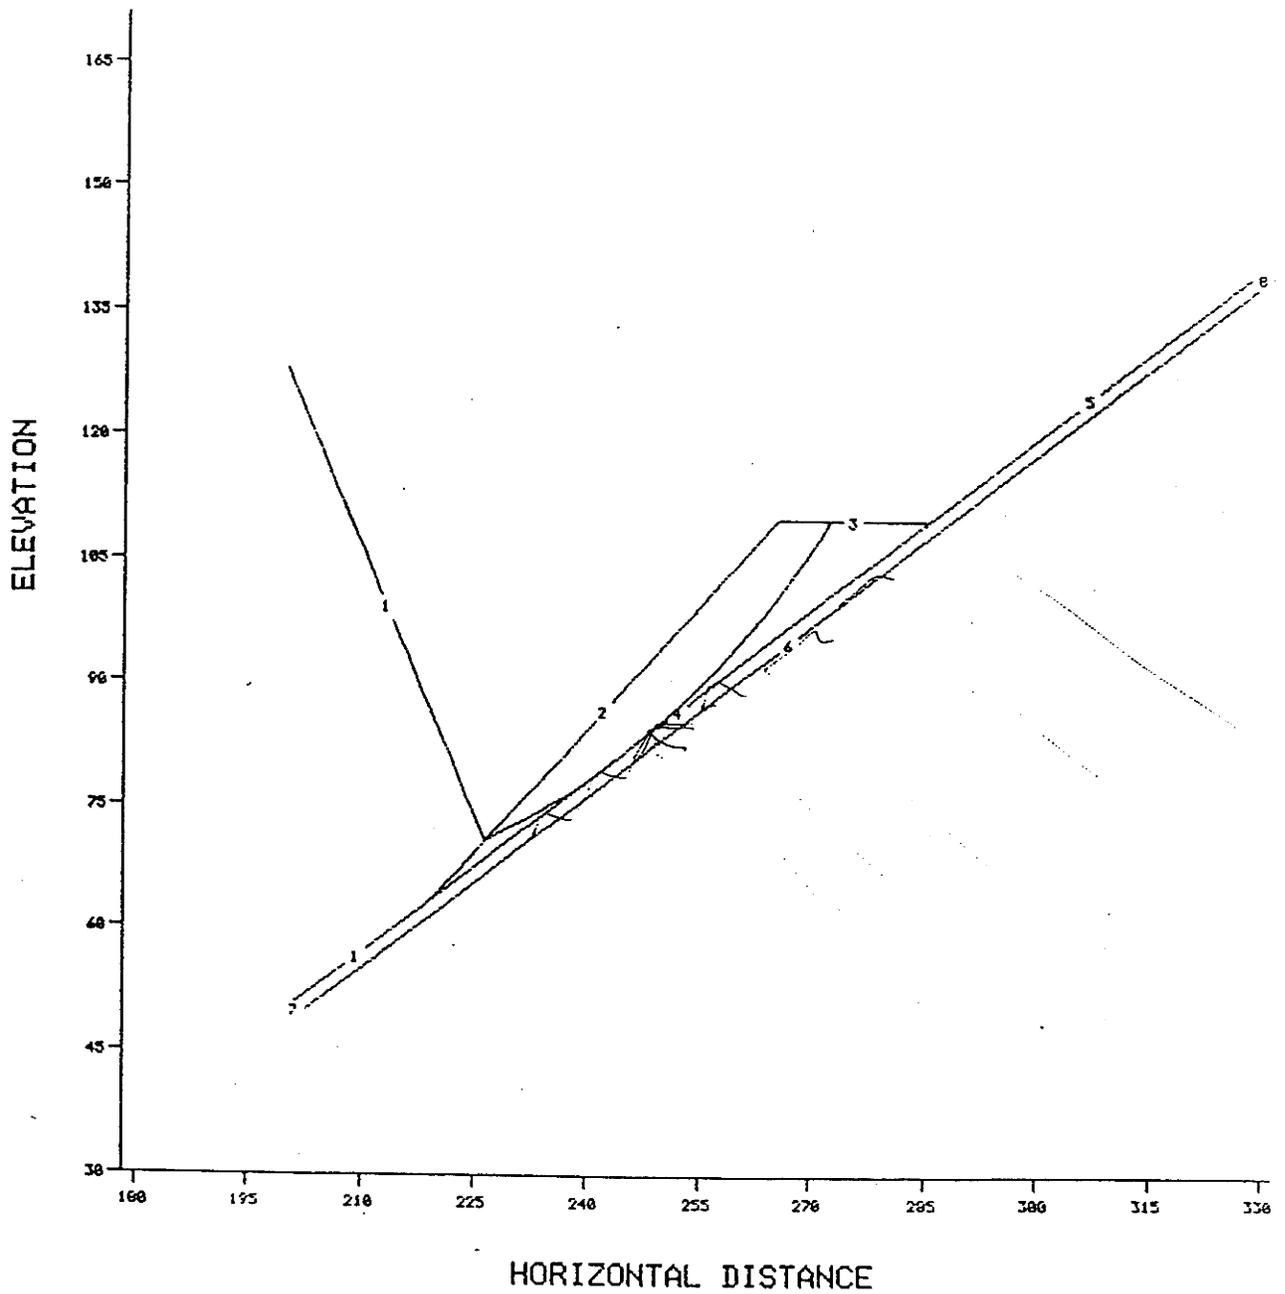
| CIRCLE | X | Y | RADIUS | FS |
| 1 | 179.0 | 173.5 | 113.2 | 1.31 |

Using the data provided by Dames & Moore, the Division performed its own computer analysis of the stability of the operational road slopes. This analysis indicated the presence of a potential circular failure surface, with a safety factor of less than the required 1.3, which extends from the top of the fill into the native material and again emerges near the toe of the fill. Dames & Moore explained, both in telephone conversations with this writer and in a July 12, 1994 letter to the Division, that this failure surface, though indicated as a possibility by the Division's analysis, is very improbable for two reasons. First, even though the model, for simplicity, assumes a depth to a planar bedrock surface of 6 feet, in reality the surface material ranges from 0 to 3 feet in thickness and the bedrock surface is stepped and rough and often even exposed at the surface. This means that any failure through the native material would cut through bedrock—a very unlikely occurrence. Second, Dames & Moore's experience indicates that, in situations like that of the Tank Seam Access Road where fill is placed and compacted atop native material, any failures which occur almost always occur in the fill or along the boundary between the fill and the native material and rarely extend into the native material. This writer's experience also indicates that this is the case.

The Division then modified its model by assigning rock properties to all areas of the natural slope. Safety factors of 1.31 were discovered for some failure surfaces.
