SUBSIDENCE CONTROL PLAN
FOR
GENWAL COAL COMPANY, INC.

Submitted to
Mr. William C. Wollen, Vice President
GENWAL COAL COMPANY, INC.
Orangeville, Utah

By
David A. Skidmore
L. G. Manwaring
COAL SYSTEMS, INC.
Salt Lake City, Utah

August 28, 1981

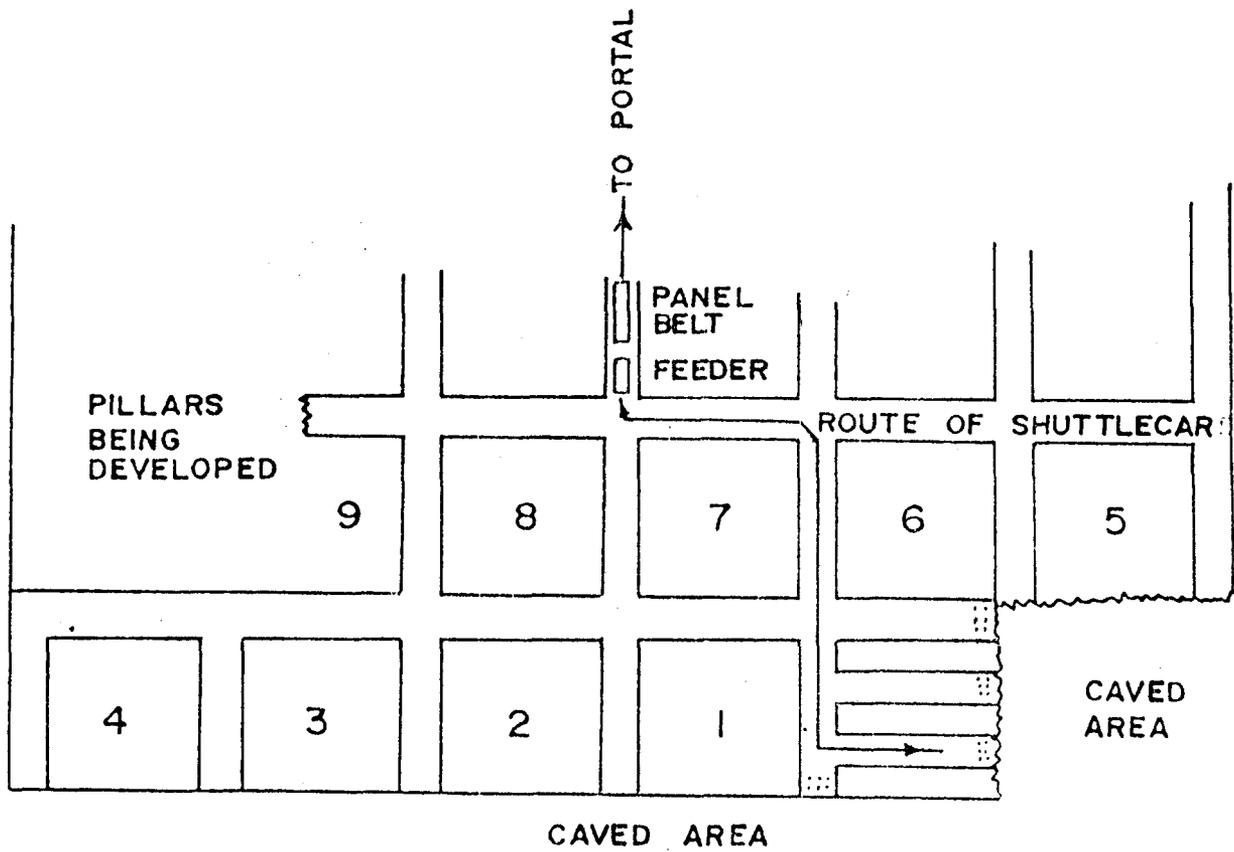
SEQUENCE IN WHICH EACH PILLAR WILL BE EXTRACTED

Sheet 7 indicates the sequence in which the remaining pillars will be extracted. Past experience indicates this method will recover between 60 and 70 percent of the coal within a panel area. If bleeder support pillars are left for ventilating the panel, this will move the recovery factor closer to 60 percent.

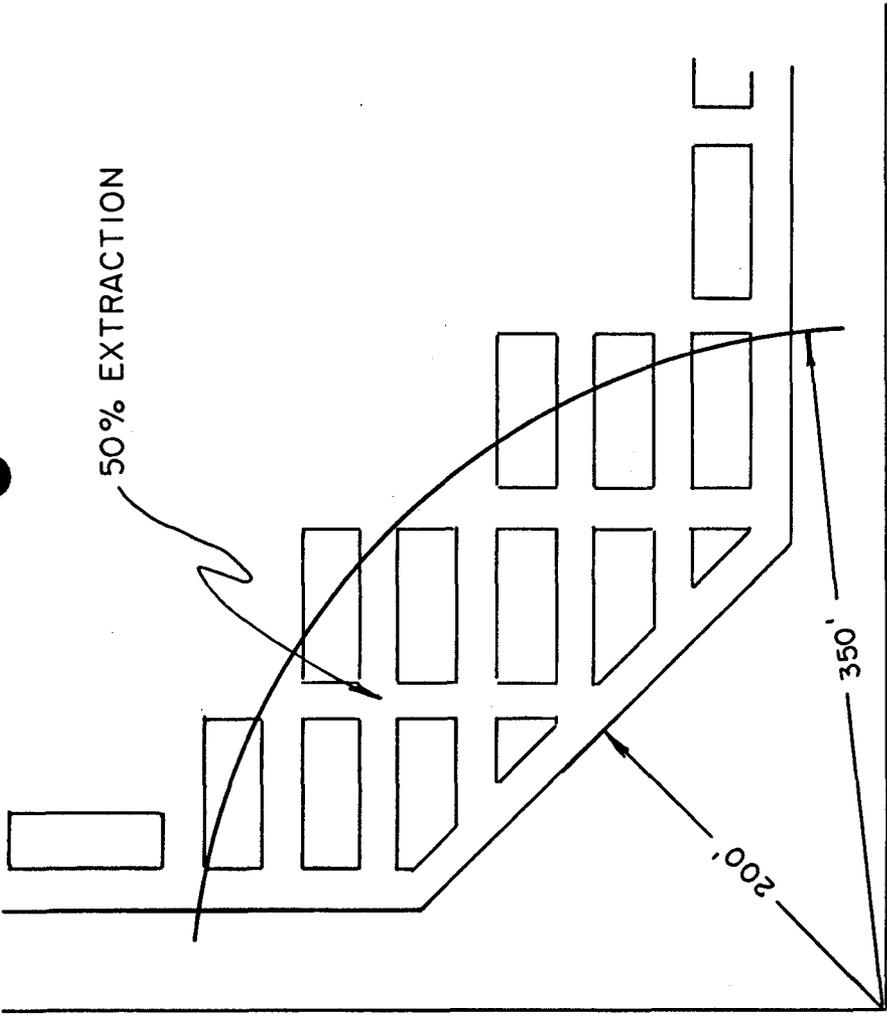
DRAWING NUMBER
SHEET NO. 8

CRANDALL CANYON CREEK

It is recommended that in order to protect the integrity of Crandall Creek, an additional 150 feet of barrier pillar be left in place (200 feet total). In addition to the increased barrier pillar, the developed coal between the barrier pillar and a 350-foot radius from the southwest corner of the property will be restricted to a mining recovery of 50%. The size and shape of pillars in this area are illustrated on Sheets 8 and 9.

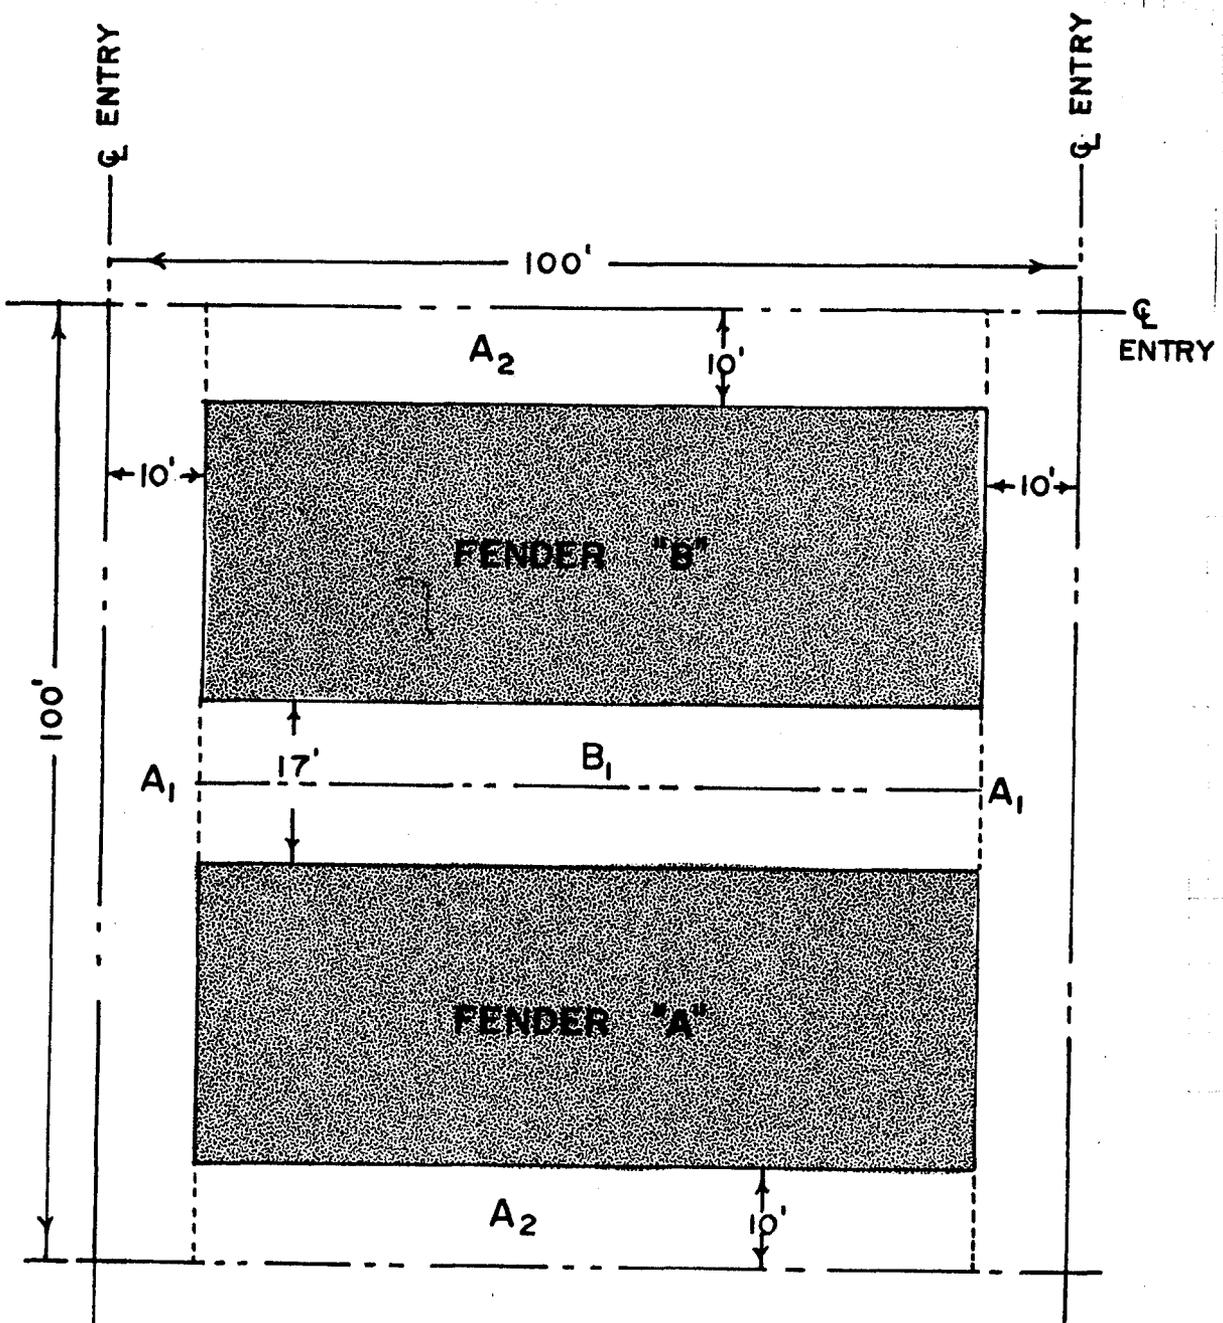
AREA (FT. ²)	% OF TOTAL AREA
A ₁ = 2000	20
A ₂ = 1600	16
B ₁ = 1360	<u>14</u>
	50%

TYPICAL 50% RECOVERY PLAN FOR 80' x 80' PILLAR

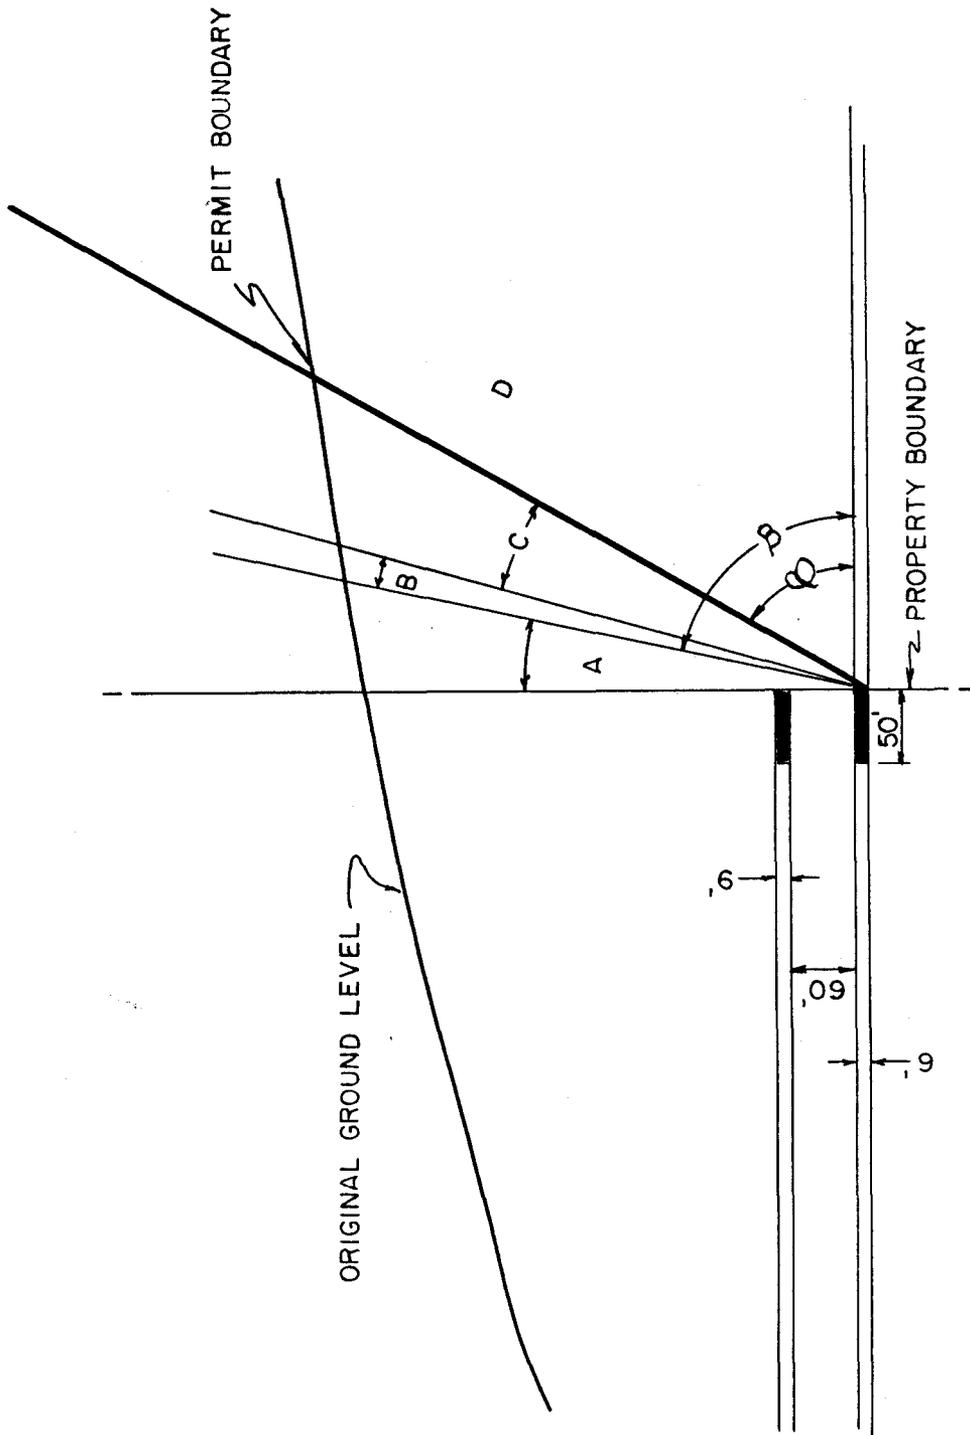
APPROVED BY:		DRAWN BY	
SCALE:					
DATE:				REVISED	
				DRAWING NUMBER	
				SHEET NO. 10-A

- A. This angle is the reciprocal of the break line angle (B) of 78°. This angle also corresponds to the plan view in Drawing 4047-4 and is also represented in that drawing by the letter "A". ^{1/}
- B. Angle "B" represents the maximum break line found at the Geneva Mine, Utah. ^{1/} It is felt that some form of deformation will take place in this area. Drawing 4047-4 also indicates this area with the letter "B".
- C. Angle "C" represents that area where light to moderate subsidence will be experienced. This also represents the expected extent of the subsidence. This angle is also called the Positive Limit (or Draw) Angle (ϕ). Drawing 4047-4 denotes this area with the letter "C" and is part of the permit area.
- D. This area is outside the permit boundary where little or no subsidence is planned.

^{1/} U.S.G.S. Professional Paper 969, pages 4 and 34.

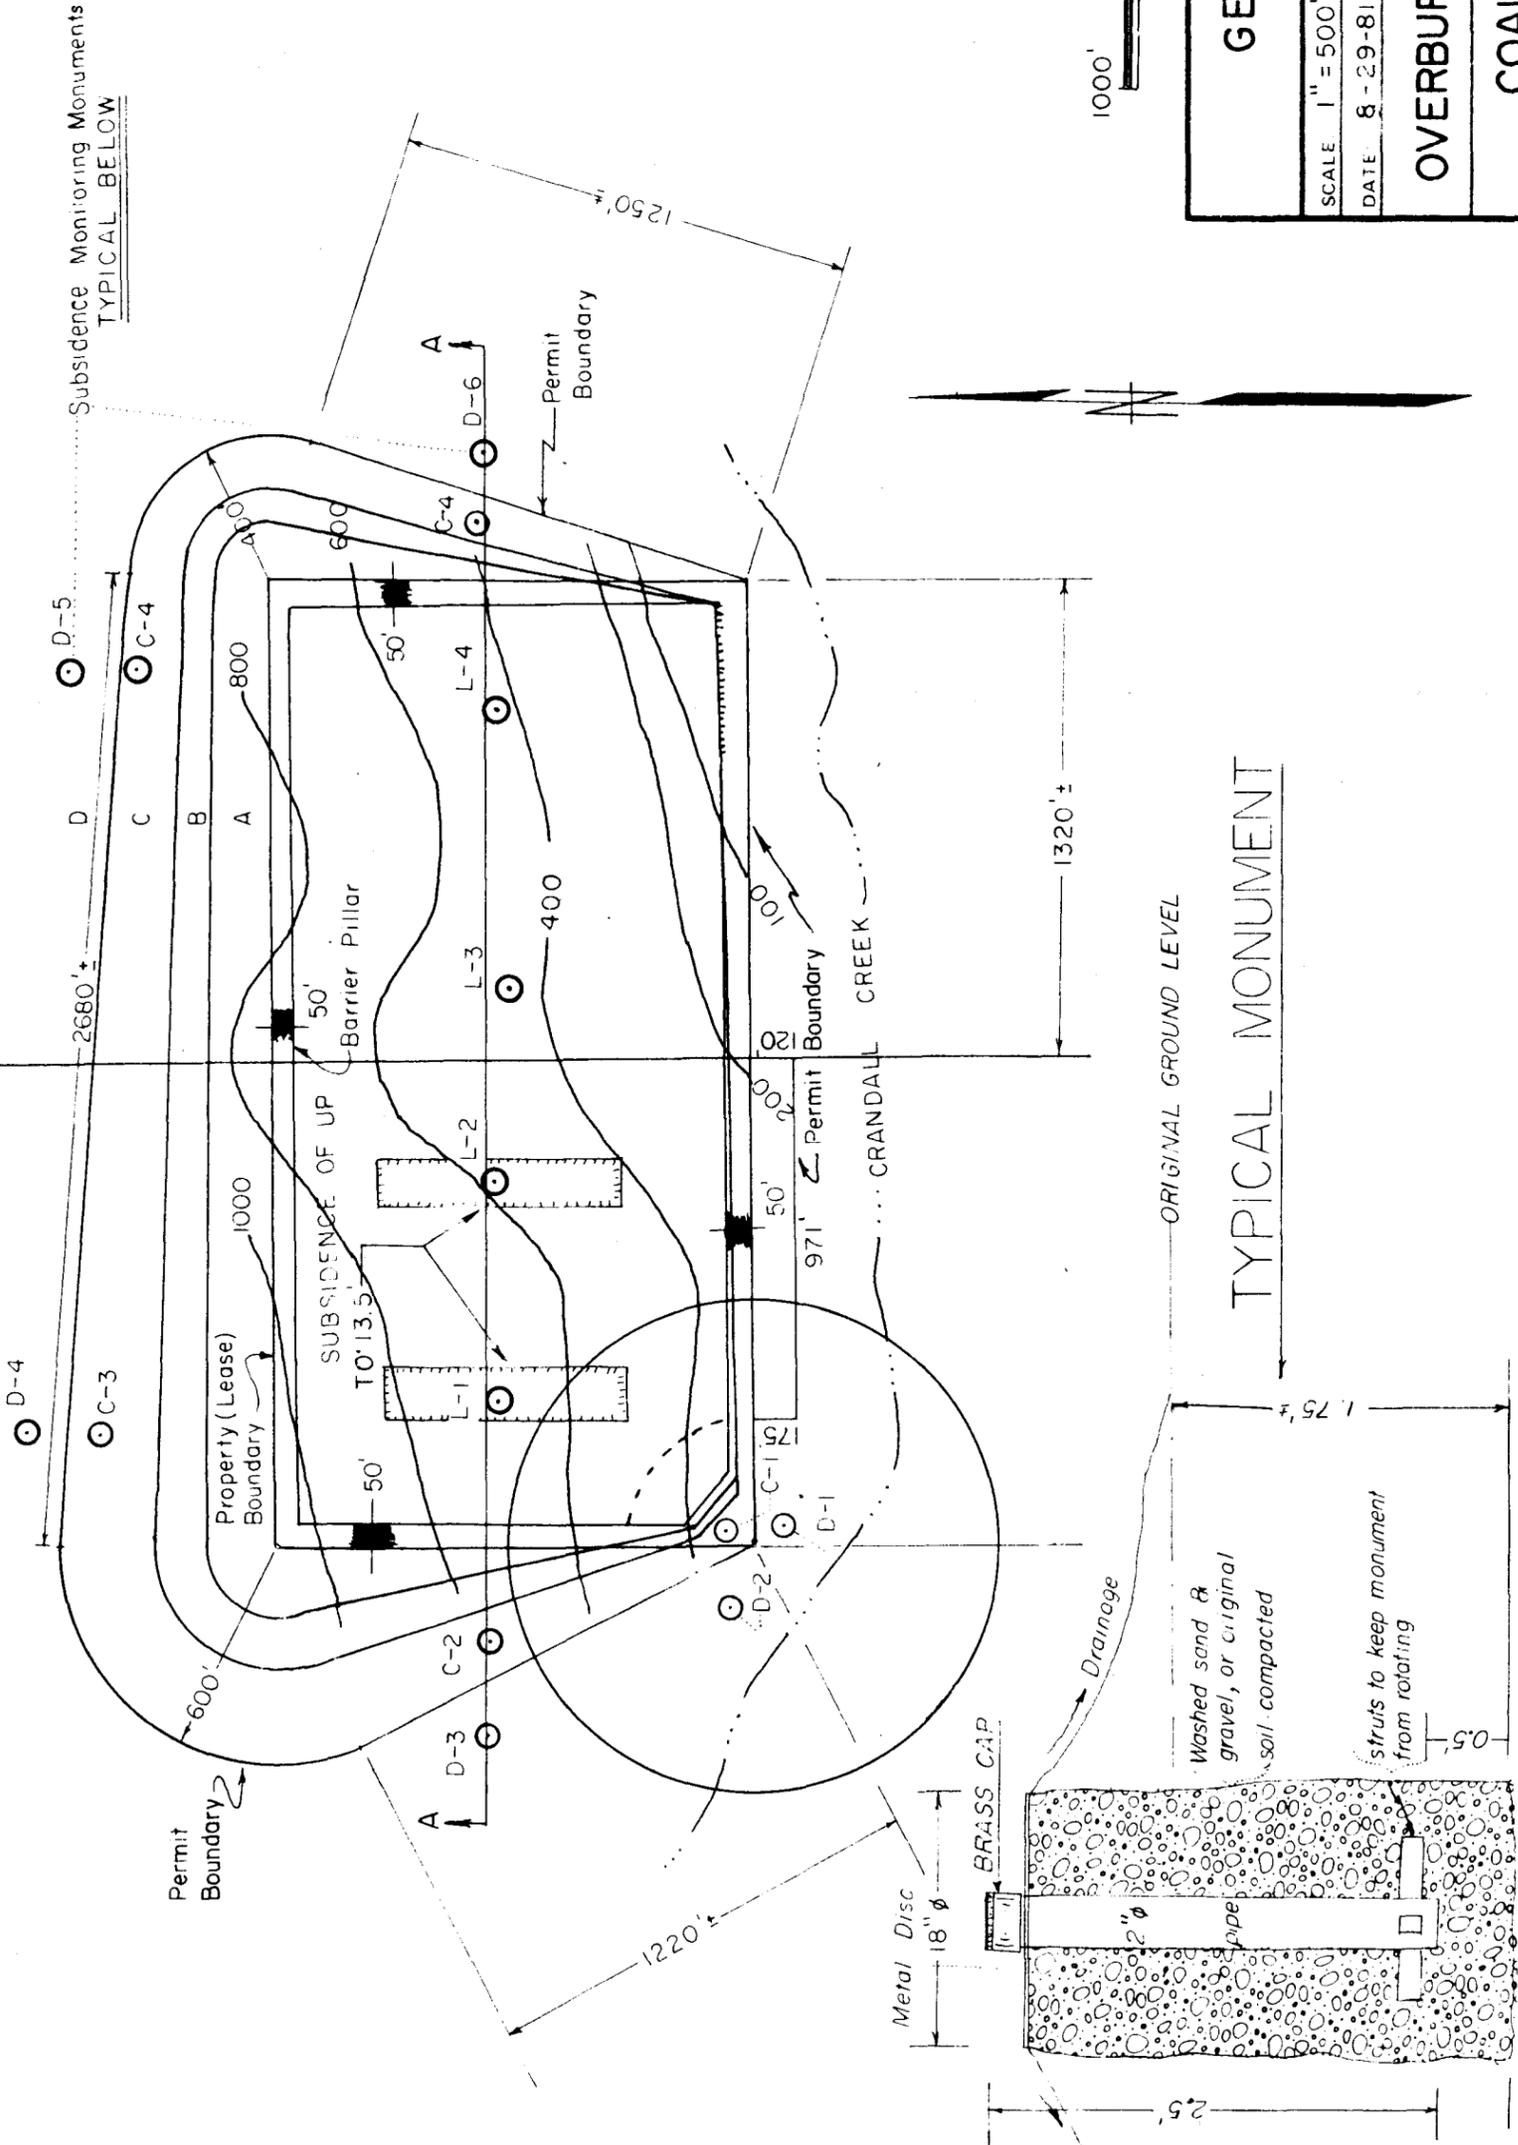
SECTION 6 SECTION 5

- A** Strong possibility of visual subsidence 12° positive break line.
- B** Moderate possibility of subsidence
- C** Moderate to light possibility of subsidence.
- D** NO SUBSIDENCE EXPECTED OUTSIDE OF PERMIT AREA.

Amount of Subsidence - Maximum surface subsidence anticipated will amount to approximately 90% of the combined thickness of the two seams. Areas of maximum subsidence are expected in the $SE\frac{1}{4}$ $NE\frac{1}{4}$ Section 6 ($6' + 9' \times 0.90 = 13.5'$) and in the $SW\frac{1}{4}$ $NW\frac{1}{4}$ Section 5 ($9' \times 0.90 = 8.1'$) (see Sheet 12).

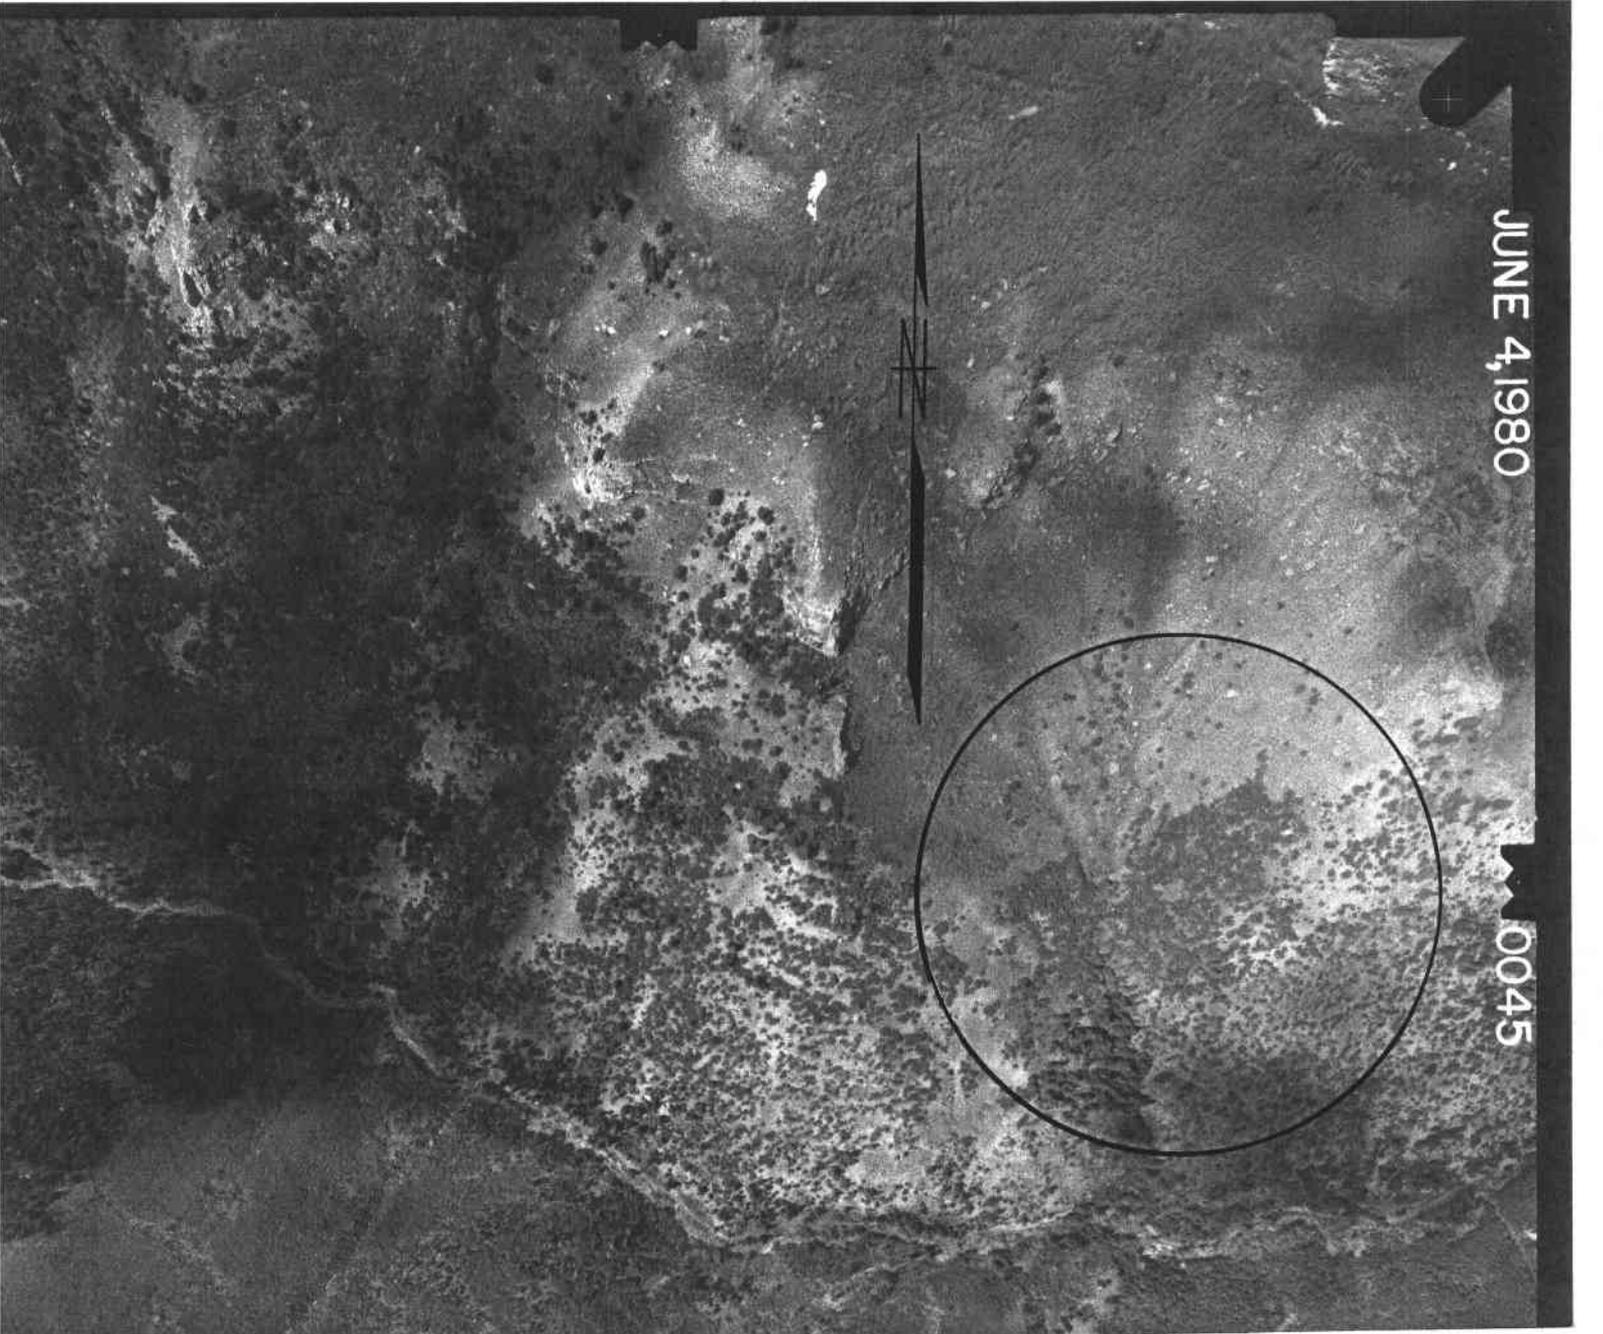
Circle represents the general area that the surface survey covered-Crandell Creek is the main creek generally trending east-west.

The Statement of Fact in the Appendix confirms there are no man-made structures inside the property boundary that would require subsidence control planning. The accompanying photo and maps of the area also confirm Mr. Wollen's conclusions.
