Boyle Engineering Corporation

In order to improve the factors of safety of the downstream slope of the pond embankment, the typical cross-section of the pond was revised by Boyle Engineering Corp. of Price, Utah as shown in Fig. 6 attached herewith. The crest of the pond was lowered to Elev. 7787 ft, the upstream slope of the pond embankment was steepened to 1.5H:1V, and the pond floor was lowered to Elev. 7769 ft to form a V-shape. Due to those changes, the pond embankment was shifted slightly toward the hillside.

Presented in this report are the results of our slope stability analysis of a sedimentation pond proposed by Genwal Coal Company for its Crandall Canyon Mine facilities. The Crandall Canyon Mine, located within Crandall Canyon, is approximately 16 miles northwest of Huntington, Carbon County, Utah and is approximately 1½ miles west of the junction of Crandall Creek and Huntington Creek (Fig. 1).

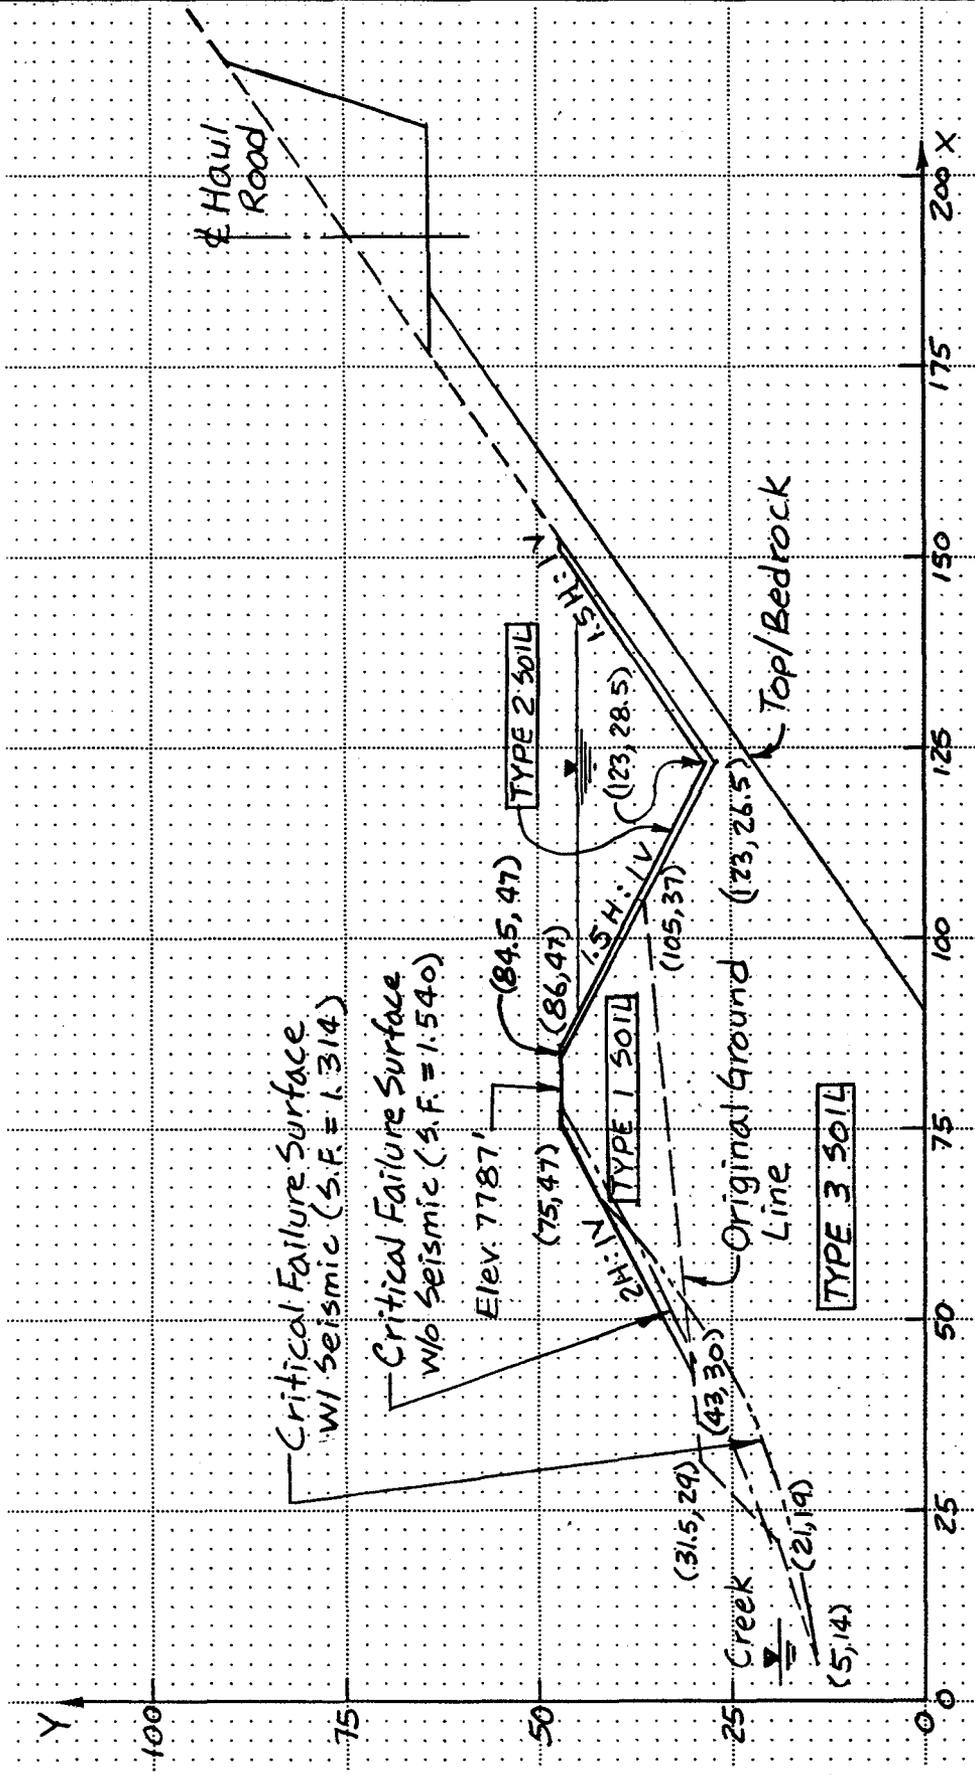
FB
GRID
PROJ. NO. 161031
DWG. NO. Fig. 6

2H:1V DOWNSTREAM SLOPE AND 1.5H:1V UPSTREAM SLOPE
WITH LOWERED CREST AND POND FLOOR

The same soil parameters as in the original study was used in the STABL2 computer program for the analysis of the slope stability of the downstream slope. For a 2H:1V slope, the factor of safety is 1.540 under static conditions and 1.314 under seismic conditions (with unassumed horizontal acceleration equal to 8% of gravity). A set of copies of the computer output is attached.

The factors of safety of the revised cross-section of the sedimentation pond, as shown in Fig. 6, provide an adequate margin against slope failure. We will be glad to answer any questions you may have regarding this supplemental study.

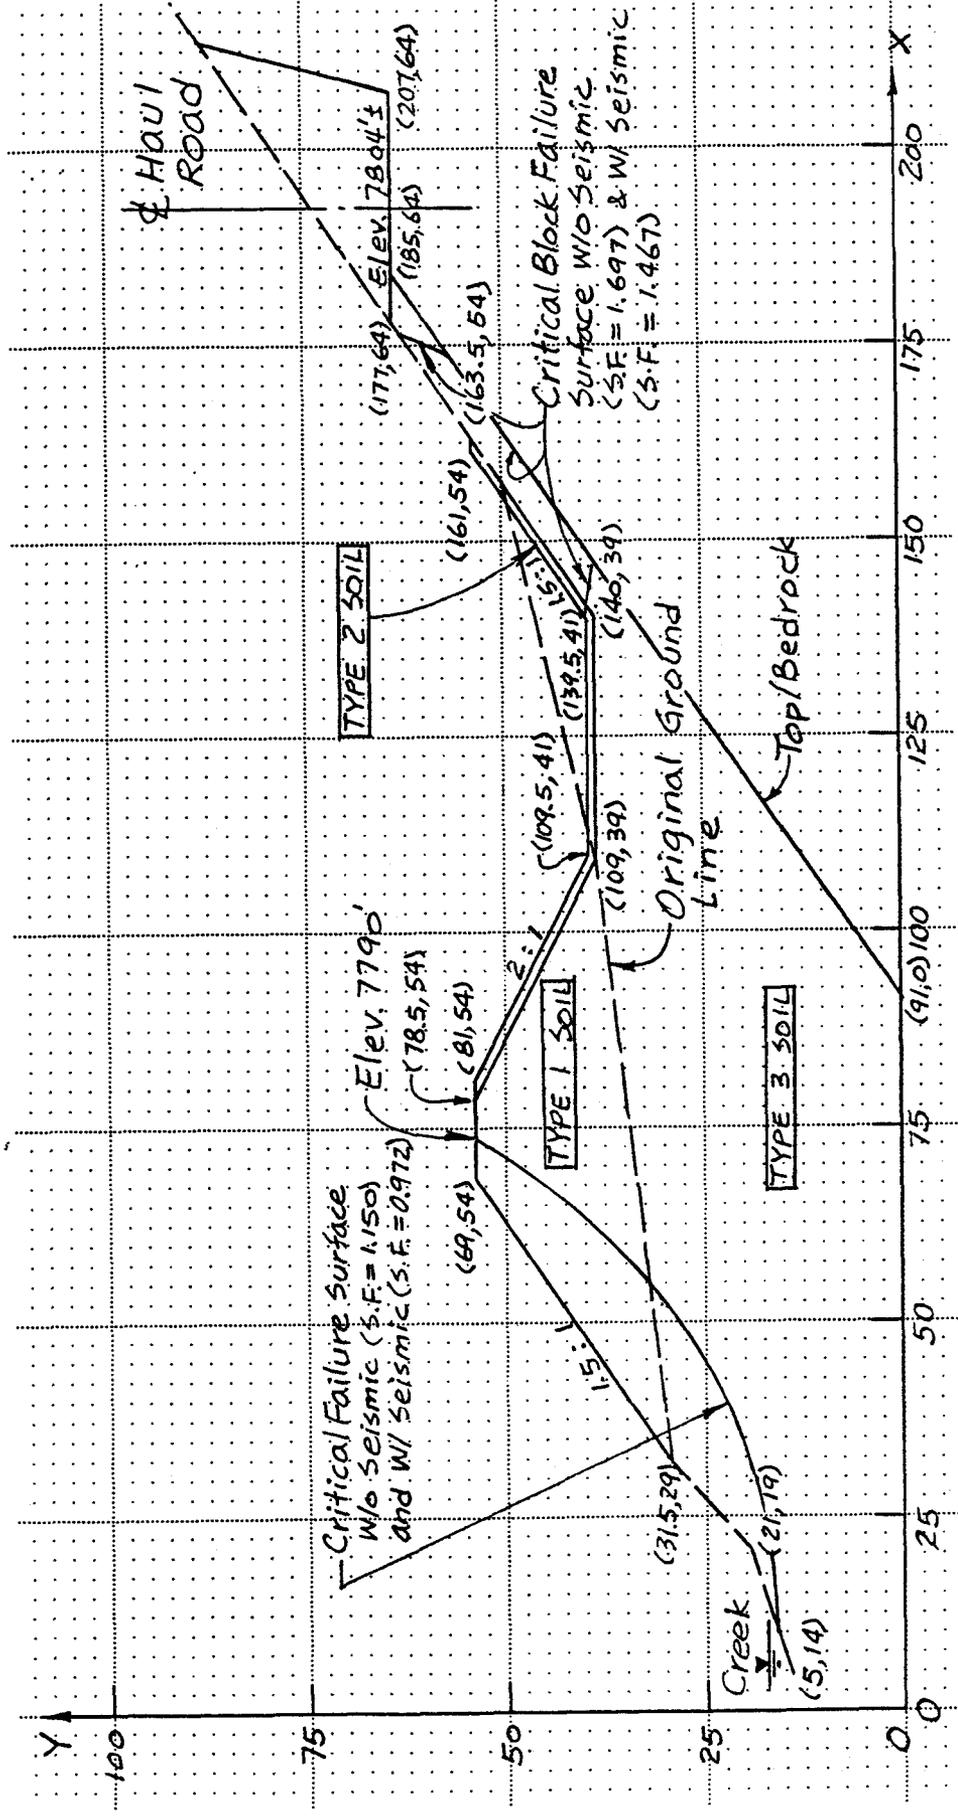
FB.
 GRID.
 PROJ. NO. 161031
 DWG. NO. Fig. 3

HAUL ROAD EMBANKMENT AND 1 1/2 H:1 V DOWNSTREAM SLOPE WITH EMPTY POND

Note: For downstream slope, the critical failure surfaces and their corresponding safety factors are same as those for empty pond case shown in Fig.

A typical cross section cut through Station 75+40 of the haul road was analyzed for the slope stability (Fig. 3). Included in the analyses are three slopes: 1) the downstream slope of the pond embankment, 2) the upstream slope of the pond embankment, and 3) the haul road embankment, which forms a portion of the impoundment of the sedimentation pond. An equivalent uniform of load 100 psf covering two 11-ft lanes was used as the traffic load for the proposed haul road.

The most critical potential failure surfaces for each slope investigated are superimposed onto its cross section, as shown in Figs. 3 to 7. The minimum factors of safety of the most critical potential failure surfaces of each case are summarized in Table 1. The computer output of the STABL2 program for the analysis of the downstream slope of the pond embankment ($2H:1V$) is included in Appendix A. The print-out material for the remaining analyses are not included in this report, due to their volume, but are available on file upon request.
