## INTRODUCTION

The Subsidence Control Plan contained herein for Federal Coal Leases Salt Lake 062648 and Salt Lake 050655 addresses specifically those items that are required by UMC 784.20 on pages 90-91 and UMC 817.121-.126 on pages 229-231 of the "Regulations Pertaining to Surface Effects of Underground Coal Mining Activities (including regulations for coal exploration), Final Rules of the Utah Board and Division of Oil, Gas and Mining," dated 9-20-82.

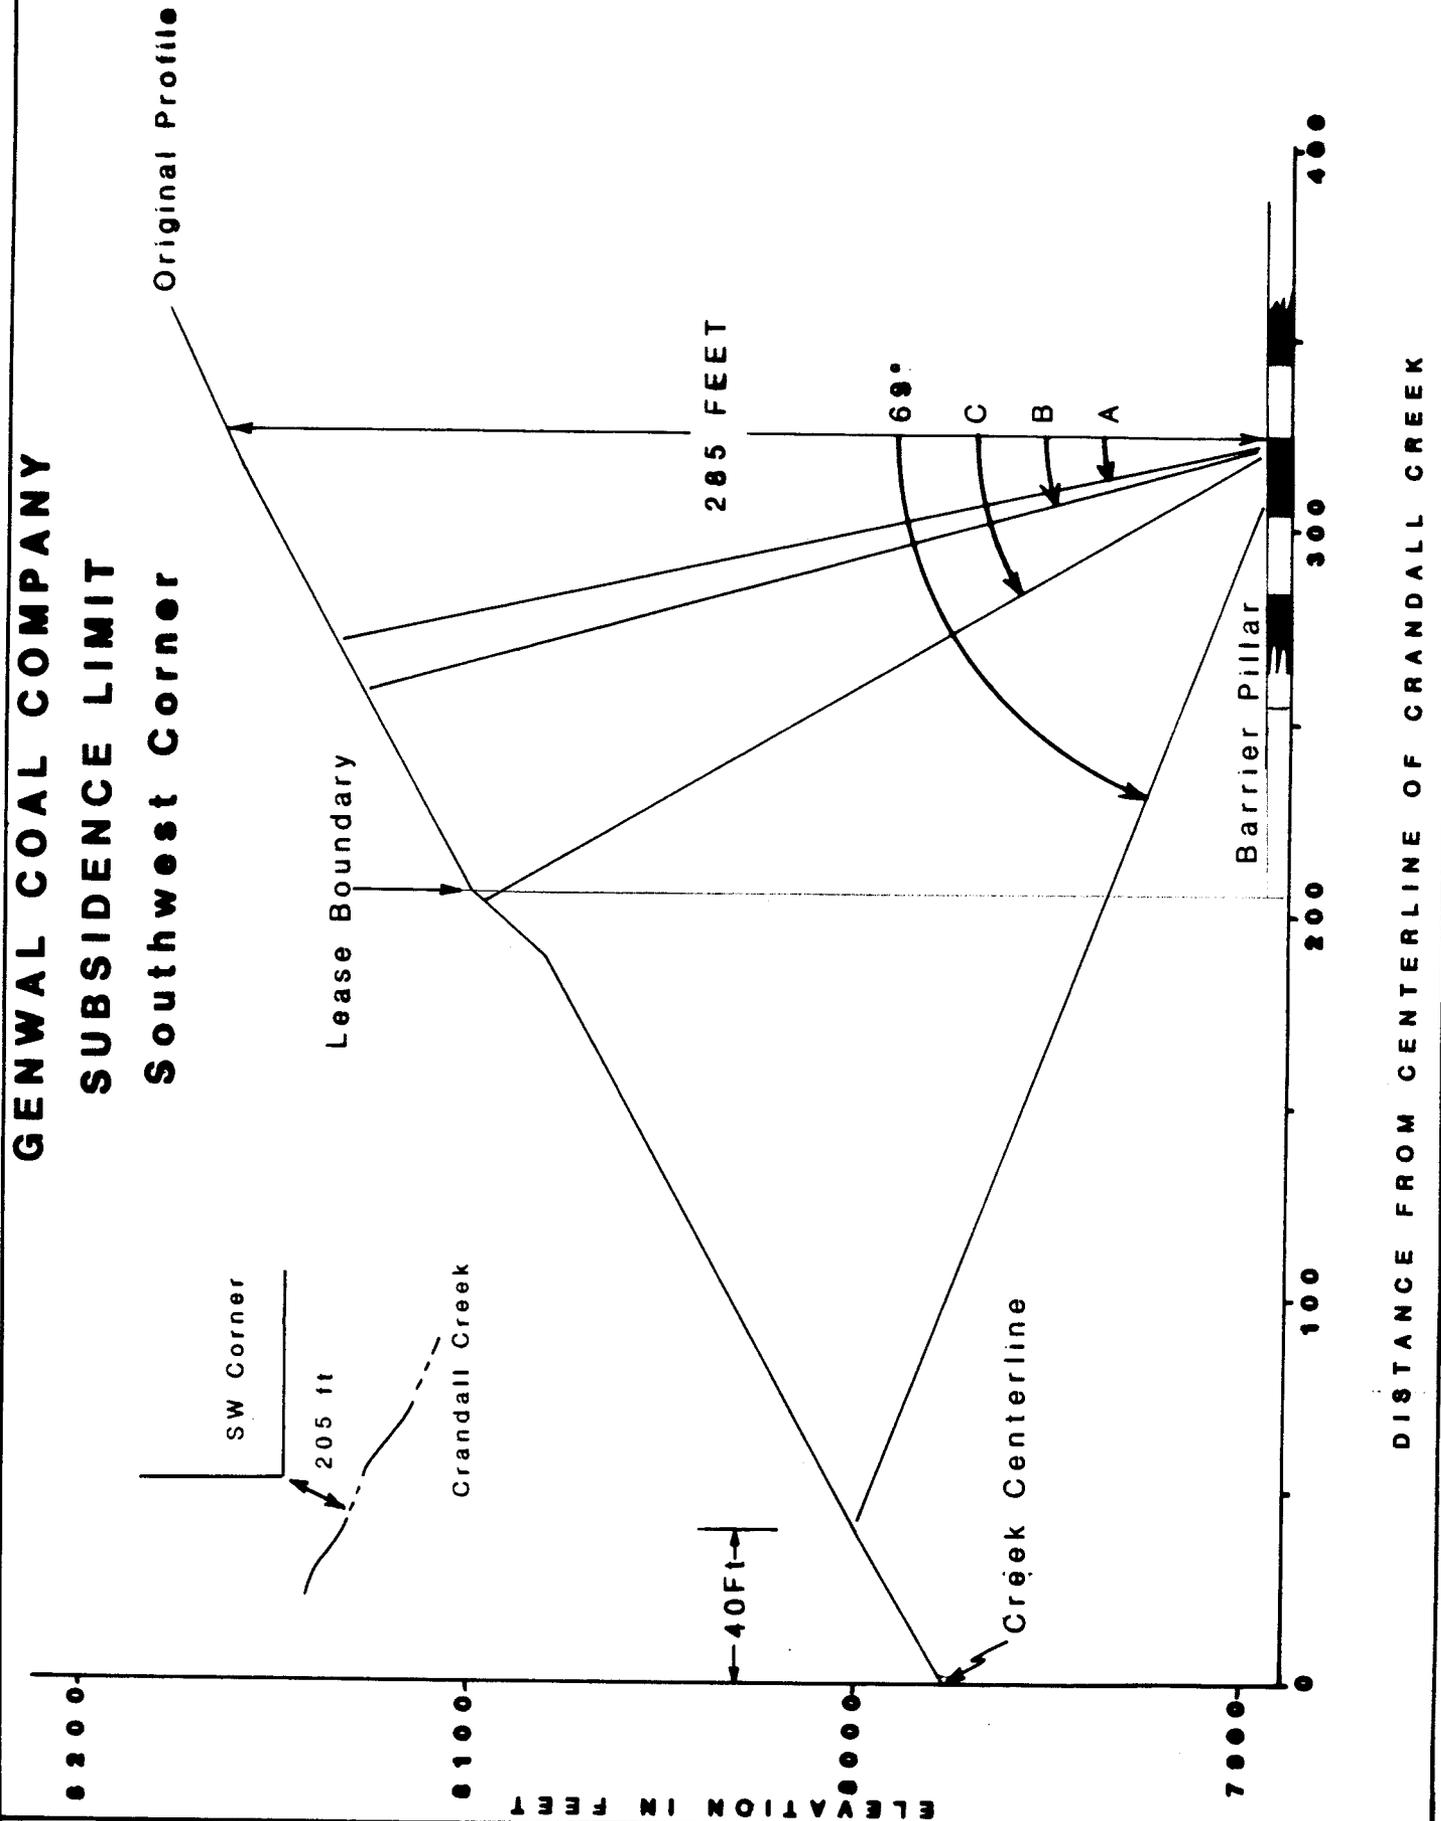
FIGURE 1.

Definitions for Figure 1.

B. Angle "B" is equal to 15.5 degrees and represents the maximum break line found at the Geneva Mine, Utah as discussed in the USGS Professional Paper 969 on pages 4 and 34. It is felt that some form of deformation will take place in this area. Item XII-4 indicates this area with the letter "B".

Crandall Creek comes no closer than 205 feet to the lease boundary as shown on Figure 1 and on Item XII-3 which occurs in the southwest corner. Calculations and the results shown on Figures 1 and 2 indicate that the subsidence will occur no closer than 200 feet from the centerline of Crandall Creek using a 30 degree angle of draw and a 50 foot barrier pillar along the southern boundary. An angle of draw equal to 69 degrees or greater is required before the area within 40 feet of Crandall Creek becomes subject to any possible subsidence. This magnitude of draw angle in shale and sandstone formations is unrealistic.

Tangent  $30 \times 279$  feet of overburden = 161.1 feet (use 160)  
No radius was drawn on Item XII-4 as a result of the work on Figures 1 and 2 showing the maximum limit of subsidence occurring at the lease boundary due to the surface topography. No additional barrier pillars will be required to protect Grandall Creek.
