BUREAU OF LAND MANAGEMENT

Re: Modification Request for Resource Recovery and Protection Plan (R2P2), Northwest  
Longwall Mining Block, Crandall Canyon Mine

Enclosure  
Approved Mine Map

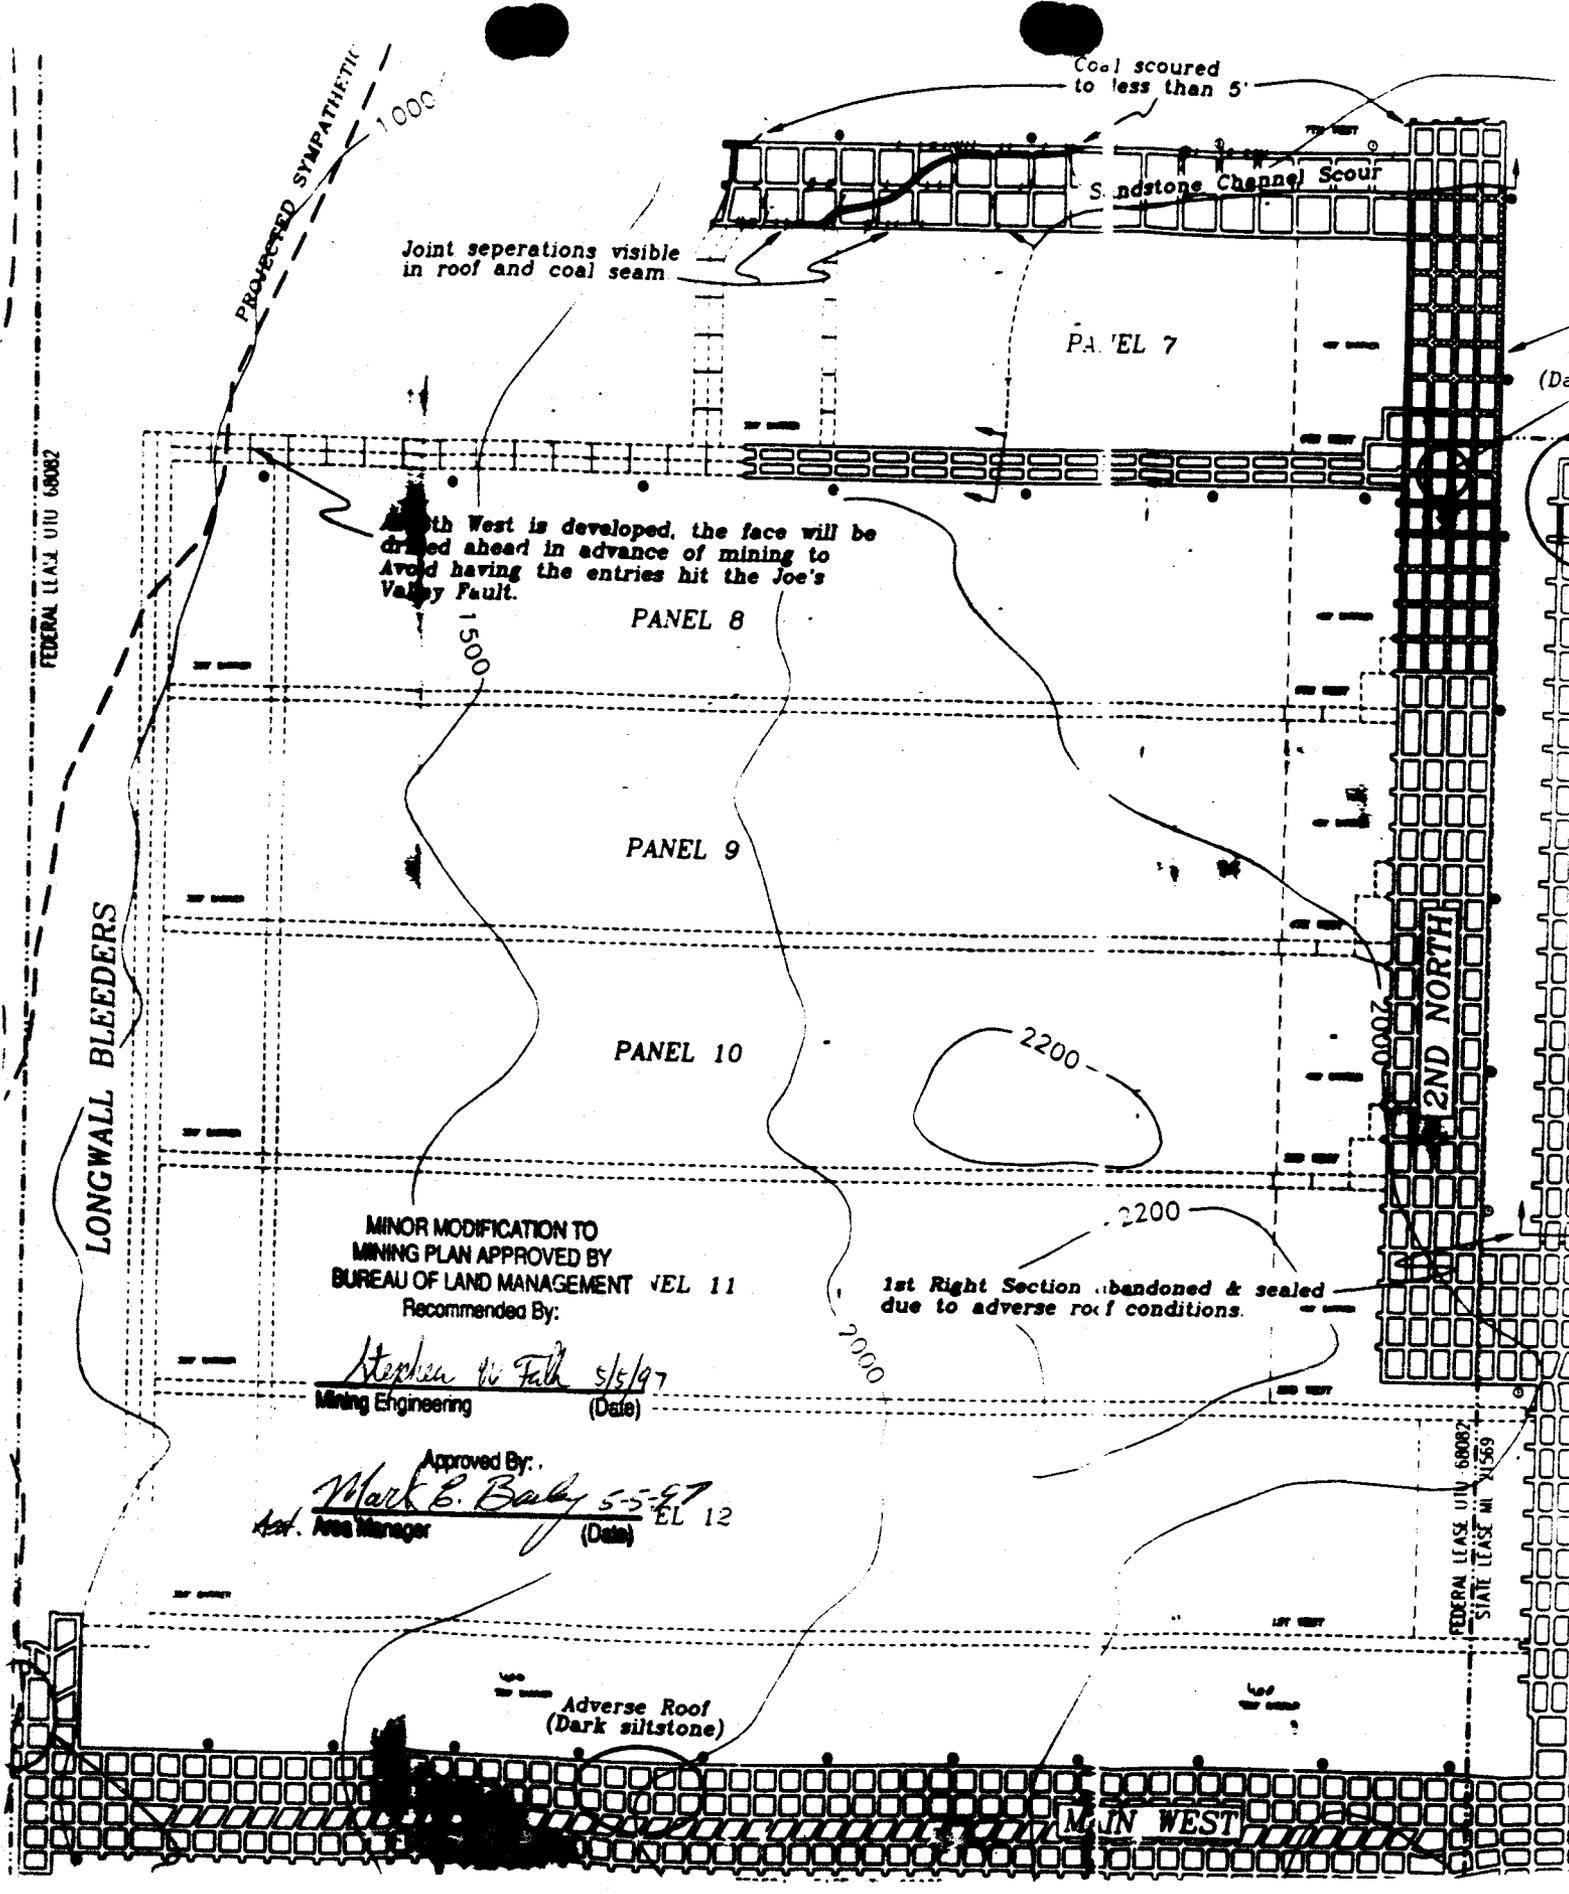
Coal scoured  
to less than 5'

Sandstone Channel Scour

Joint separations visible  
in roof and coal seam

When West is developed, the face will be  
drilled ahead in advance of mining to  
avoid having the entries hit the Joe's  
Valley Fault.

LONGWALL BLEEDERS

1st Right Section abandoned & sealed  
due to adverse roof conditions.

Adverse Roof  
(Dark siltstone)

The BLM agrees with the longwall barrier pillar sizing to protect 2nd North and Main West. The barrier pillars are slightly larger than some accepted design formula, but 2nd North's variable roof lithology warrants extra protection, especially with no history of longwall mining in this area.

The longwall bleeder/set-up design is also accepted. We are well aware of the risks and possible hazards of mining too close to the Joe's Valley Fault and have witnessed the area in Main West where the fault was encountered. In light of the requirement to have a travelable and stable bleeder entry system near the fault, barrier pillars are necessary for both the fault and the longwall set-up room.
