**GENWAL MINE  
015/032**

**MINING AND RECLAMATION  
PLAN**

**CHANGE TO THE RECLAMATION PLAN  
FOR THE**

**CRANDALL CANYON MINE MEMORIAL  
and the  
PORTAL WATER DISCHARGE**

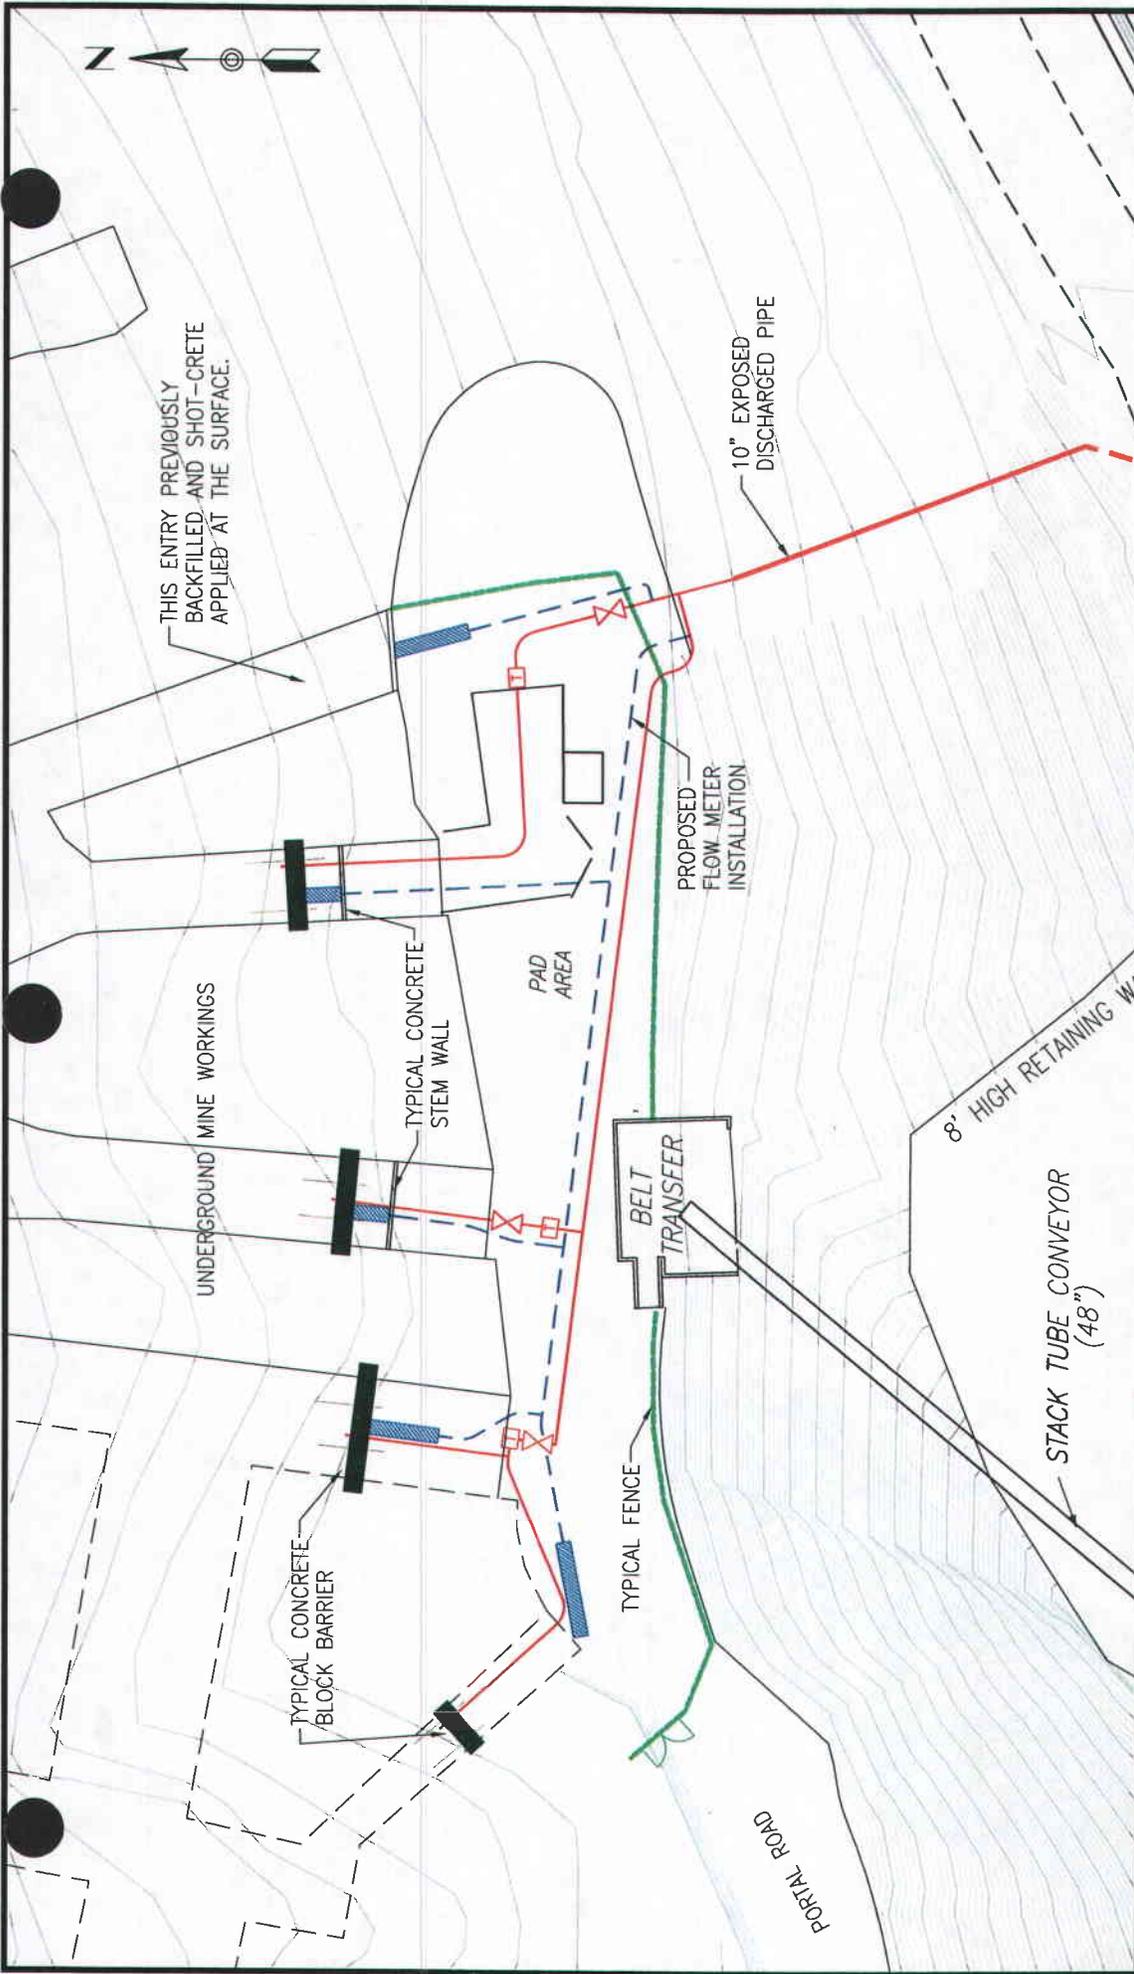
**EXISTING DRAIN PIPING**

**FIGURE 5-14**

**PORTAL & DISCHARGE WATER  
RECLAMATION DRAWINGS**

- a) Existing Plan View
- b) Reclamation Plan View
- c) Reclamation Cross-Section View

4) Presently, the discharge water is conveyed down from the portals down over the hill through a 12" PVC pipeline. This line then empties into an existing CMP culvert which leads to the main bypass culvert at an approved UPDES monitoring point. Upon final reclamation the PVC pipe would be replaced with an overland channel. In this area the sandstone bedrock lies very close to the surface, and forms natural outcrop ledges in the immediate and surrounding area. With a minor amount of work debris and weathered material can be removed to expose the competent bedrock below and thereby create a permanent, non-erosive channel for the discharge water course. In those areas where the weathered material is thicker, such as below the Forest Service Road (which will remain in place after mine reclamation) the channel would be lined with a suitable rip-rap. There would be no other flow in this channel other than the continuous 600 gpm mine discharge.

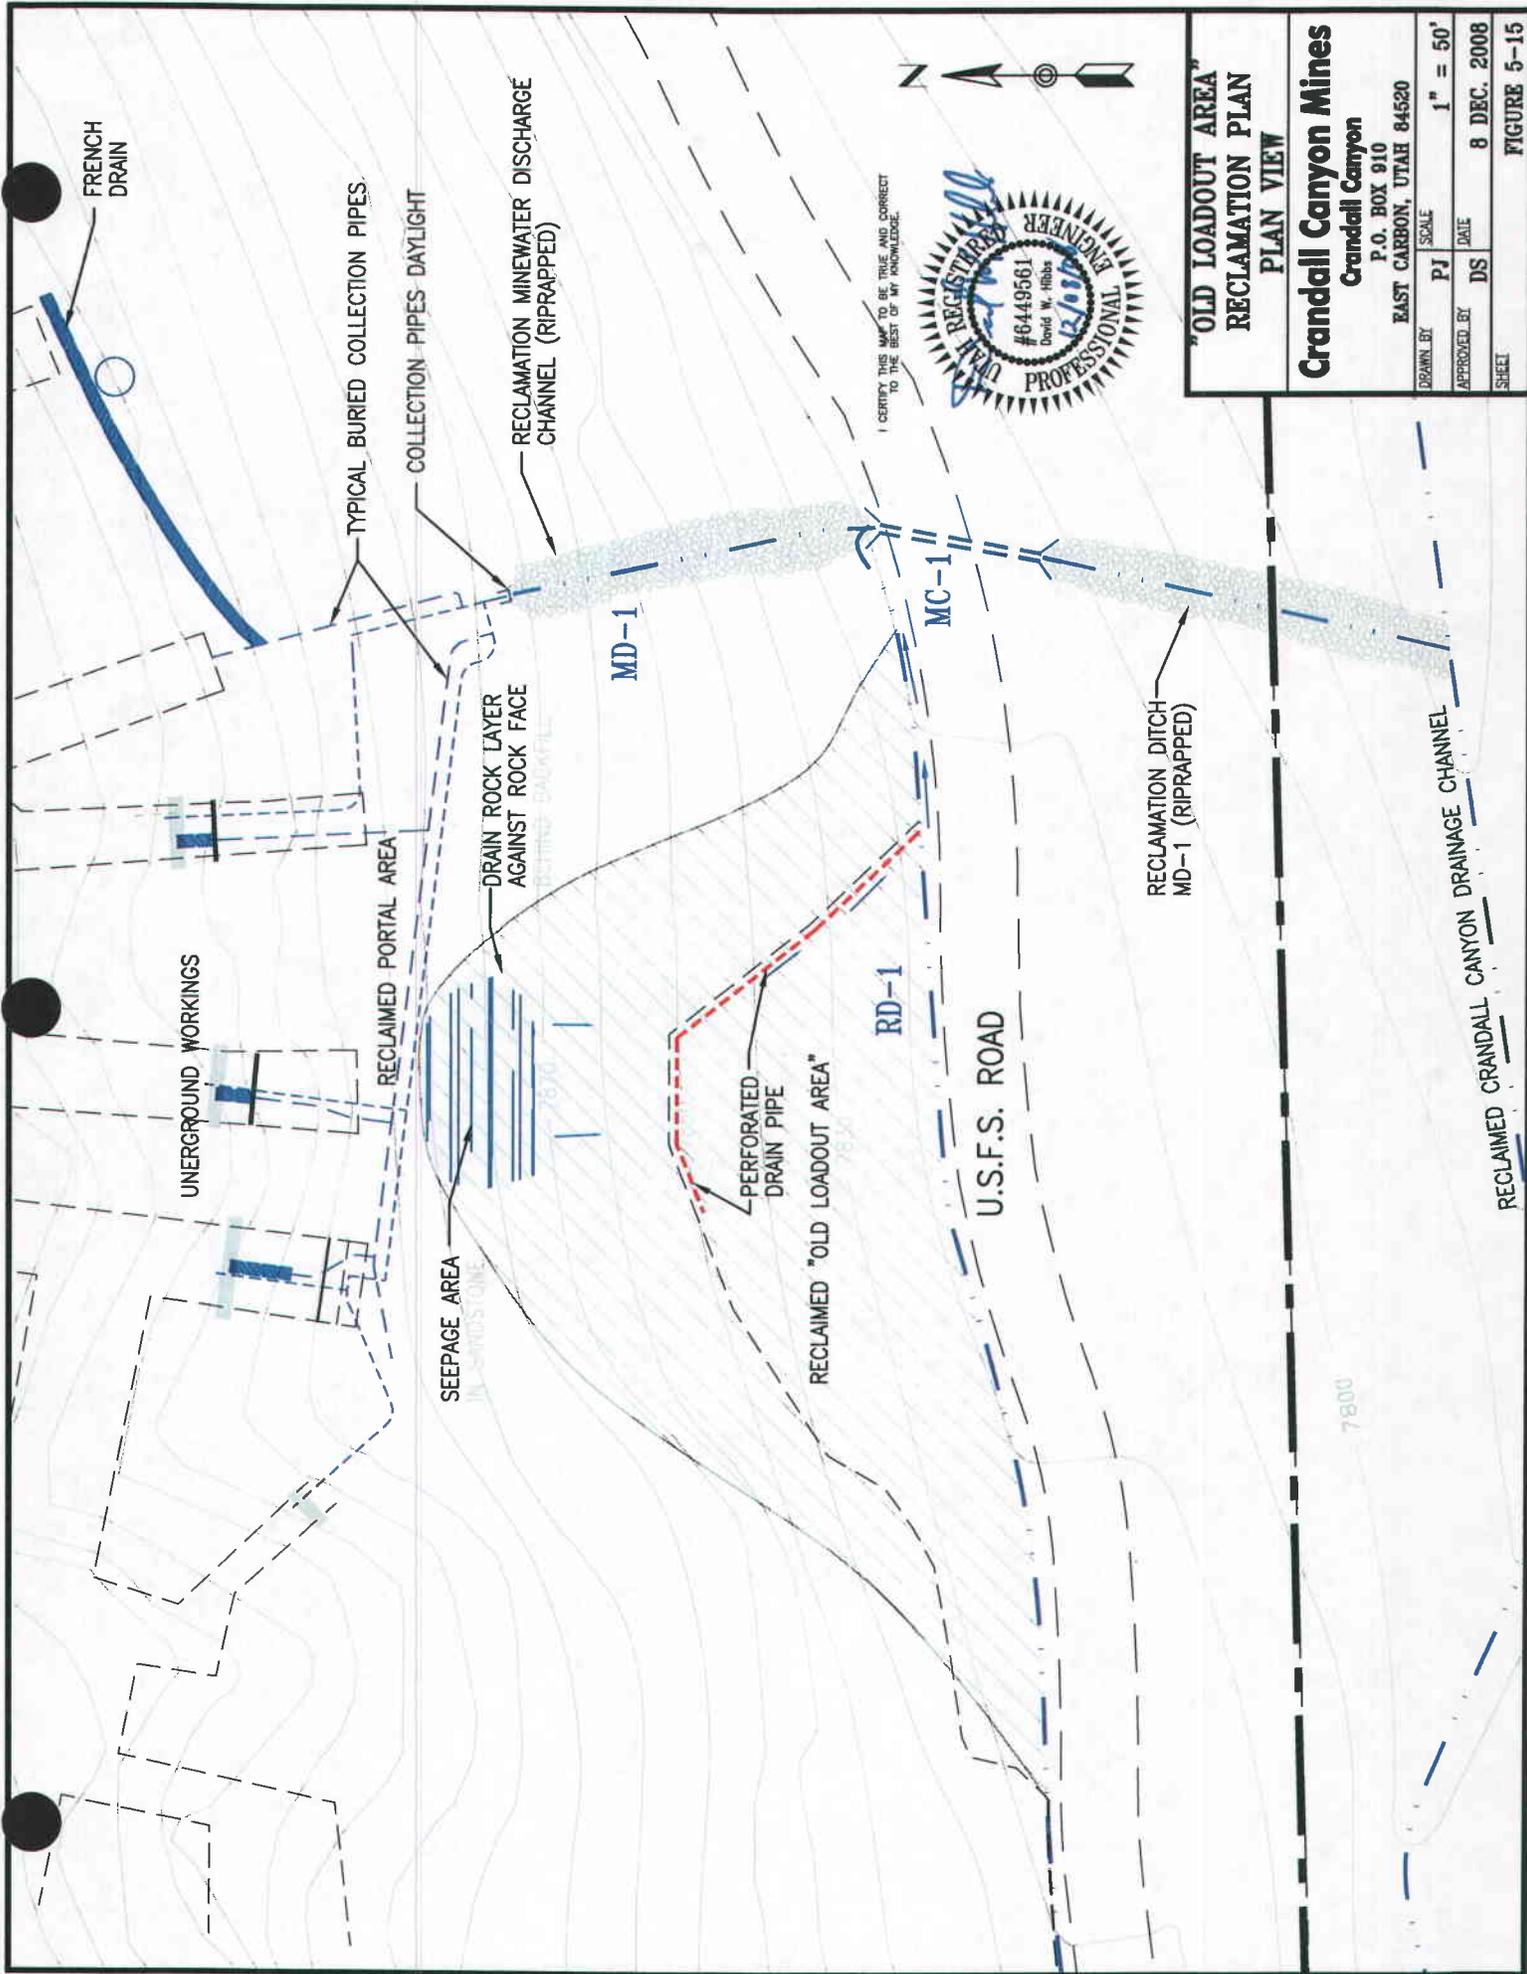
**“OLD LOADOUT AREA”  
RECLAMATION DRAWING**

- a) Plan View
- b) Cross-Section View

As noted in item 4 above, there is a small but continuous seepage of water coming out of the sandstone ledge below the portals. This seepage water will be collected into a permanent drain system as part of final reclamation. Prior to backfilling, a 4" perforated drainpipe will be laid along a trench dug into the base of the existing ledge. The trench will be filled with drainrock to surround the pipe. A layer of filter-cloth will then be laid over the trench to protect the drainrock. As the backfill material is placed in layers, at the contact area between the fill and the sandstone ledge, a layer of drainrock will be placed at the interface in all areas subject to seepage flow coming down the ledge. As each successive layer of backfill is installed, the drainrock interface layer will be installed as well. Therefore, as the backfill layers build up from bottom to top, a drainrock layer between the fill and the ledge rock will be built up as well. This will form a permanent conduit for the seepage water to follow from the ledge down to the collection drainpipe. The collection pipe will extend beyond the extent of the fill and will discharge into the same culvert under the Forest Service Road as does the primary discharge flow from the reclaimed portals described in item 4 above. Refer to Drawing 5-15 for a schematic of the Old Loadout Area ledgerock seep collection system.

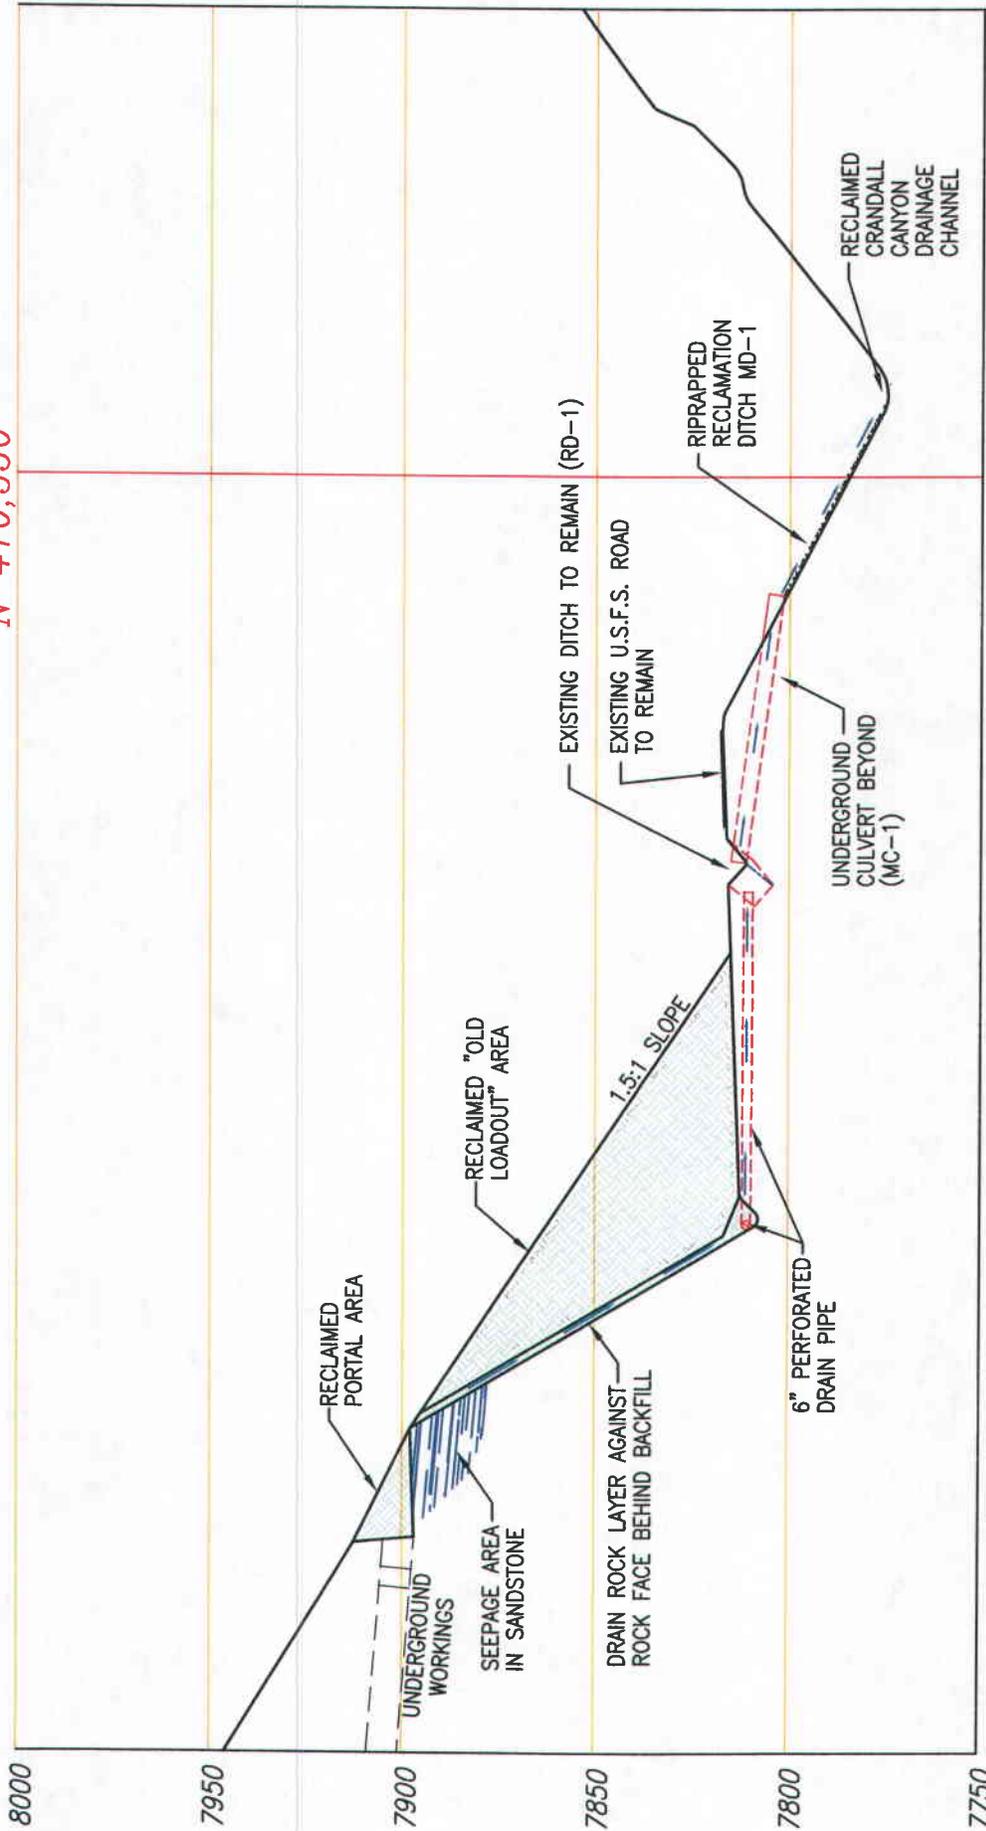
CROSS SECTION VIEW - LOOKING DOWNCANYON

**"OLD LOADOUT AREA"**  
**RECLAMATION PLAN**  
**CROSS SECTION VIEW**
