State of Utah
DEPARTMENT OF NATURAL RESOURCES
Division of Oil, Gas & Mining

Subject: Division Order to Address Mine Water Discharge and Provide Adequate Bonding, Genwal Resources, Inc., Crandall Canyon Mine, C/015/0032-DO10A, Outgoing File

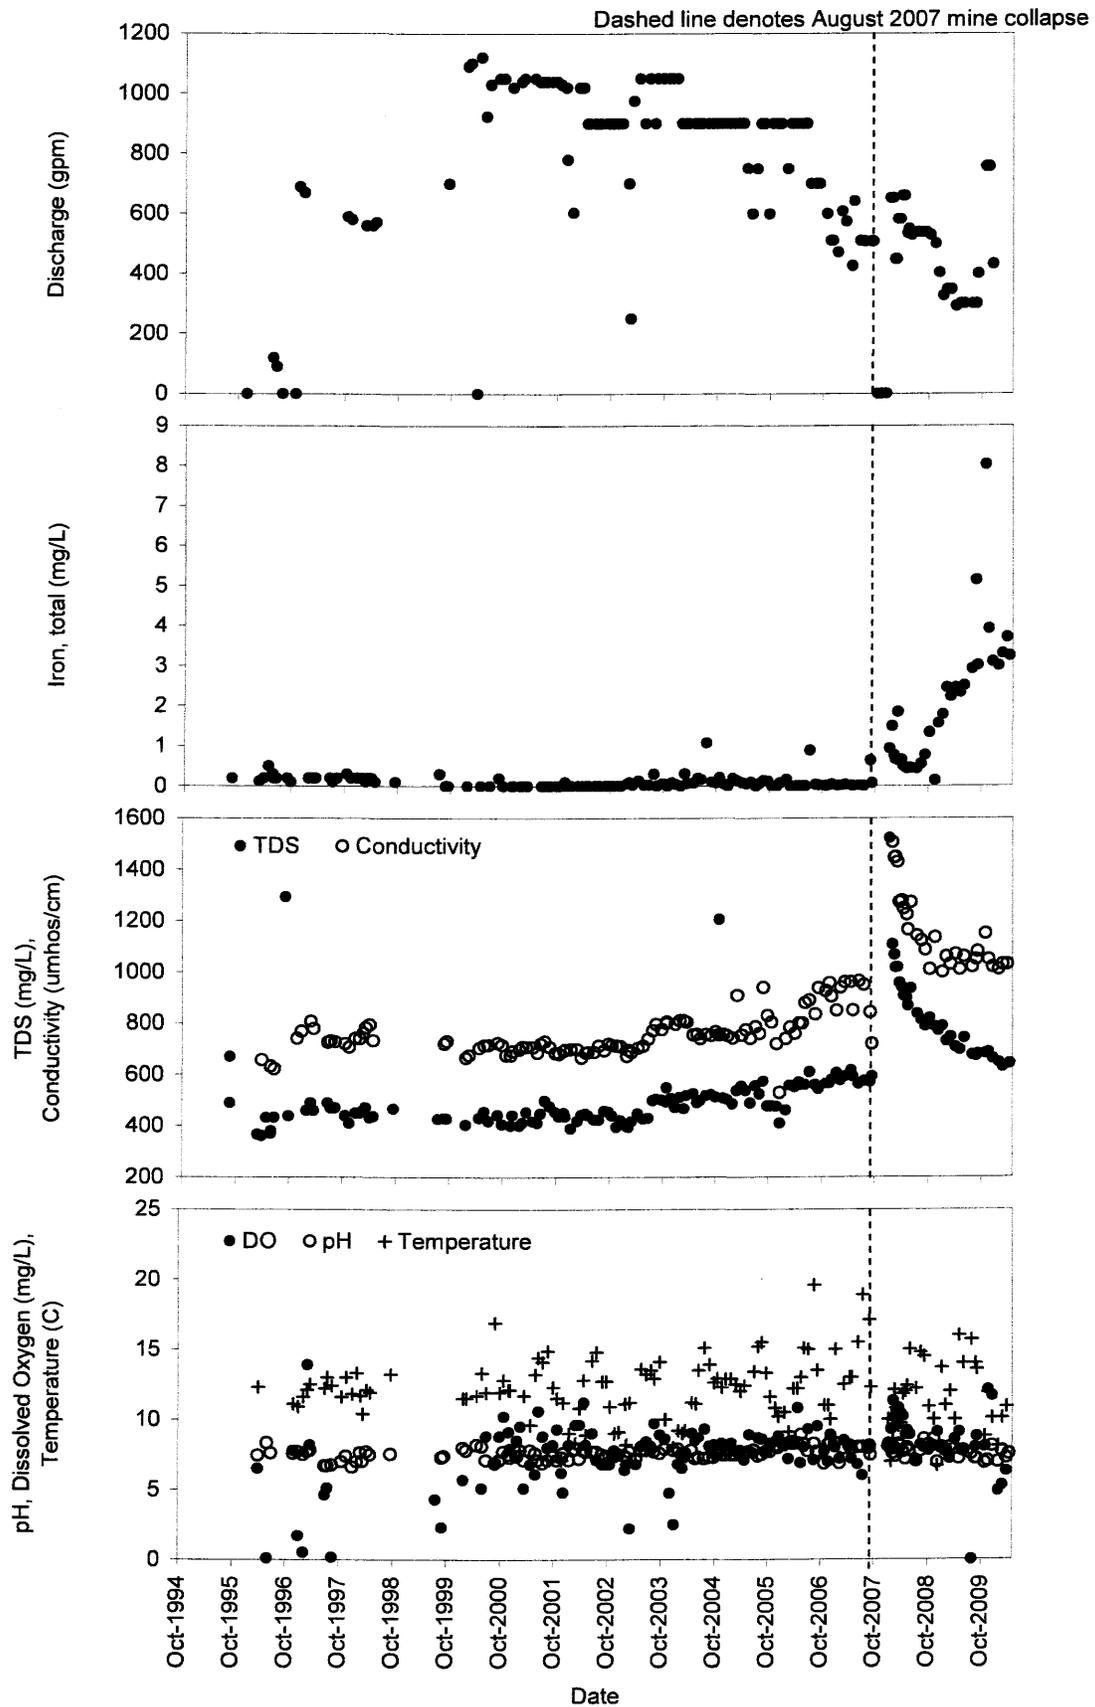
Figure 3. Plots Showing Selected Crandall Canyon Mine Water Discharge Monitoring Parameters, 1995 – Present

A summary of the available flow, temperature, and dissolved oxygen data for the mine water discharge is provided in Table 1 and plotted in Figure 3. Data are separated into the period prior to mine collapse (1996 – 2007) and following the collapse (2008 – present). The data in Table 1 indicate that discharge conditions were more variable prior to the mine collapse and flooding, as evident by a comparison of the ranges of values reported. During the operational period of the mine, however, the mine water discharge was controlled by pumping, therefore the variability in discharge rates is likely influenced by the operation of pumps and may not reflect variability in the amount of groundwater discharging into the mine. The discharge has averaged 490 gpm with an average temperature of 11.7 degrees C and average dissolved oxygen concentration of 8.7 mg/L.

The flow data shown in Figure 3 do not illustrate a trend or seasonal variability in flow rates from the mine. The operator has reported that since the 2007 collapse, mine flow rates fluctuate as a function of barometric pressure and/or air temperature changes. The absence of a continuous monitoring record of mine discharge rate to date prevent the validation of these observations. An electronic flow meter (Grayline AVFM-100 area-velocity flow meter) capable of supporting a data logger and telemetry was installed by the operator during 1st quarter 2010. It is hoped that a continuous or daily flow record will be obtained from the new flow meter, which will improve the understanding of flow characteristics and which may enable correlation between flow and weather conditions.

1. Dissolved oxygen, pH and temperature show no discernable change prior to and following the collapse (Figure 3). Average values of dissolved oxygen, pH, and temperature in the mine discharge are 7.7 mg/L, 7.6 standard units, and 11.9 degrees C, respectively. The mine water has remained circum-neutral over the period of discharge, and no decrease in pH was recorded following the mine collapse.

2. Conductivity and TDS show a large spike after the collapse followed by a decline. Prior to the collapse, an increasing trend was evident for conductivity and TDS, as shown in Figures 3 and 4. The initial spikes in TDS and conductivity are presumably due to the flushing of readily soluble salts as the mine workings and rubble zones became flooded after the collapse and cessation of pumping at the mine. TDS and conductivity values declined as the solutes were flushed from the mine; however, values remain elevated above conditions prior to the mine collapse.

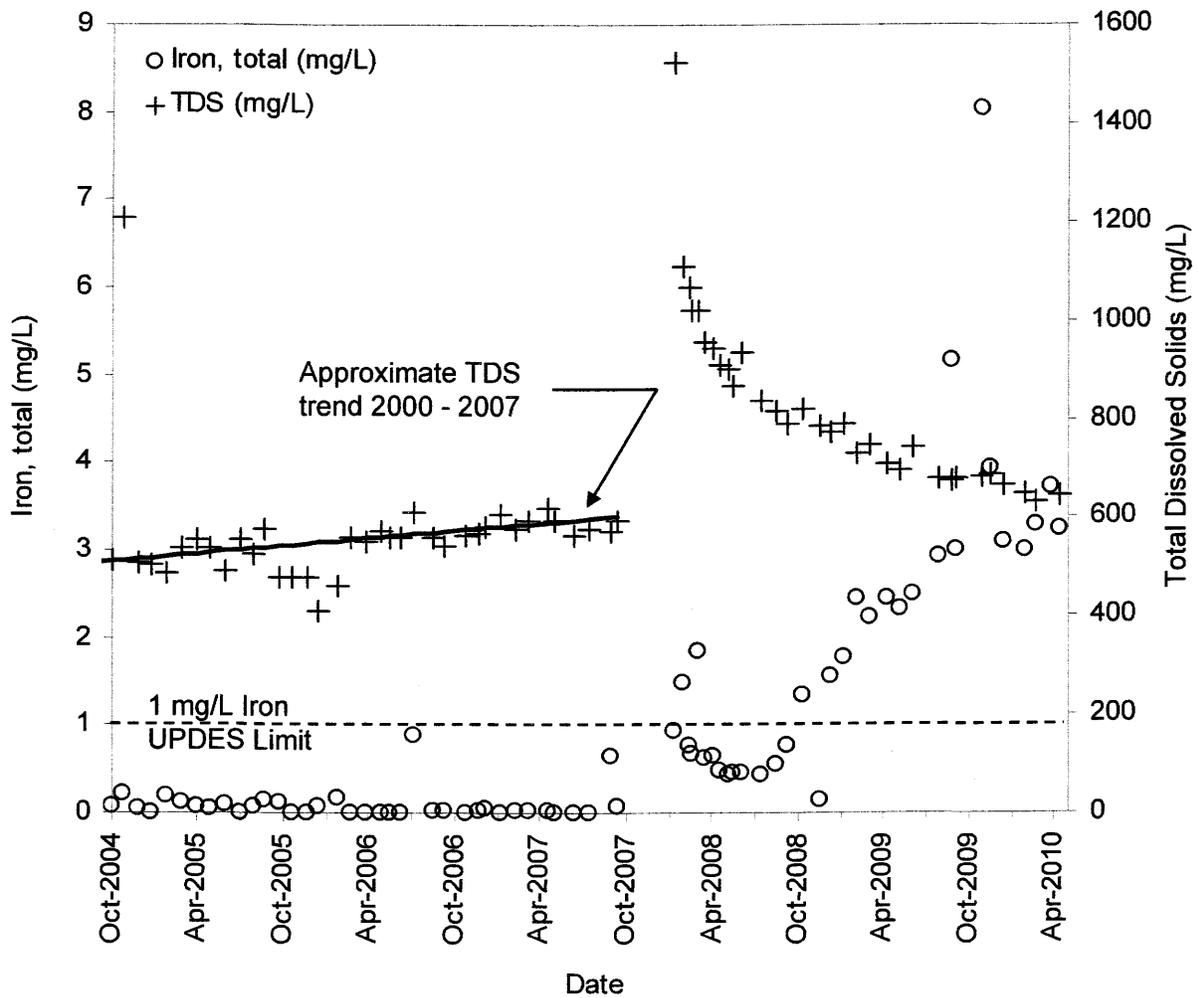
Figure 4. Recent Trends in Iron and Total Dissolved Solids Concentrations in Discharge from the Crandall Canyon Mine

The chemistry of the mine water discharge from the Crandall Canyon Mine has been monitored over the life of the mine by the Operator per the monitoring program described in the MRP and as a condition of their UPDES permit. Required monitoring parameters under the permit include discharge rate, pH, total dissolved solids (TDS), total suspended solids (TSS), total iron, dissolved oxygen, sanitary waste, whole effluent toxicity and oil & grease. UPDES monitoring includes collection of samples for laboratory analyses and measurement of field parameters (pH, temperature, conductivity and dissolved oxygen) are also monitored. Plots showing total iron, TDS, conductivity, pH, dissolved oxygen and temperature from 1995 to present are shown in Figure 3. Water monitoring data for the mine discharge from January 2008 to April 2010 are provided in Table 5. Recent trends in total iron and TDS concentrations are shown in Figure 4.

3. After the 2007 collapse total iron shows an initial, minor spike which declines and then increases (Figure 4). Prior to the mine collapse, total iron concentrations were generally non-detected or well below the UPDES discharge limitation of 1 mg/L. Samples of the mine water discharge collected from January through early March 2008 contained iron at concentrations near or greater than 1 mg/L (Table 5). Iron concentrations declined from mid-March 2008 through mid-July 2008, and then began increasing. Recent monitoring results show the mine water iron concentration to be approximately 3 to 4 mg/L (Table 5).

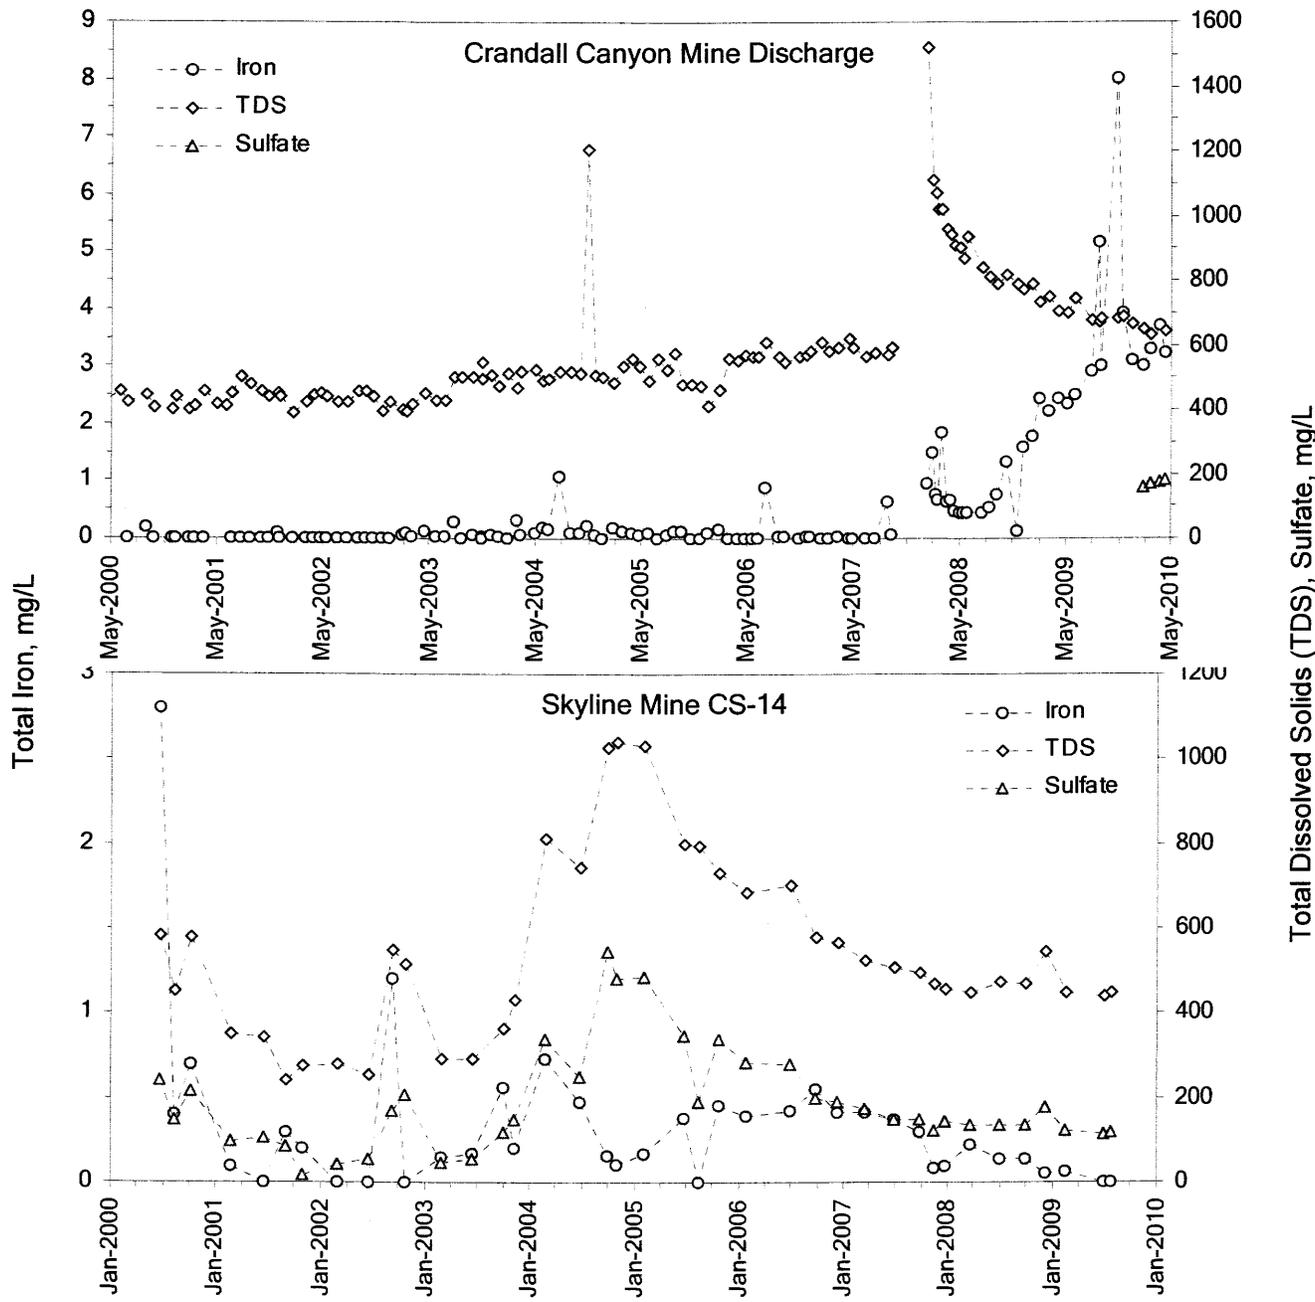
Figure 5. Plots Showing Water Quality Data from Crandall Canyon Mine and Skyline Mine CS-14

- The Skyline discharge and its elevated iron concentrations were not brought about due to a catastrophic mine collapse, but were the result of a planned flooding of a mined-out area.
- Plots of water quality data from the Crandall Canyon Mine discharge and Skyline Mine CS-14 show noticeably different trends and magnitudes for TDS and total iron concentrations (Figure 5). The 2010 Petersen Hydrologic report does not offer an explanation of the variation in TDS and total iron concentrations and trends exhibited at the Skyline Mine compared to Crandall Canyon Mine.

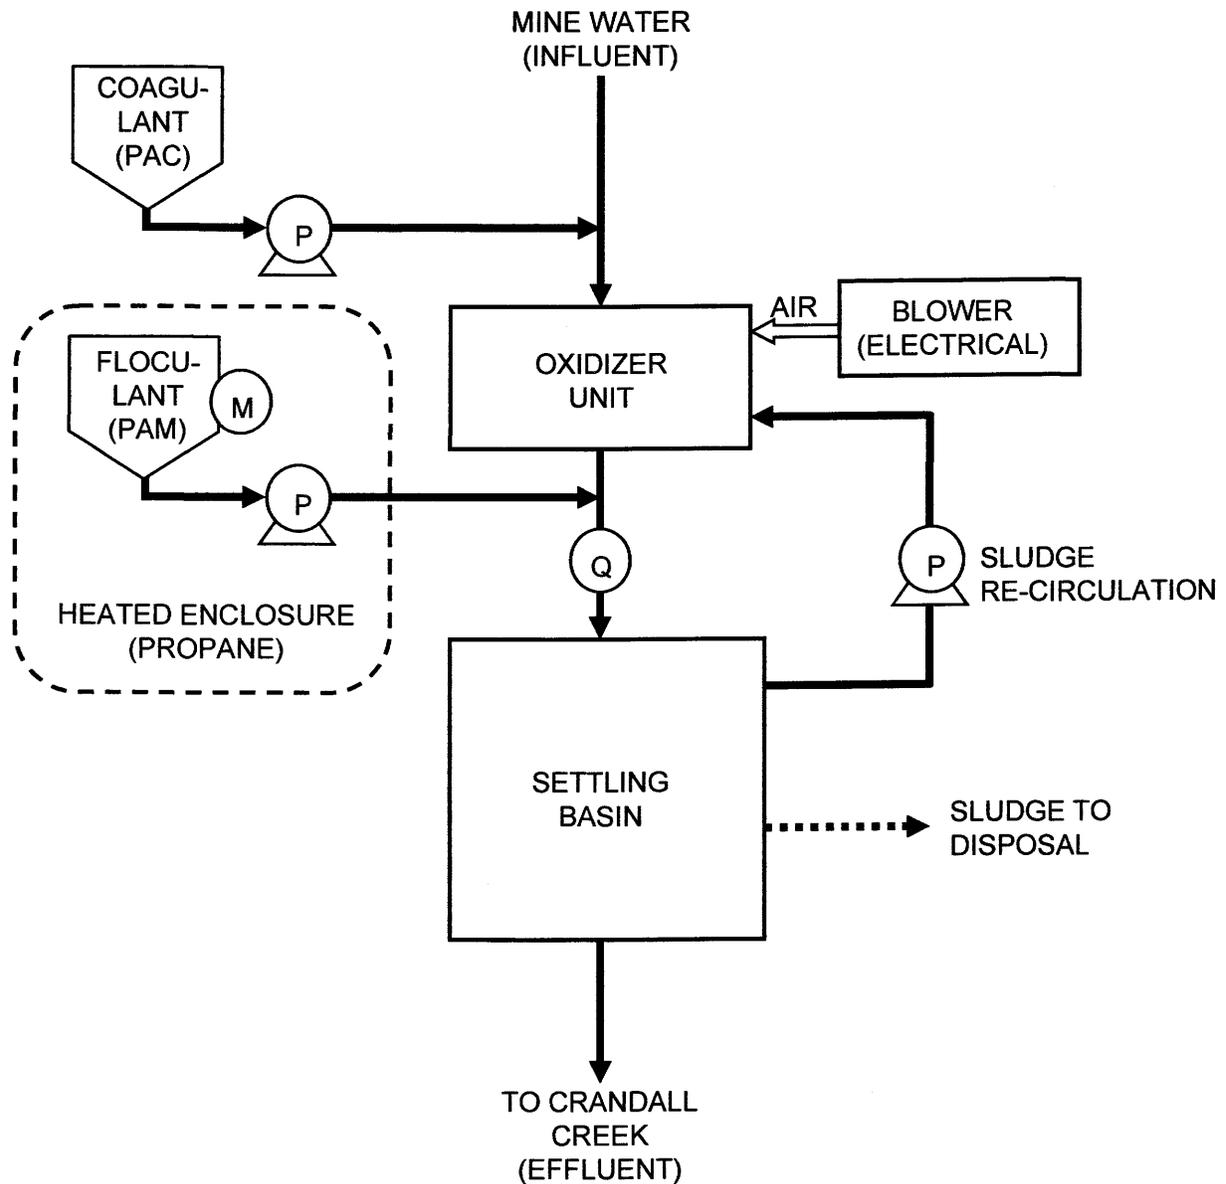
- The system requires constant monitoring by the Operator in order to prevent release of iron to Crandall Creek. The system is highly mechanized, including three pumps, a blower, a mixer and heated storage unit, all of which require maintenance and are susceptible to power outages or other utility interruptions.

- Based on the initial operation results, sludge cleanout will be required as often as monthly. The low density of the sludge results in large quantities of sludge-water slurry, which requires disposal. No disposal facility is available at the Crandall Canyon Mine. Based upon a conversation between Division personnel and an on-site contractor at the Crandall Canyon water-treatment site (Division Inspection Report #2358, May 13th, 2010), 38 vacuum trucks, ranging in size from 5,000 gallon to 6,000 gallon capacities, were filled with sludge-water slurry from the treatment system's settling basin.
