TECHNICAL MEMORANDUM

Utah Coal Regulatory Program

RE: Revised Reclamation Plan DO-10A, Genwal Resources, Inc., Crandall Canyon Mine, C/015/0032, Task #3881

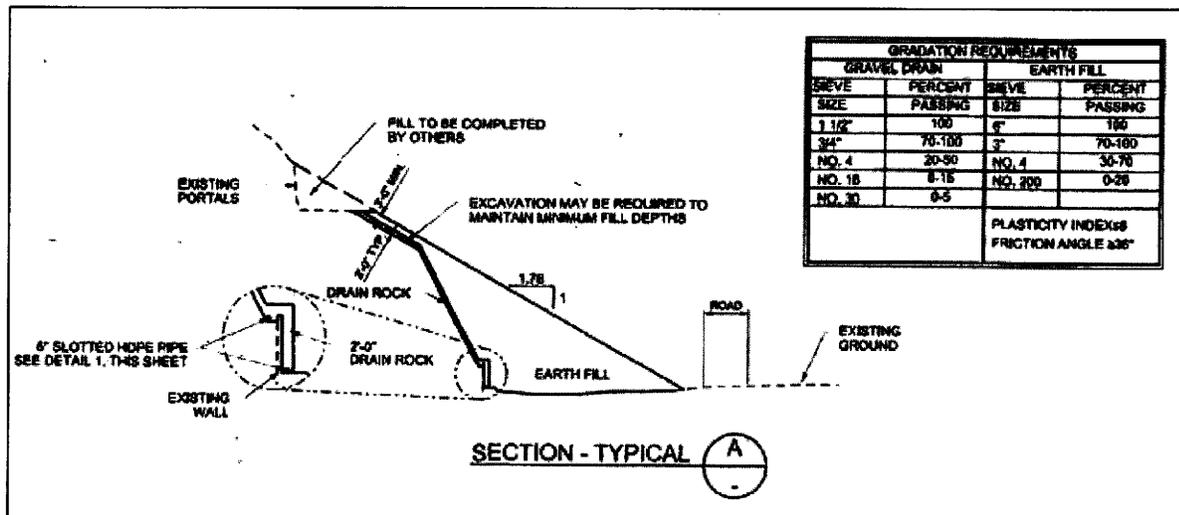
Two 6" diameter pipelines will be installed horizontally at the base of the ledge; one at the base of the existing retaining wall, and the other along the top of the retaining wall. The retaining wall is a massive reinforced concrete structure, measuring 12" thick and about 8' high in this area. This wall will be left in place at the toe of the ledge to add increased structural stability to the backfilled slope and drain system. A third perforated drain pipe will extend vertically from the horizontal drainpipes up to the location of the base of the existing (but to be removed during reclamation) crusher/ transfer building. As mentioned earlier, it is from this area from whence much of the seepage water emanates. Therefore, a vertical pipe extending up to this location will provide added assurance that the seep-water can be adequately collected and routed to discharge. This vertical pipe will connect to the upper horizontal pipe atop the retaining wall. The two horizontal collection pipes will then join together and exit from behind the backfilled area and discharge the collected seep water directly into the mine-water discharge channel MD-1 (see Item 4) near the inlet to the culvert MC-1 under the road. Figure 5-15 and Appendix 5-28 show details of the under-drain system.

reclamation backfill material. This back-drain system is described in greater detail in the geotechnical stability analysis prepared by RB&G Engineering, which was included with the application in Appendix 5-28. The back-drain would consist of a 2' thick layer of drain-rock placed against the entire height and width of the ledge, between the rock ledge and the backfill material. Historical measurements of the seep (collected at the base of the ledge at the retaining wall) show an average flow rate of 3 gpm, with a maximum flow of about 5 gpm. Engineering analysis indicates that only a couple of inches of drain-rock is needed to adequately carry this small flow, but a 24" contact layer has been specified in order to facilitate ease of placement and containment during construction as the backfill is constructed layer-by-layer from the base to the top of the ledge. In addition to the drain-rock layer the back-drain will also include a number of perforated drainpipes installed within the drain-rock layer.

The consultant states that water was observed seeping from the existing slope. In order to prevent the fill materials from becoming saturated, it was recommended that a drainage layer be installed between the existing slope and the fill. The drainage layer should consist of clean well graded gravel and should be 2 feet thick measured perpendicular to the existing slope. The drain gravel layer should have at least 3 feet of cover to protect against frost and to inhibit infiltration of surface water. Slotted collection pipes should be placed within the drainage layer at the locations indicated on the plan sheet to collect the water and carry it outside the embankment. Details of the recommended drainage system were provided in the attached plan sheets.
