**RE: Revised Probable Hydrologic Consequences Update – Genwal Resources, Inc.,
Crandall Canyon Mine, C/015/0032, Task ID #4103**

APPLICATION FOR COAL PERMIT PROCESSING

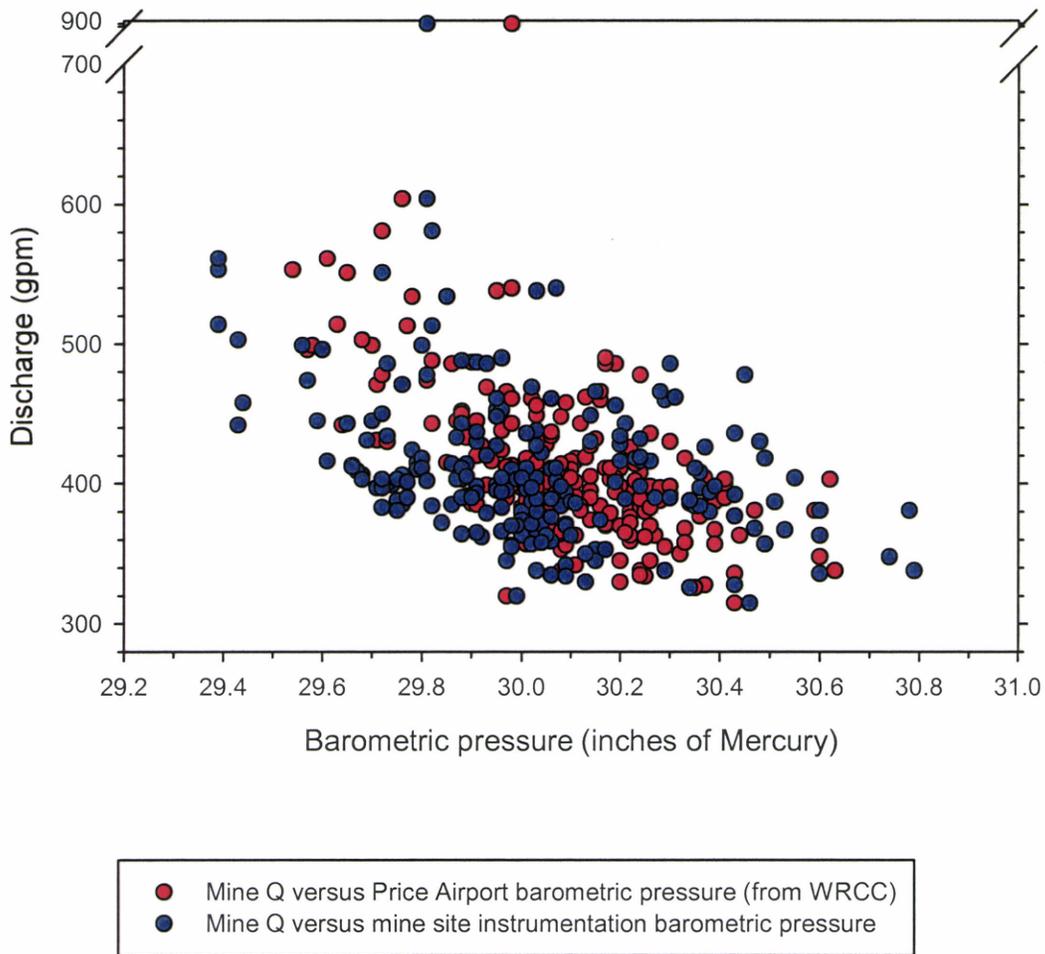
Figure PHC-7 Plot of daily discharge rate from the Crandall Canyon Mine versus barometric pressure.
