Re: Genwal Resources, Inc. C/015/032  
C17-002 Crandall Canyon Reclamation Plan

Please find attached the application to update the Reclamation Plan for the approved Crandall Canyon MRP.

# APPLICATION FOR PERMIT PROCESSING

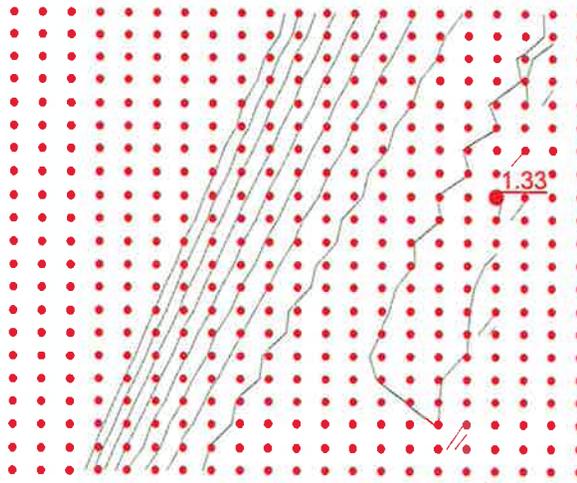
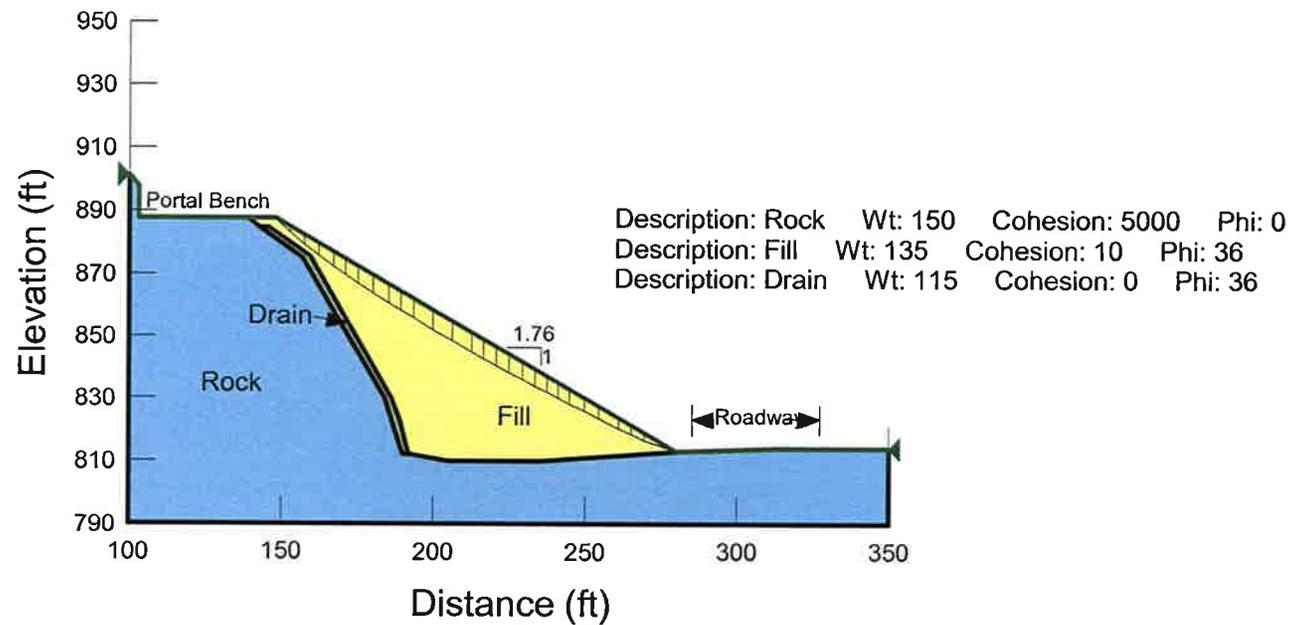
Crandall Canyon Mine Slope Stability  
Static Conditions

***Slope Stability Analyses and Design Recommendations***

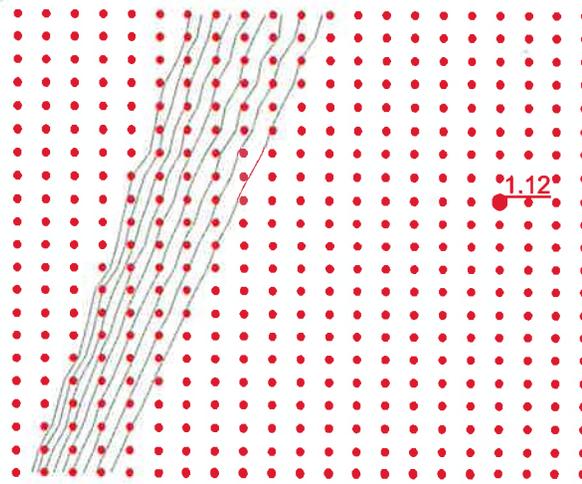
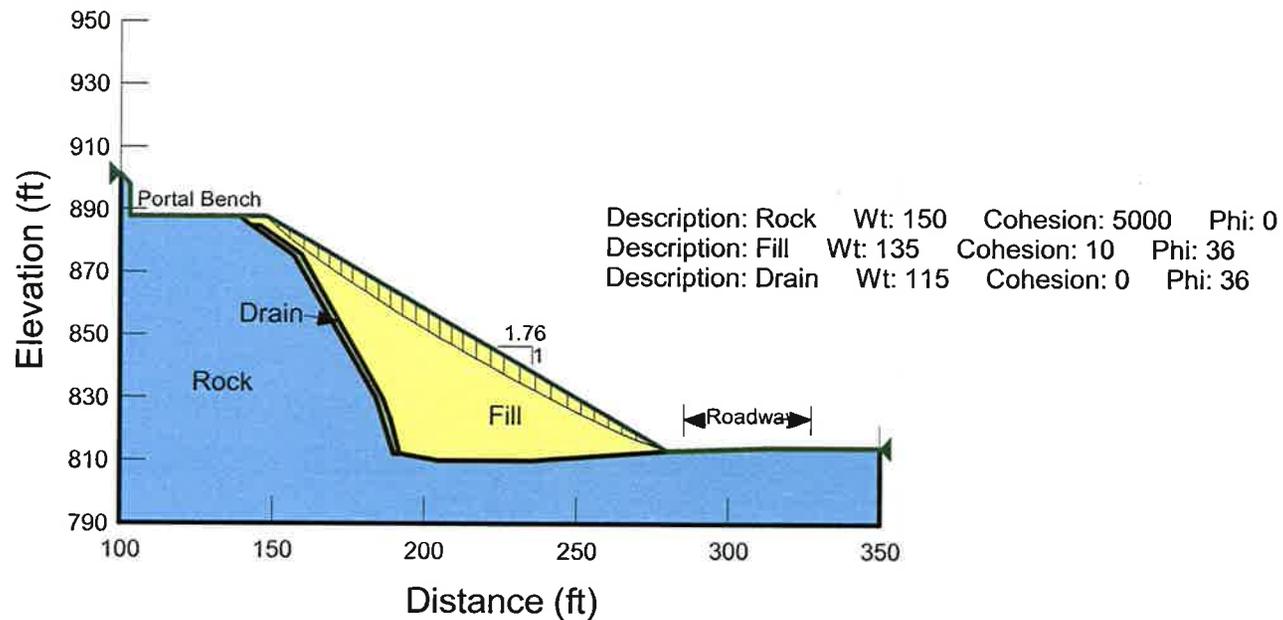
Crandall Canyon Mine Slope Stability  
 Seismic Condtion  
 Pseudo-static Coefficient = 0.08g

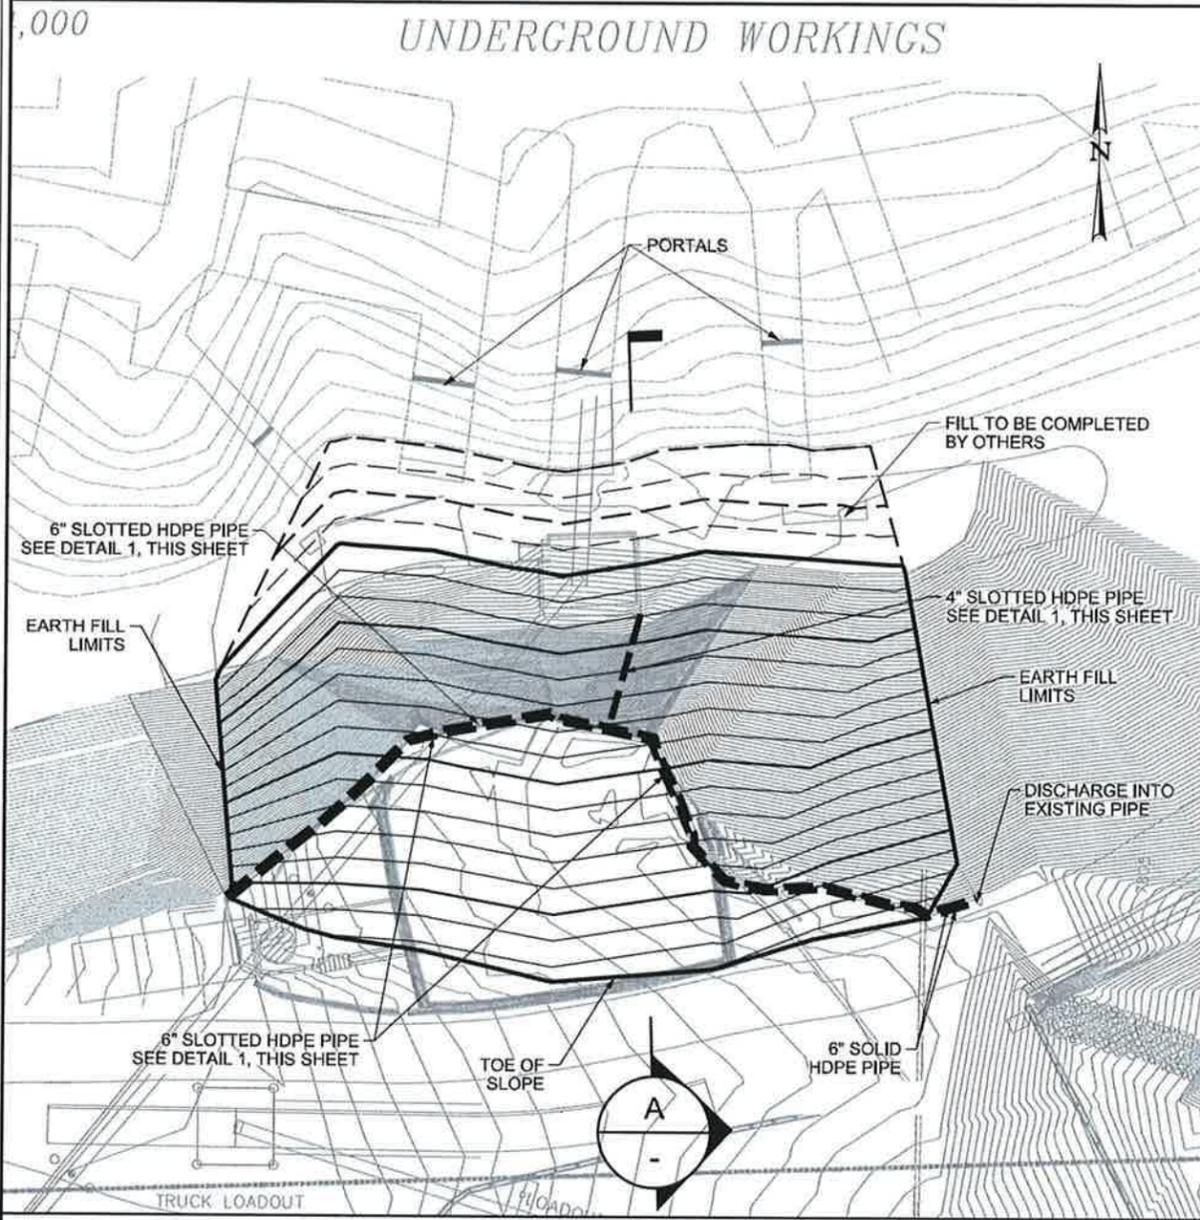
**SITE PLAN OPTION 1**

GRADATION REQUIREMENTS			
GRAVEL DRAIN		EARTH FILL	
SIEVE SIZE	PERCENT PASSING	SIEVE SIZE	PERCENT PASSING
1 1/2"	100	6"	100
3/4"	70-100	3"	70-100
NO. 4	20-50	NO. 4	30-70
NO. 16	0-15	NO. 200	0-20
NO. 30	0-5		
PLASTICITY INDEX ≤ 6 FRICTION ANGLE ≥ 36°

The soils used to construct the embankment should meet the gradation requirements and Atterberg limits shown on the attached plan sheet. The soils should be moisture conditioned to within 2 percent of the optimum moisture content and then spread in loose lifts not exceeding 12 inches thick. Each lift should be compacted to at least 95 percent of the maximum dry density. Optimum moisture content and dry density should be determined by the standard Proctor test (ASTM D 698). One to two density tests should be performed for each lift of fill to verify field compaction. If lifts are compacted with a smooth drum roller or otherwise become smooth or dry, the top 2 inches of the lifts should be scarified prior to placing the subsequent lift.

Gravel drain material used to construct the drainage system should be compacted. In order to compact against the existing slope, hand operated compaction equipment such as jumping jacks and/or walk behind rollers will likely be necessary. We recommend that gravel drain material to be compacted with hand equipment be placed in lifts not exceeding 8 inches in thickness. Each lift should be compacted with a minimum of 4 passes of the compaction equipment.

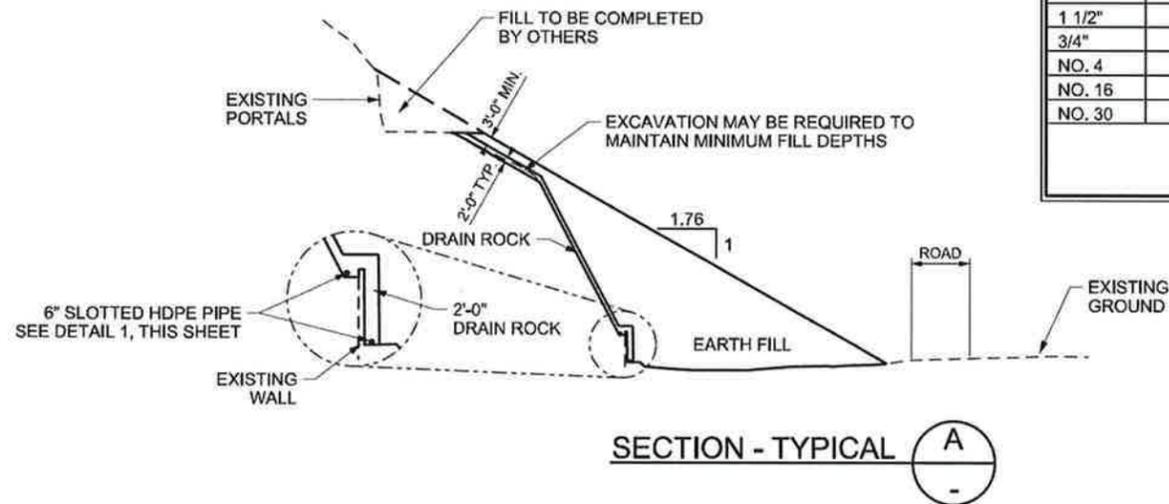
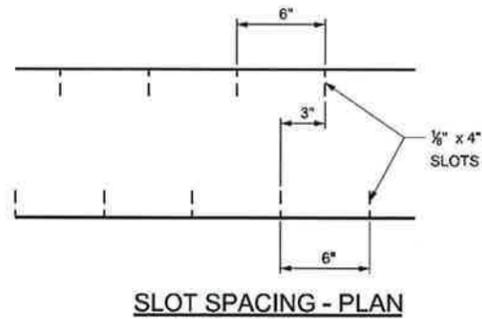
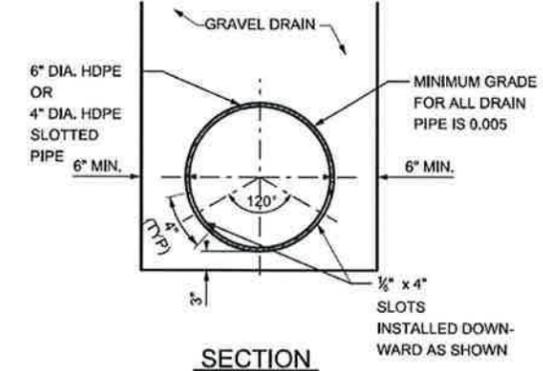
SLOTTED PIPE	1
DRAIN DETAIL	-

**6" HDPE OR 4" HDPE SLOTTED PIPE**

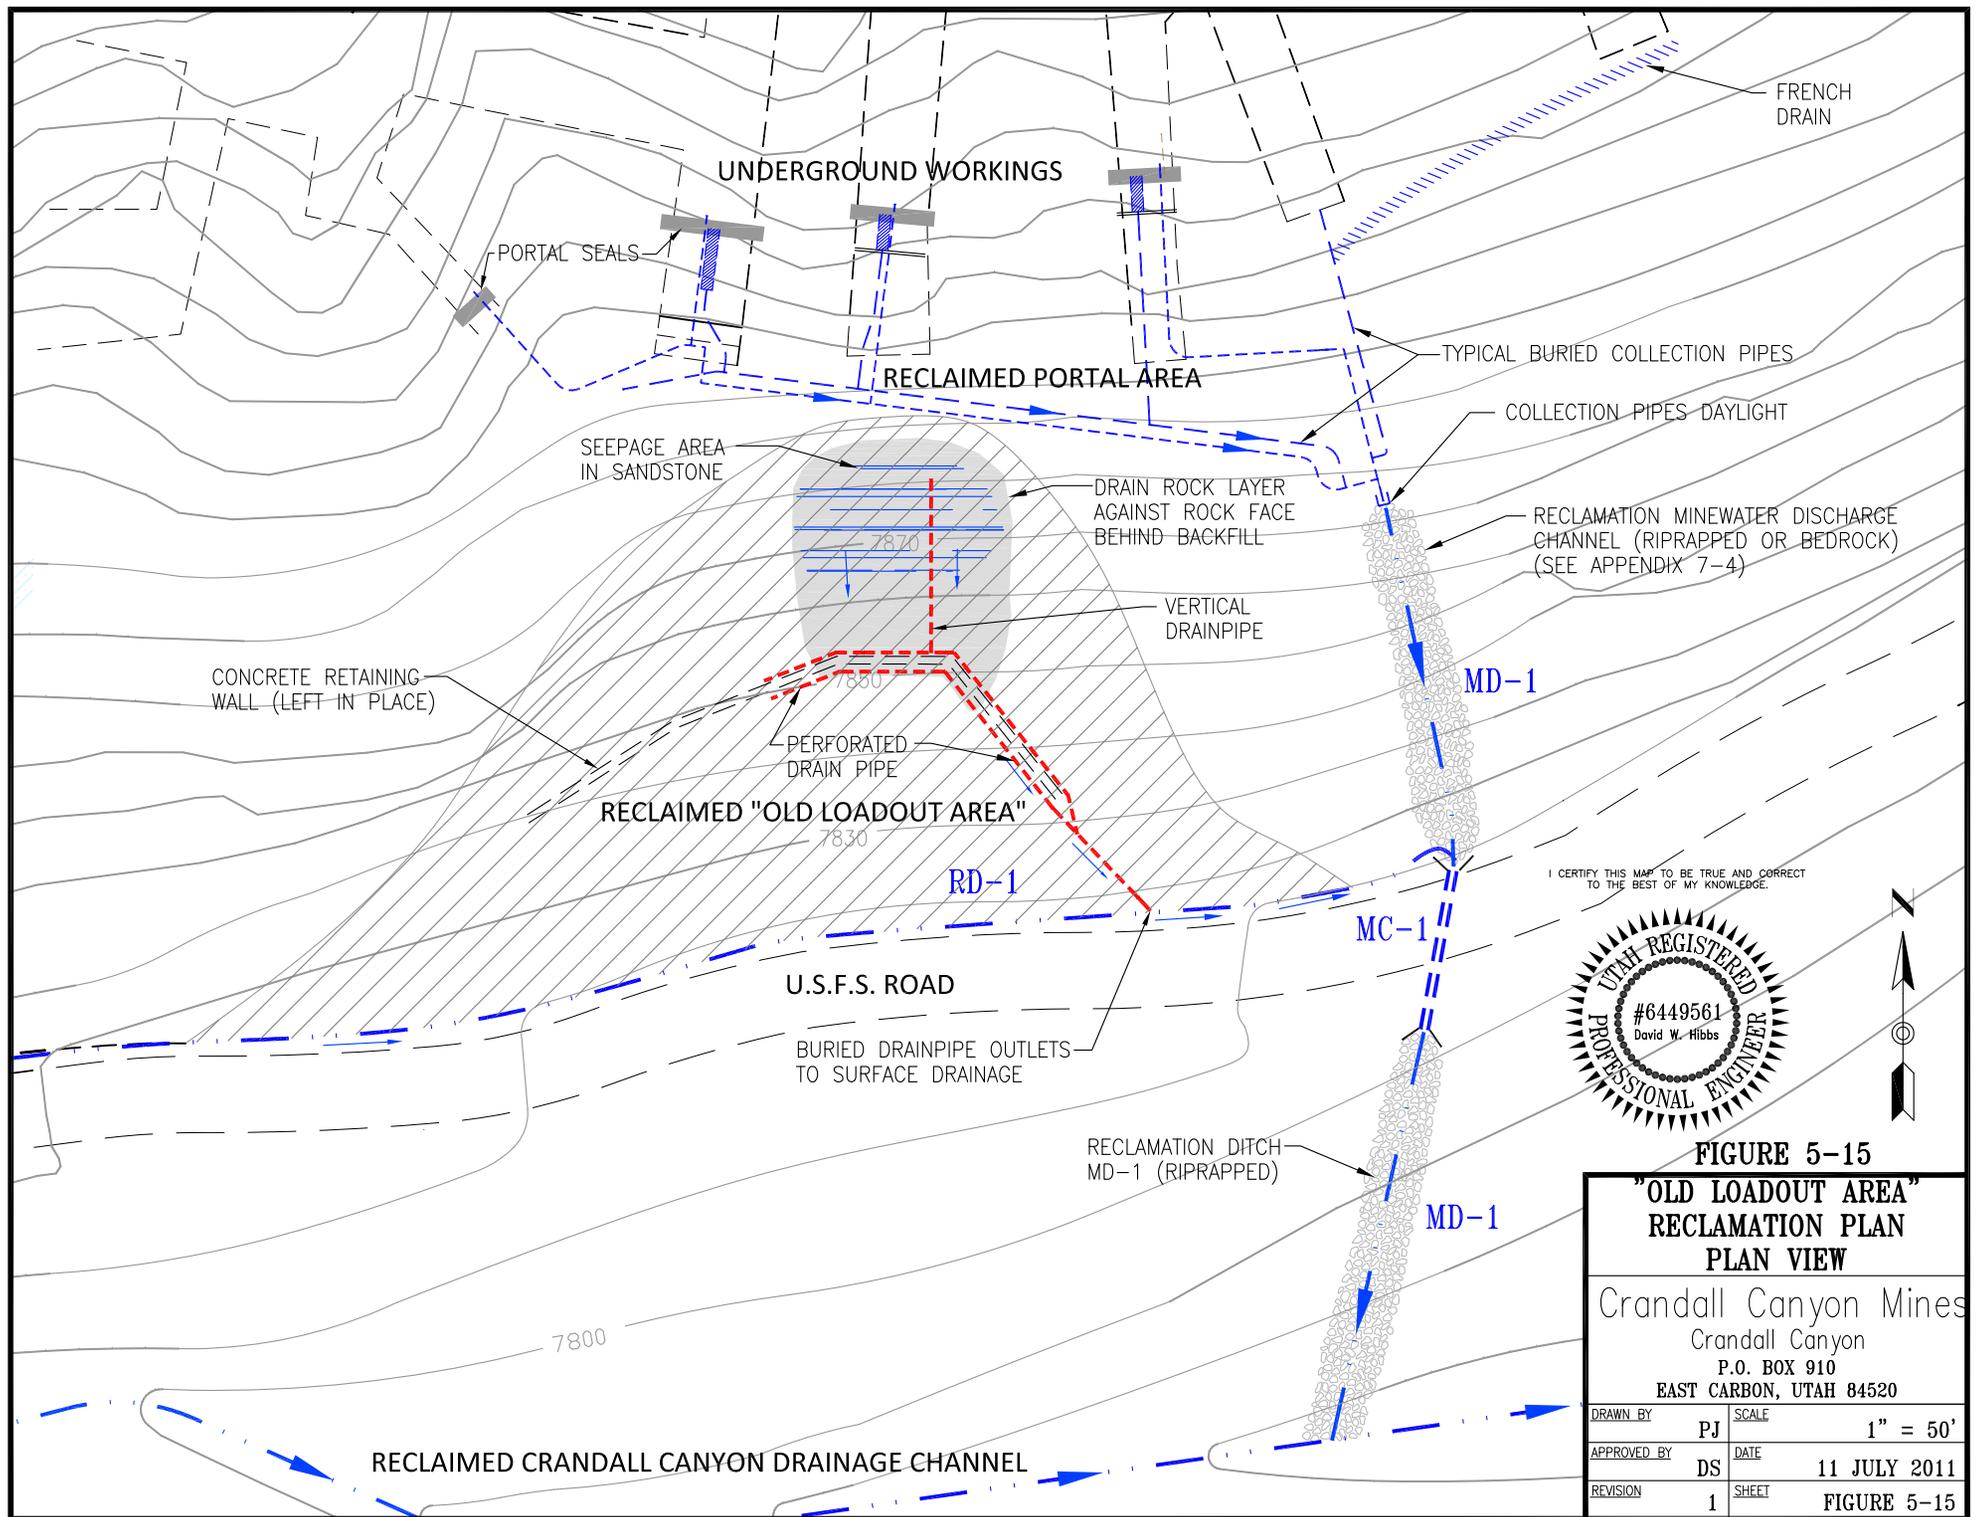
**FIGURE 5-15**

**"OLD LOADOUT AREA"  
RECLAMATION PLAN  
PLAN VIEW**

3) Upon final reclamation, the sandstone ledge below the portals (a.k.a. Old Loadout Area) will be backfilled to a slope of 2 horizontal units to 1 vertical contour as described in Item 13 below. As explained above, due to the porous nature of this sandstone, it is now conveying a small but constant amount of mine water (approx.3 gpm) from behind the seals to the ledge outcrop below the portals. The seepage conduit appears to be localized and can easily be contained during final reclamation. This will be done by installing a drain system between the ledge-rock and the back-filled slope which will collect the seepage water into a single discharge pipe. This will then be directed so that all discharge enters into the Crandall Creek. The details of this backdrain collection system are explained in greater detail in Item 13 (Old Loadout Area) below, as well as Figure 5-15 and Appendix 5-28.

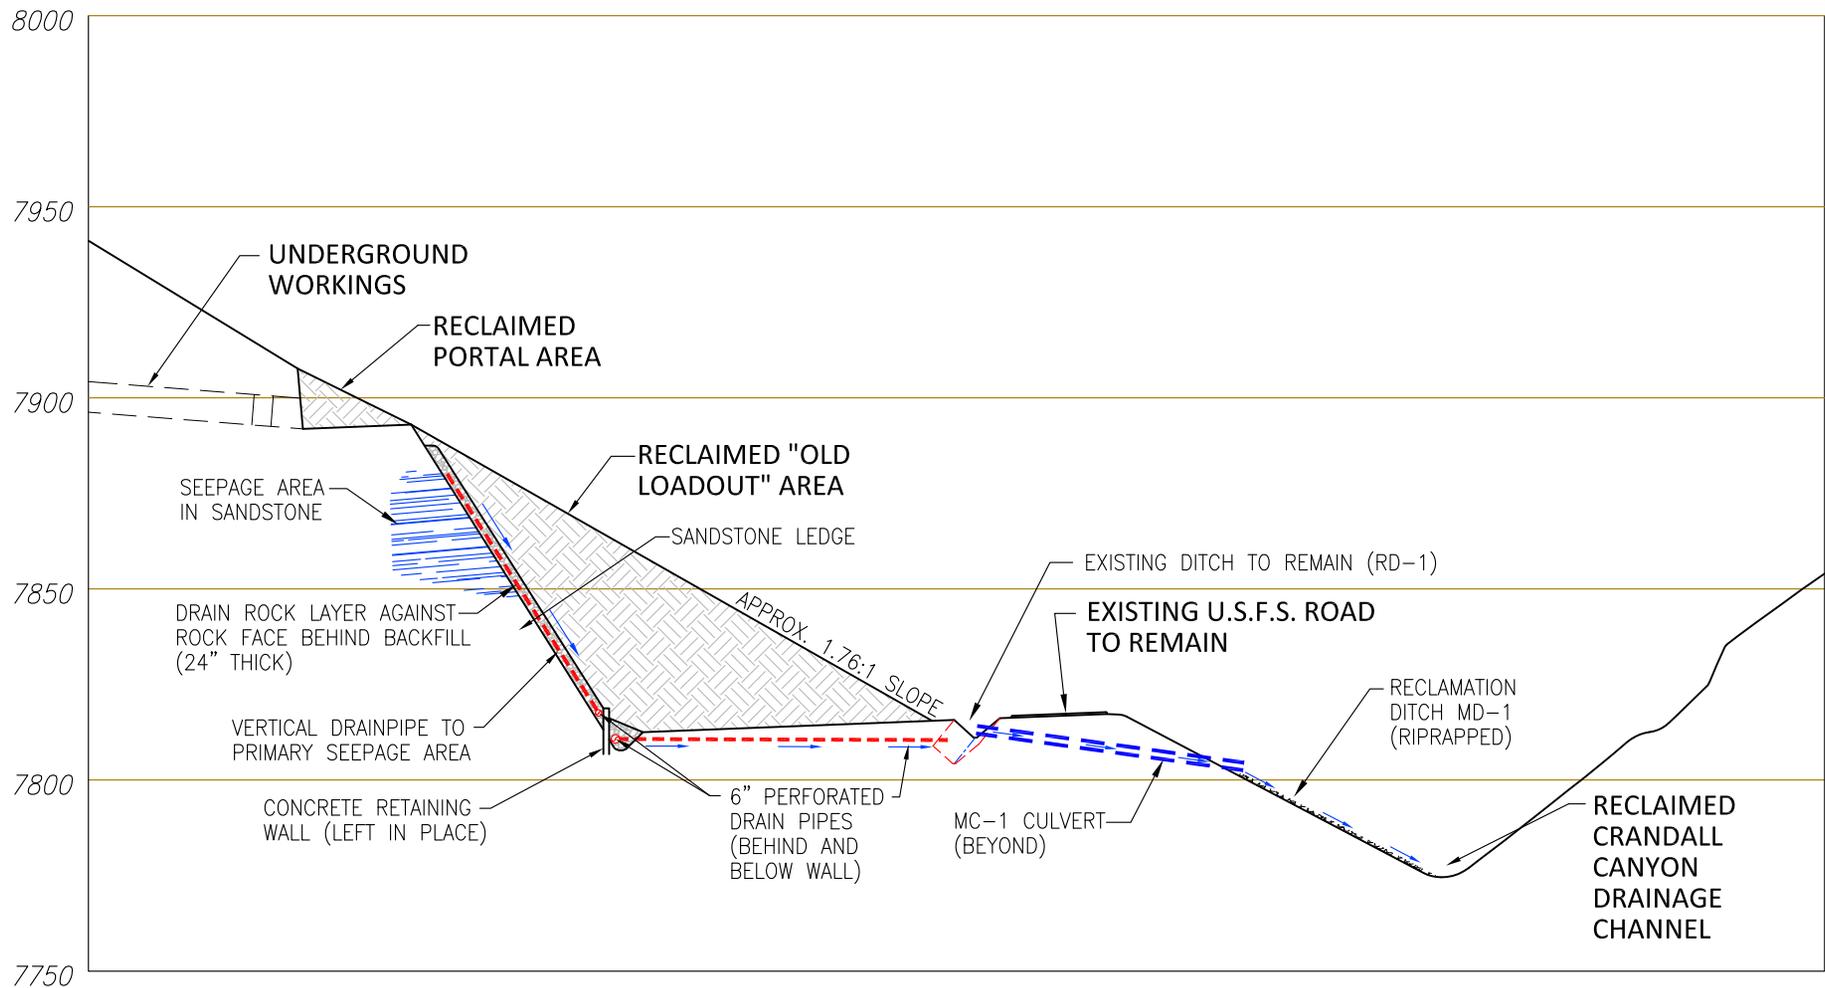
TYPICAL CROSS SECTION VIEW - LOOKING DOWNCANYON

<b>"OLD LOADOUT AREA"</b>	
<b>RECLAMATION PLAN</b>	
<b>TYP. CROSS SECTION VIEW</b>	
Crandall Canyon Mines	
Crandall Canyon	
P.O. BOX 910	
EAST CARBON, UTAH 84520	
DRAWN BY	PJ
APPROVED BY	DS
REVISION	1
SCALE	1" = 50'
DATE	11 JULY 2011
SHEET	FIGURE 5-15(a)

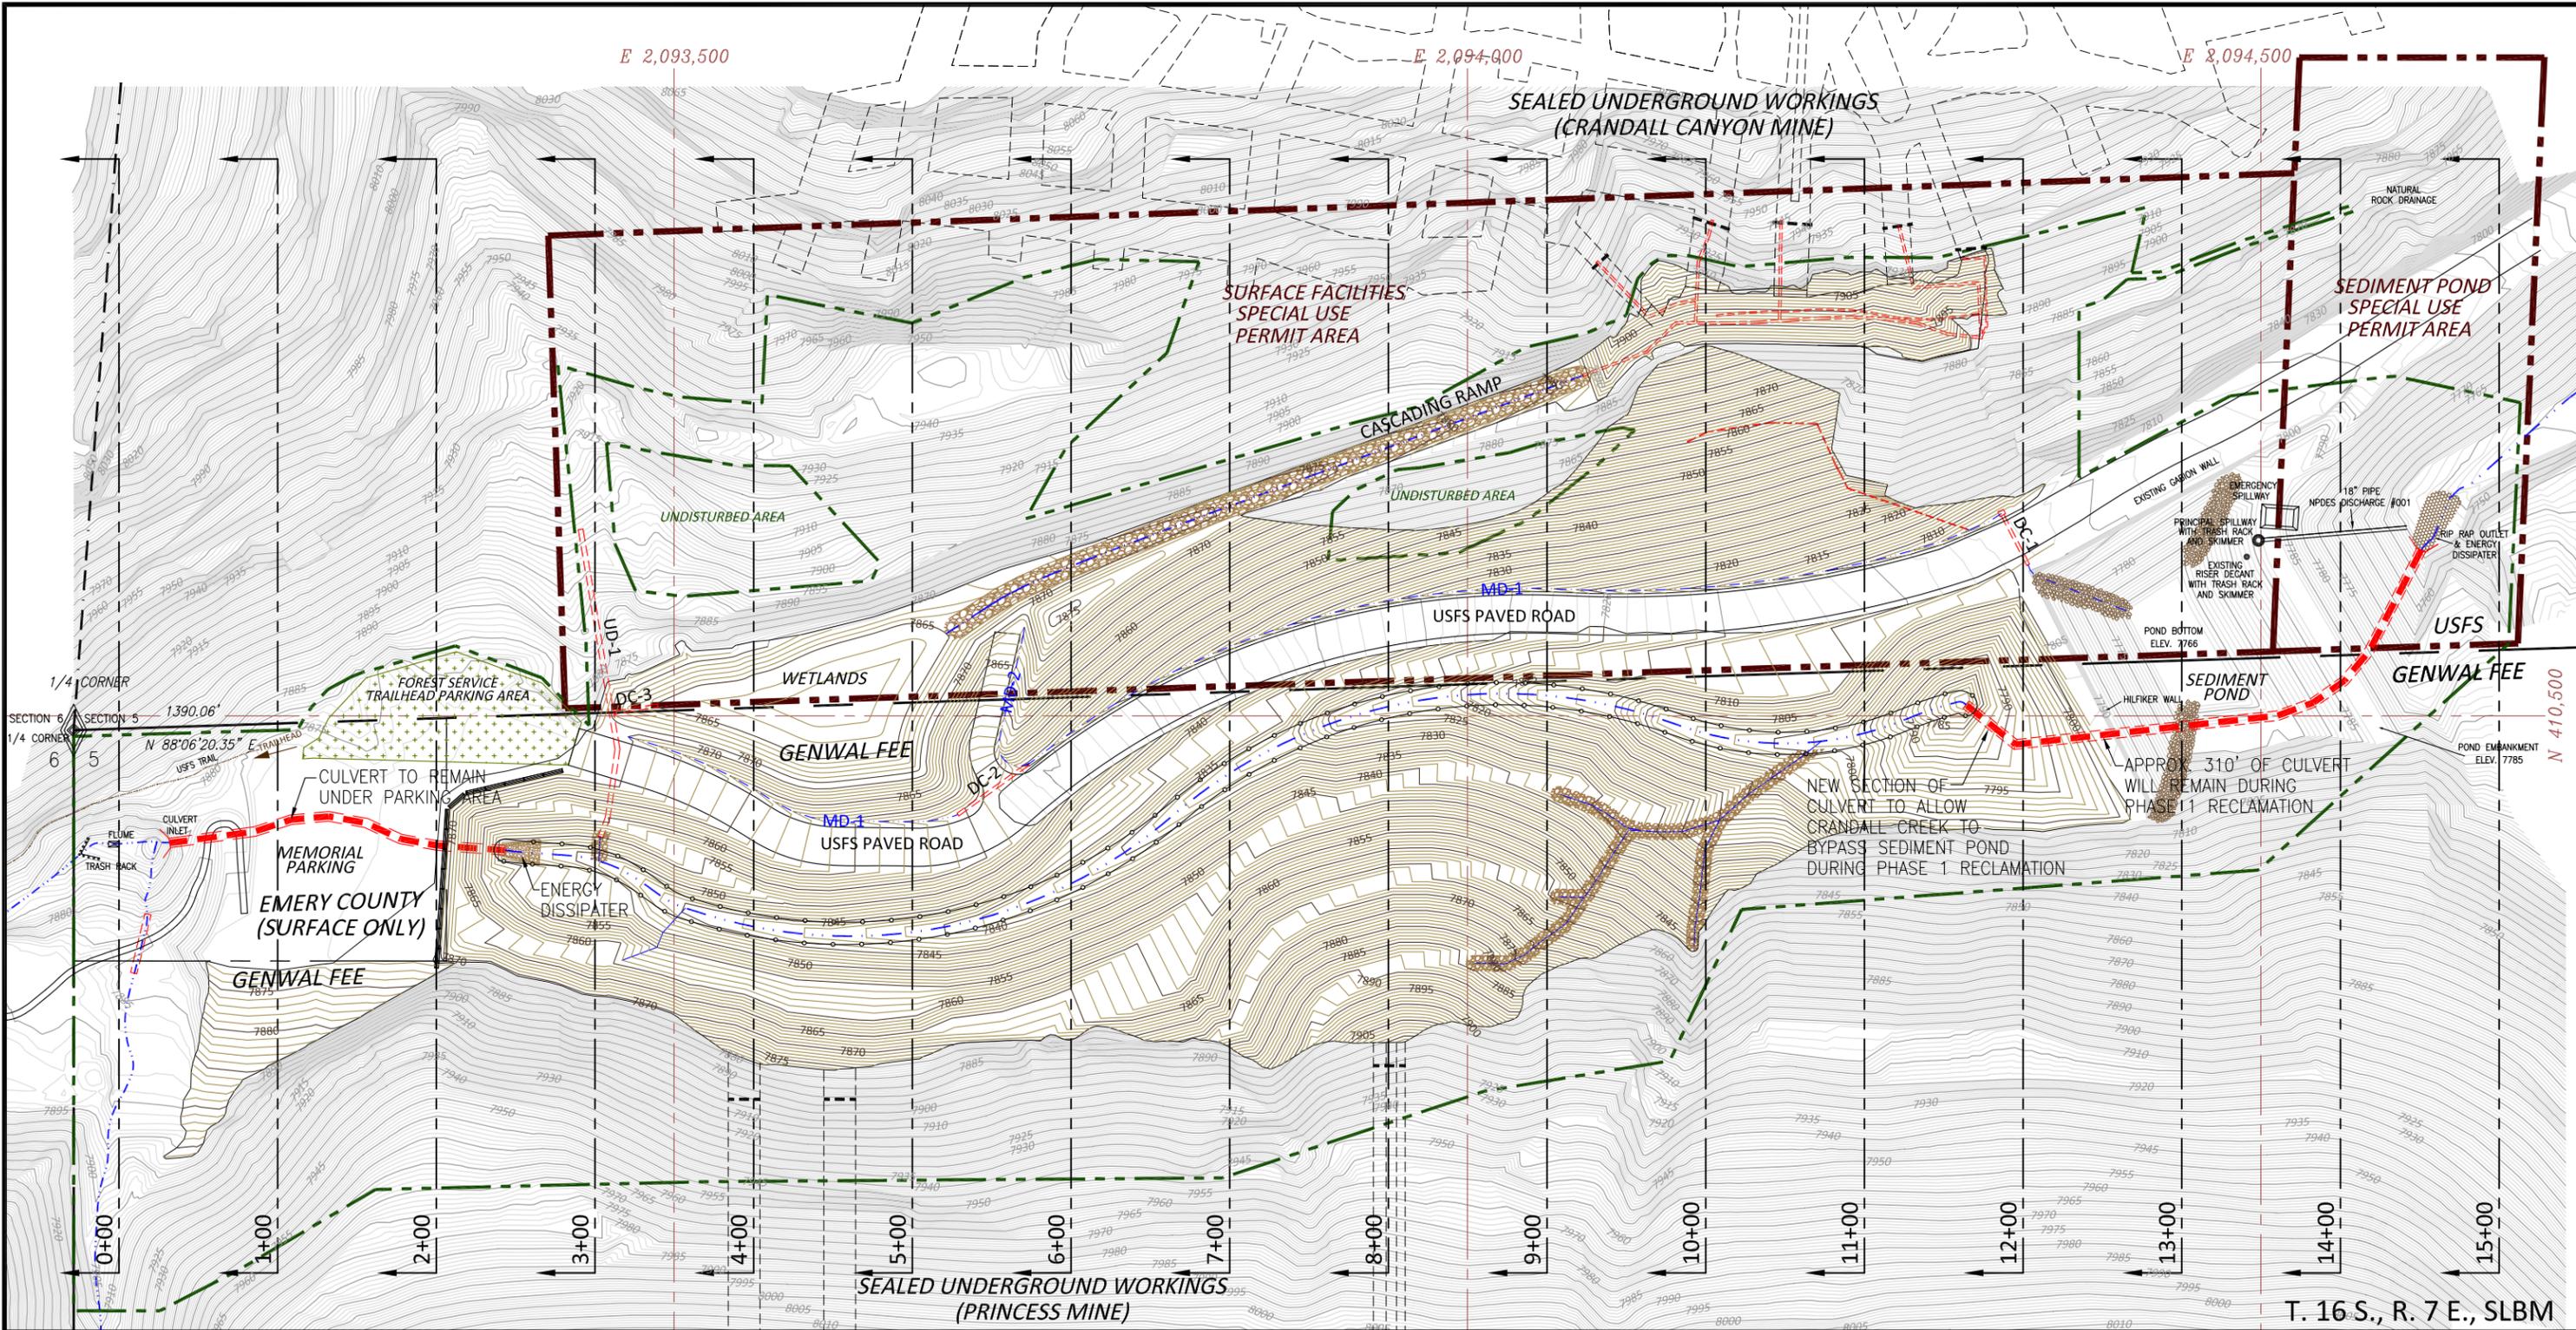
G:\Current Drawings\MRP Maps\Crandall Canyon\Reclamation Plan Update\Plate 5-16 - Reclamation Plan Update\Plate 5-16 - Reclamation Contours Phase 1, 3/13/2017 10:04:23 AM, 1:1

- SEDIMENT POND TO REMAIN IN-PLACE DURING PHASE 1 RECLAMATION.
- MAXIMUM SLOPE ON ALL RECLAIMED SLOPES TO BE 2 HORIZONTAL TO 1 VERTICAL UNIT.
- SEE PLATES 5-17A THROUGH 5-17D FOR CROSS-SECTION PROFILES.

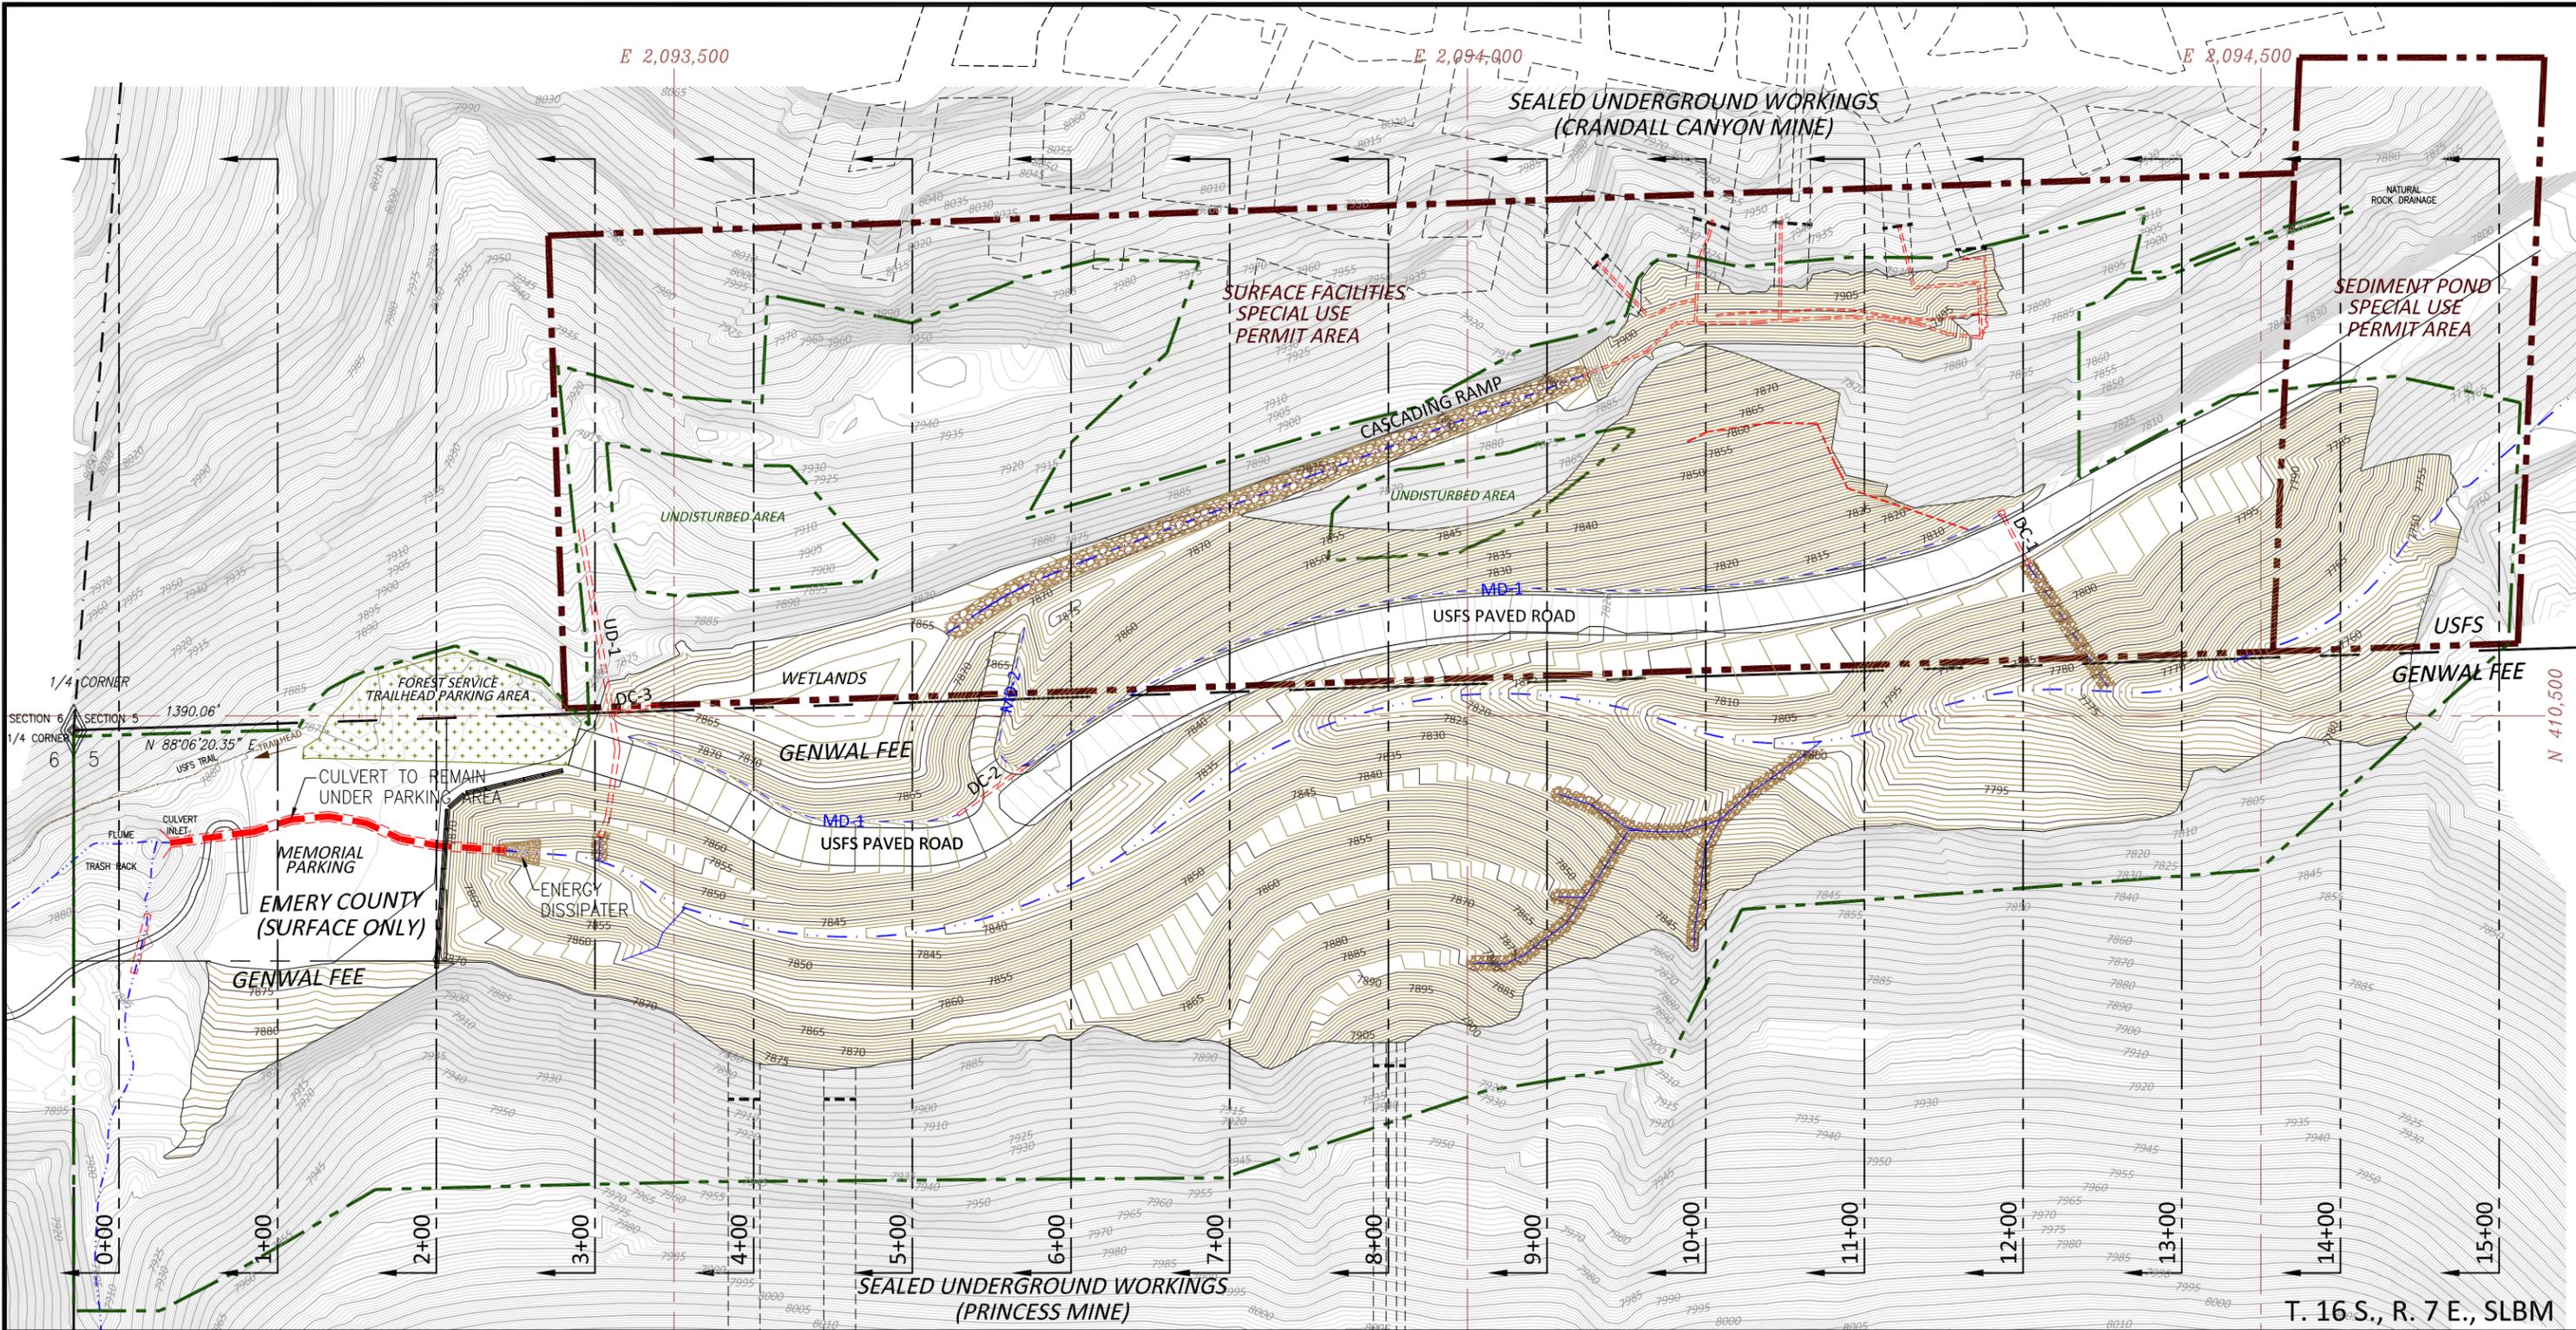
DRAWN BY	PJ	SCALE	1" = 100'
APPROVED BY	DH	DATE	13 MARCH 2017
REVISION:	1	PLATE	5-17

1. MAXIMUM SLOPE ON ALL RECLAIMED SLOPES TO BE 2 HORIZONTAL TO 1 VERTICAL UNIT.
2. SEE PLATES 5-17A THROUGH 5-17D FOR CROSS-SECTION PROFILES.

G:\Current Drawings\MRP Maps\Crandall Canyon\Reclamation Plan Update\Plate 5-17 - Reclamation Plan Phase 2.dwg, Reclaimed Contours Phase 2, 3/13/2017 10:05:44 AM, 1:1

and have a somewhat gentler slope. The entire length of the new channel will be riprap armored to prevent erosion. The new channel will intersect the original channel just below the sediment pond upon the completion of Phase 2 of this reclamation plan designed for the South Slope is based on input from reclamation specialists who have experience in steep-slope reclamation situations.(see Plate 5-17).

Due to the gentler slopes associated with this reclamation plan, the original channel for the Crandall Creek will not be restored. However, a new channel will be constructed for Crandall Creek that allows for the more stable slopes (2 horizontal to 1 vertical maximum) utilizes throughout the site. The reconstructed channel will resemble the original channel and follow its original path as closely as possible, but will be slightly higher in elevation to the original channel and have a somewhat gentler slope. The entire length of the new channel will be riprap armored to prevent erosion. The new channel will intersect the original channel just below the sediment pond upon the completion of Phase 2 of this reclamation plan (see Plate 5-17).

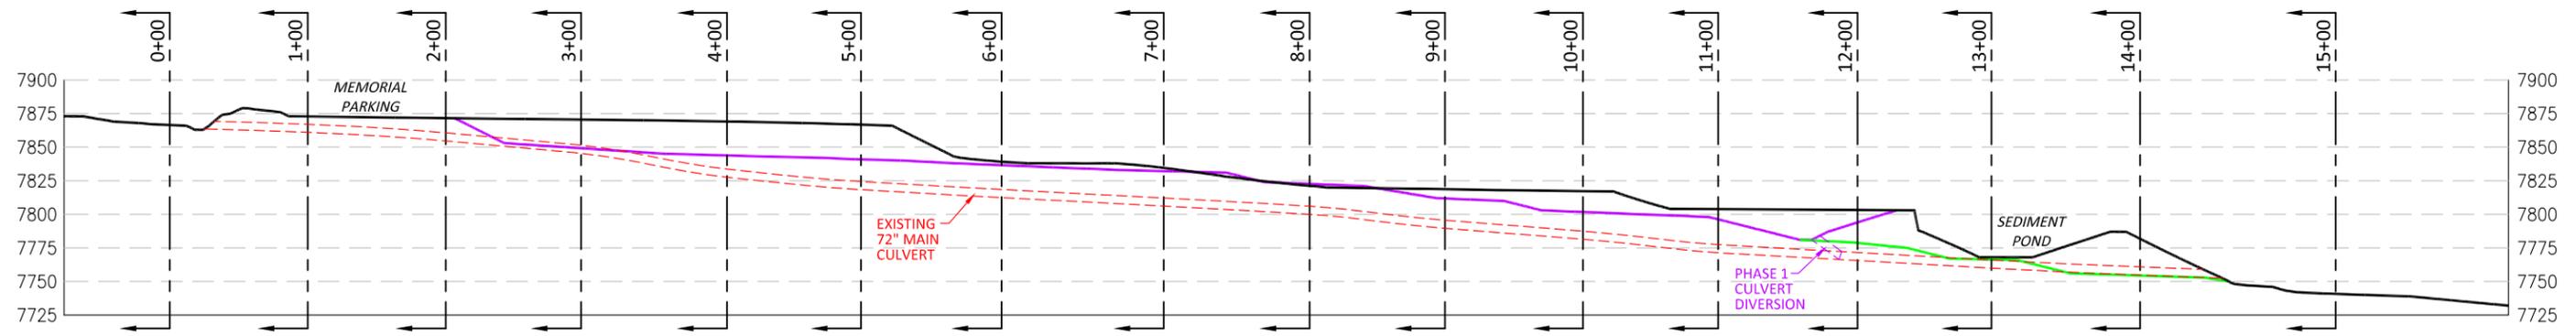
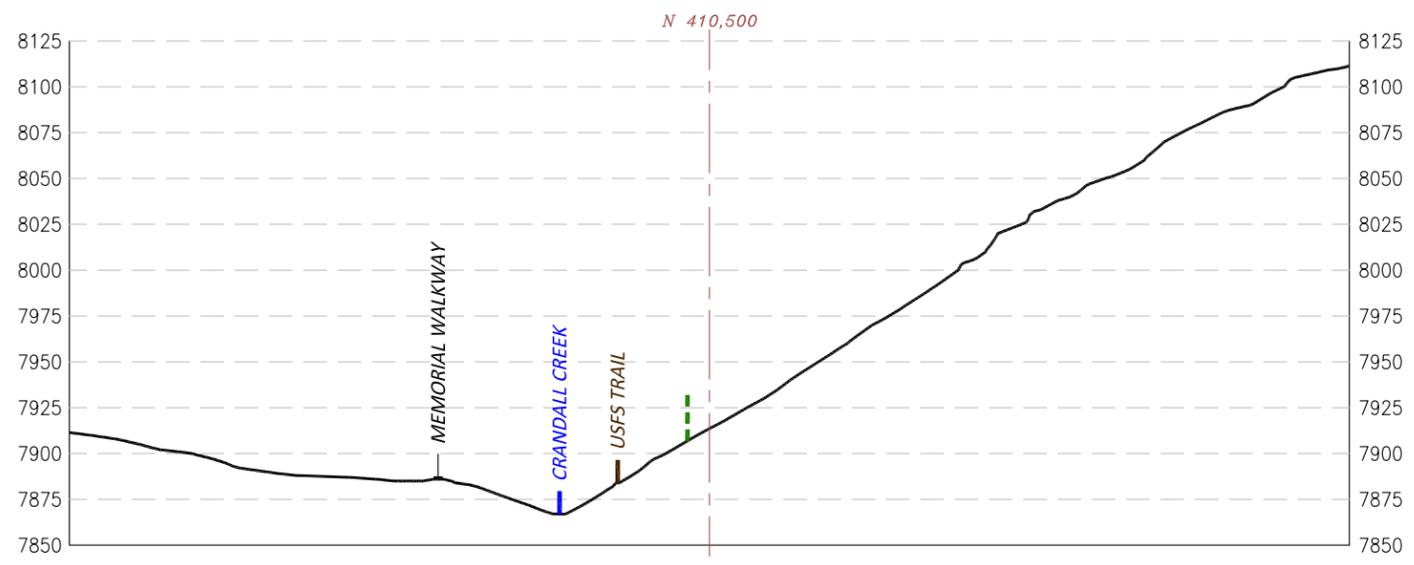
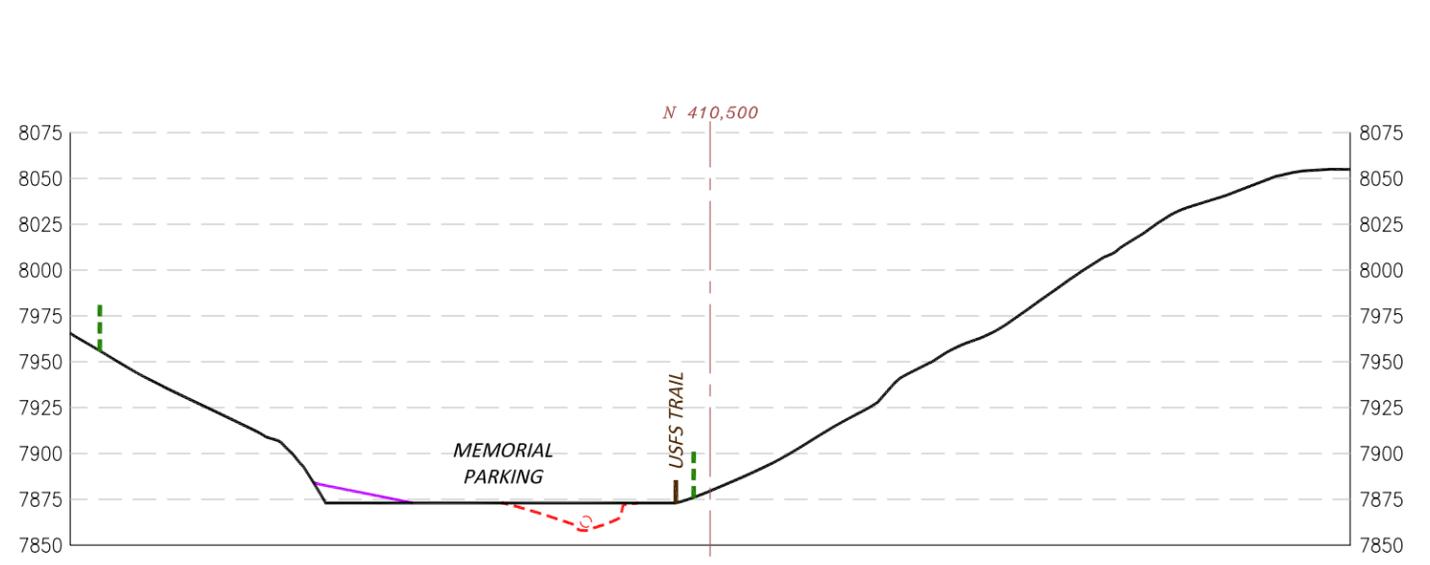
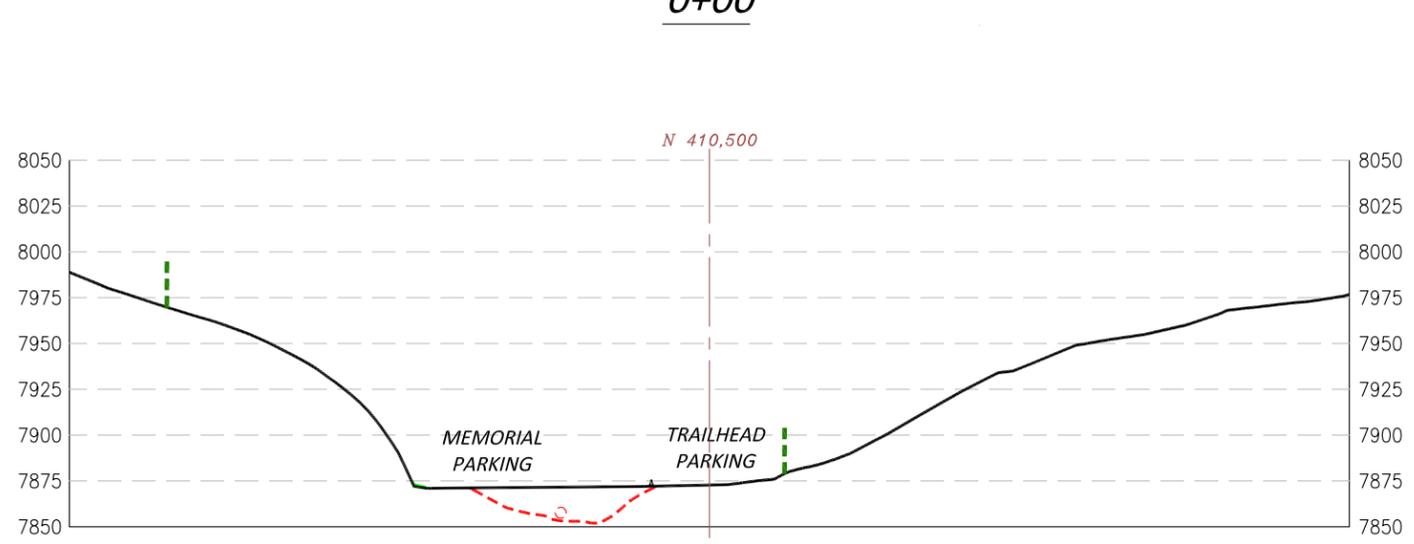
CRANDALL CREEK PROFILE
