Re: Genwal Resources, Inc. C/015/032  
C17-002 Crandall Canyon Reclamation Plan

Please find attached the application to update the Reclamation Plan for the approved Crandall Canyon MRP.

# APPLICATION FOR PERMIT PROCESSING

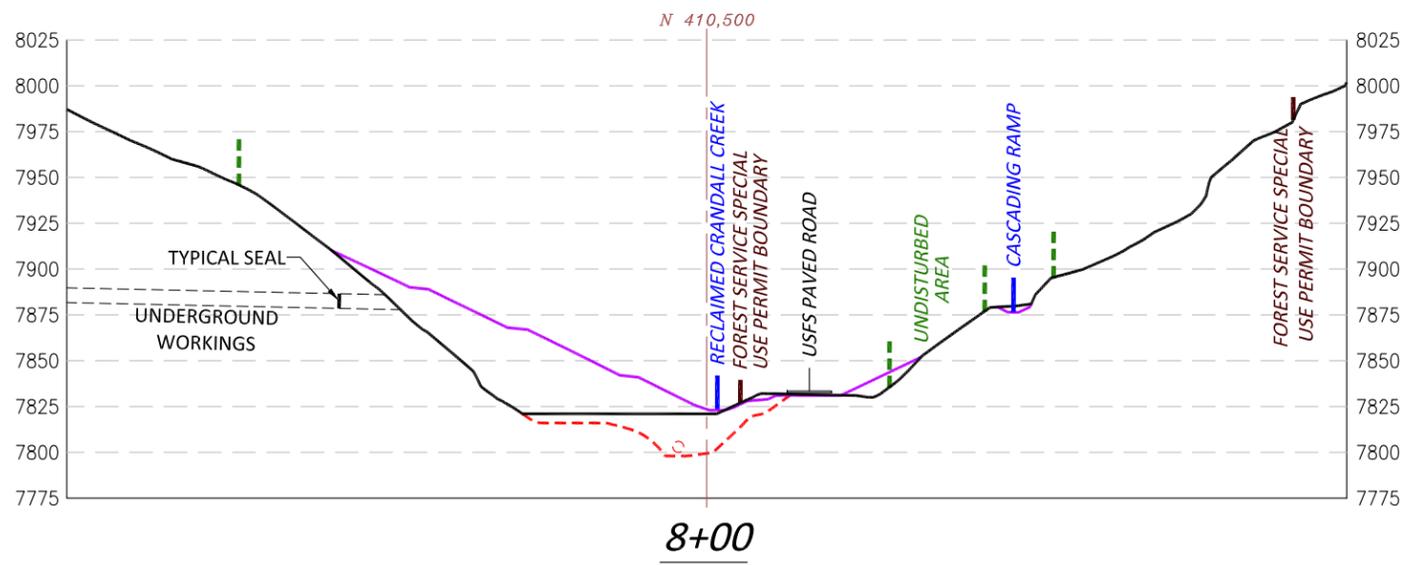
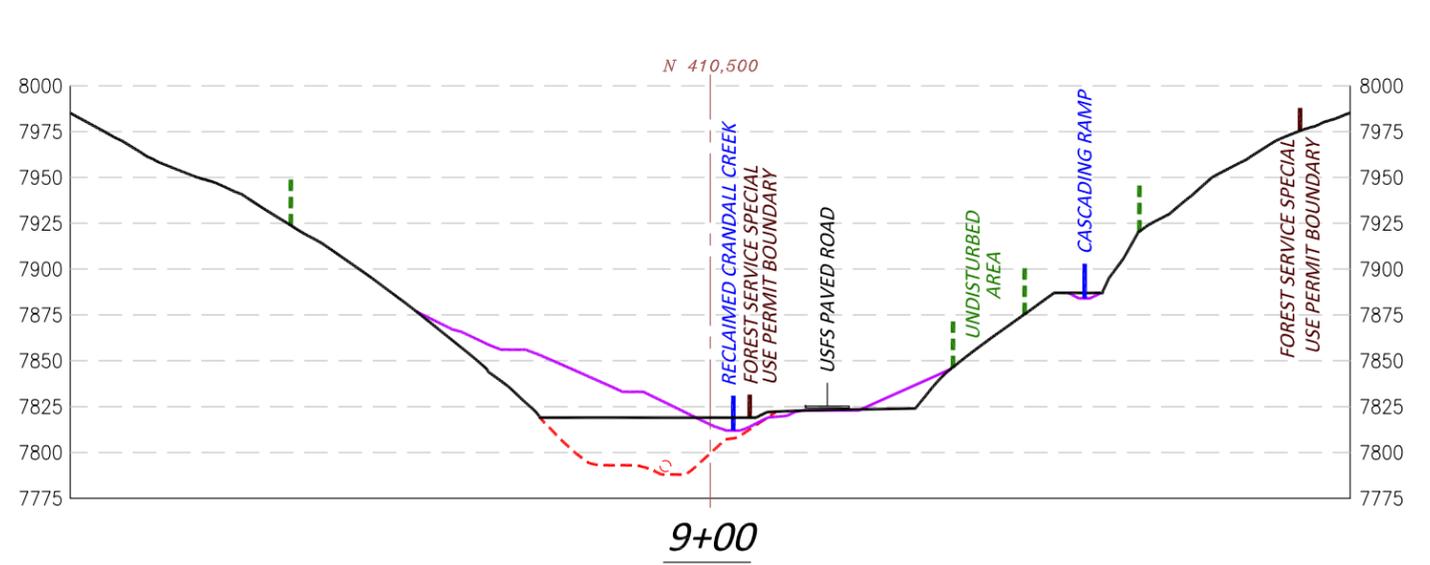
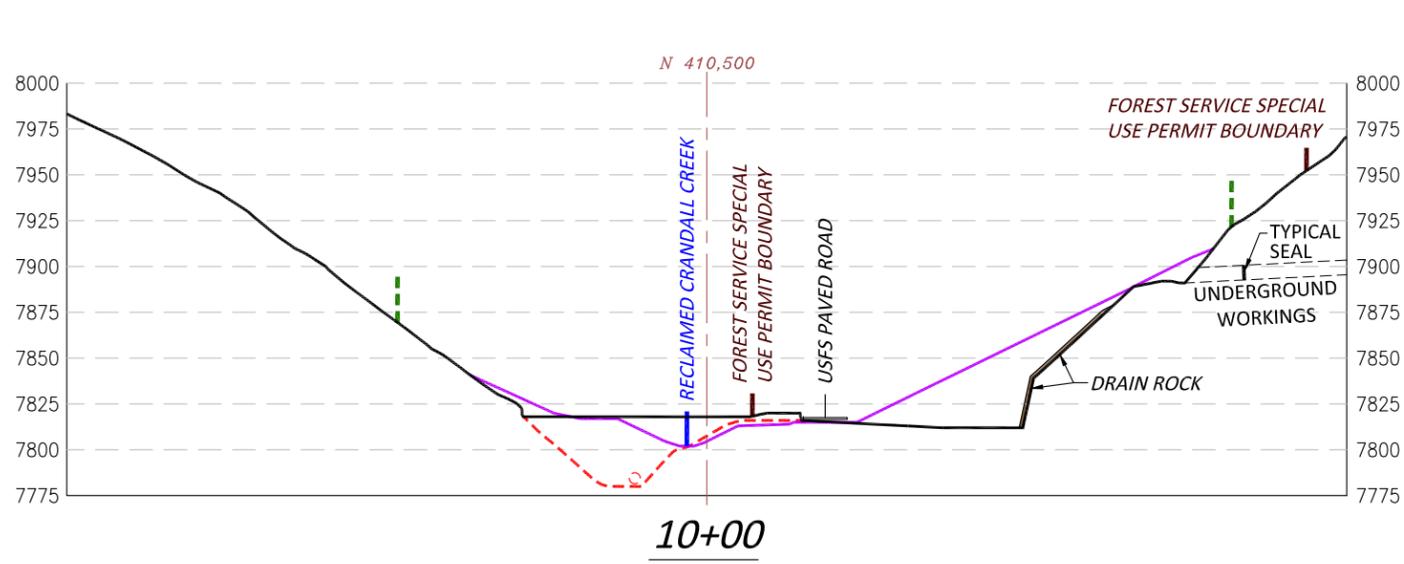
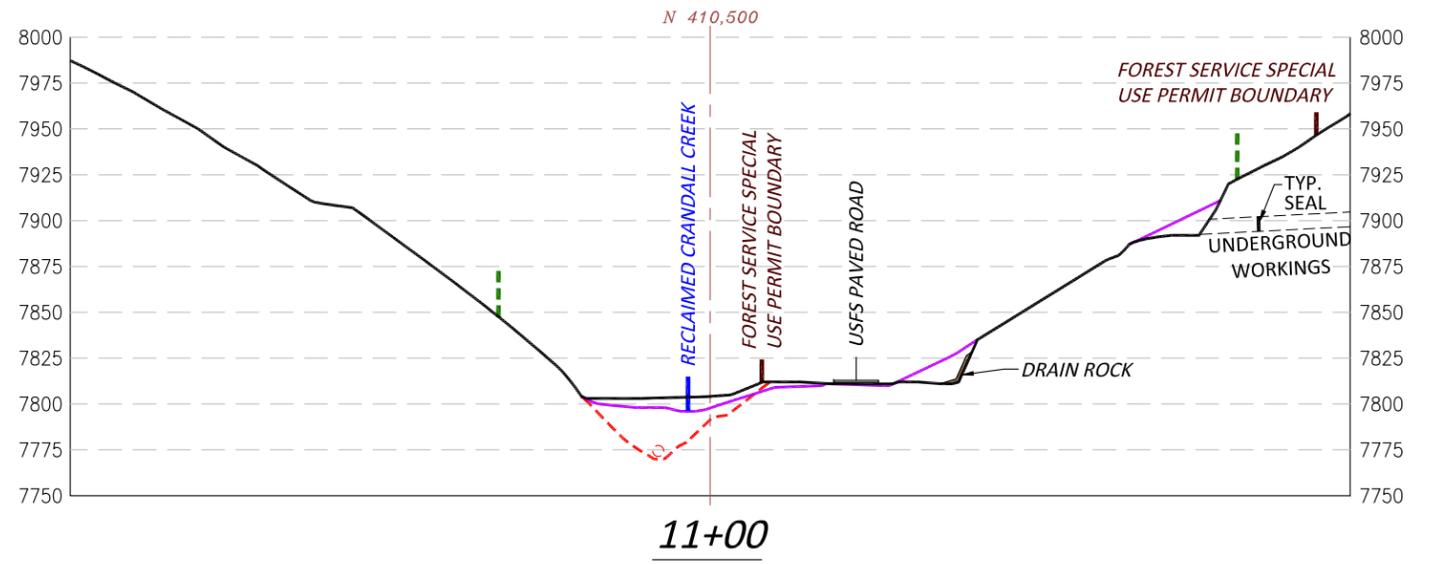
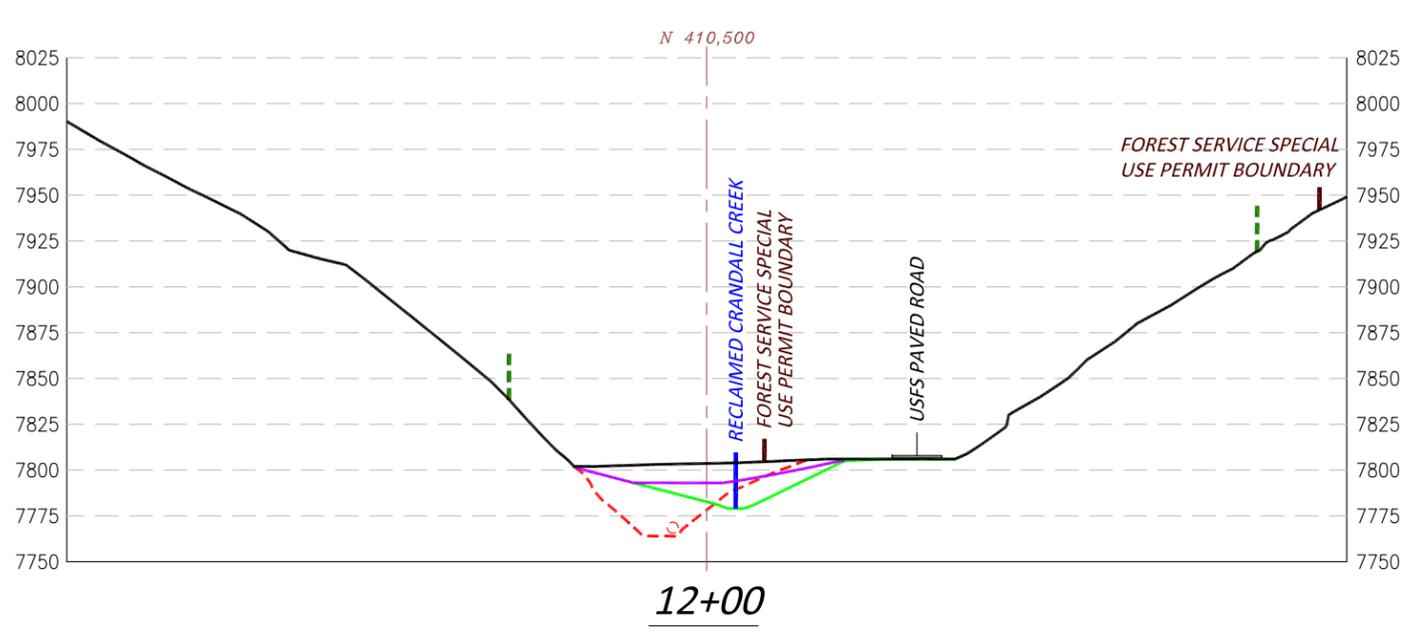
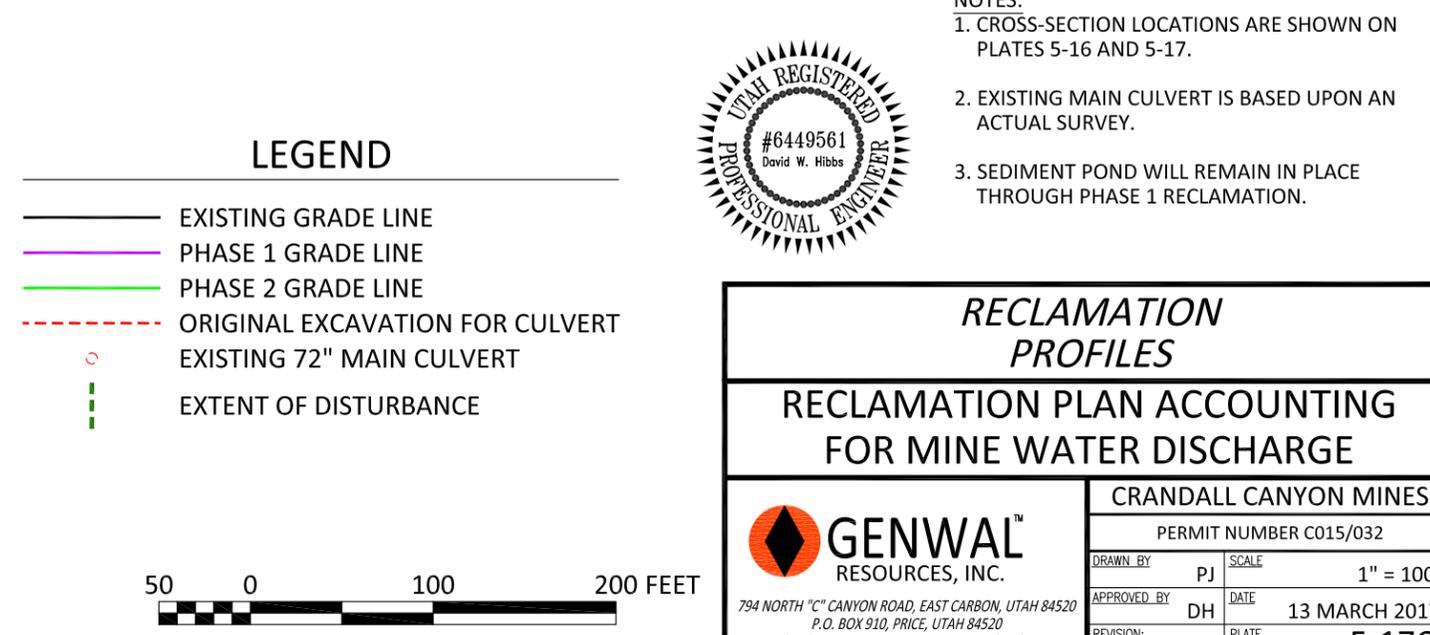
DRAWN BY	PJ	SCALE	1" = 100'
APPROVED BY	DH	DATE	13 MARCH 2017
REVISION:	1	PLATE	5-17C

- LEGEND**
- EXISTING GRADE LINE
  - PHASE 1 GRADE LINE
  - PHASE 2 GRADE LINE
  - - - ORIGINAL EXCAVATION FOR CULVERT
  - EXISTING 72" MAIN CULVERT
  - - - EXTENT OF DISTURBANCE

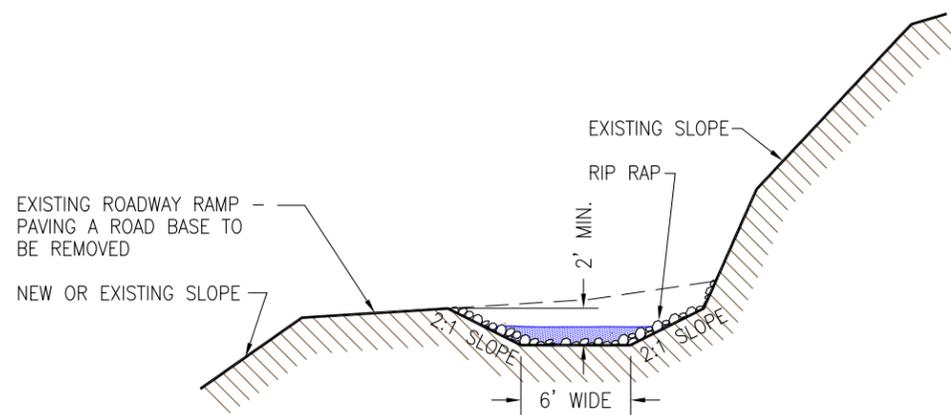
**NEW INCISED CASCADING RAMP**  
NO SCALE

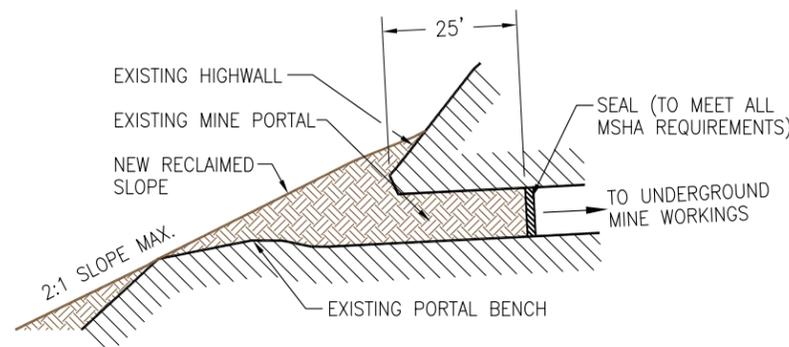
**TYPICAL RECLAIMED PORTAL**  
NO SCALE
