**Re: Crandall Canyon Draft Revised Reclamation Plan Preliminary Review**

### Crandall Canyon Mine Slope Stability Static Conditions

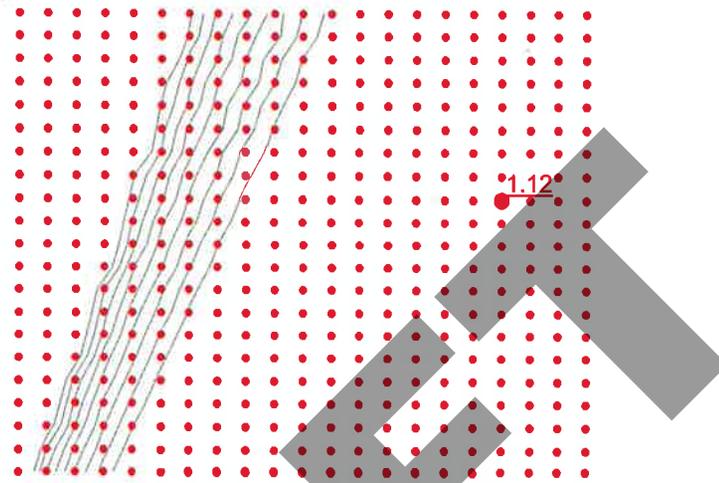
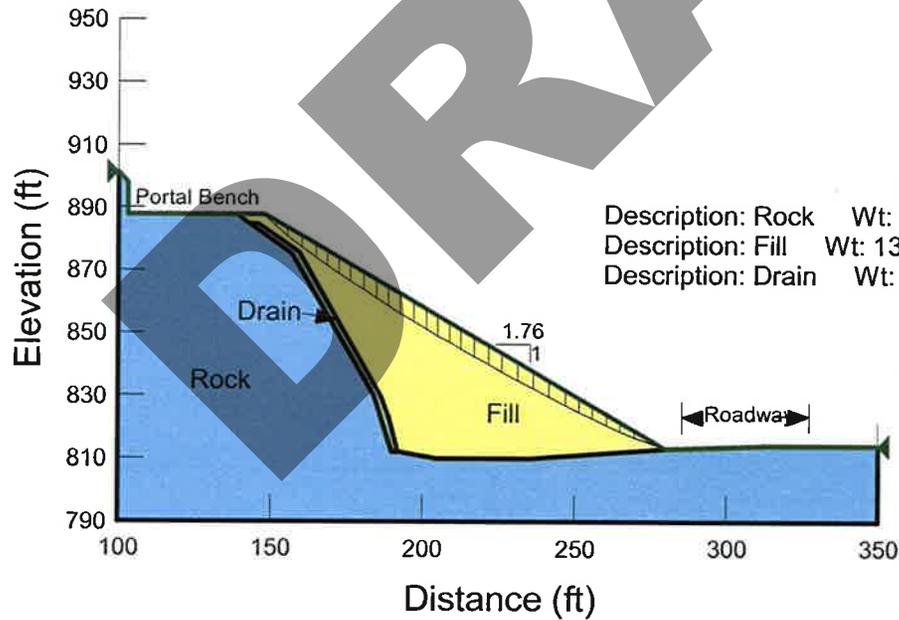
Crandall Canyon Mine Slope Stability  
 Seismic Condition  
 Pseudo-static Coefficient = 0.08g

Description: Rock	Wt: 150	Cohesion: 5000	Phi: 0
Description: Fill	Wt: 135	Cohesion: 10	Phi: 36
Description: Drain	Wt: 115	Cohesion: 0	Phi: 36

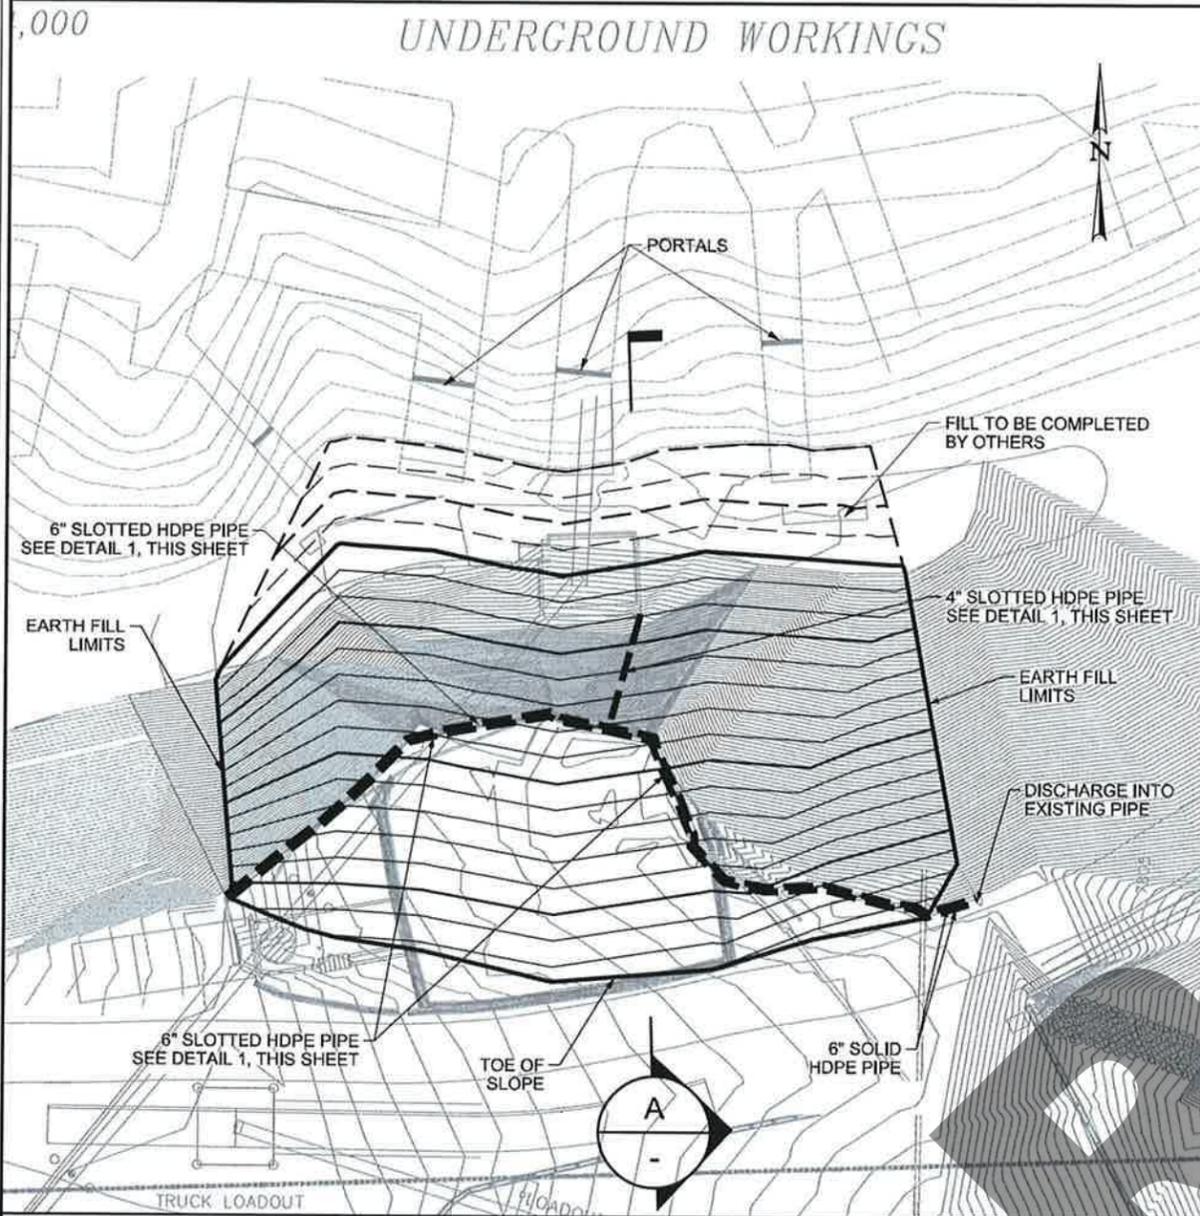
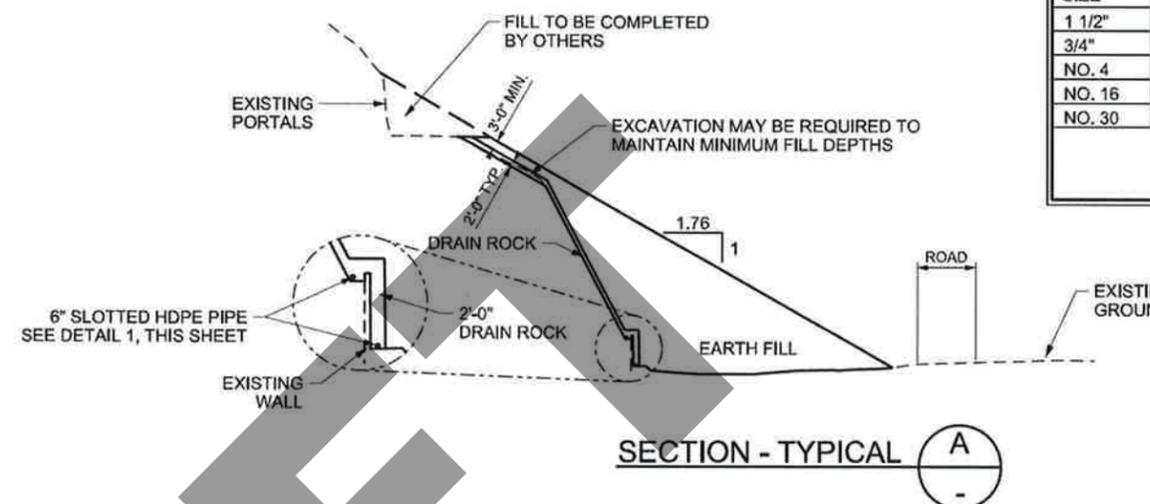
GRADATION REQUIREMENTS			
GRAVEL DRAIN		EARTH FILL	
SIEVE SIZE	PERCENT PASSING	SIEVE SIZE	PERCENT PASSING
1 1/2"	100	6"	100
3/4"	70-100	3"	70-100
NO. 4	20-50	NO. 4	30-70
NO. 16	0-15	NO. 200	0-20
NO. 30	0-5

PLASTICITY INDEX ≤ 6  
FRICTION ANGLE ≥ 36°

The soils used to construct the embankment should meet the gradation requirements and Atterberg limits shown on the attached plan sheet. The soils should be moisture conditioned to within 2 percent of the optimum moisture content and then spread in loose lifts not exceeding 12 inches thick. Each lift should be compacted to at least 95 percent of the maximum dry density. Optimum moisture content and dry density should be determined by the standard Proctor test (ASTM D 698). One to two density tests should be performed for each lift of fill to verify field compaction. If lifts are compacted with a smooth drum roller or otherwise become smooth or dry, the top 2 inches of the lifts should be scarified prior to placing the subsequent lift.

Gravel drain material used to construct the drainage system should be compacted. In order to compact against the existing slope, hand operated compaction equipment such as jumping jacks and/or walk behind rollers will likely be necessary. We recommend that gravel drain material to be compacted with hand equipment be placed in lifts not exceeding 8 inches in thickness. Each lift should be compacted with a minimum of 4 passes of the compaction equipment.

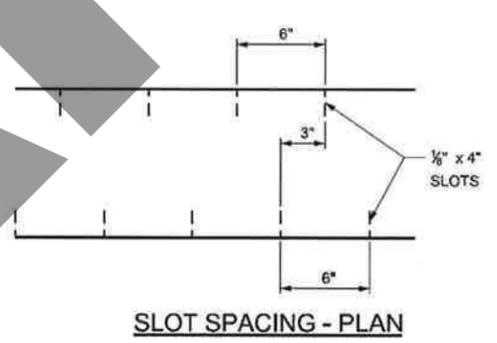
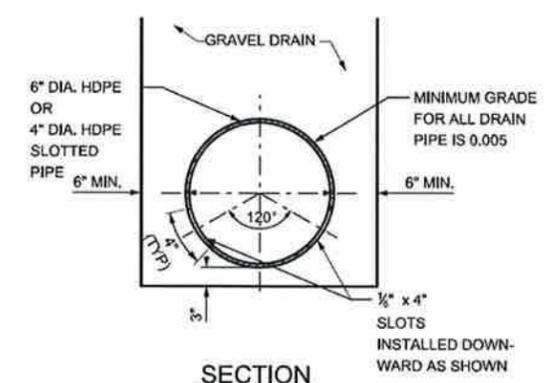
SLOTTED PIPE	1
DRAIN DETAIL	-

6" HDPE OR 4" HDPE SLOTTED PIPE

3. DRAIN PIPE
  - A. JOINTS SHALL BE MADE BY BUTT FUSION WHEN POSSIBLE. THE PIPE MANUFACTURER'S FUSION PROCEDURES SHALL BE FOLLOWED AT ALL TIMES AS WELL AS THE RECOMMENDATIONS OF THE FUSION MACHINE MANUFACTURER.

- B. IF MECHANICAL FITTINGS ARE UTILIZED, THE RECOMMENDATION OF THE MECHANICAL FITTING MANUFACTURER MUST BE FOLLOWED.
  - C. THE DIMENSION RATION (DR) OF THE SOLID AND SLOTTED DRAIN PIPES SHALL BE 11.

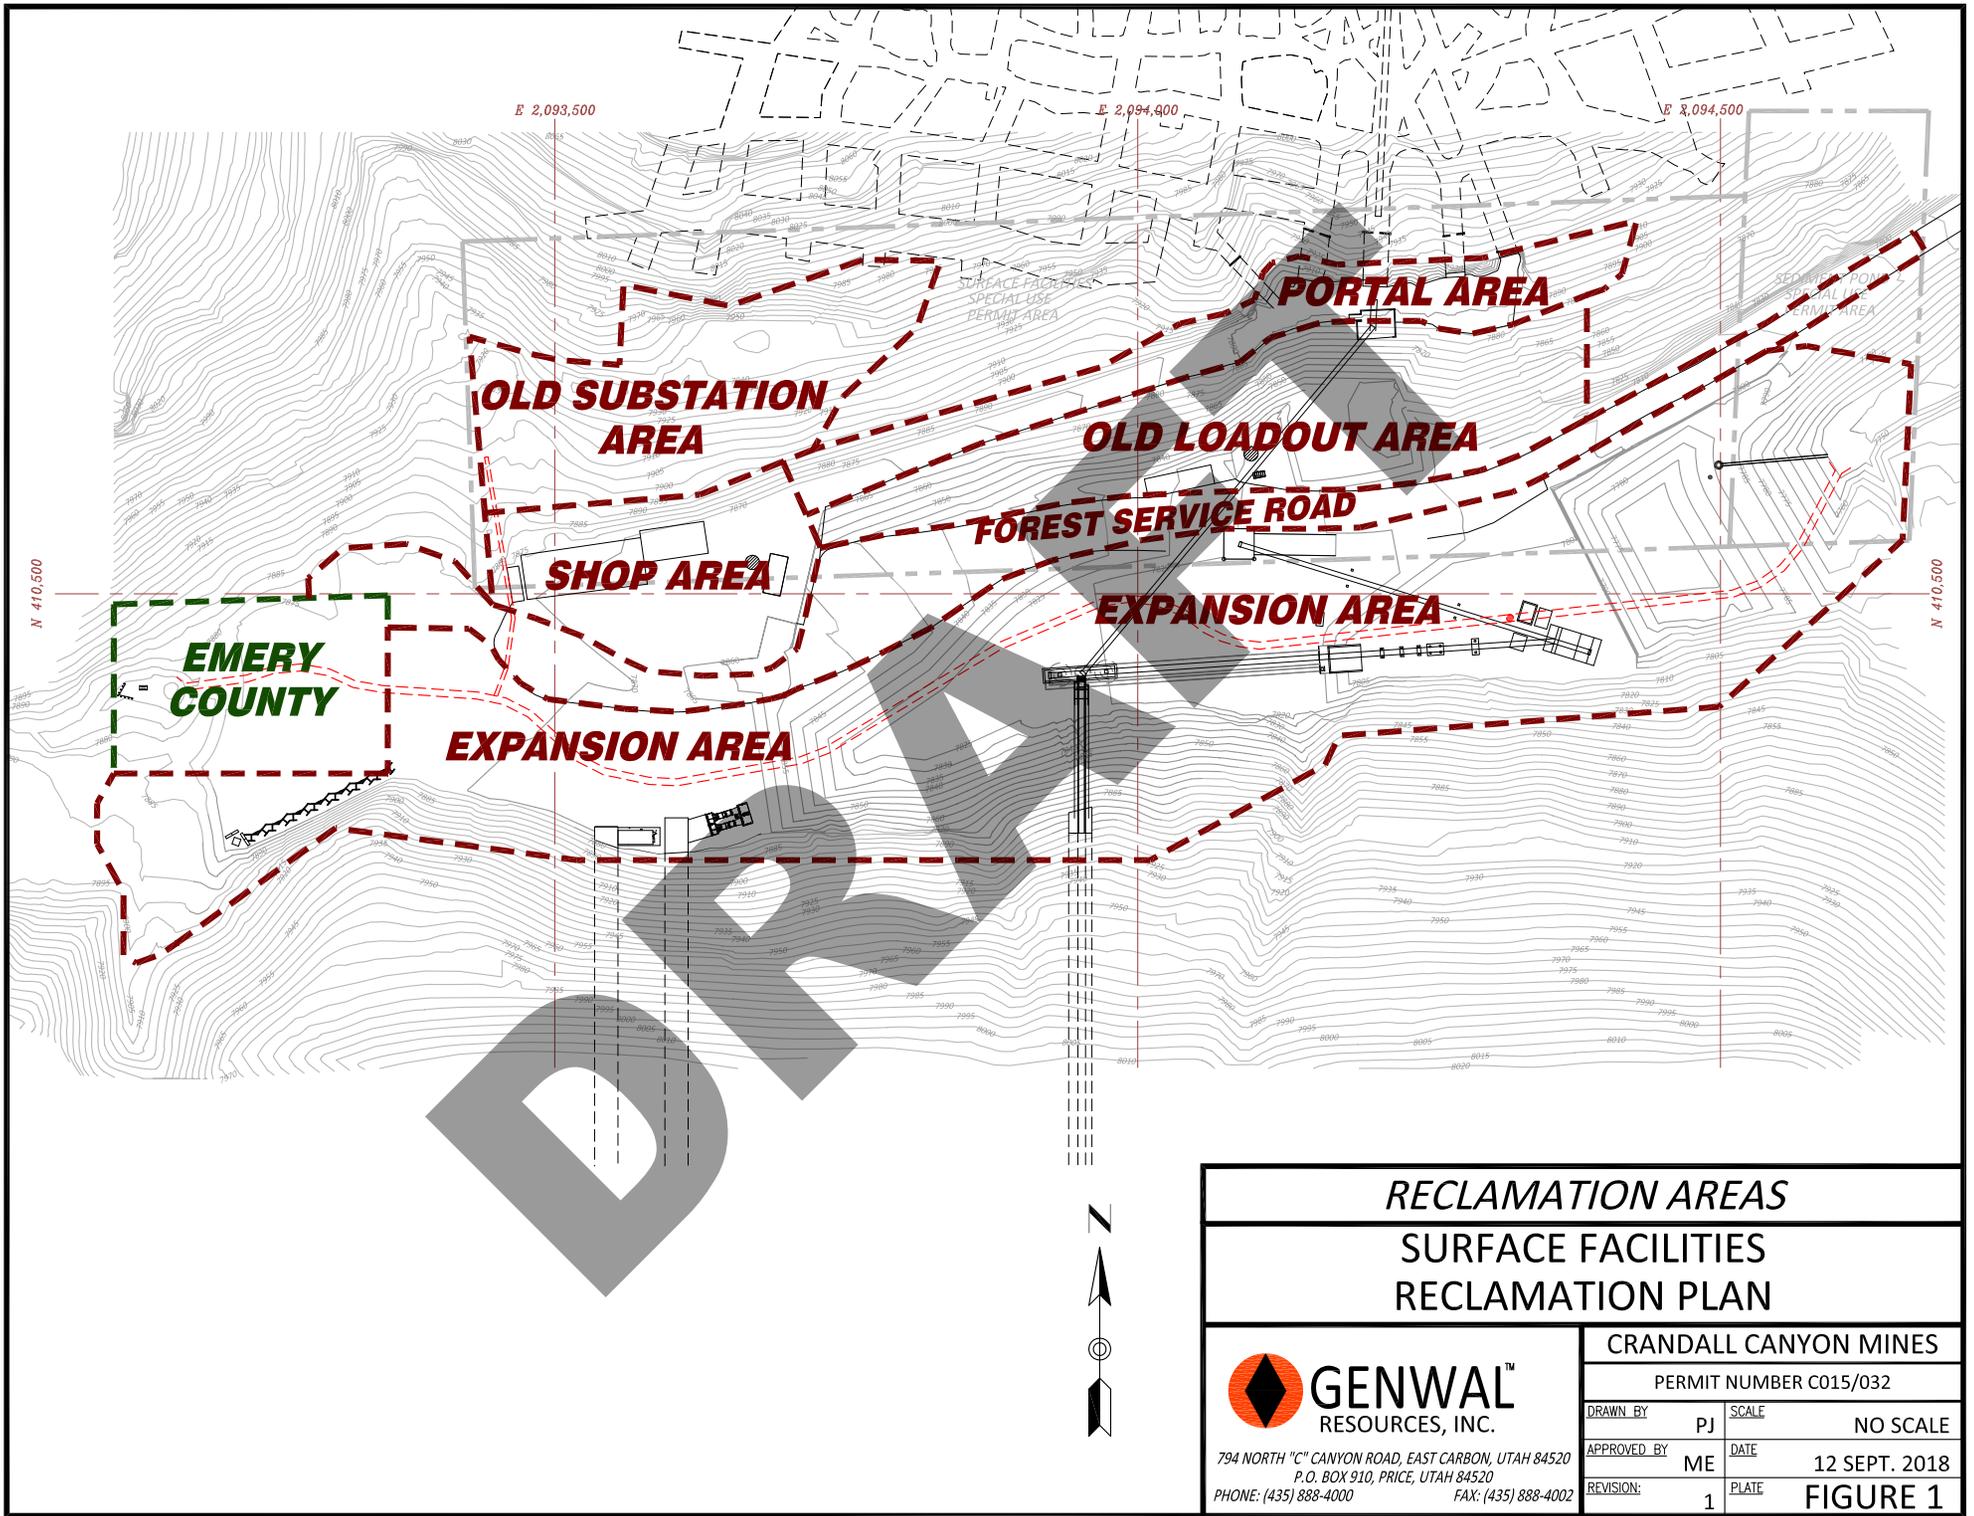
<b>RECLAMATION AREAS</b>			
<b>SURFACE FACILITIES</b>			
<b>RECLAMATION PLAN</b>

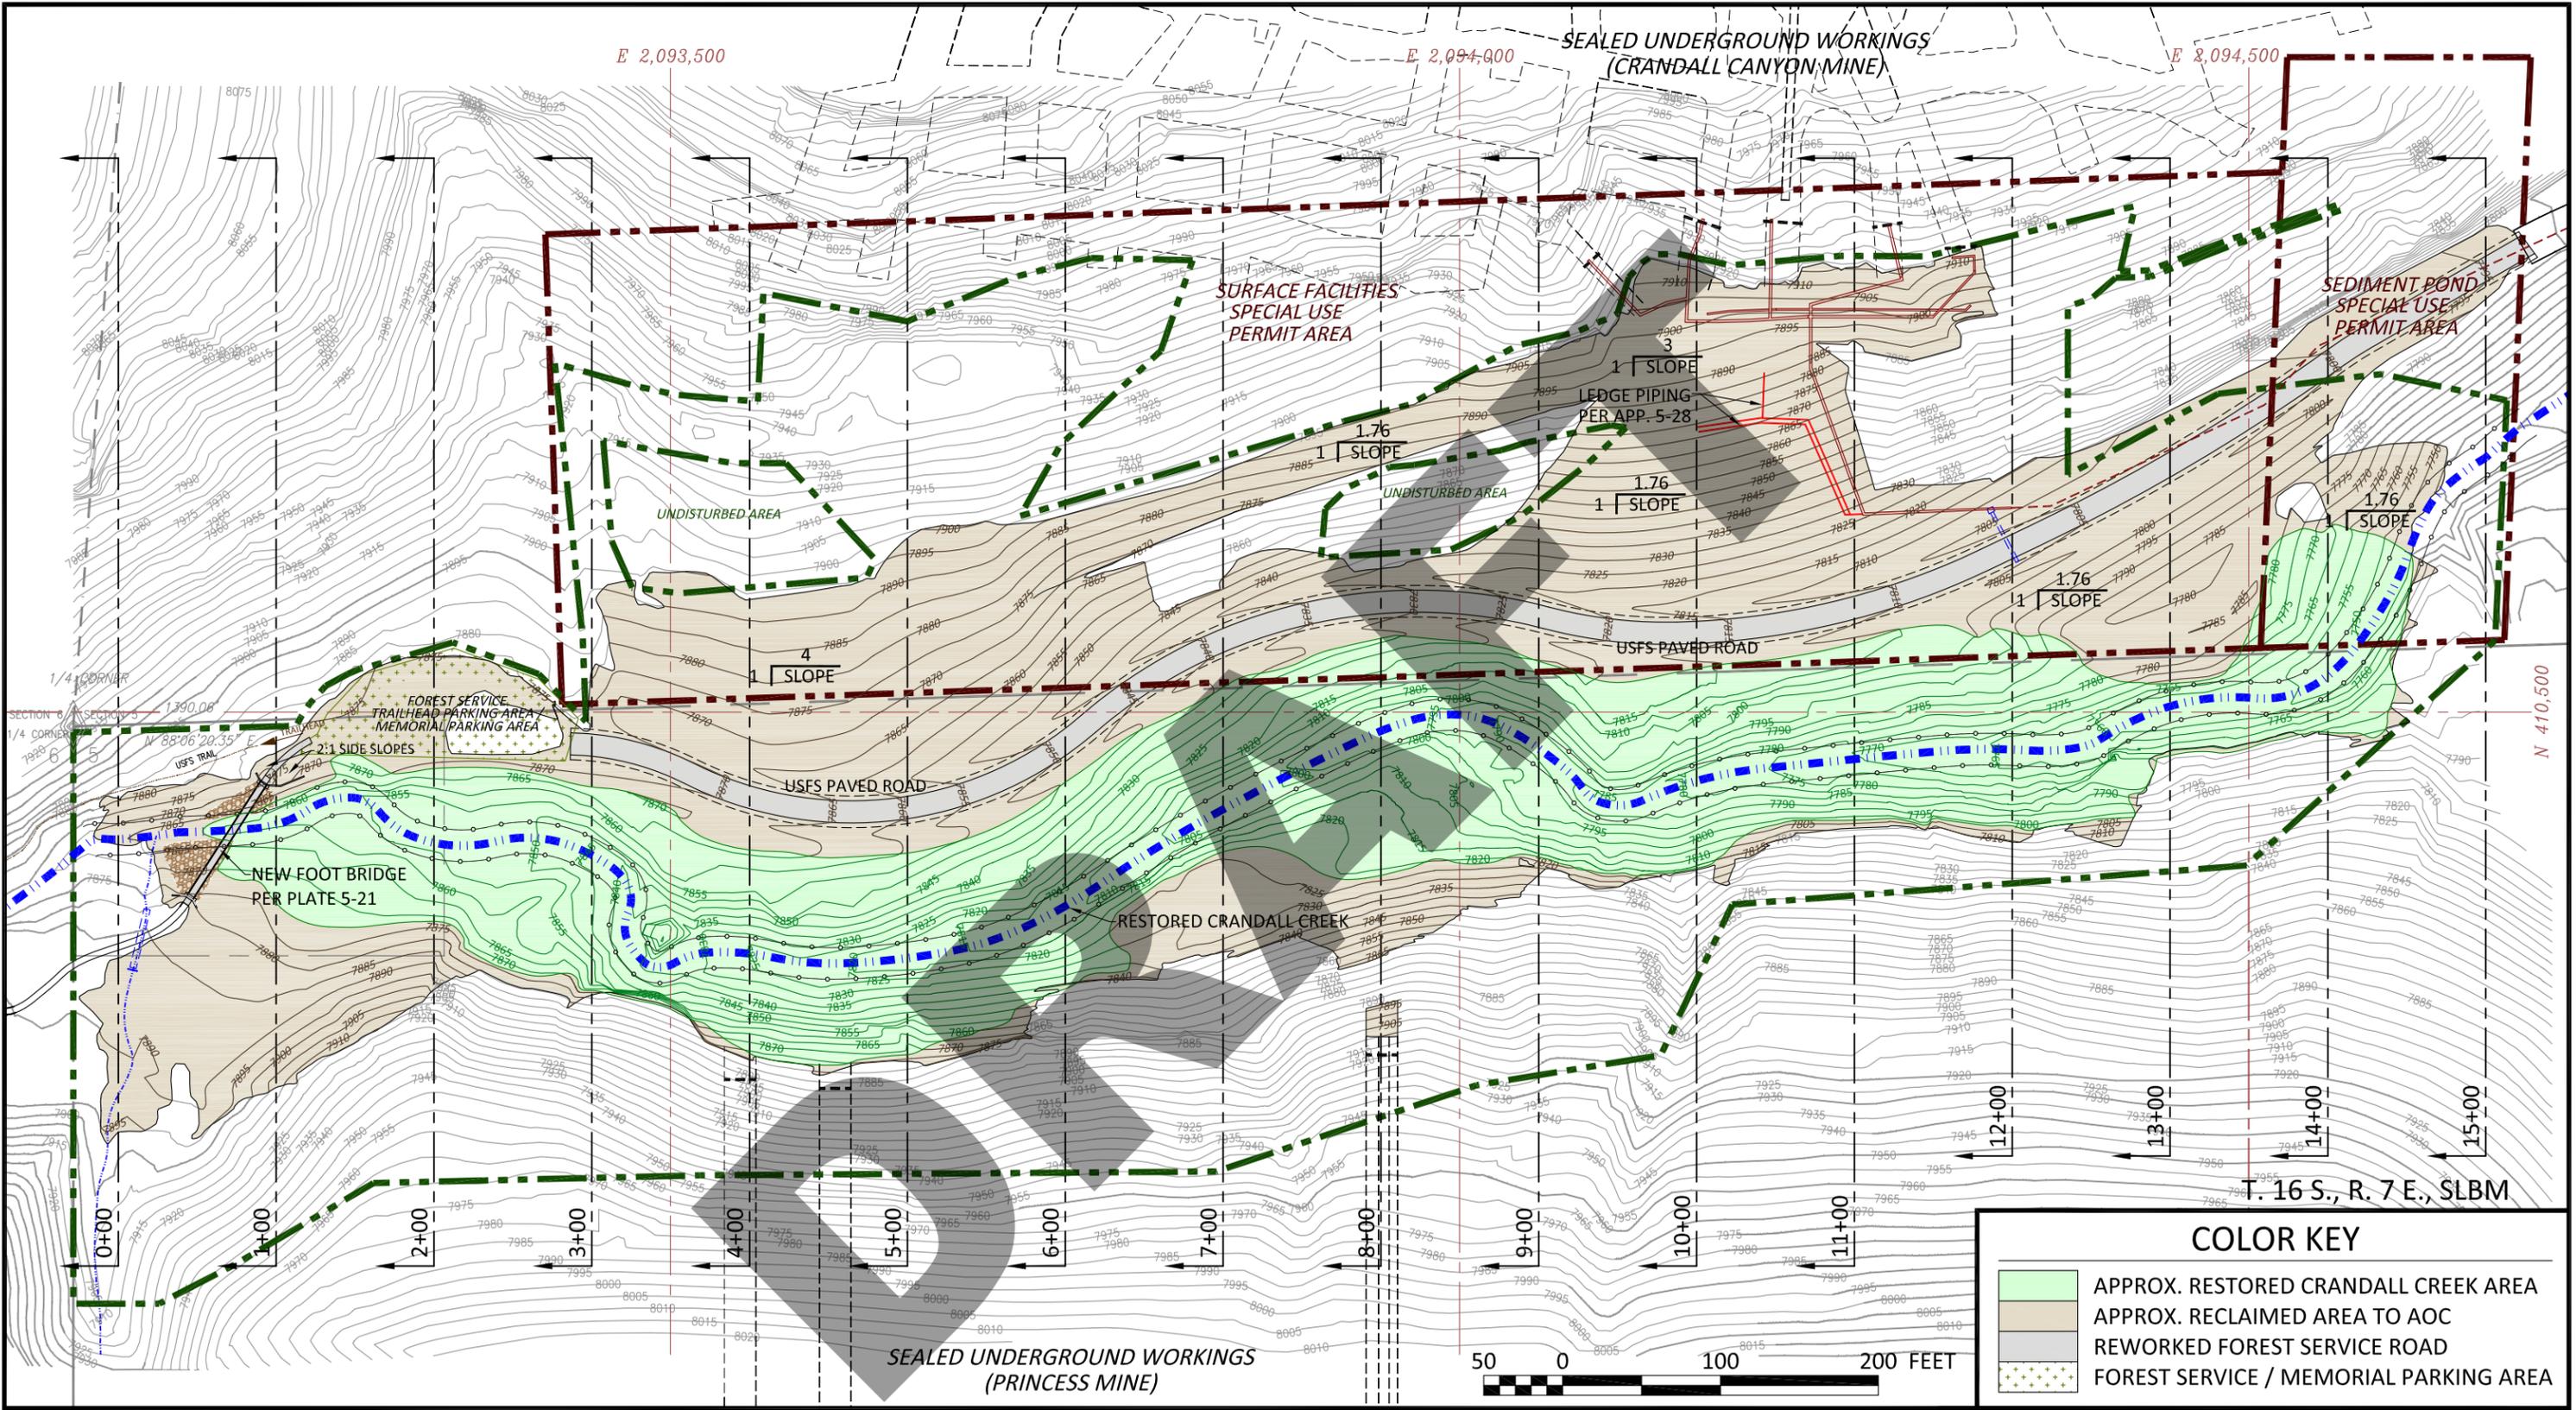
DISTURBED AREA BOUNDARY		RECLAIMED INDEX CONTOURS (5' INTERVALS)
	FOREST SERVICE SPECIAL USE PERMIT BOUNDARY		RESTORED INDEX CONTOUR (5' INTERVALS)
	CROSS-SECTION (SEE PLATES 5-17A TO 5-17D)		EXISTING INDEX CONTOUR (5' INTERVALS)
	ALTERNATE SEDIMENT CONTROL		NEW 12" ID HDPE PIPING TO HUNTINGTON CREEK (SEE 5-16)
	PIPING FOR MINE WATER DISCHARGE SYSTEM		ALTERNATE SEDIMENT CONTROL
	NEW RIP RAP CHANNEL PROTECTION

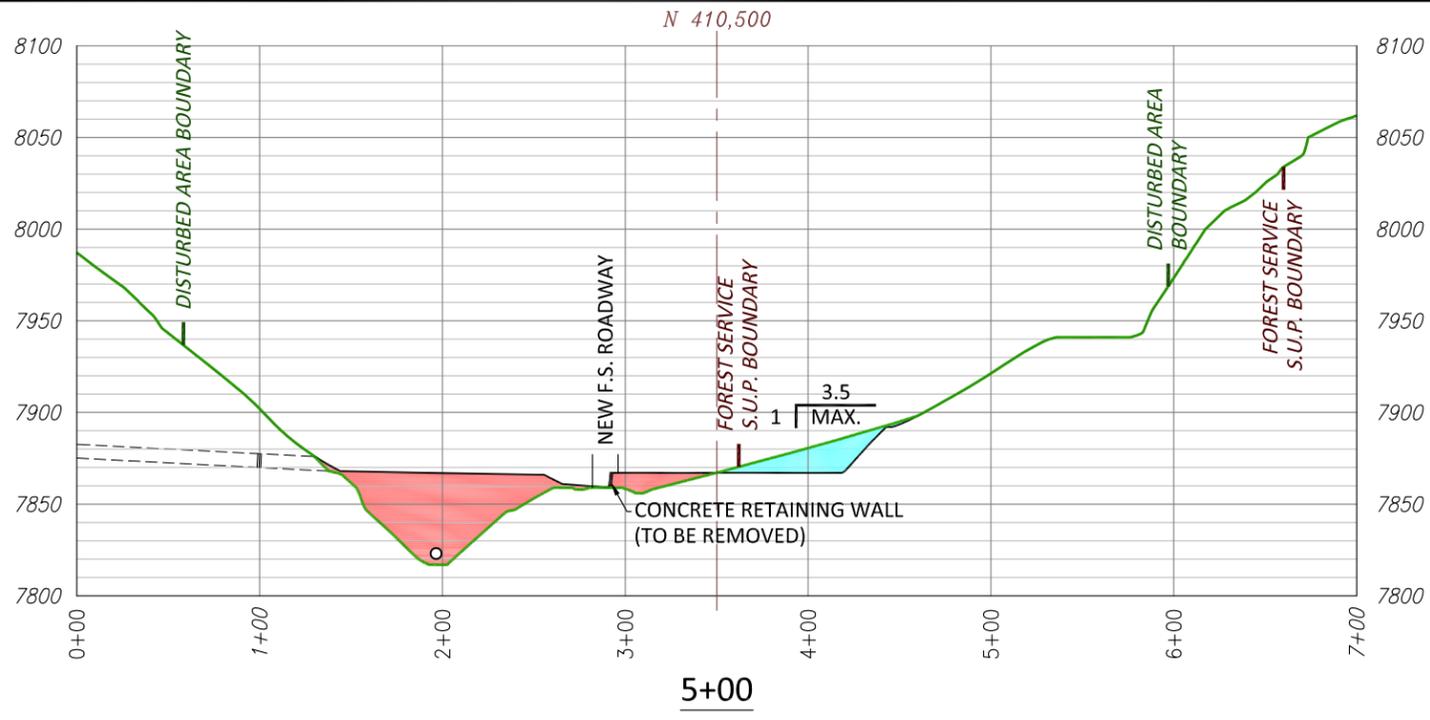
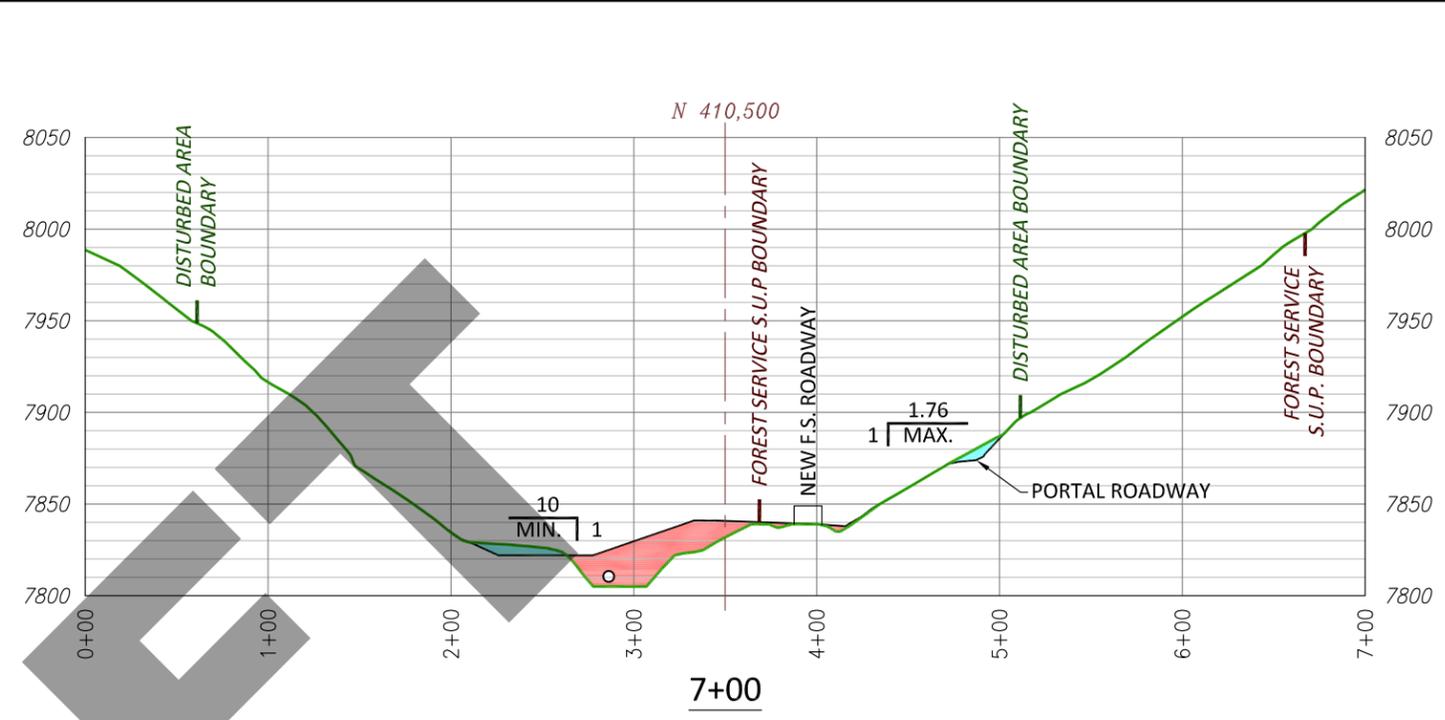
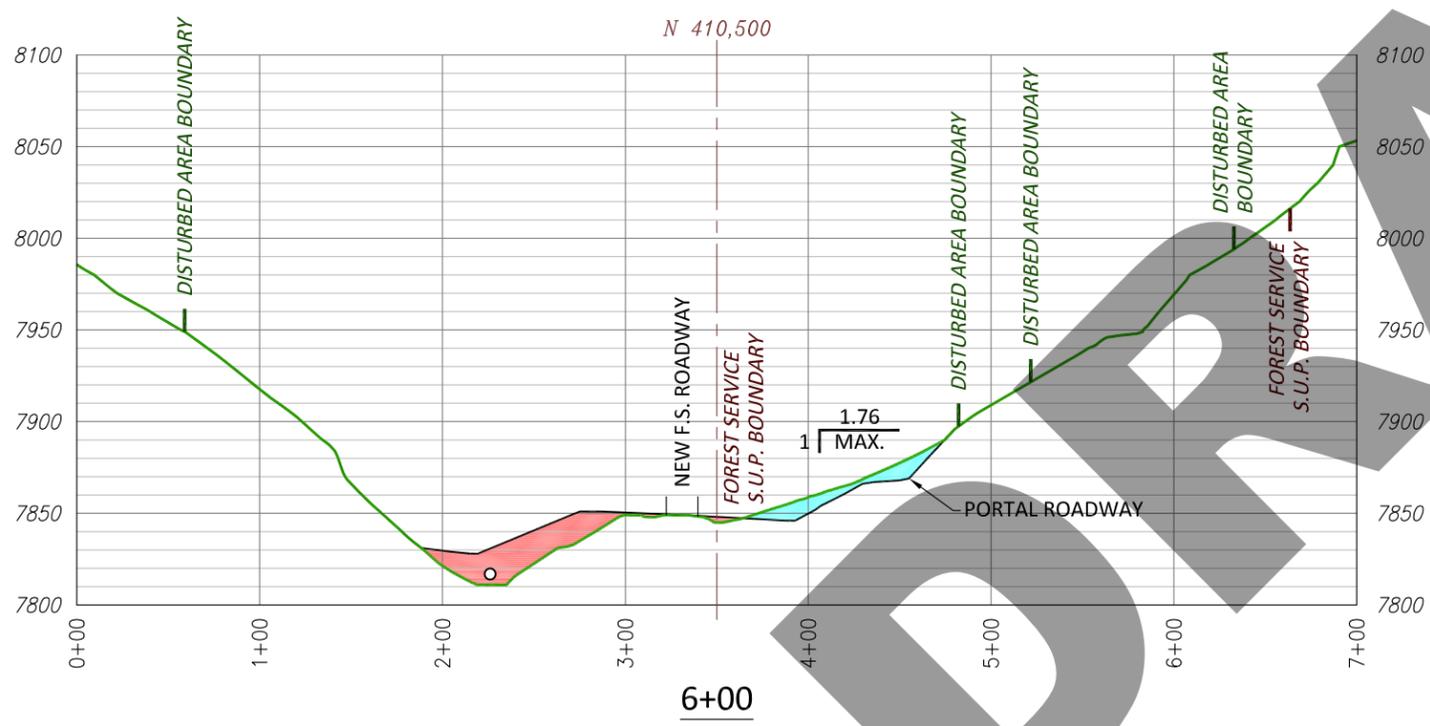
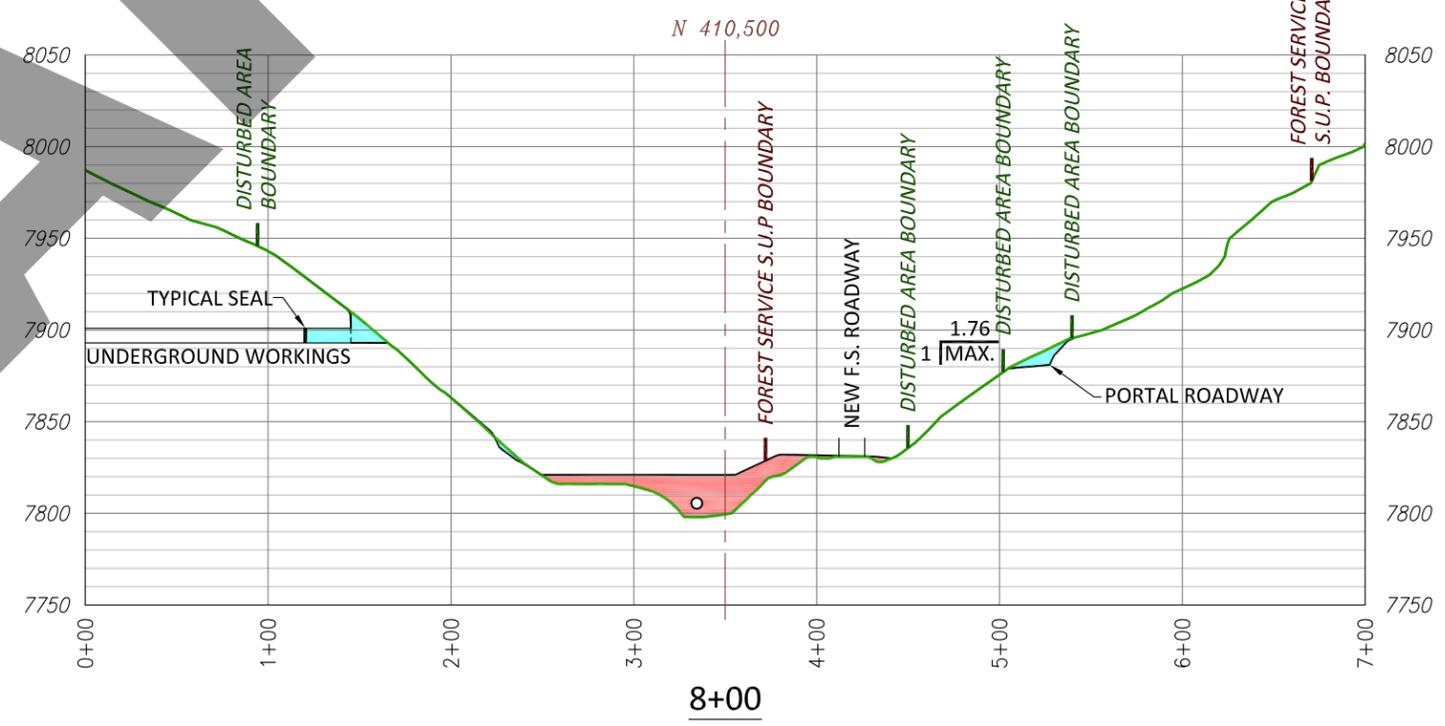
DRAWN BY	PJ	SCALE	1" = 100'
APPROVED BY	ME	DATE	12 SEPT. 2018
REVISION:	1	PLATE	5-17B

- CURRENT SURFACE LINE
- RECLAIMED SURFACE LINE
- CUT AREA
- FILL AREA
- EXISTING CULVERT (TO BE REMOVED)

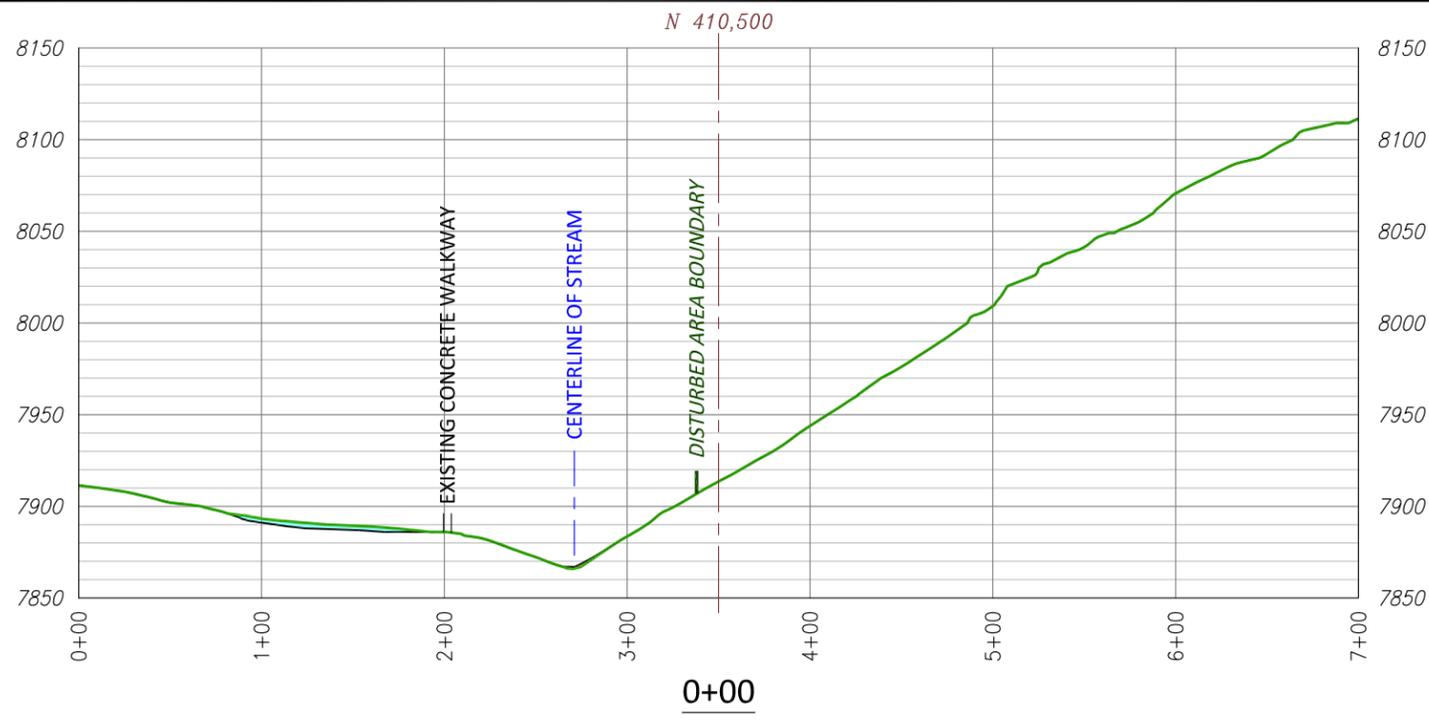
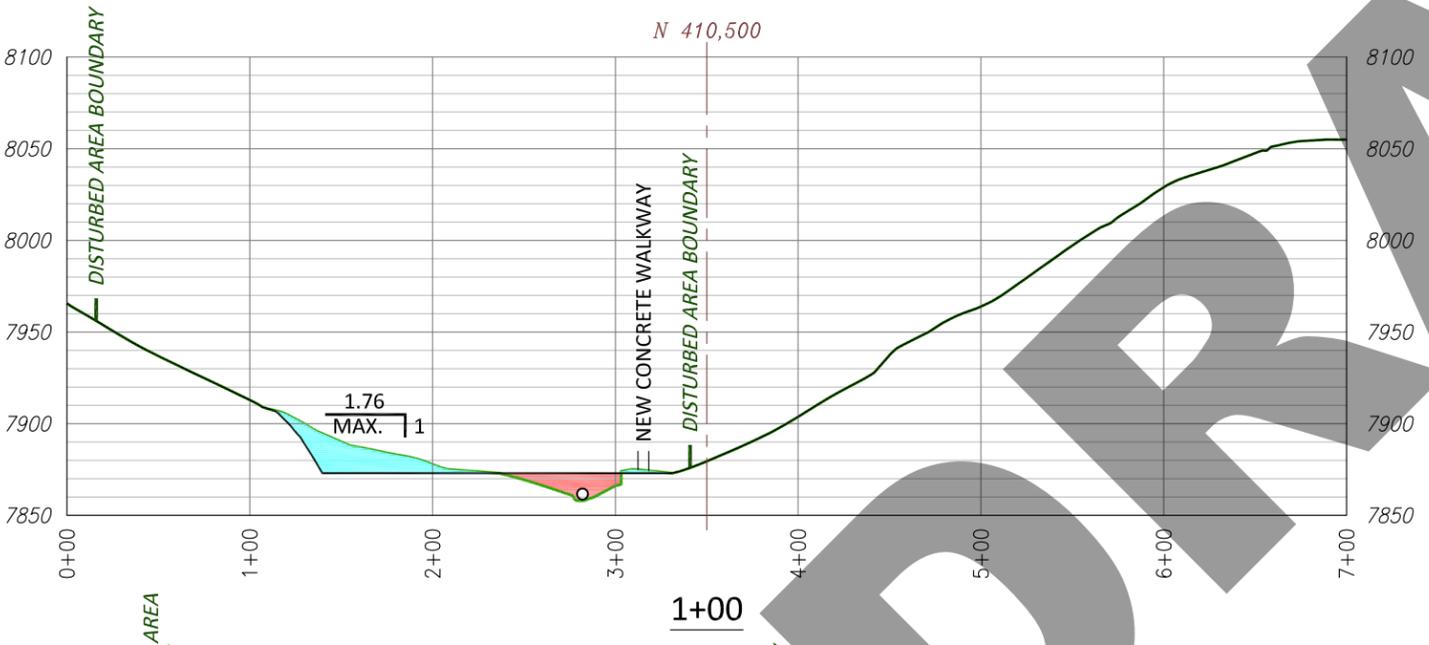
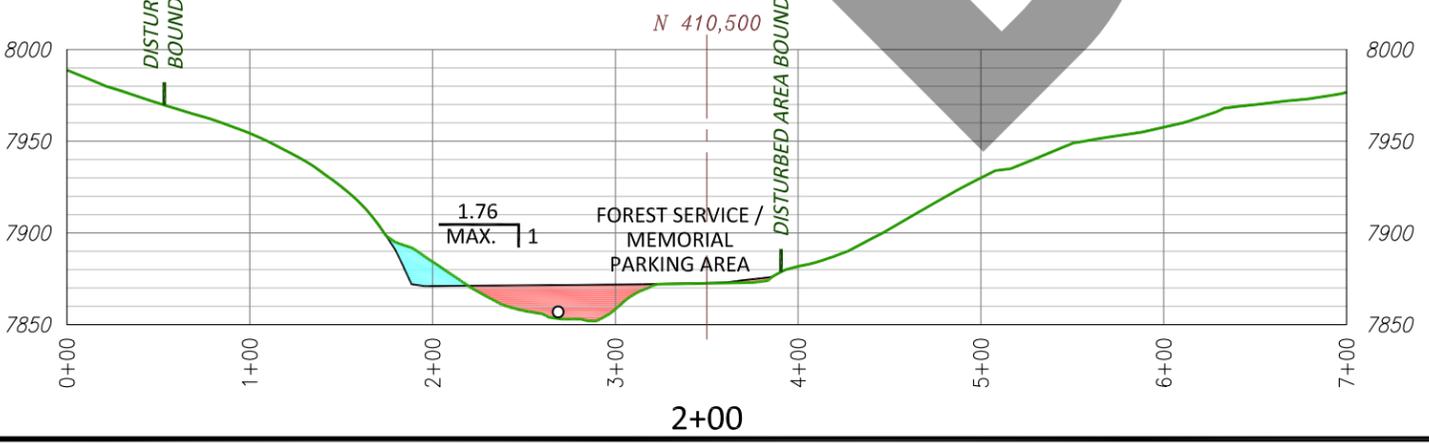
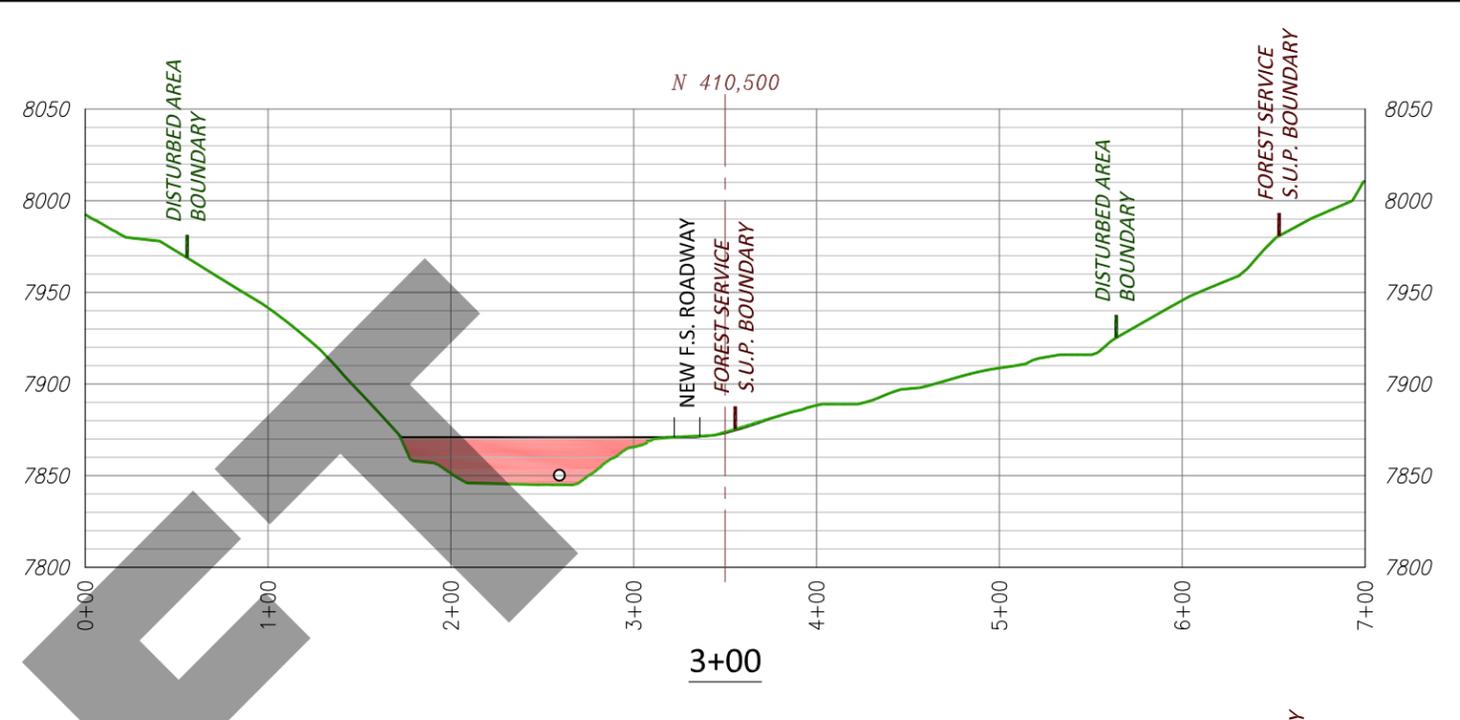
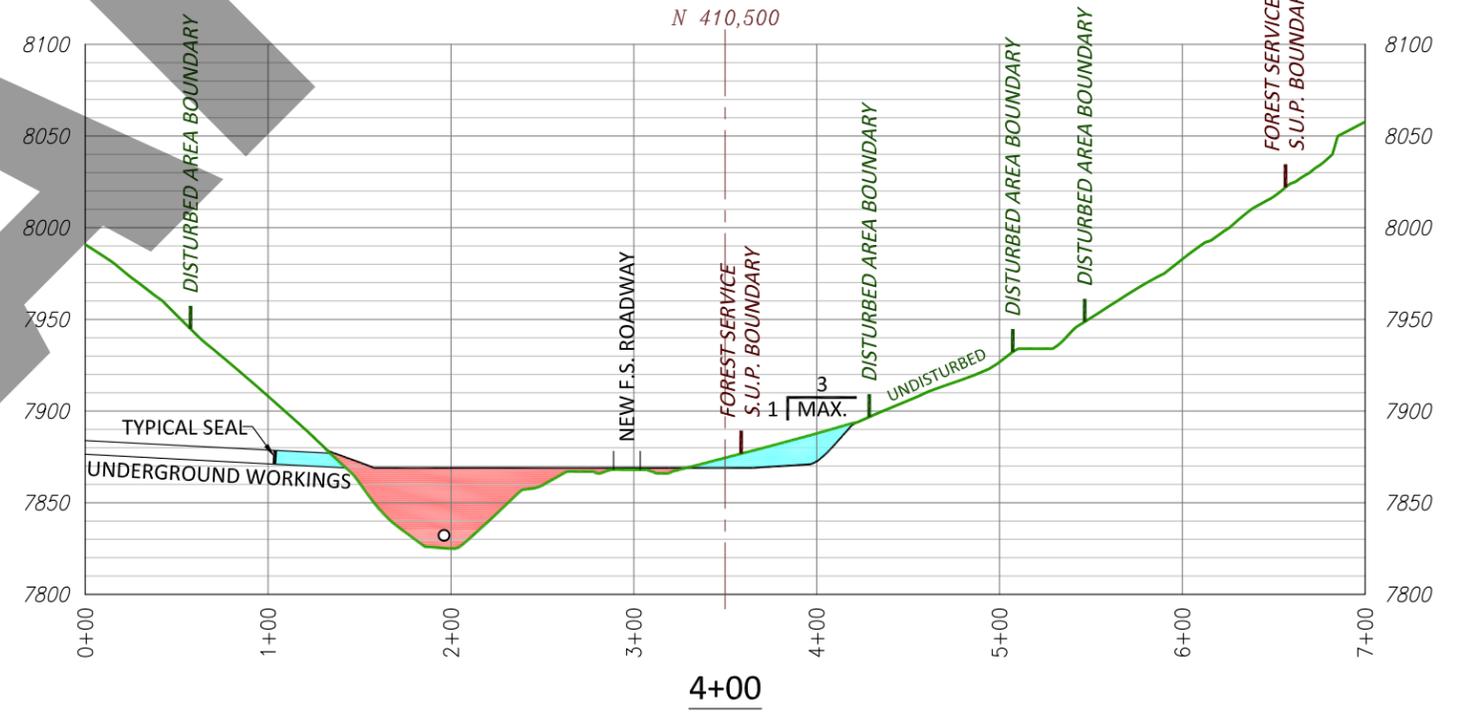
DRAWN BY	PJ	SCALE	1" = 100'
APPROVED BY	ME	DATE	12 SEPT. 2018
REVISION:	1	PLATE	5-17A

- CURRENT SURFACE LINE
- RECLAIMED SURFACE LINE
- CUT AREA
- FILL AREA
- EXISTING CULVERT (TO BE REMOVED)

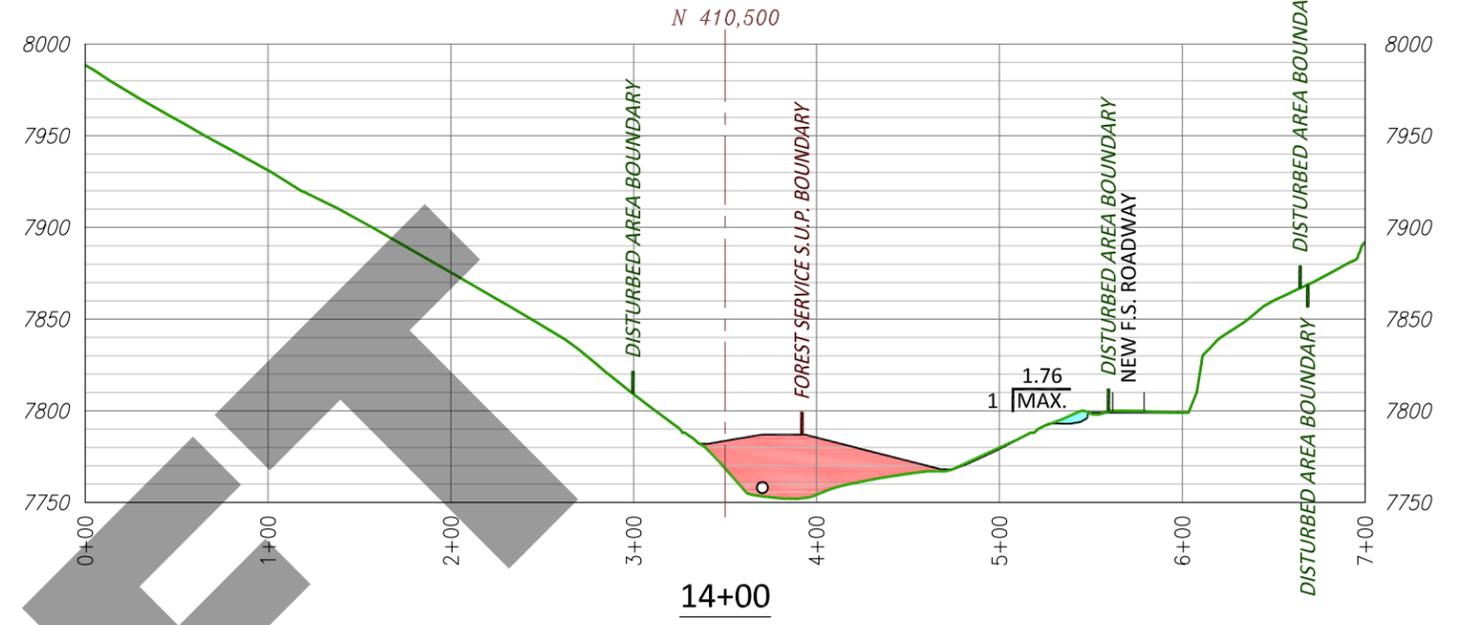
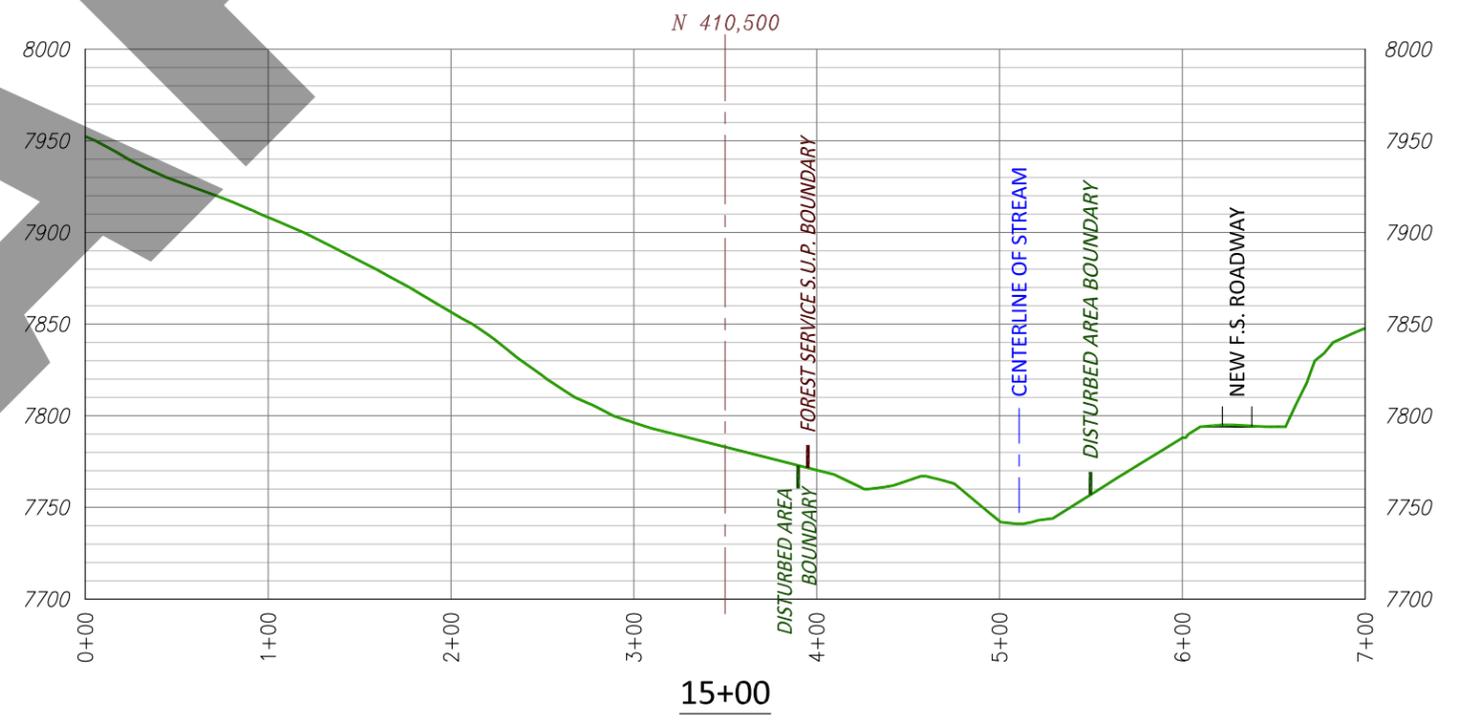
DRAWN BY	PJ	SCALE	1" = 100'
APPROVED BY	ME	DATE	12 SEPT. 2018
REVISION:	1	PLATE	5-17D

- CURRENT SURFACE LINE
- RECLAIMED SURFACE LINE
- CUT AREA
- FILL AREA
- EXISTING CULVERT (TO BE REMOVED)
