**Re: Crandall Canyon Draft Revised Reclamation Plan Preliminary Review**

### Crandall Canyon Mine Slope Stability Static Conditions

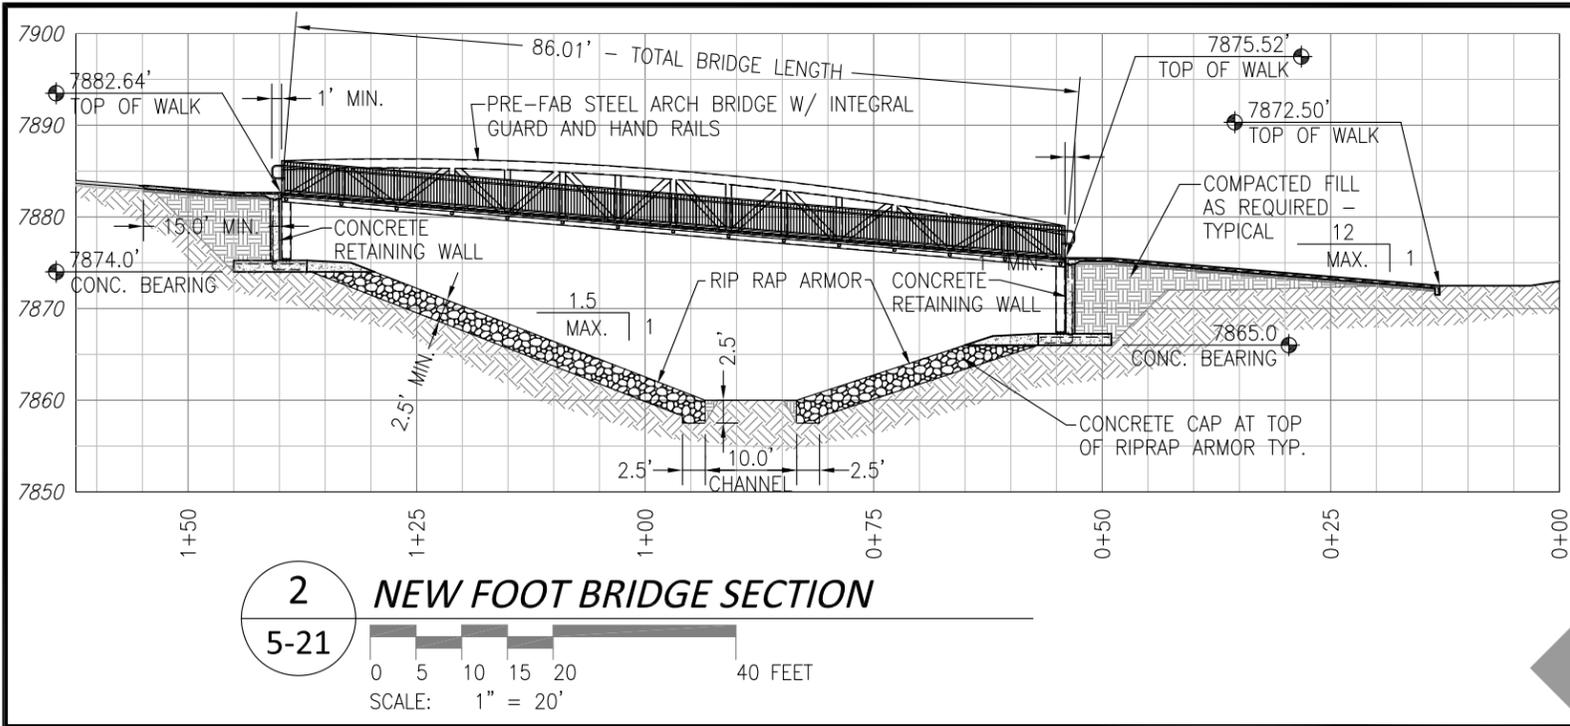
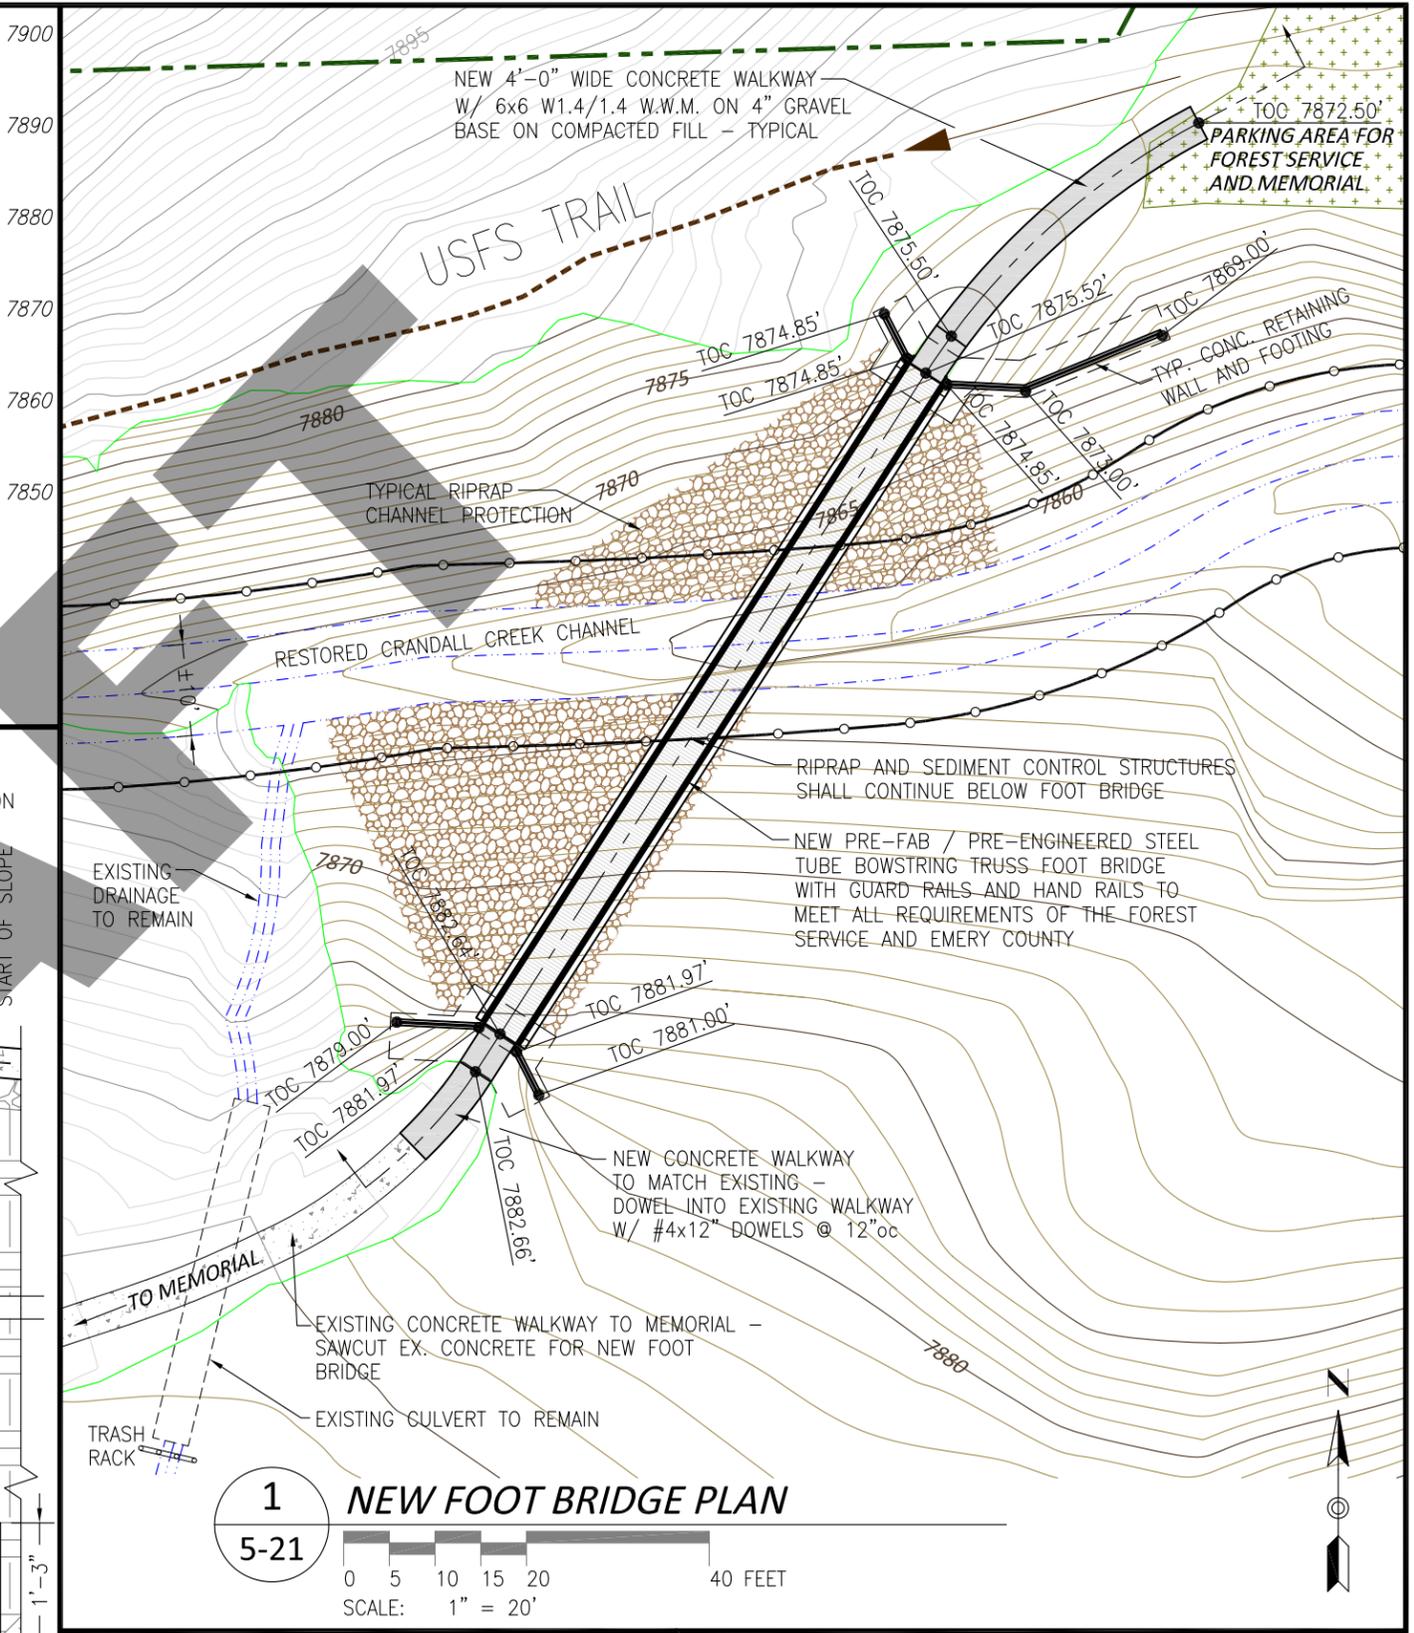
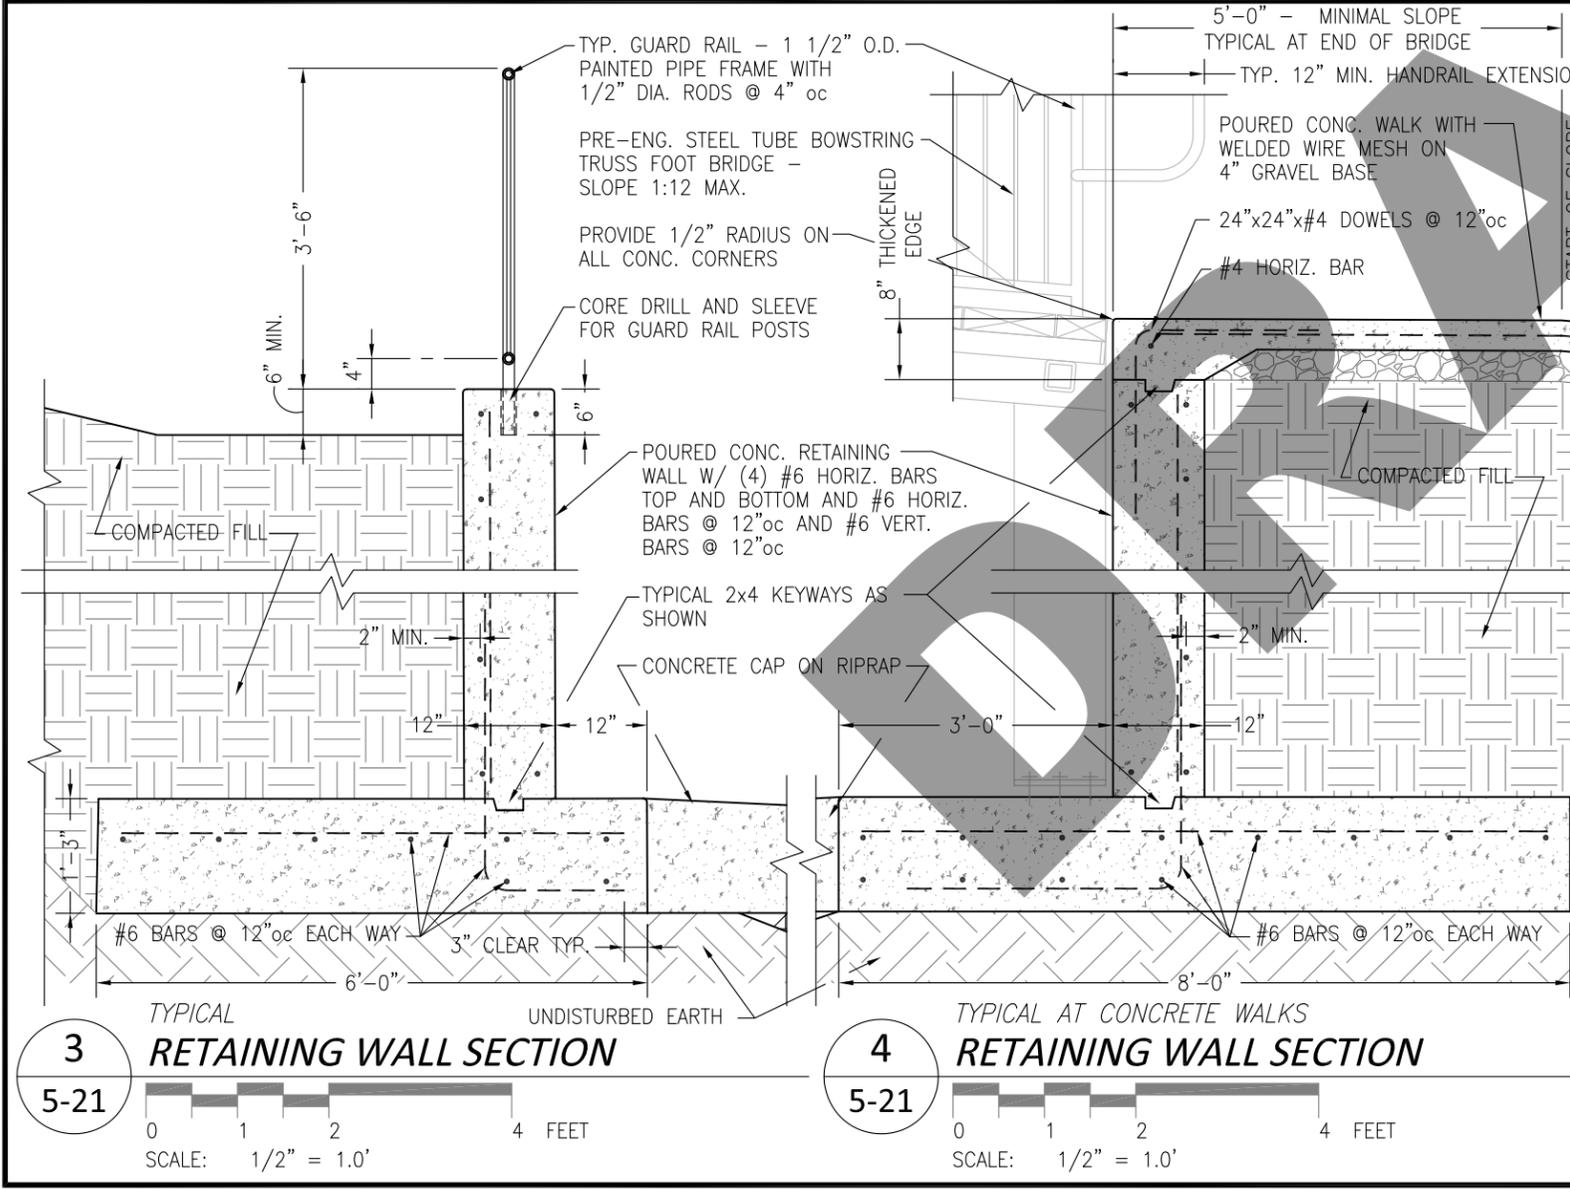
- 7865 RECLAIMED INDEX CONTOURS (5' INTERVALS)
- RECLAIMED INTERMEDIATE CONTOUR (1' INTERVALS)
- 7910 EXISTING INDEX CONTOUR (5' INTERVALS)
- EXISTING INTERMEDIATE CONTOURS (1' INTERVALS)
- DISTURBED AREA BOUNDARY
- ALTERNATE SEDIMENT CONTROL
