Annual Report

Company Name	Alton Coal Development, LLC	Mine Name	Coal Hollow Mine
Permit Number	C/025/0005	Permit expiration Date	2015-11-08
Operator Name	Alton Coal Development, LLC	Phone Number	+1 (435) 867-5331
Mailing Address	463 N 100 W, Suite 1	Email	knicholes@altoncoal.com
City	Cedar City		
State	Utah	Zip Code	84721

Ponds 1, 1B, 2, and 3 were constructed in the 1st quarter of 2011. Certified inspection of all ponds and the Excess Spoils Pile was completed on Mar. 27, 2012. Certified Inspection of the Excess Spoils Pile and Quarterly inspections of the constructed ponds were completed on 6/20/2012 for 2nd quarter, 9/25/2012 for 3rd quarter, and 12/7/2012. Copies of the Excess Spoils pile and Impoundment inspections are included in this submittal.

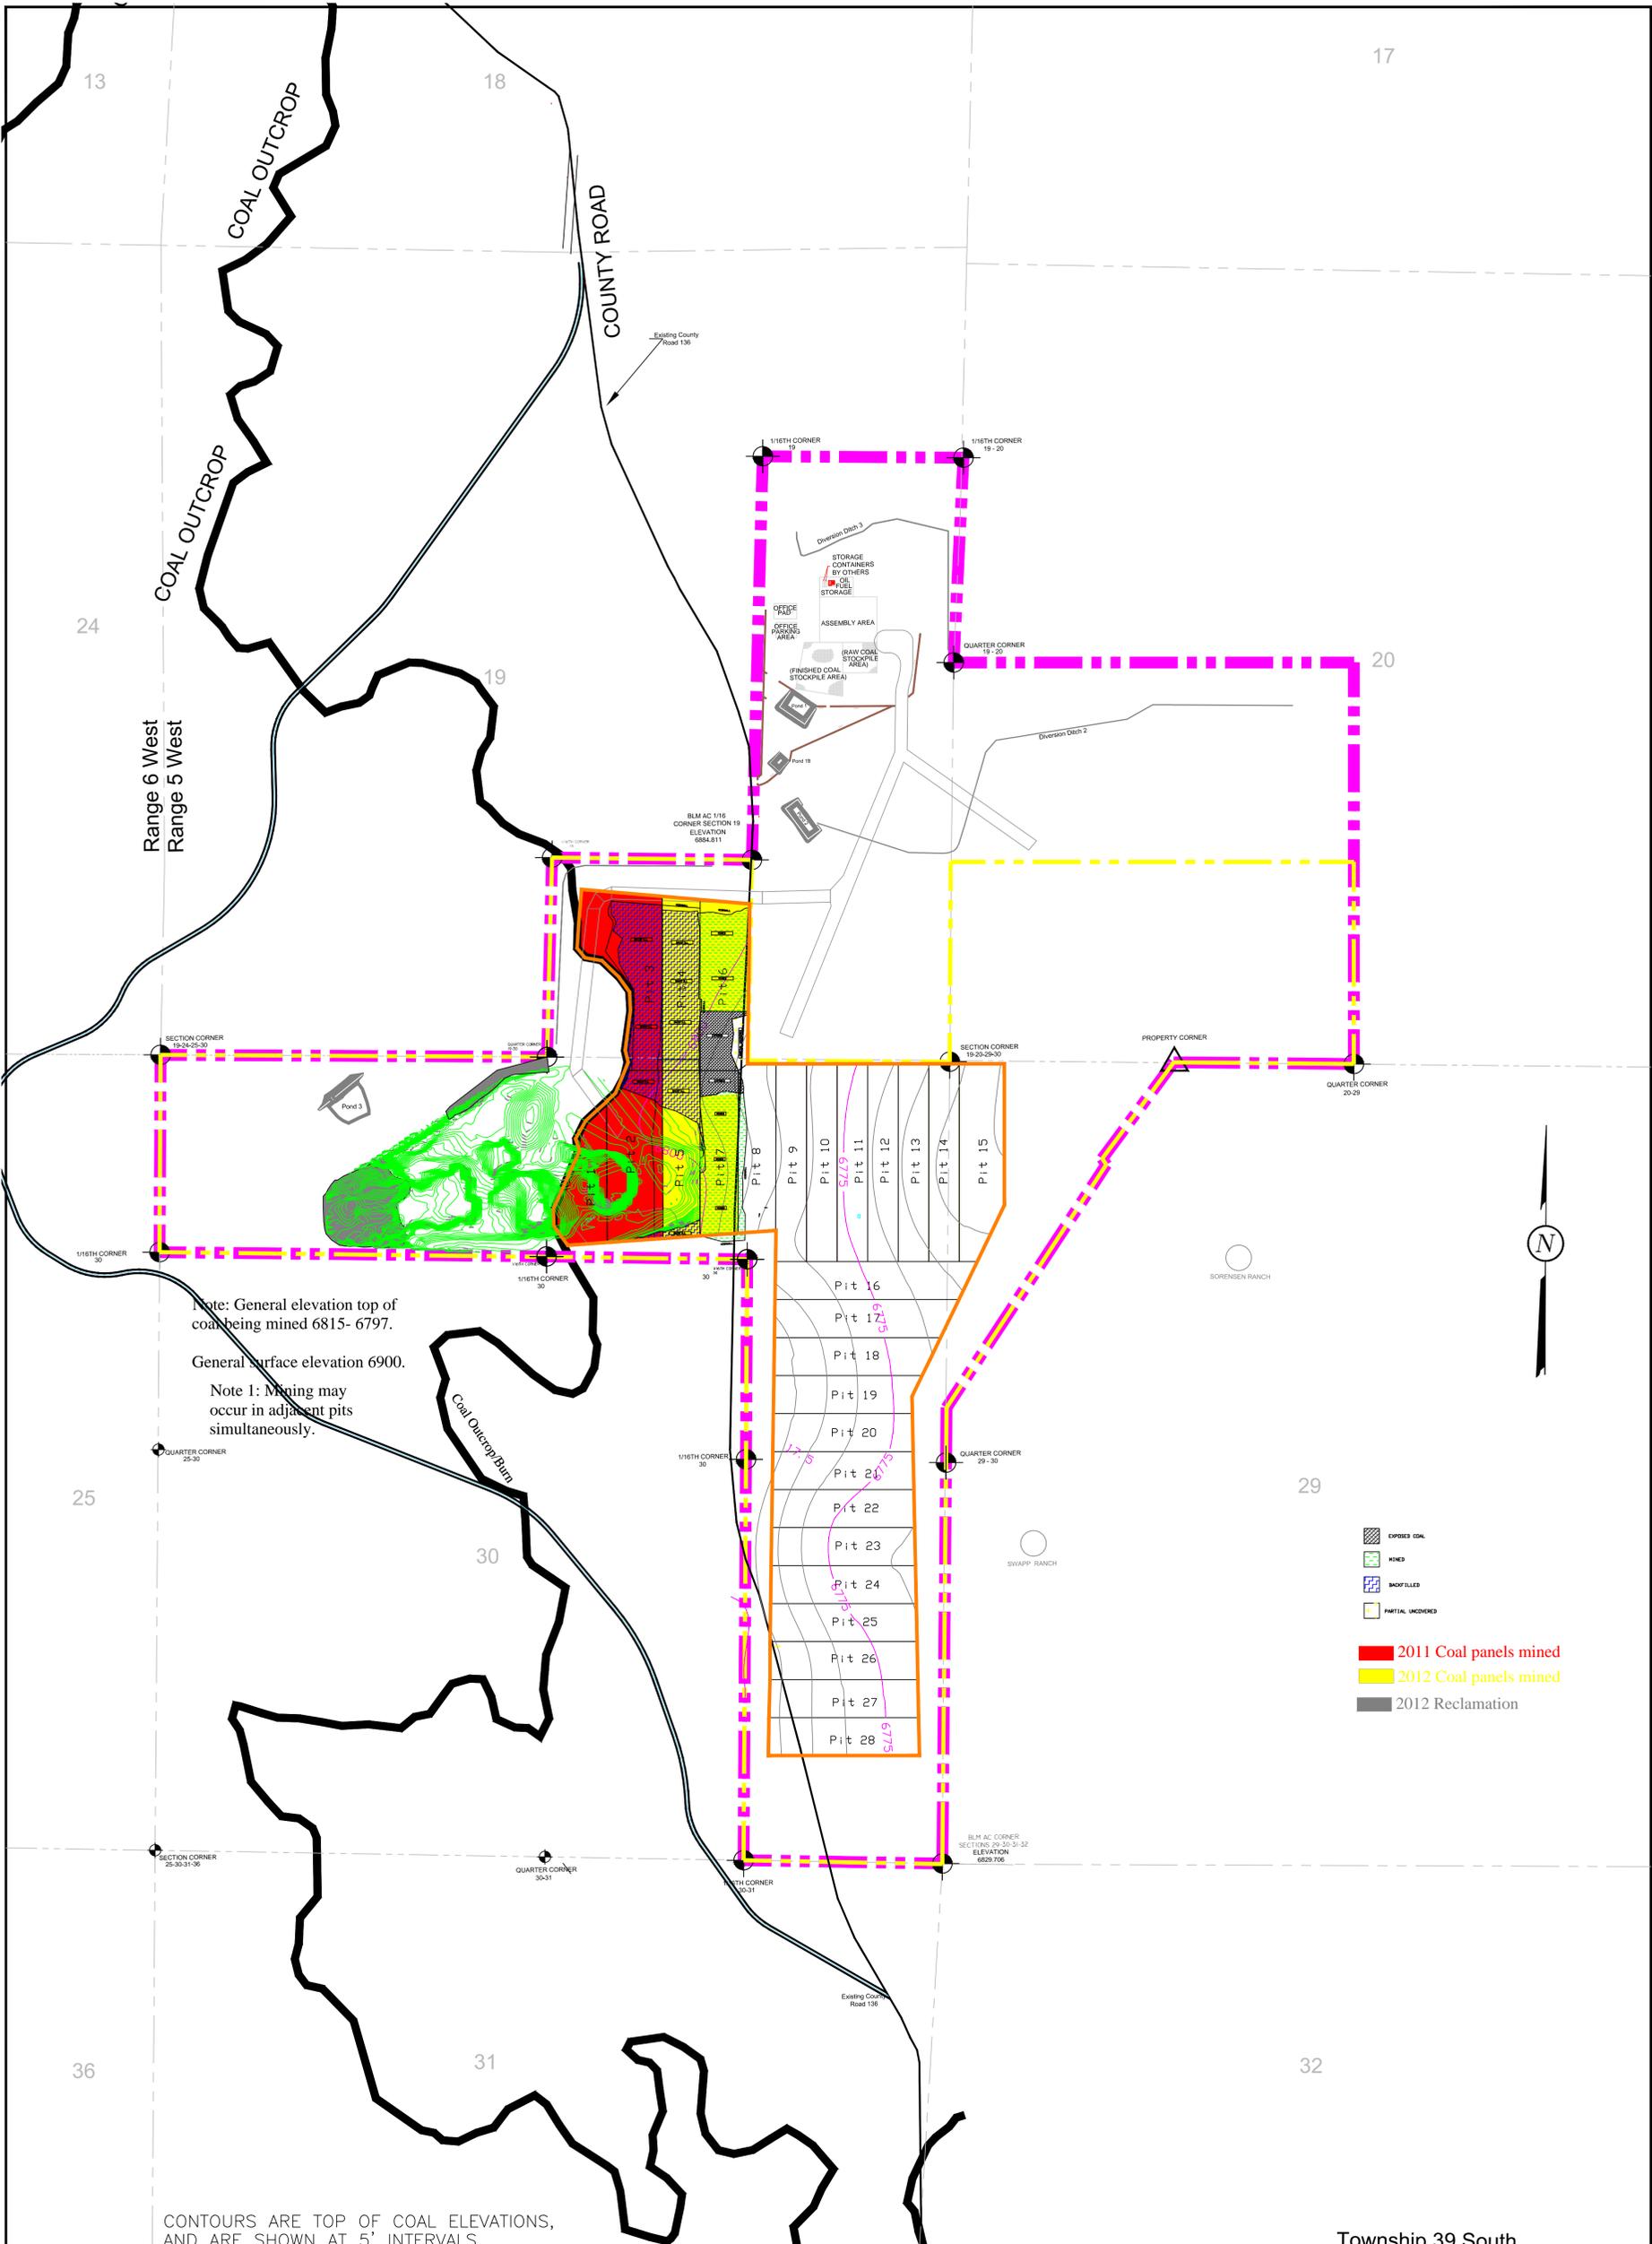
Note: General elevation top of coal being mined 6815- 6797.
 General surface elevation 6900.
 Note 1: Mining may occur in adjacent pits simultaneously.

CONTOURS ARE TOP OF COAL ELEVATIONS, AND ARE SHOWN AT 5' INTERVALS.
