Alton Coal Development, LLC

Subject: 2014 Annual Report; Alton Coal Development LLC, Coal Hollow Mine, C/025/0005

Title: MRP Annual Report 2014 amendments to permit

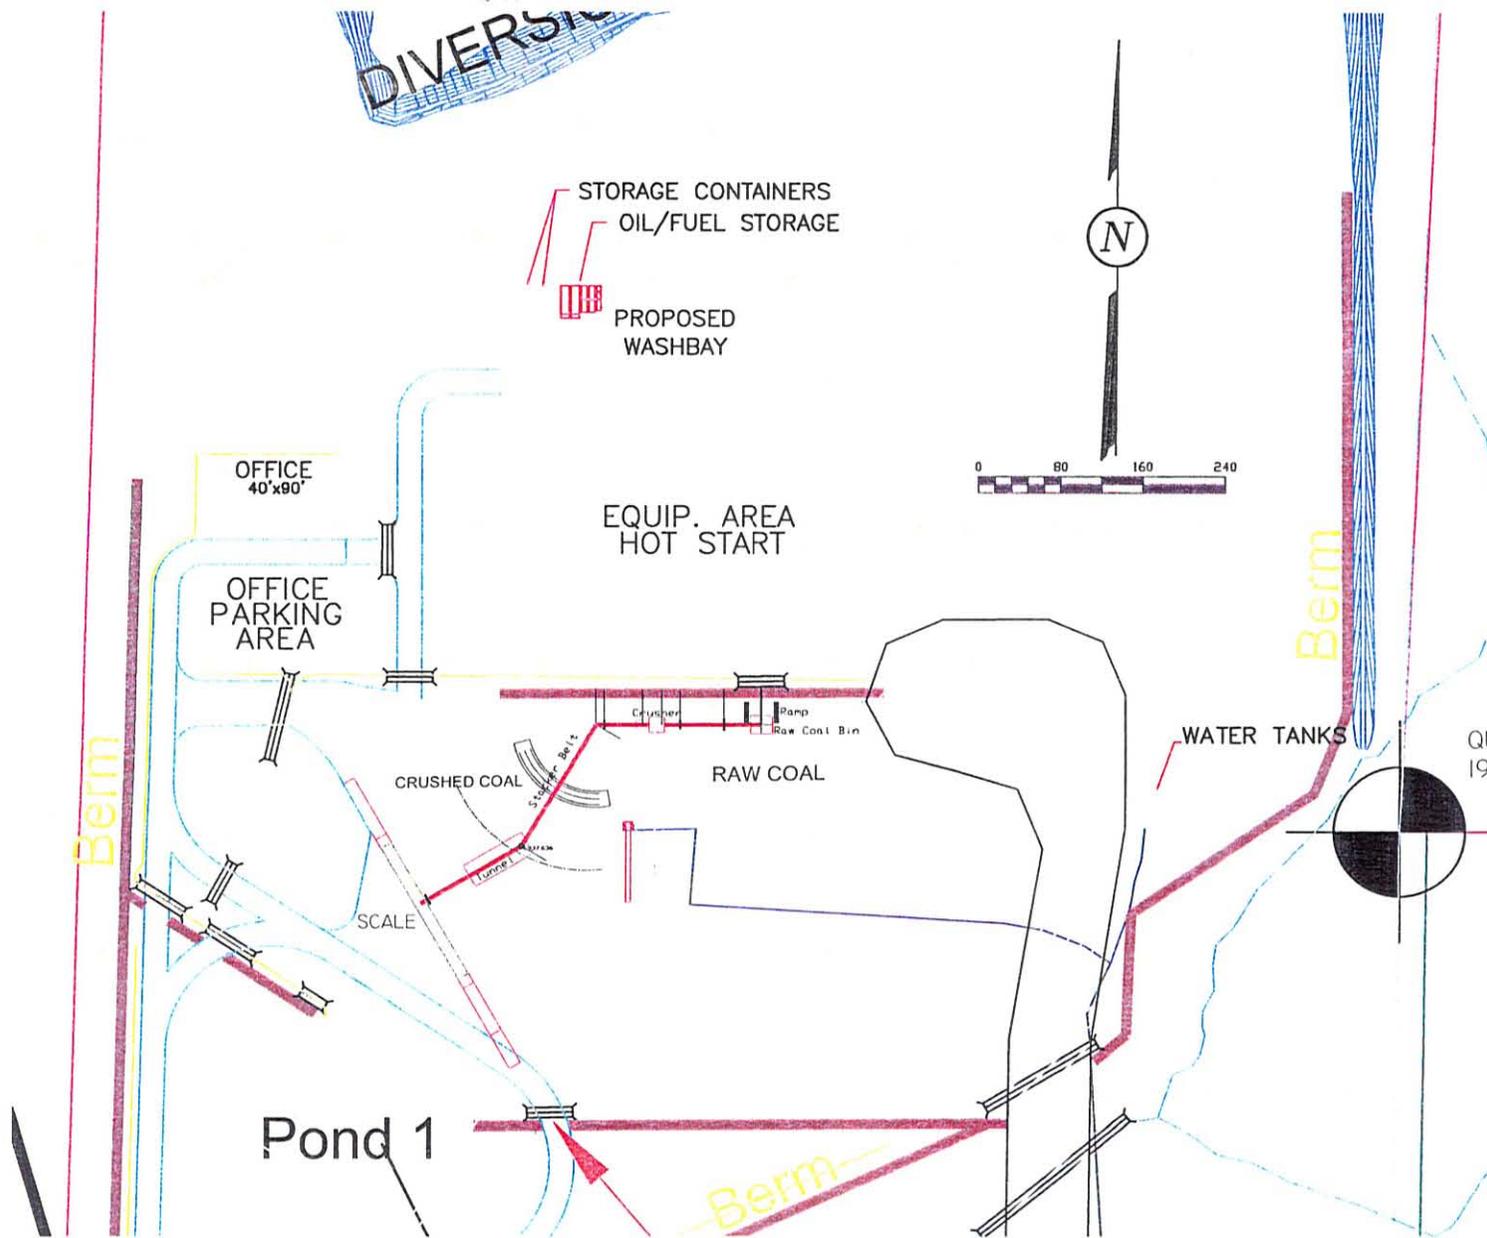
The proposed physical layout of the facility is shown in Figure 3-1. The layout of the facility as well as the equipment quantities and types shown are subject to change.

Figure 3-1	Proposed Facility Site Plan	5
------------	-----------------------------------	---

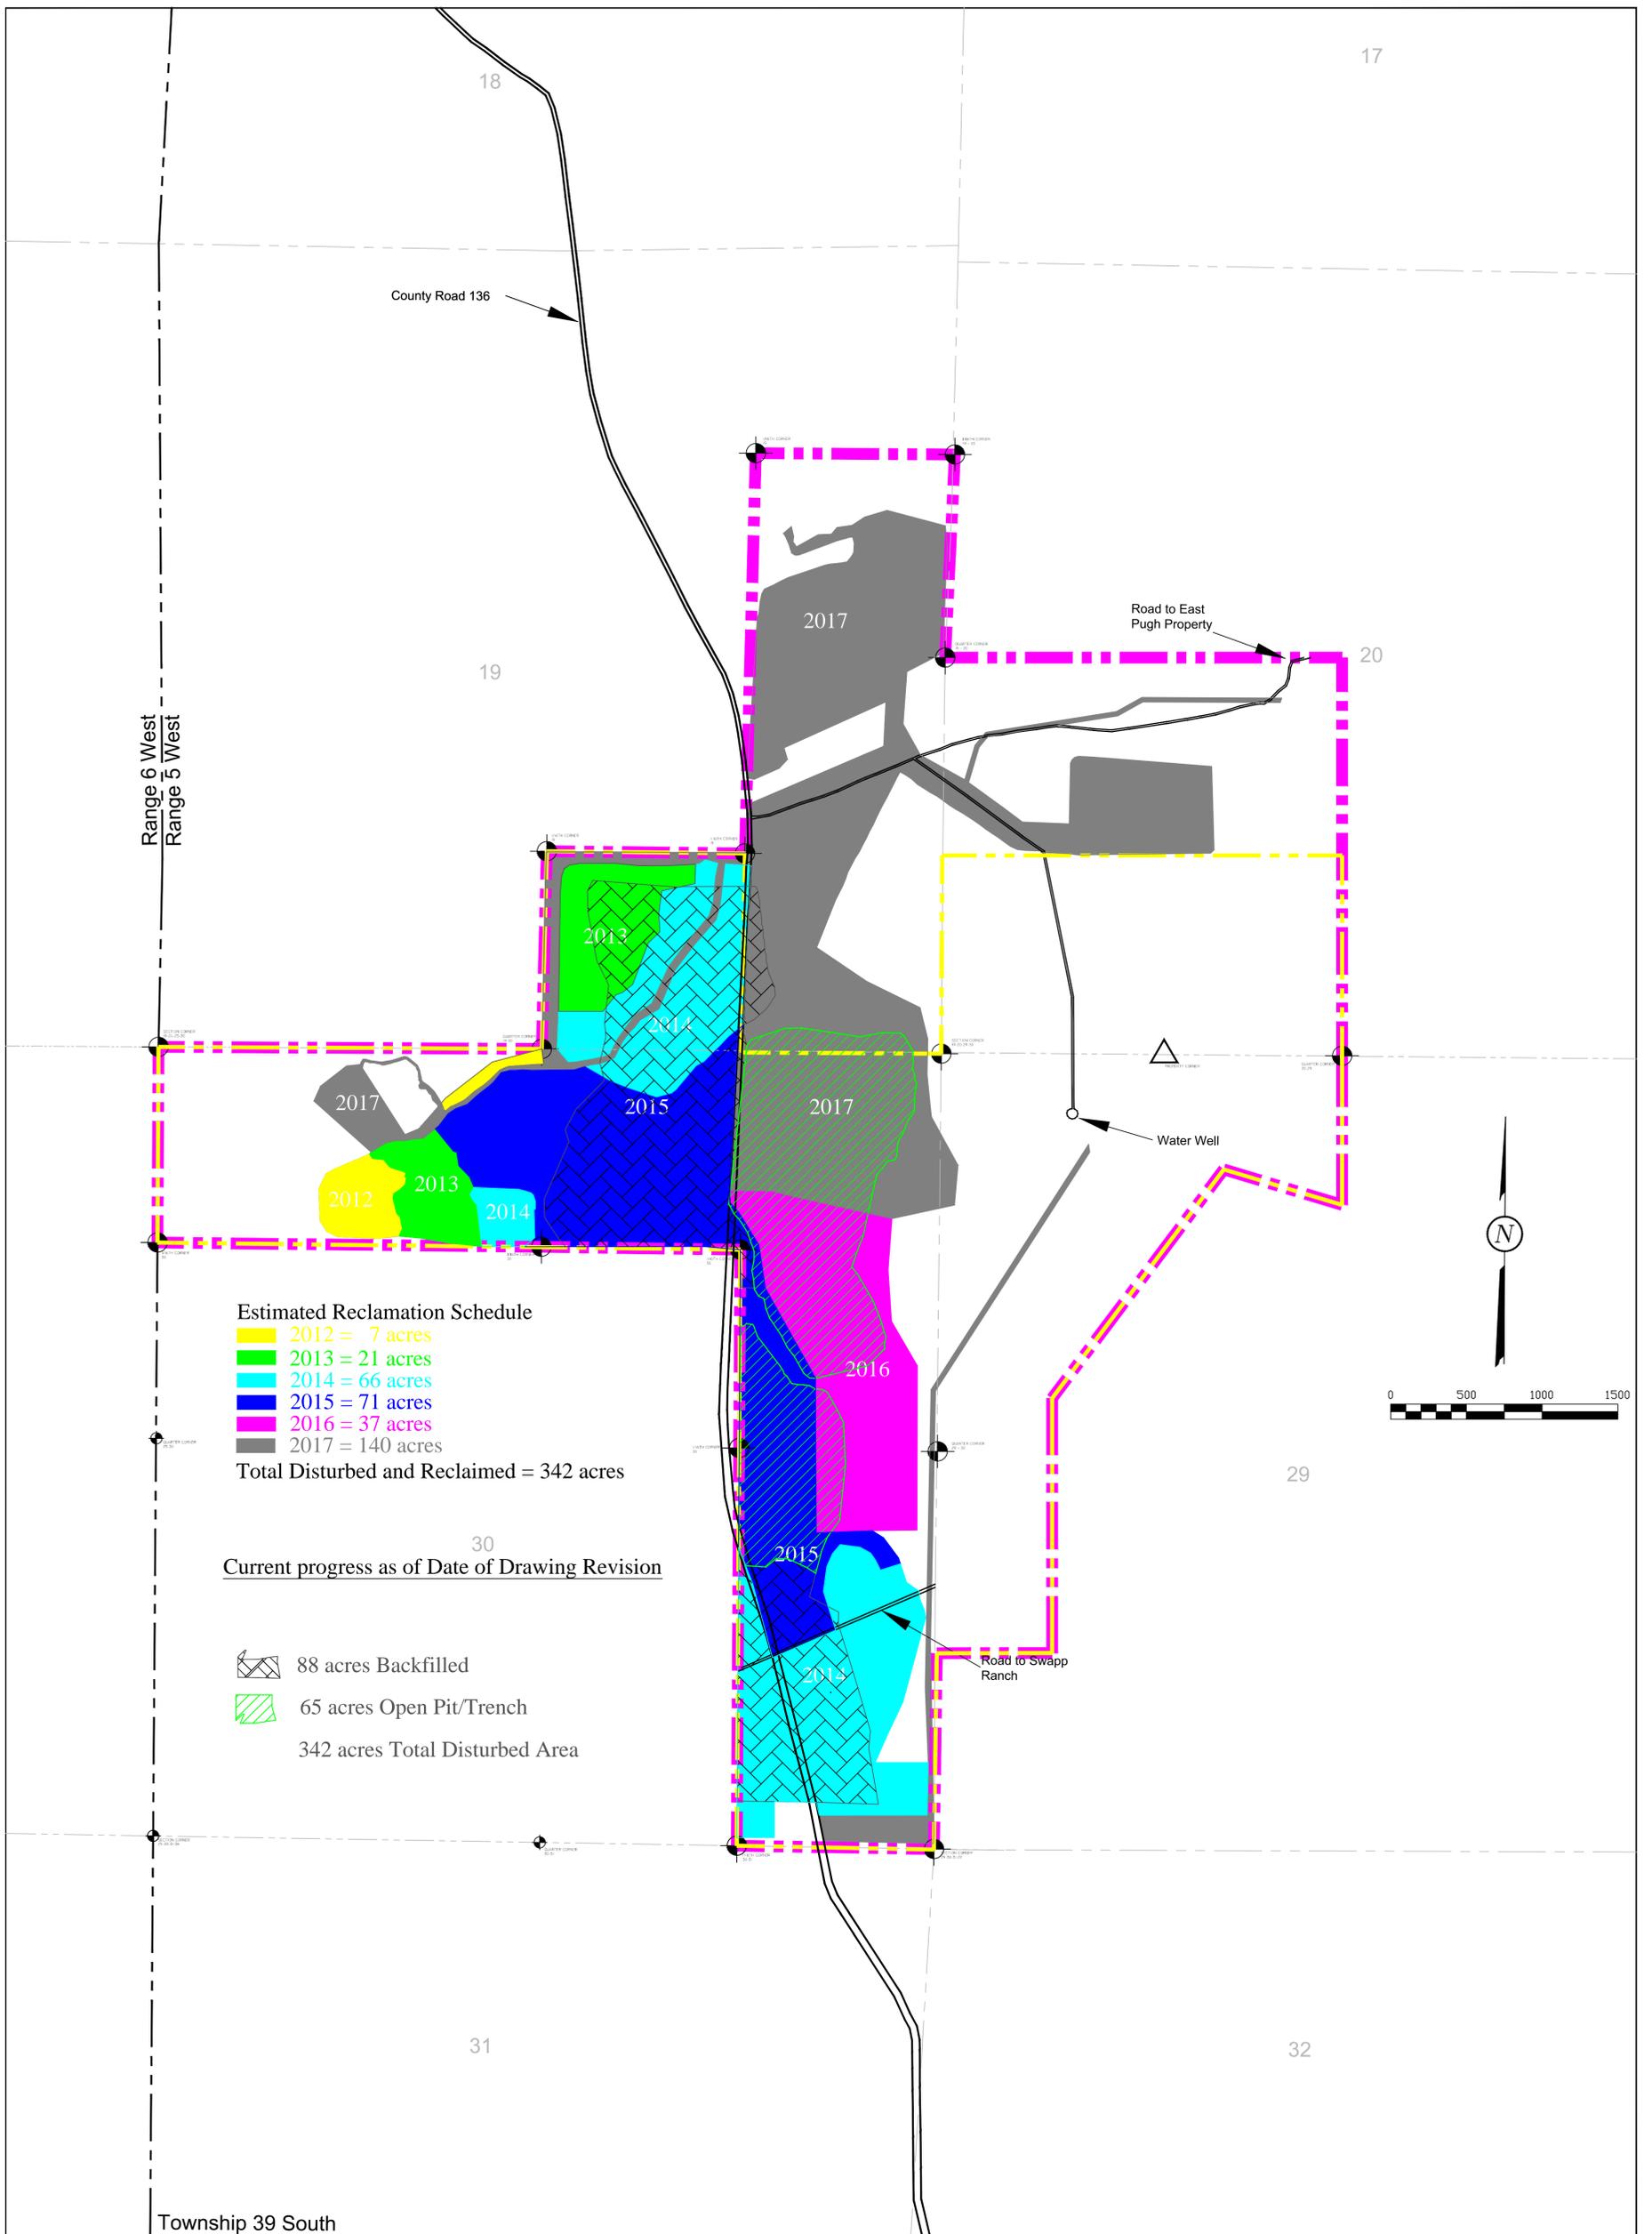
LEGEND: PERMIT BOUNDARY PRIVATE COAL OWNERSHIP SECTION LINE FOUND SECTION CORNER FOUND PROPERTY CORNER POSTMINING ROADS	DRAWN BY: K. NICHOLAS	CHECKED BY: LWJ	REVISIONS		RECLAMATION SEQUENCE COAL HOLLOW PROJECT ALTON, UTAH DRAWING: 5-38		 Also: Coal Development 463 North 100 West, Suite 1 Cedar City, Utah 84721 Phone (435)867-5331 Fax (435)867-1192
	DRAWING: 5-38	DATE: 12/18/2014	DATE: 03/05/14	BY: KN			
	JOB NUMBER: 1400	SCALE: 1" = 500'	SHEET
