Subject: 2015 Coal Mining Annual Report; Alton Coal Development LLC, Coal Hollow Mine,  
C/025/0005

## APPLICATION FOR COAL PERMIT PROCESSING

**Title:** MRP Annual Report 2015 amendments to permit

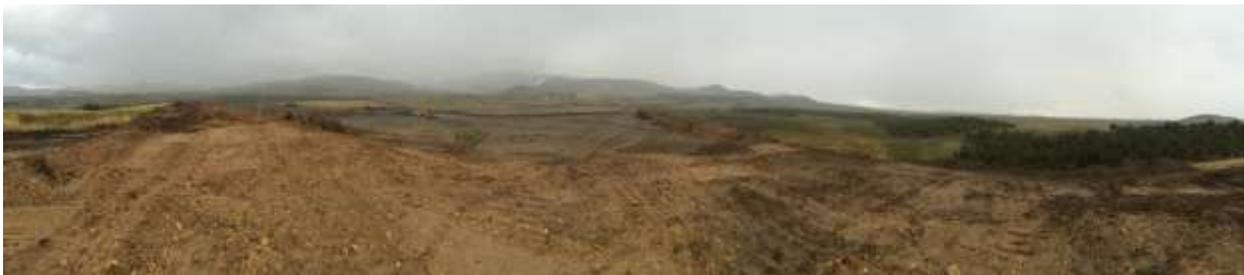
Figure 1. Panoramic view of the disturbance created by mining activities. Sage-grouse are often observed within this mining footprint. Each bird observed by employees is reported to the Environmental Manager who records these to identify locations visited by birds and to determine trends of site use over time.

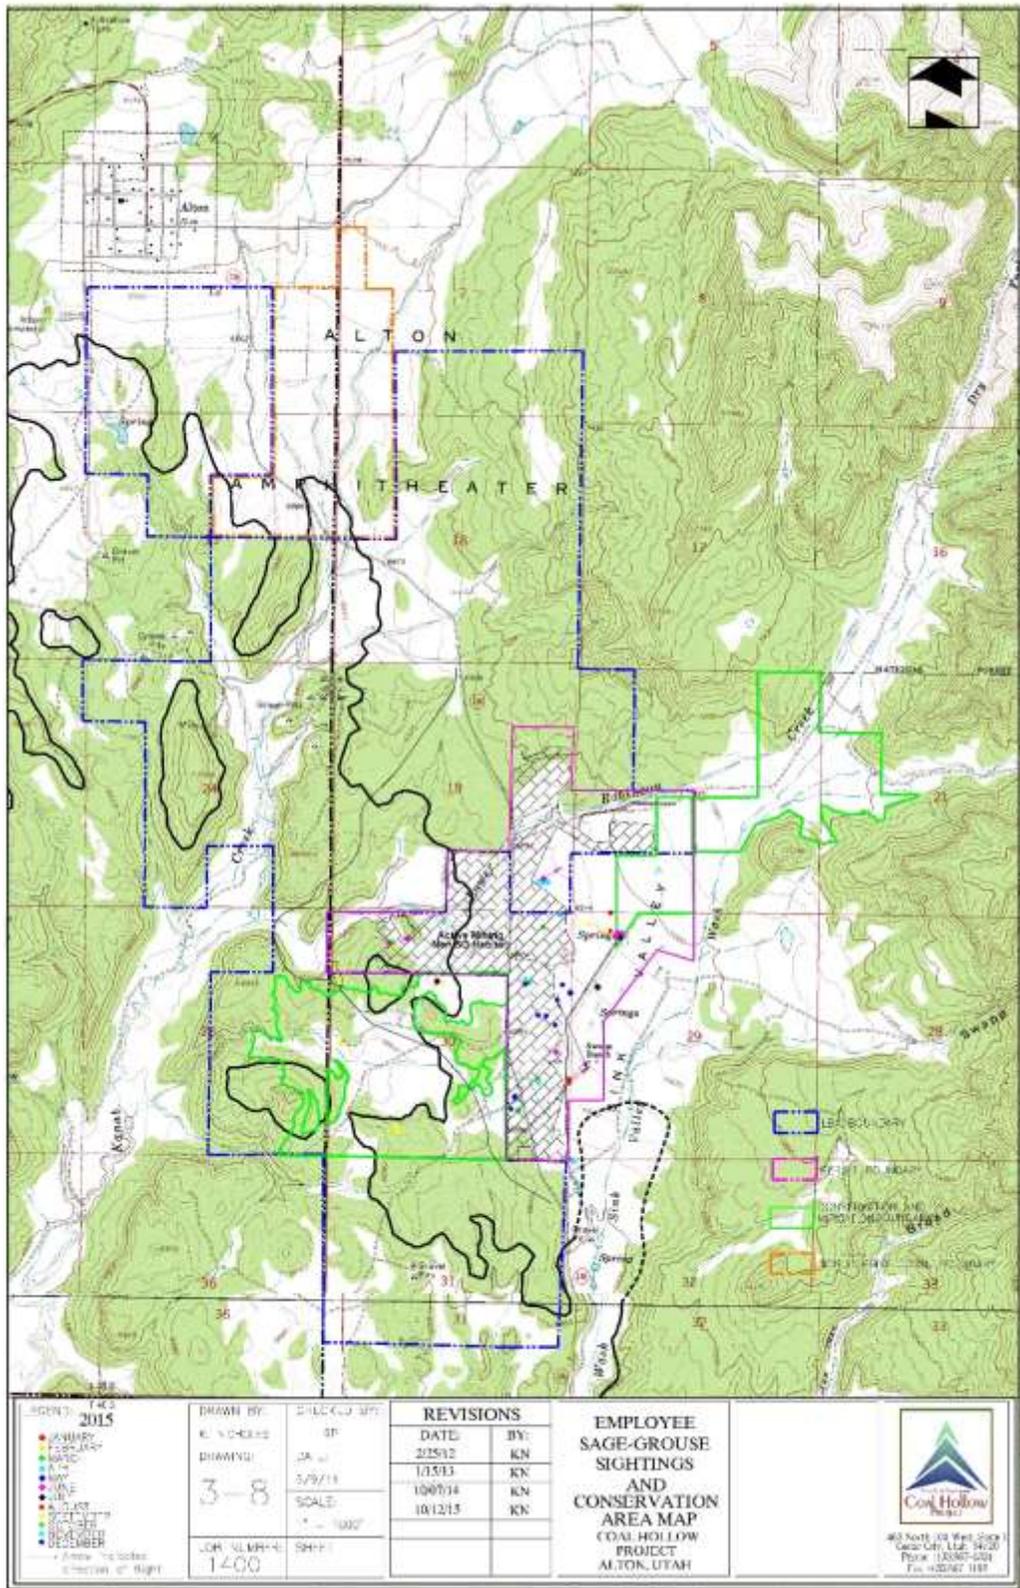
Figure 2. Location of sage-grouse observations made by ACD employees in 2015.

Each mine employee is trained to identify sage-grouse and to report any sighting to Kirk when the observation is made. When Kirk receives an employee sighting report, he identifies the coordinate location for that sighting and records this information in a logbook. The results of these sightings are used to assess population patterns and trends within the mining area (Table 1). For each employee report, Kirk maps the coordinate location for that sighting and the time the data was collected. This provides a record of sage-grouse population activity and habitat use within the Alton and Sink Valley areas directly associated with mining activities (Figure 2). To capture long-term employee observation patterns, Figure 3 represents all employee sightings over the past 3 years (2013-2015).

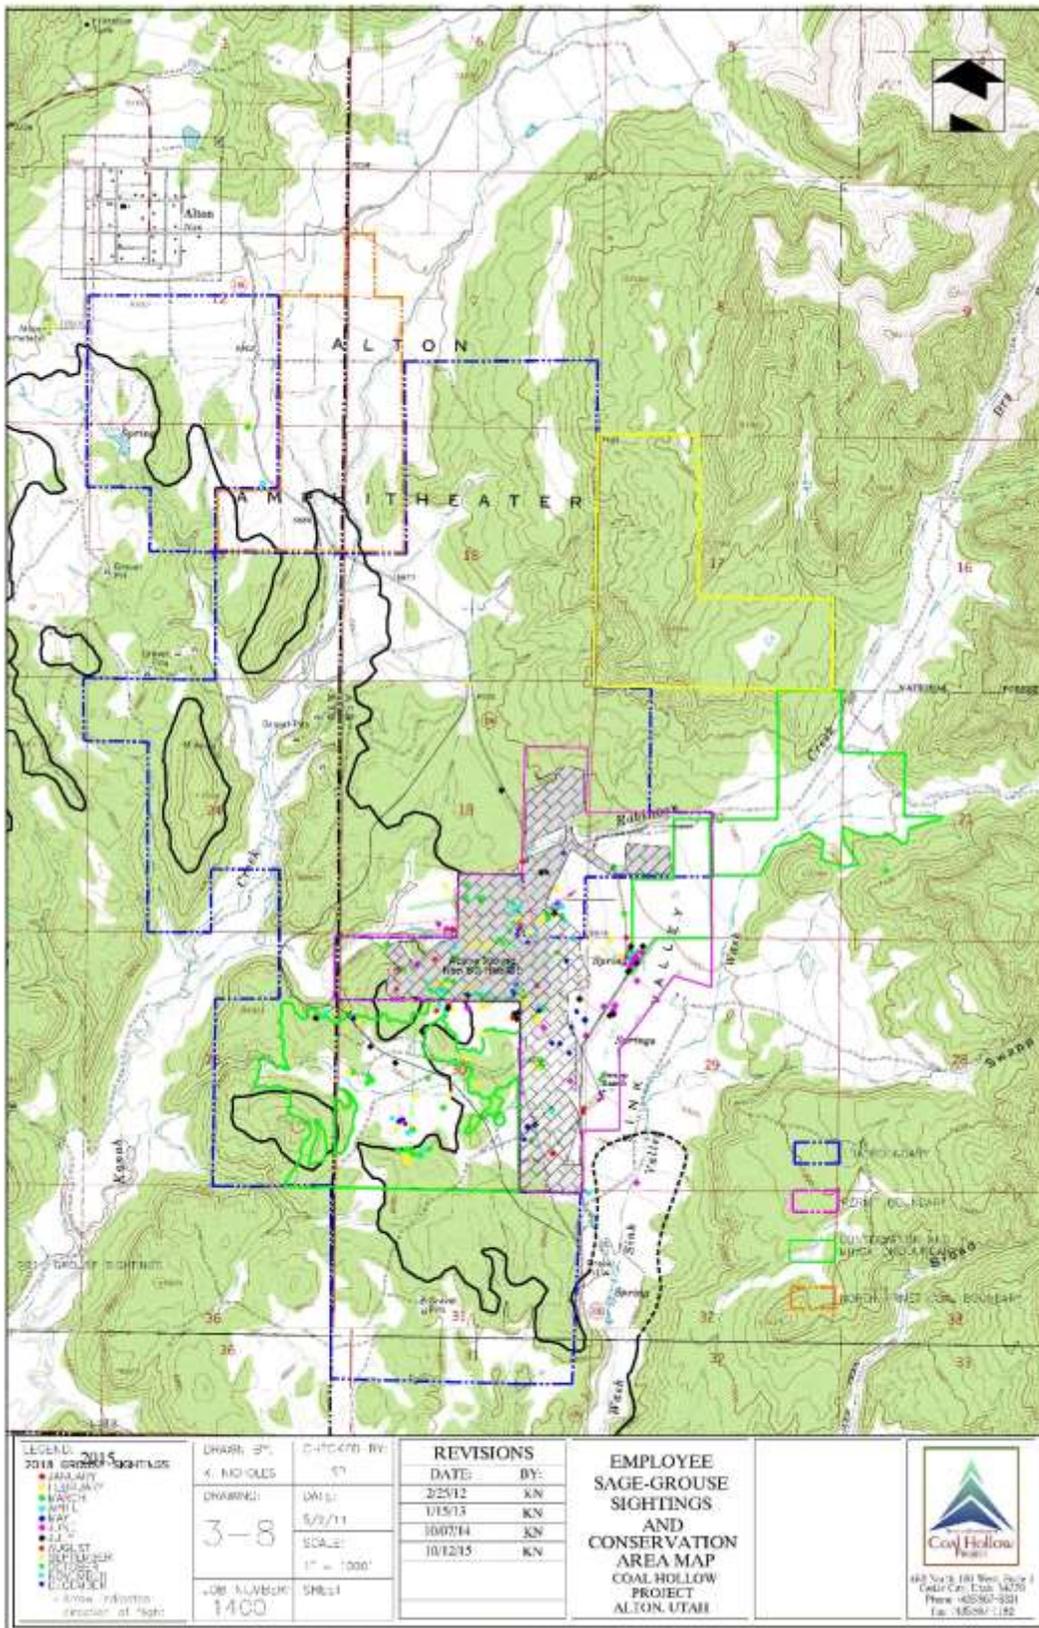
Figure 3. Combined employee sightings from 2013-2015.

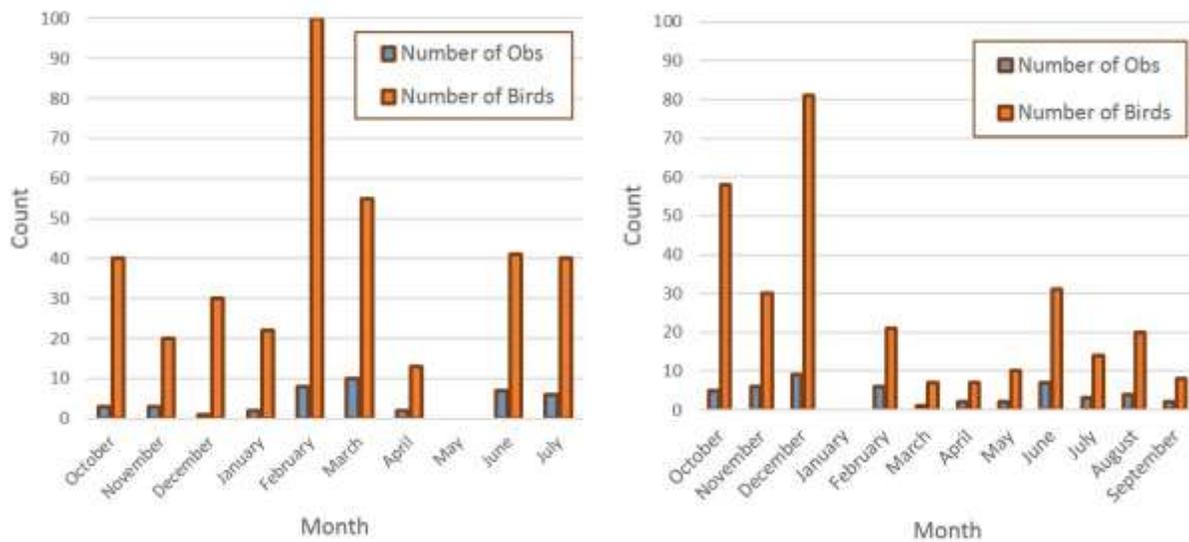
Figure 4. Employee sightings reported by month for 2014 (left) and 2015 (right). The “number of obs” reports how many times during each month employees reported bird observations. The “number of birds” reflects the total number of birds that were reported for those sightings. This number may include repeats that were seen from one day to the next. It is not a measure of bird densities for the mining area.

Comparing 2014 and 2015, employee observations have remained steady throughout the mining period (Figure 4). There are no detectable fluctuating patterns in mine site use between years and within each year.

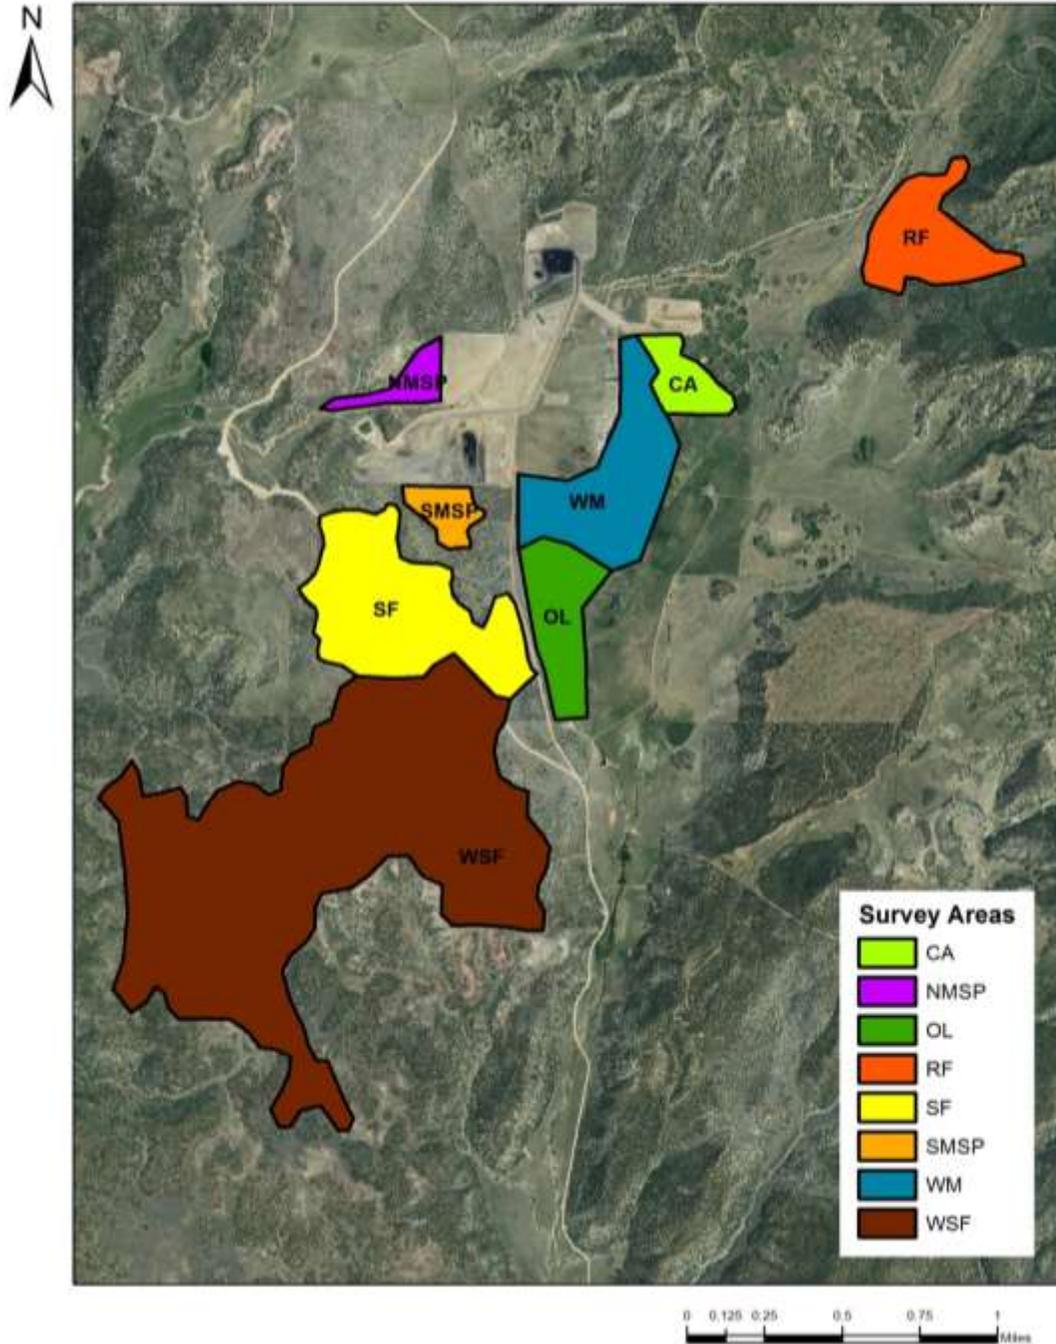
Figure 6. Location of survey areas for greater sage-grouse during the 2012-2014 monitoring seasons. CA = Conservation area, NMSP = North mine sagebrush patch, OL = Original lek, Rabbitbrush field, Sagebrush flat, SMSP = South mine sagebrush patch, WM = Wet meadow, and WSF = West sagebrush fields. Additional sites not shown above include the corridor (C) and the alfalfa fields (AF) south of Alton.

During each survey, all areas where birds may be found were searched (Figure 6). These areas included 1) the sagebrush flat area 0.5 km south of the open coal pits (SF), 2) the new lekking area located at the top of the ridge at the south end of the sagebrush flat area, 3) the sagebrush patch located just south of the spoils pile (SMSP) and north of the spoils piles (NMSP), 4) the original lekking area (OL), 5) the wet meadow (WM) located in grass/rush/sedge community surrounding the well, 6) the sagebrush area immediately east of the open mine, 7) the conservation area east of the mine site (CA), and 8) Ford's Pasture located 10 miles south of Sink Valley.

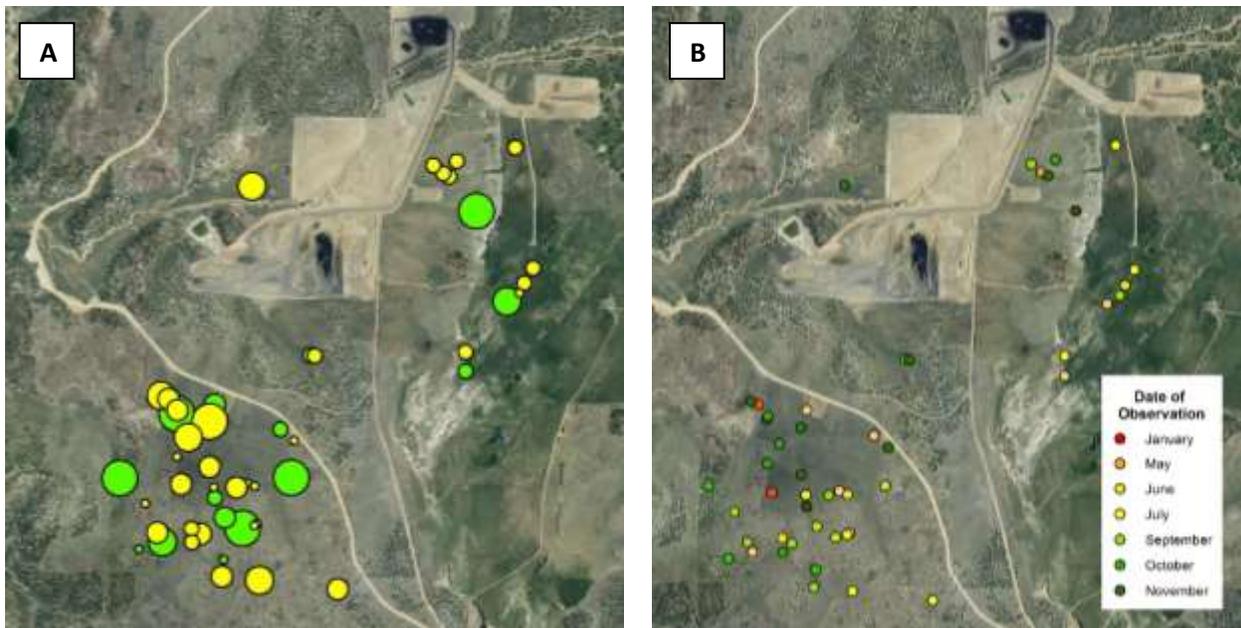
Figure 7. A) Location of greater sage-grouse during monthly field samples. Green points represent observations recorded in 2014 and yellow points are observations in 2015. The size of the dot is proportionate to the number of birds observed at that location (flock). B) Location of bird observations by month during non-breeding months for the 2014-15 survey period.

A summary of the results recorded for each monthly sage-grouse survey is provided in table 2. Figure 7 (map) shows the location for all sage-grouse sightings recorded during monthly surveys in the Alton/Sink Valley area (2014-2015) and displays bird observation locations by month. Of all sites observed, birds were most consistently found in the sagebrush flat area south of the mine (Figure 8) and in the region surrounding the conservation area (Figure 5). These sites are dominated by black sagebrush (*Artemisia nova* A. Nelson) and mountain big sagebrush (*Artemisia tridentata* Nutt. ssp. *vaseyana* (Rydb.) Beetle) with a diversity of associated perennial grasses and forbs. Detailed descriptions of plant community composition and structure in these areas can be found in vegetation reports prepared by Patrick Collins.

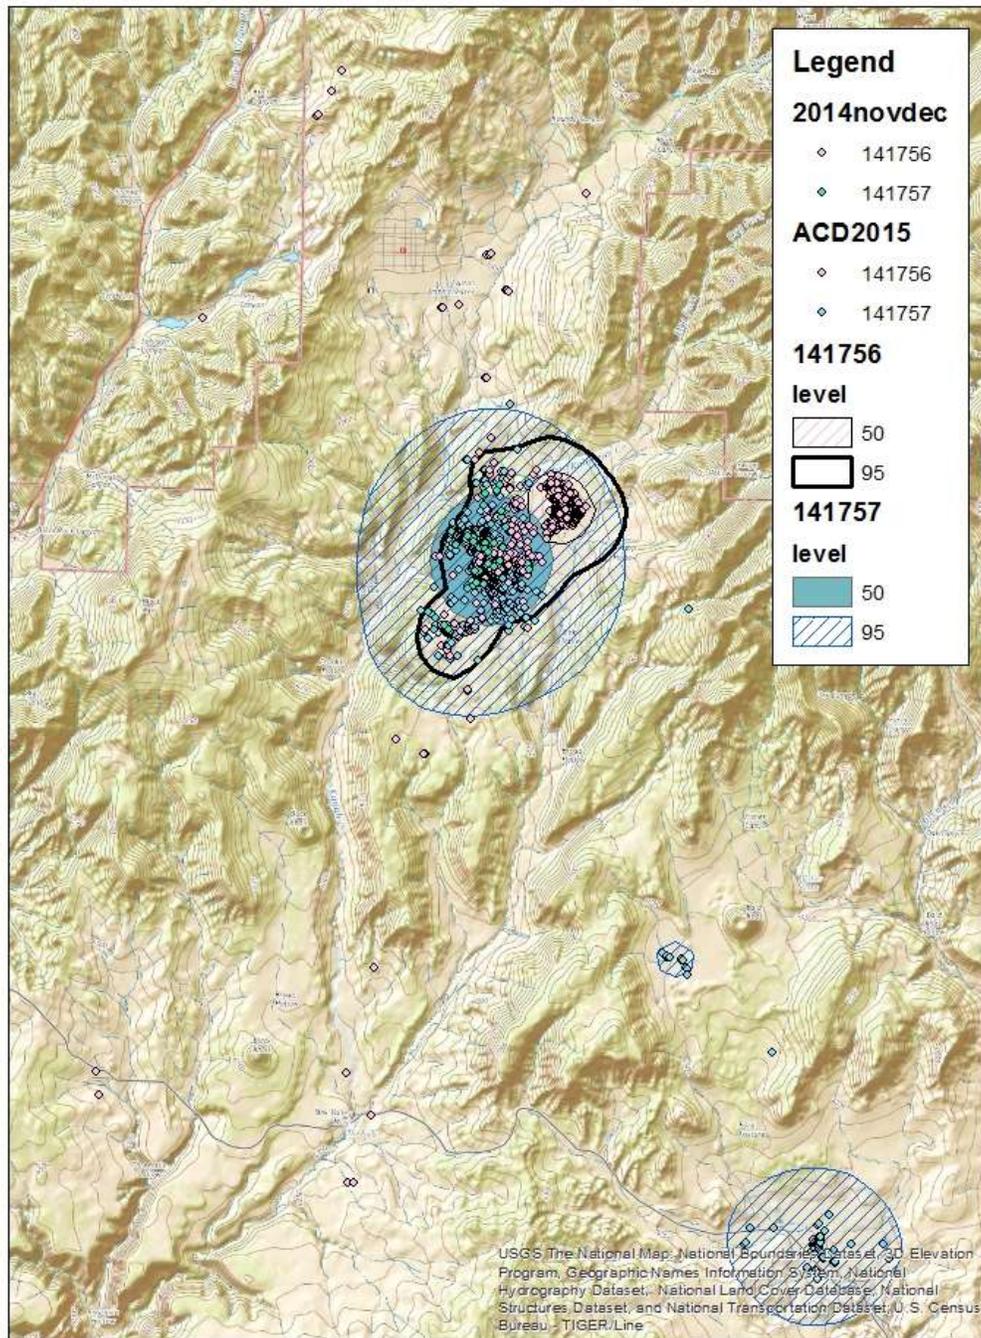
Figure 9. Coordinate locations for two sage-grouse trapped and monitored in the Alton / Sink Valley area and Fords Pasture to the south (southeast corner of the map). These data span over a 1 year time period collecting approximately 3 points per day. Data were collected, managed and owned by Dr. Nicki Frey (Utah State University Extension, Southern Utah University). These data should not be used or shared without her consent.

Results of the data collected from the Alton/Sink Valley GPS collared birds demonstrate similar movement patterns compared those recorded from the monthly surveys and employee sightings (Figure 9 and 10). According to Dr. Frey:

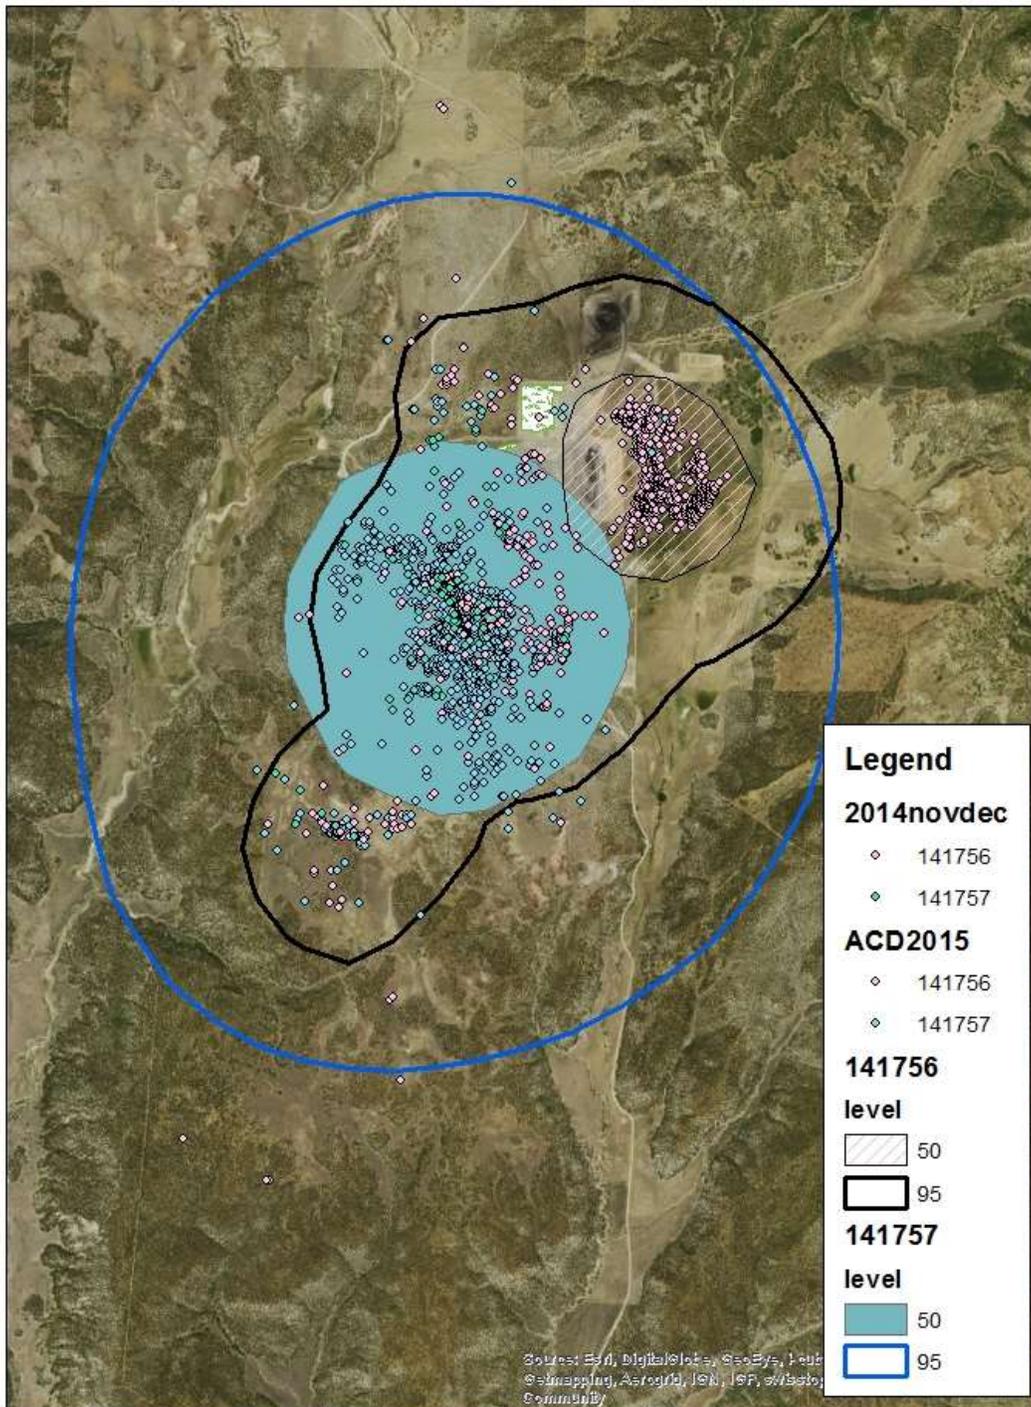
Figure 10. Coordinate locations for two sage-grouse trapped and monitored in the Alton / Sink Valley area span over a 1 year time period, representing approximately 3 points per day. This area shows kernel density estimates for sage-grouse habitat use. The area in blue is located around the sagebrush flat area and within the mine footprint directly. Clustering of points on the east side of the mine represent brood rearing habitat. These data were collected and are currently managed and owned by Dr. Nicki Frey (Utah State University Extension, Southern Utah University). These should not be shared or used without her consent.

*Kernel Density Estimates are those that depict the core area (50% "most dense" locations) and the general home range (95% of the locations). This analysis determined that more 75% percent of the location fell within the 50% core for each animal. You may also note that the brood rearing habitat appears to be directly to the east of the mining activity.*

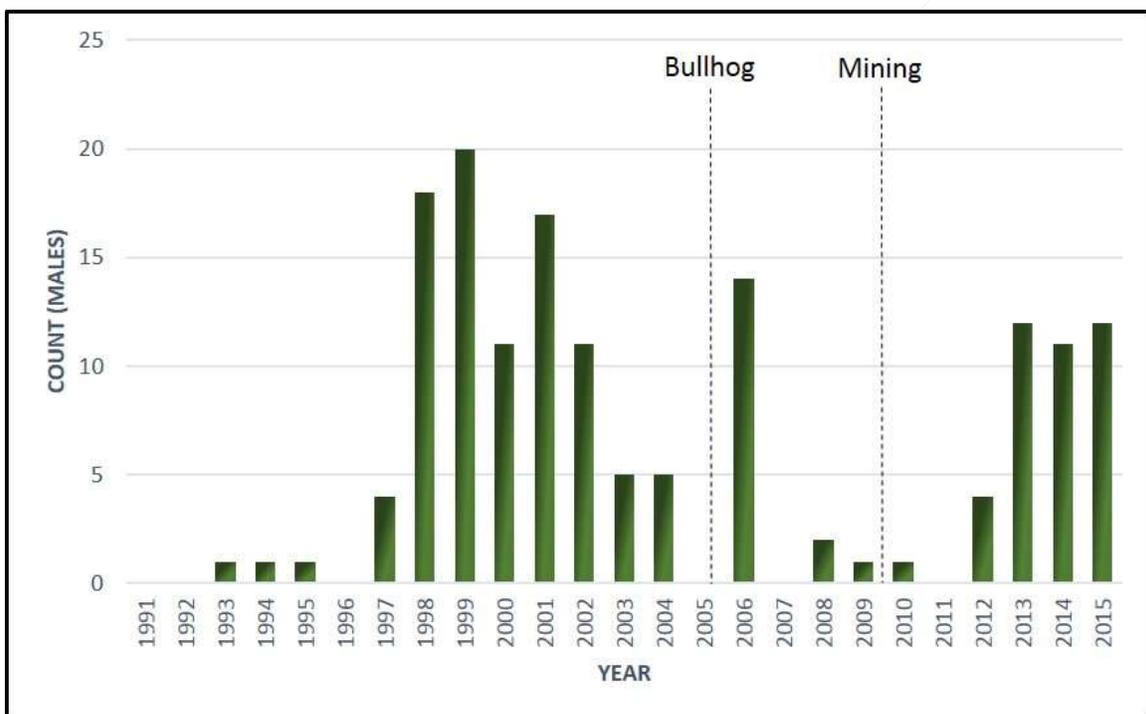
Figure 11. Male bird attendance at the Sink Valley lek, located south of Alton, Utah. Observations were made by Utah DWR employees observing during the spring breeding months (February – April). The 2005 and 2007 data are missing for this graph. Birds recorded from 2012-14 were located on the new lek. Previous observations were from the historic lek.

Greater sage-grouse have been found in the Sink Valley and Alton areas of Kane County, Utah for many generations. This has consisted of breeding activity (at the Sink Valley lek), nesting and brood rearing (likely near Sink Valley but this has been poorly documented), and winter habitat use primarily in Sink Valley and the Alton area. The density of birds reported using the Sink Valley area has fluctuated widely during the time they have been observed. The most accurate estimates of bird densities in this region are from lek counts that were conducted annually by wildlife biologists with the Utah Division of Wildlife Resources (UDWR). Since 1991, lek counts have experienced significant declines in strutting males. Data suggest that there has been an oscillation in male lek attendance over the past 24 years which likely reflects variable sage-grouse occurrence and habitat use within this area (Figure 11).

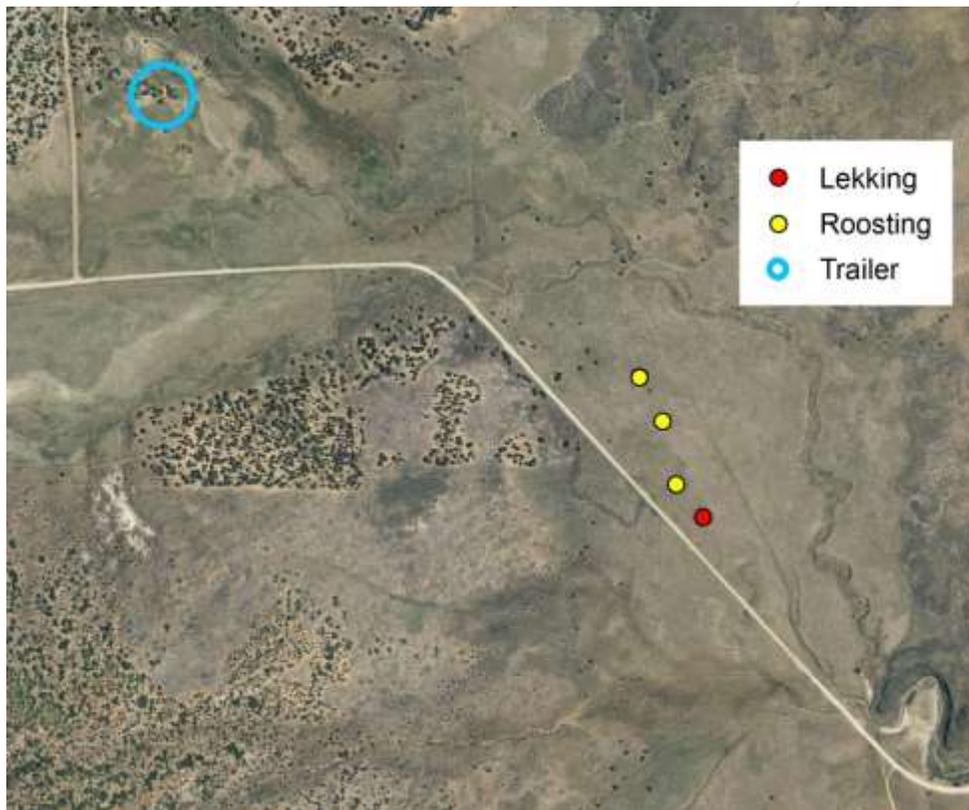
Figure 12. Fords Pasture area that supports fluctuating sage-grouse habitat use. Approximate location of lekking activity observed on March 7<sup>th</sup> and roost sites where birds were flushed during spotlight surveys. The blue circle represents the location of the trailer found in relatively close proximity to the sage-grouse use site (as a reference). The actual coordinate location of the lek was not recorded to avoid flushing displaying males.

To compare lek count results with nearby leks, Hoyts Ranch was reported to have had as many as 21 strutting males (April 16). On March 7, 3 males were observed strutting at the Fords Pasture (Figure 12). This was the first time birds have been observed strutting in that area for at least 10 years. This lek was historically active, reporting 12 males strutting at the lek in 1982. Since that date the lek became inactive for undetermined reasons. This strutting behavior reported this year in Fords Pasture represents the most southern lekking behavior for the species.

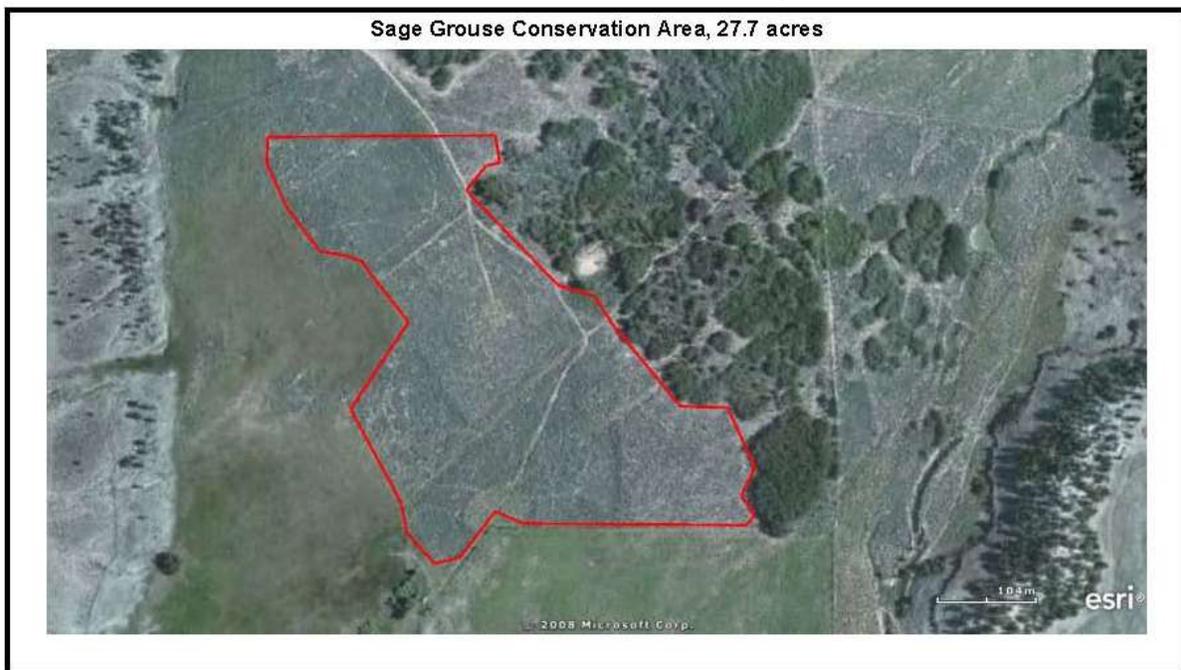
Figure 13. Area east of the mine site (Conservation Area) treated to reduce sagebrush in areas with high cover and shrub decadence.

In Fall 2015, 27 acres of mountain big and basin big sagebrush located in the Conservation Area (Figure 13) were treated to reduce sagebrush cover and open sites for intercanopy plant establishment. Kevin Heaton was contracted to disk decadent sagebrush areas aiming for post-treatment target cover of 15% (low end of recommended sagebrush cover for nesting and brood rearing; Connelly et al., 2000). After disking this area, a seed mix consisting of perennial grasses and forbs was broadcast using a ATV mounted spreader. A description of the seed mix is provided in Chapter 3 of the MRP.

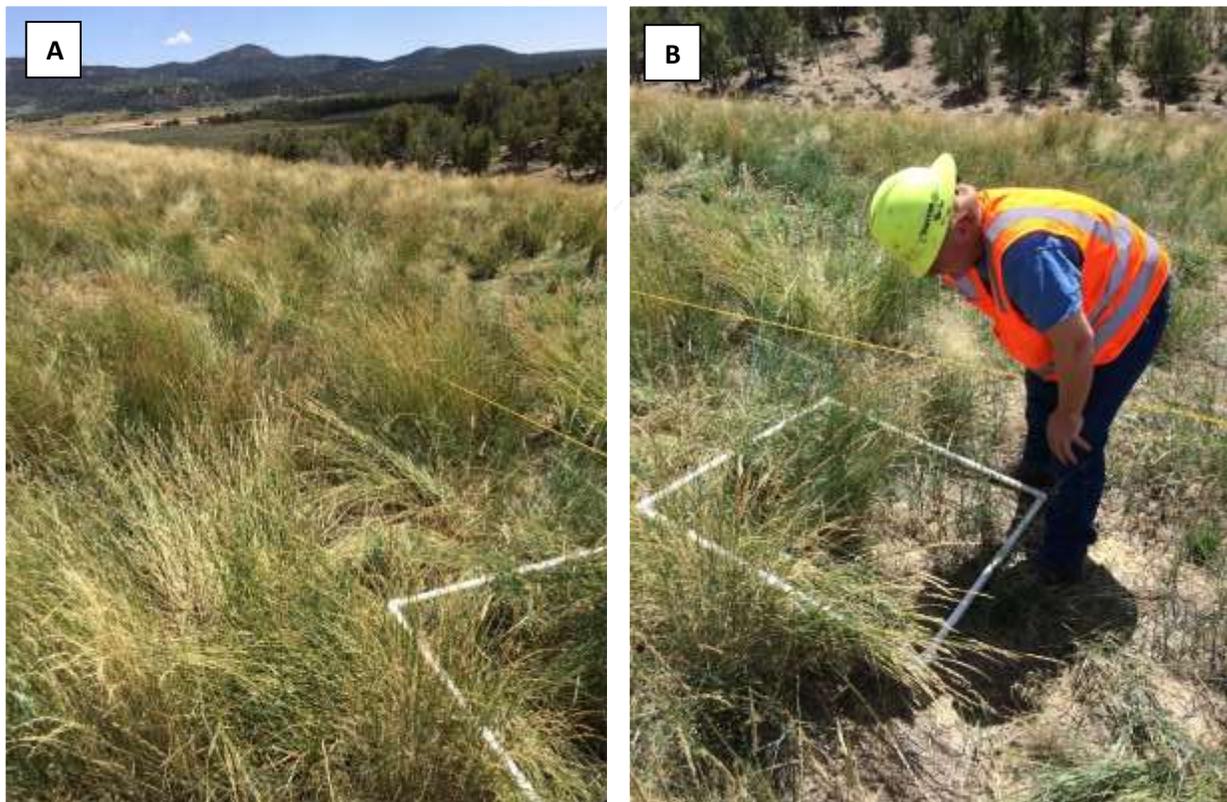
Figure 14. A) Vegetation growth and plant community establishment 2 years after seeding. B) Samples were collected to determine plant structure (density of plant species and percent cover).  
Photo with Kevin Heaton, USU Extension Specialist.

During the fall (August 24<sup>th</sup>), vegetation surveys were completed on the spoils pile positioned on the west side of the mining area. Topsoil was spread across the site and then seeded in fall 2013. Seeds were broadcast using a seed mix consisting of both native and introduced perennial grass and forb species (Figure 14A).

Four transects, each 100m long, were randomly positioned within the sample area to measure plant density and plant canopy cover (Figure 14B). A total of 20-1x1m quadrats were placed at 5m intervals along each transect to collect plant density data. The total number of individual plants rooted within the plot was recorded by species. Along the same transect lines, plant canopy cover was measured using the point-intercept method. A pin was dropped at 0.5m intervals along the entire transect length, and the first feature contacted with the falling pin was recorded. The total number of observations by feature was divided by the total number of pin drops to produce total feature cover. Features recorded included plants by species, rock, large litter (i.e. branches), fine litter (i.e. needles, detached dead herbaceous plant parts), and bare ground.

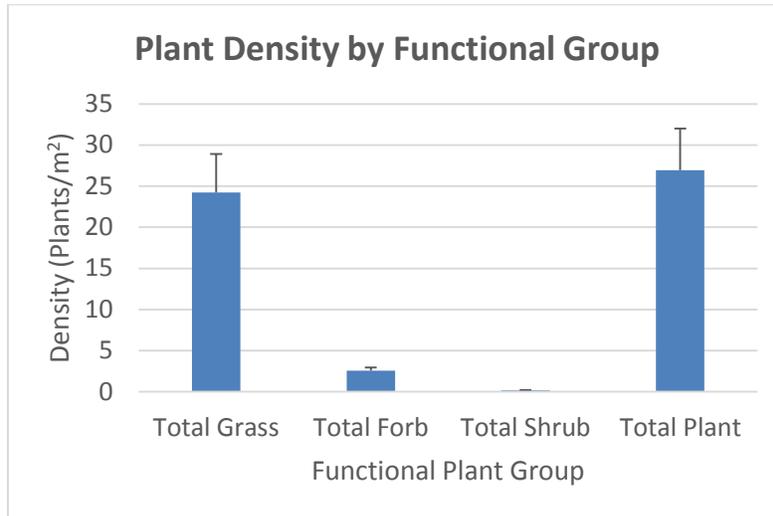
Figure 15. Density of plants established within the spoils pile reclamation area. Error bars represent the standard deviation of the data.

Species included in the reclaimed spoils pile reclamation area are provided in Appendix A, Table 2. Total plant density was highest for grasses and lowest for shrubs (Figure 15). By species, the most prevalent in the reclaimed plant community were western wheatgrass (ELSM) and slender wheatgrass (ELTR; Figure 16-19). Cheatgrass (BRTE) had high a density, however the variability in this species was also high across the spoils pile. Russian thistle, another invasive species, was also present in the community but with relatively low densities ( $0.6\pm 0.4$ ) and cover ( $0.3\pm 0.2$ ).

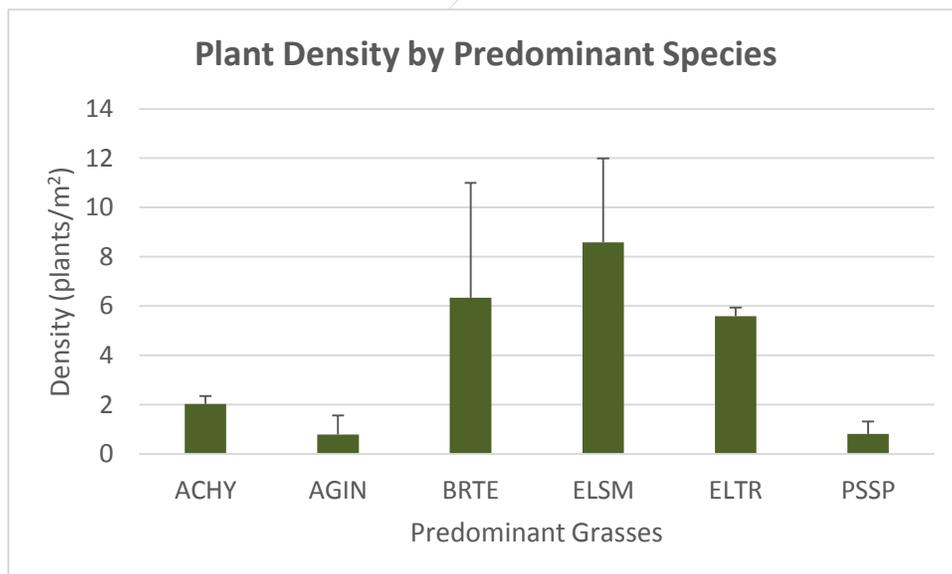
Figure 16. Plant species with the highest density of species sampled in the spoils pile reclamation area. Species include Indian ricegrass (ACHY), intermediate wheatgrass (AGIN), cheatgrass (BRTE), western wheatgrass (ELSM), slender wheatgrass (ELTR), and bluebunch wheatgrass (PSSP). Error bars represent the standard error ( of the data).

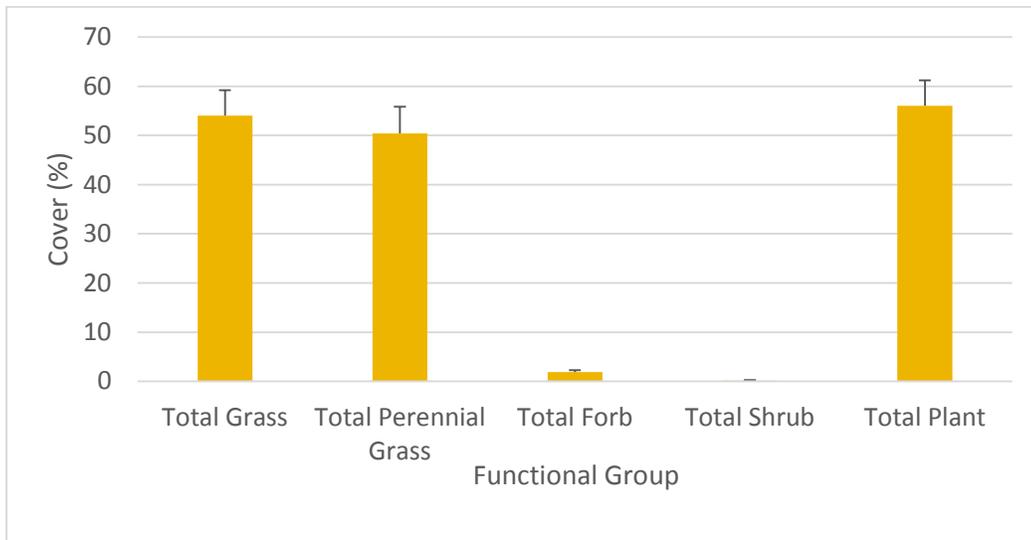
Figure 17. Percent canopy cover of plants sorted by functional group.

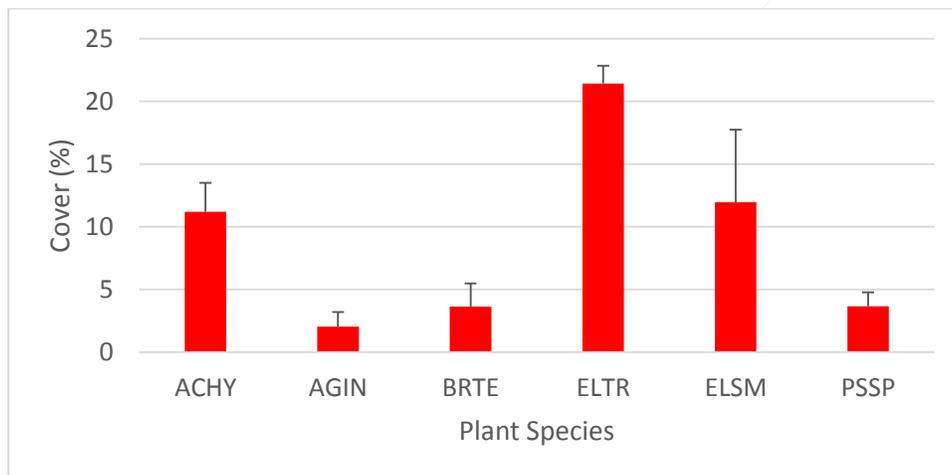
Figure 18. Percent canopy cover by predominant plant species based on those with highest values.

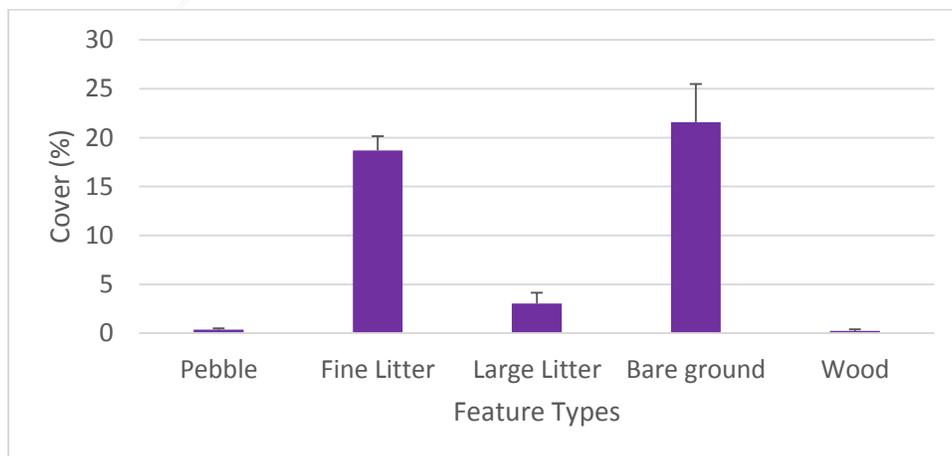
Figure 19. Percent canopy cover of surface features.

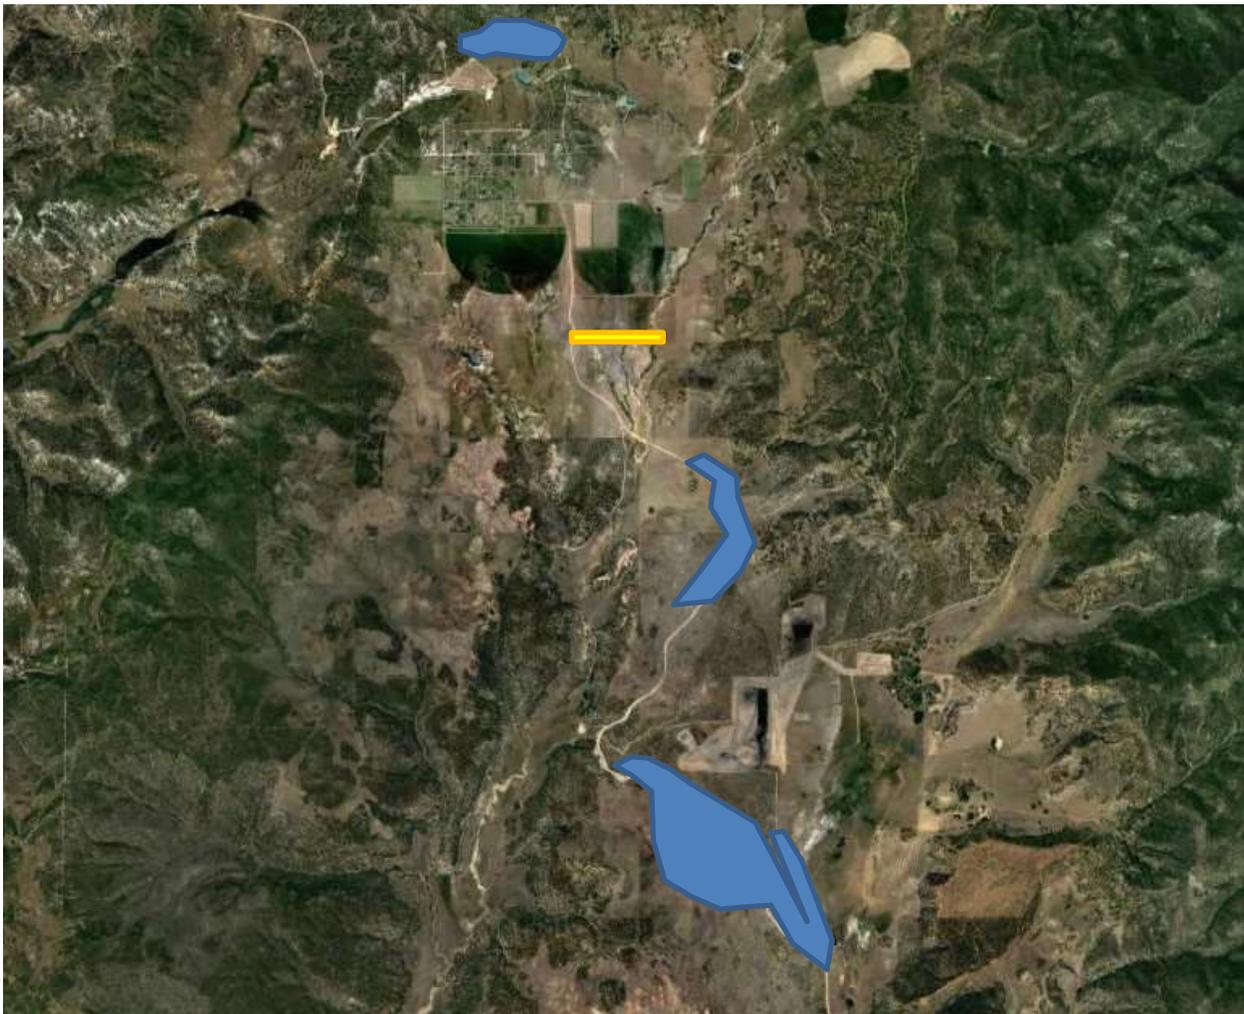
Figure 20. Blue polygons indicate areas where poison eggs were distributed by USDA Wildlife Services for raven control. This includes roadsides near critical habitat and the stock yard near Alton where birds congregate. The yellow polygon represents the location where coyote snares are set and trapped. Approximately 20 snares are set and checked every two days during the trapping season.

Teresa Wright, a raven control specialist with USDA wildlife services, has been funded by ACD to control ravens within the Alton/Sink Valley area. Raven control occurred from December 1, 2014 through December 1, 2015. A total of 1500 poisoned eggs were distributed within target areas shown in Figure 14. Eggs were treated with DRC 1339, a chemical that is specific for

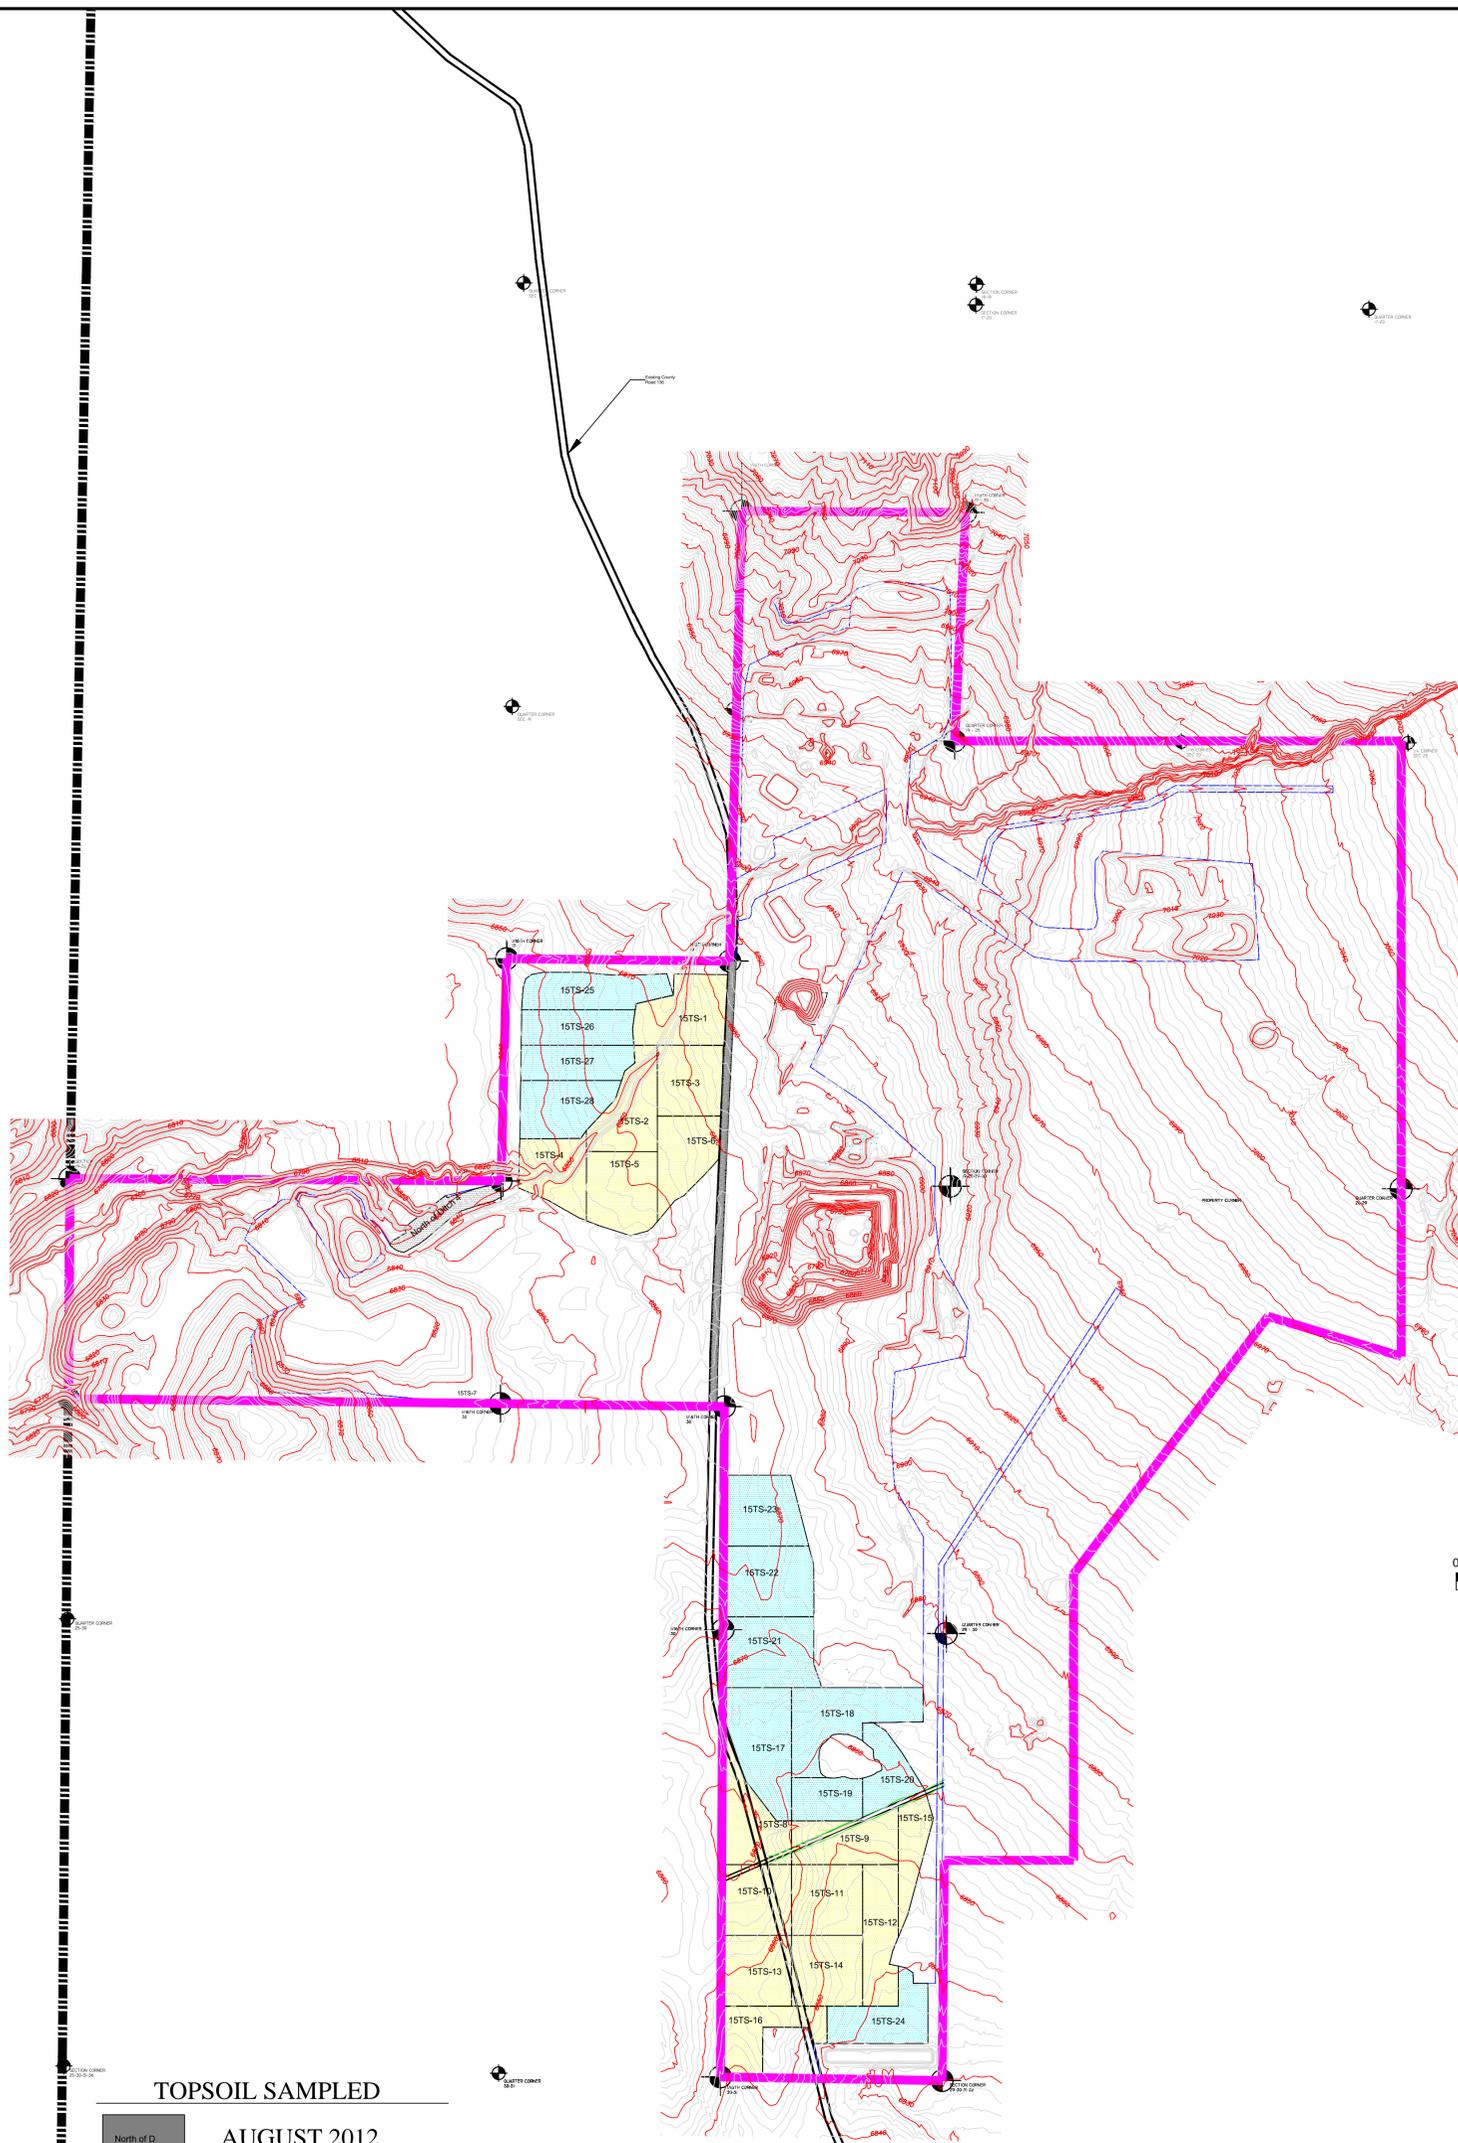
**FIGURE 1**

**TOPSOIL SAMPLED**

North of D	AUGUST 2012
15TS-XX	JULY 2015
15TS-XX	NOVEMBER 2015

Fifteen Topsoil samples were collected and analyzed in 2015 for topsoil placed in reclaimed areas. They have been included with the Annual Report along with an updated Figure 1 depicting sample locations.
