Subject: 2015 Coal Mining Annual Report; Alton Coal Development LLC, Coal Hollow Mine,  
C/025/0005

## APPLICATION FOR COAL PERMIT PROCESSING

**Title:** MRP Annual Report 2015 amendments to permit

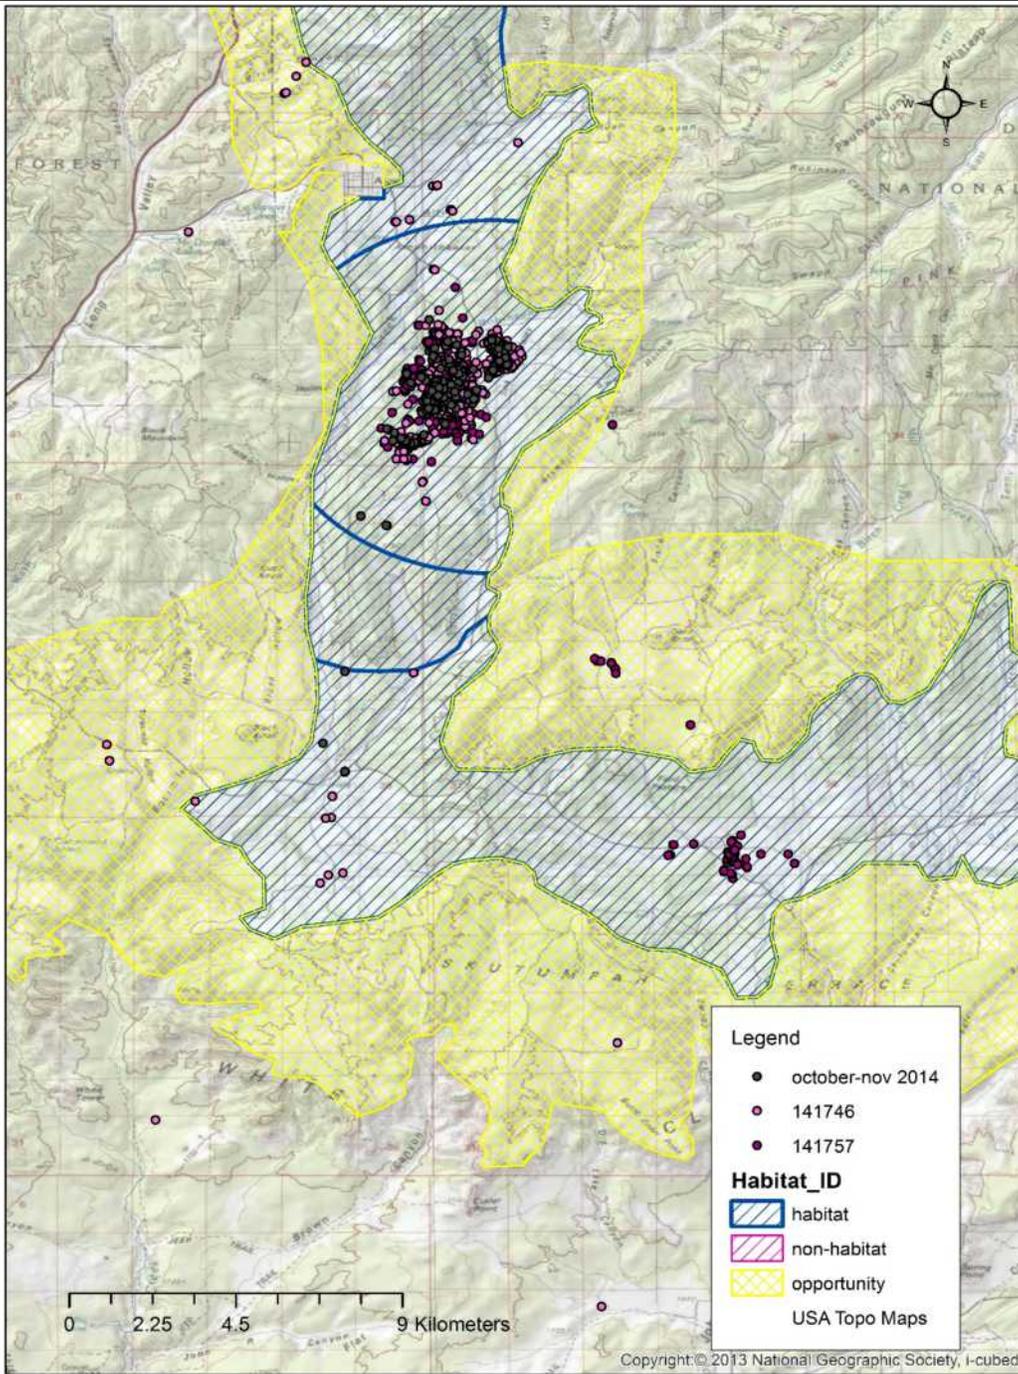
Figure 1: Location of GPS telemetry points of Greater sage-grouse, October 31, 2014 – December 31, 2015; Panguitch SGMA, Utah.

In October and November of 2014, 2 transmitters were deployed in Sink Valley; 1 adult male and 1 yearling female. Our female has remained on the air through the present time. Our male's receiver stopped projecting in November 2015; however, I report on data collected through December 31, 2015. We have acquired 1596 locations through December for the hen (141756) and 1247 locations for the male (141757). During the course of our study, October 2014- December 2015, both sage-grouse exclusively used the lek at Sink Valley during the breeding season. However, past data collected for the BLM in the breeding season of 2014 recorded individual grouse using both Sink Valley and Hoyt's Ranch lek. Therefore, we conclude that the population of grouse using Sink Valley is not isolated from other populations. All but 4 locations fell within the Panguitch SGMA Boundary. Twenty-one locations fell within opportunity areas, while the remaining locations were found within the areas designated as habitat (Figure 1).

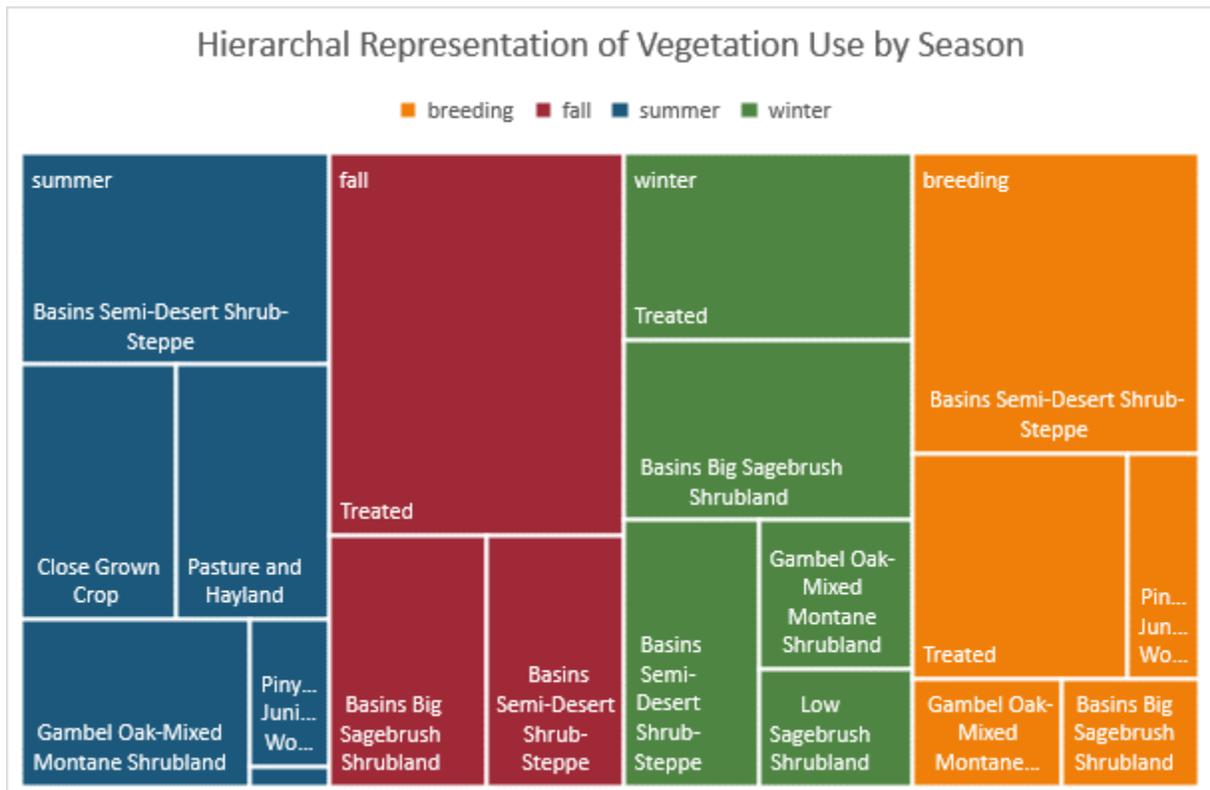
Figure 6: A hierarchal representation of vegetation use by 2 Greater sage-grouse by season, November 2014 – December 2015.

Using a hierarchal table to illustrate the importance of each habitat type for each season, several habitat types are highlighted (Figure 6). Treated areas feature prominently in all but the summer months. During the summer the hen was using more mesic sites, such as close-grown crops, pasture and hay lands.

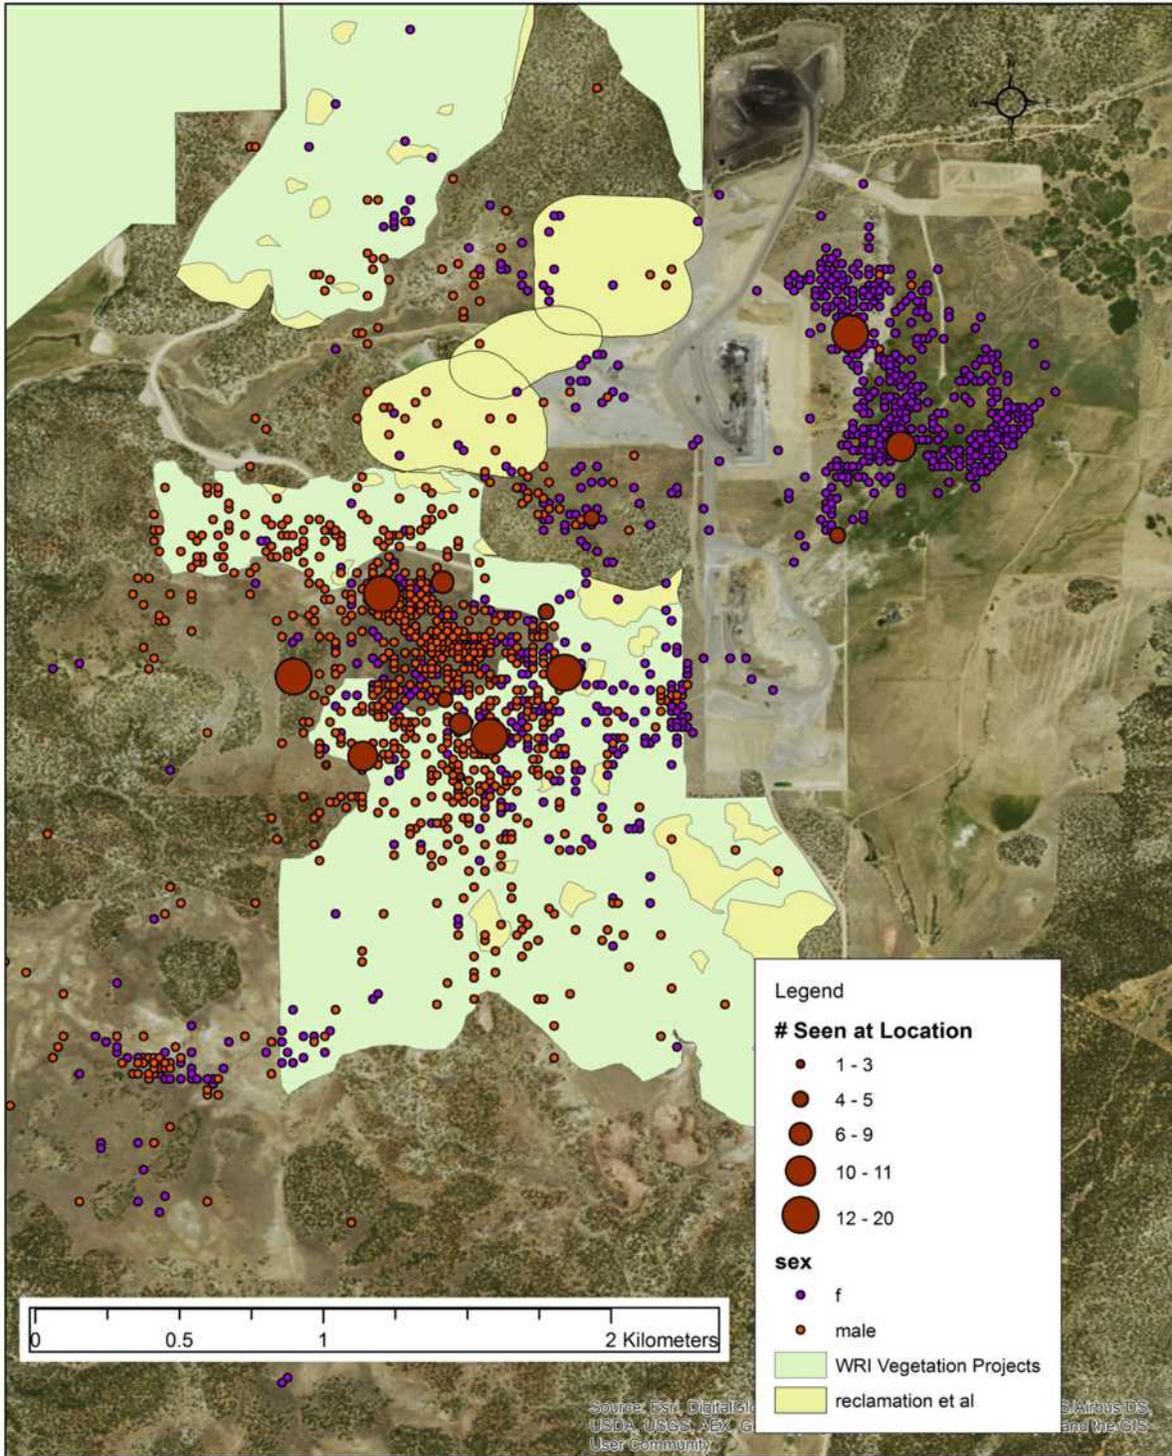
Figure 7: A depiction of grouse GPS location data and spotlight surveys in the Alton Sink Valley area, November 2014 – December 2015.

### Grouse locations combined with spotlight surveys 2014-2015

In the future, we propose to incorporate the telemetry data with spot-light survey data. This will combine spatial accuracy of grouse with a high-detail in time with data that illustrates the number of birds using each area (Figure 7). It will provide a better understanding of the importance of each telemetry location. For example, if a study bird is located with a flock of 10 other birds, then we know that its locations are common, rather than an exception. I provide a map of what the combined data will look like; however, I have not had time to assess the relationship between the spotlight surveys and the GPS locations.

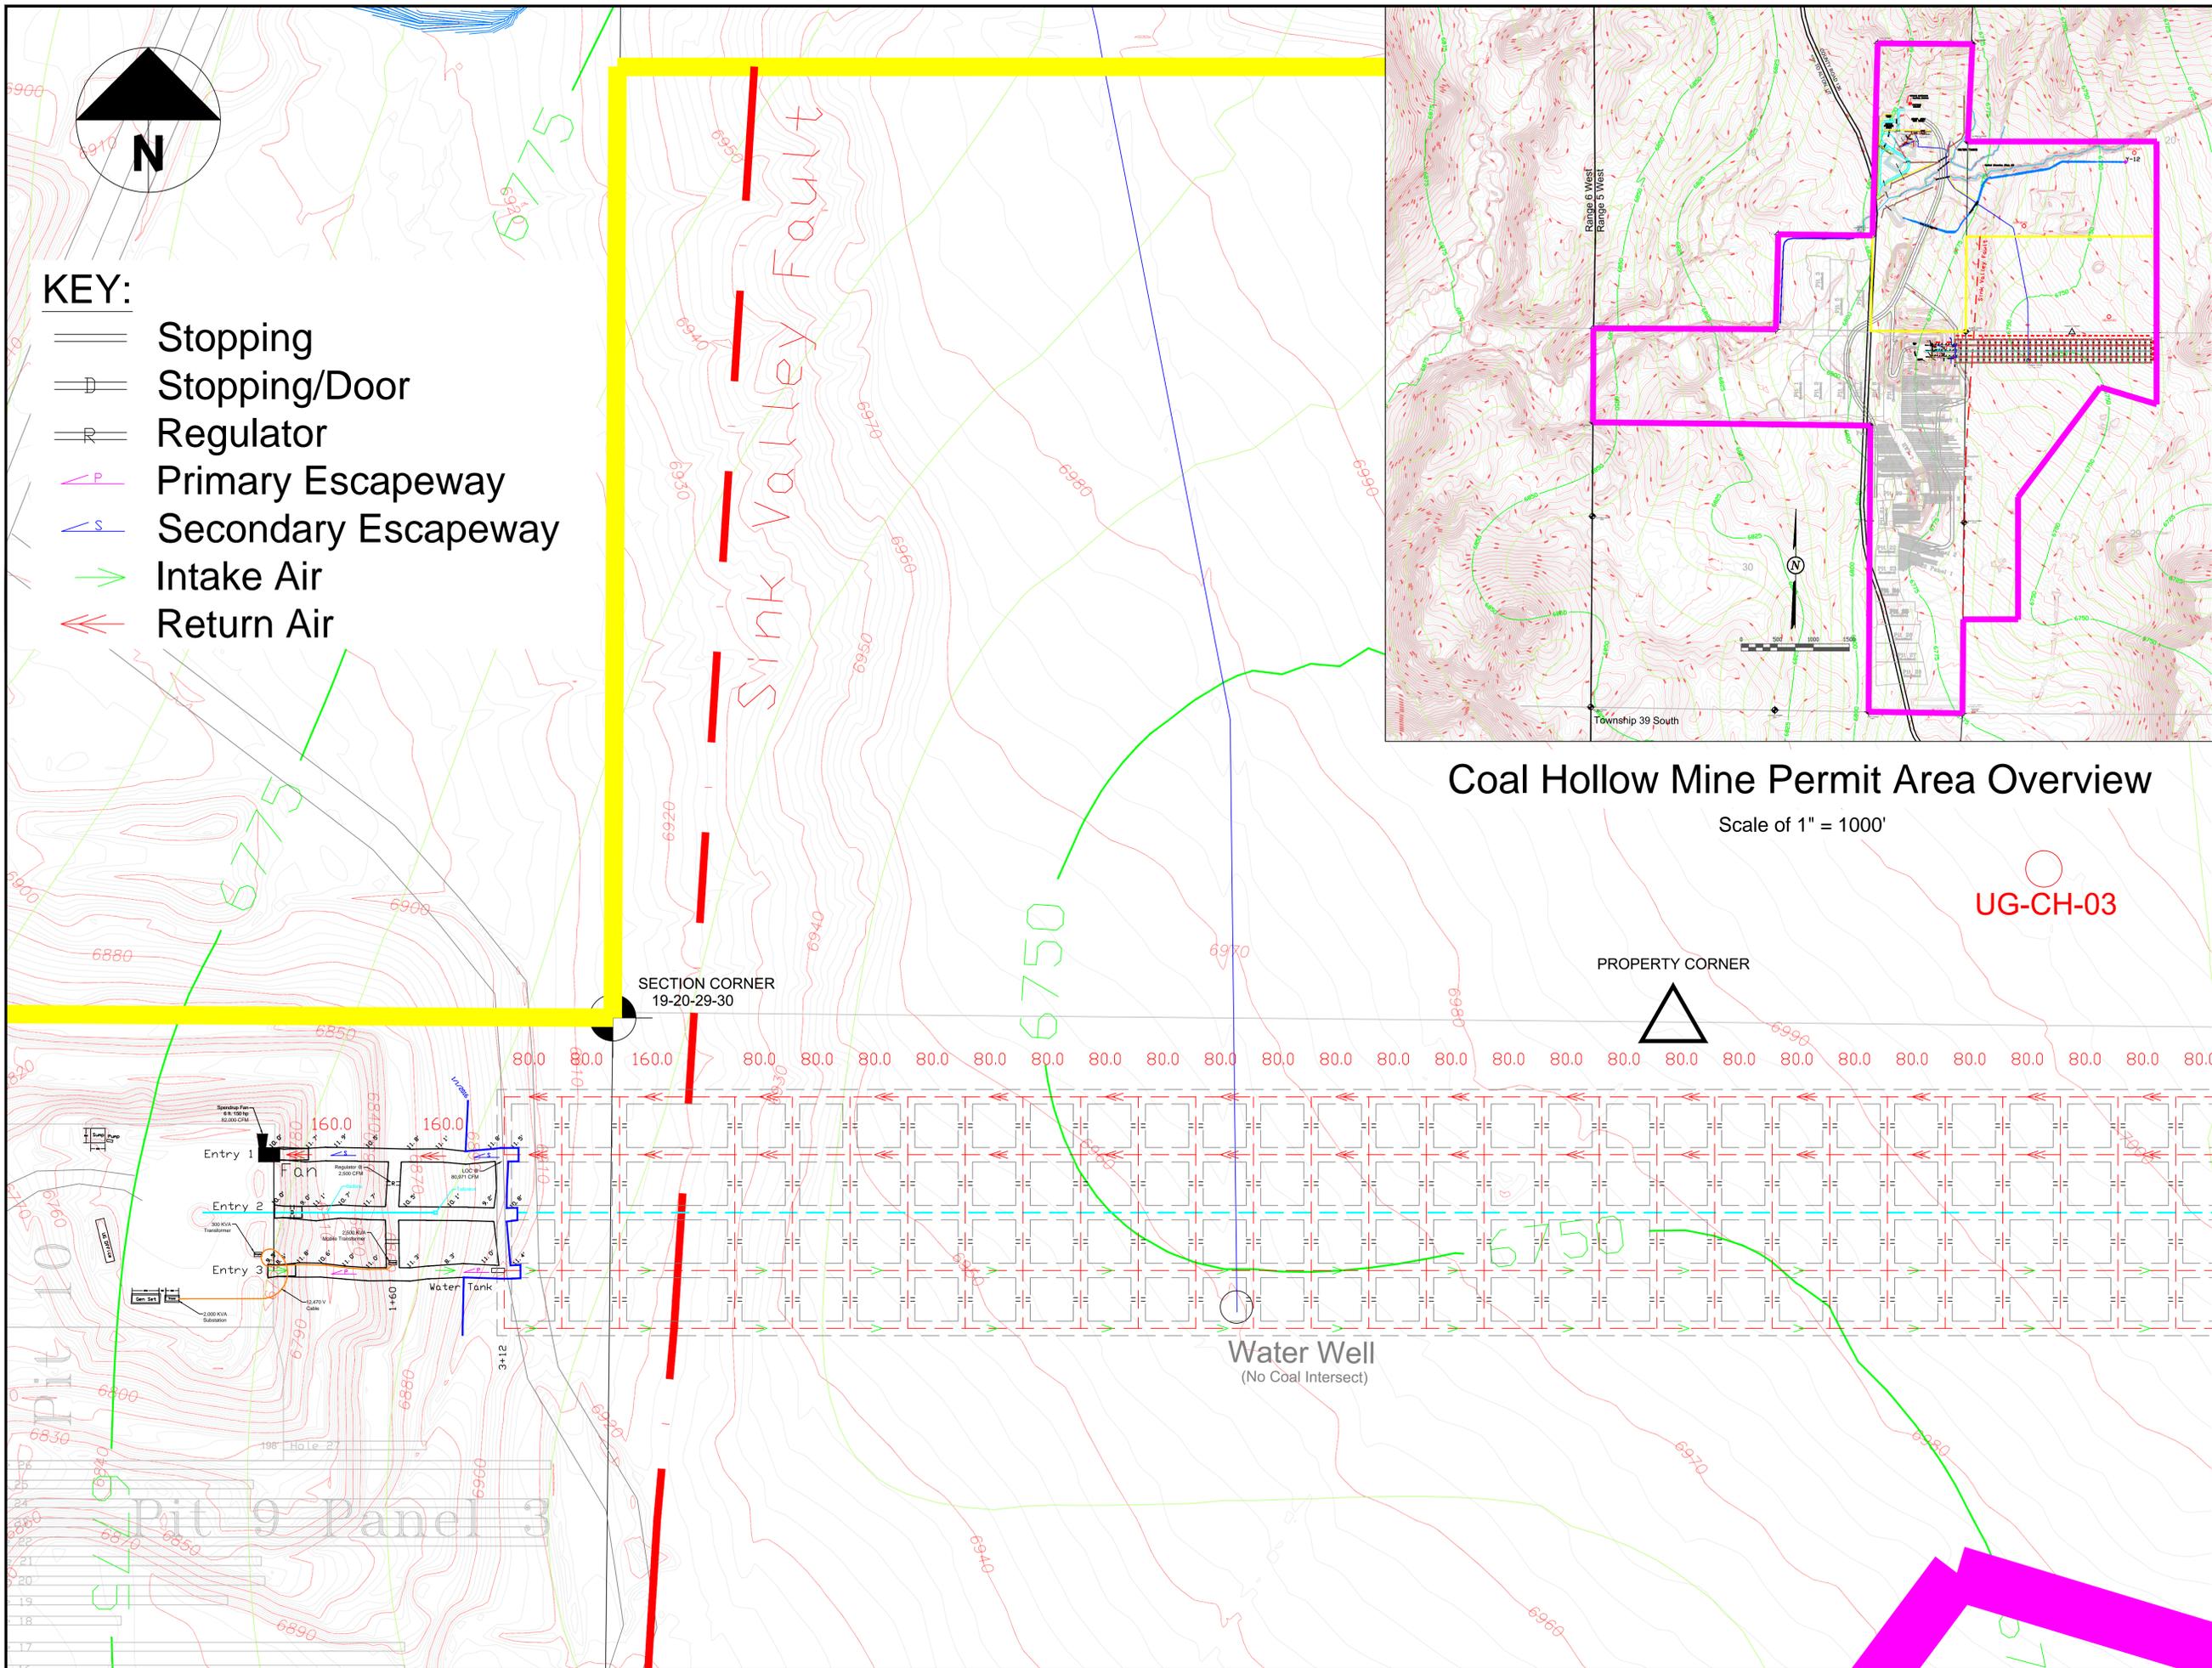
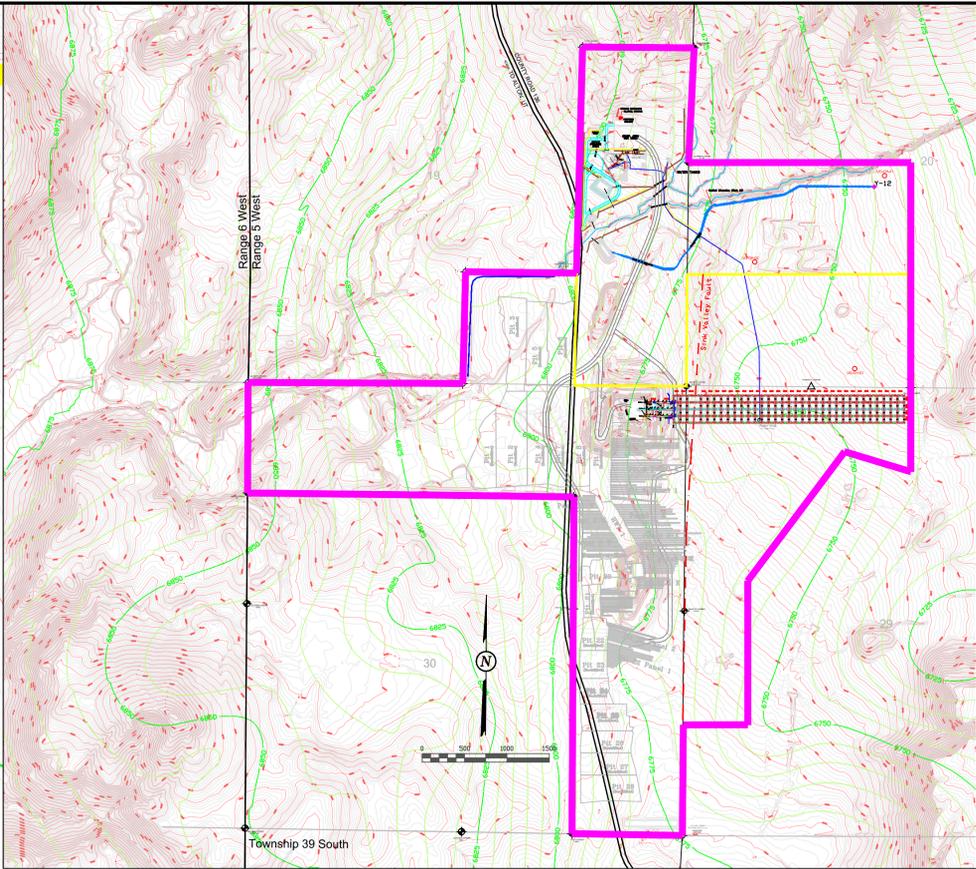
**MINE MAP**  
**Burton #1 Mine**  
MSHA ID - 42-02639

- Stopping
- Stopping/Door
- Regulator
- Primary Escapeway
- Secondary Escapeway
- Intake Air
- Return Air
