Subject: **Submission of Pre-blast Surveys at the NPL, Alton Coal Development, LLC, Coal Hollow Mine, Kane County, Utah, C/025/0005**

**PRE-BLASTING SURVEY
GARY KALPAKOFF PROPERTY
FOR
ALTON COAL DEVELOPMENT, LLC
COAL HOLLOW MINE**

**BY
DAN W. GUY, P.E.
OCTOBER 25, 2017**

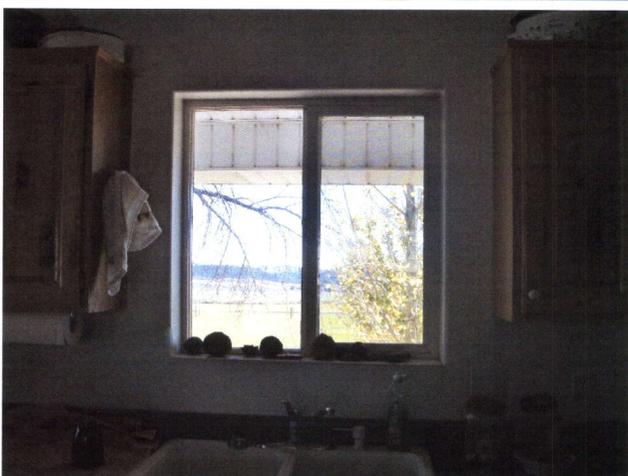
House – The house is basically wood frame construction with masonry siding and a galvanized metal roof. The foundation is rock with concrete poured around it. A covered porch has been added on the east side of the house. The original porch has been enclosed. There is also an addition on the south side of the house. This area has a concrete floor with some wood laminate and is enclosed. The house has no basement, but does have an upstairs area with 3 small bedrooms.

The exterior of the house is covered with a masonry siding and a galvanized, corrugated metal roof. There was no obvious weather damage or evidence of instability noted on the home exterior during this inspection. The house exterior is shown on Plates 3 through 5 of this report.

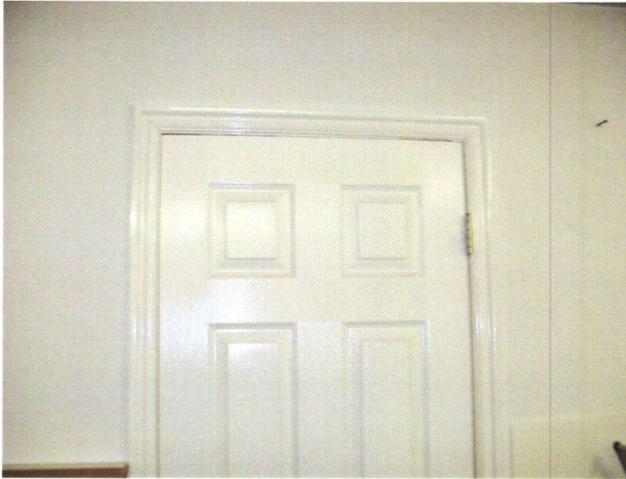
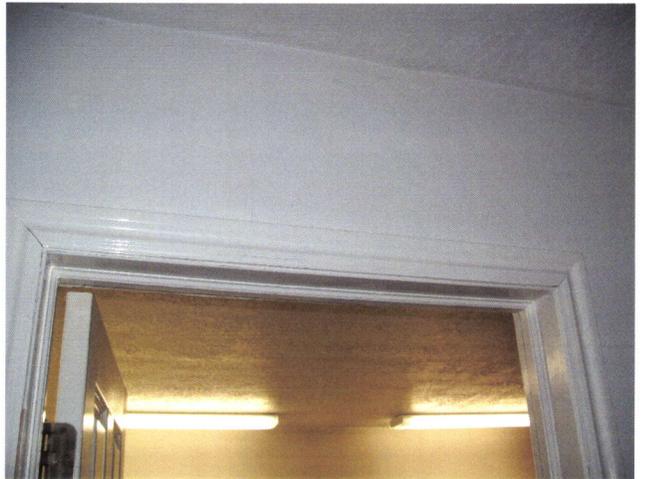
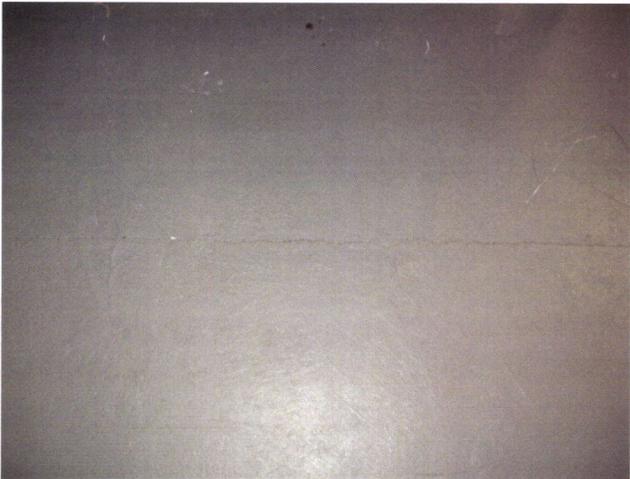
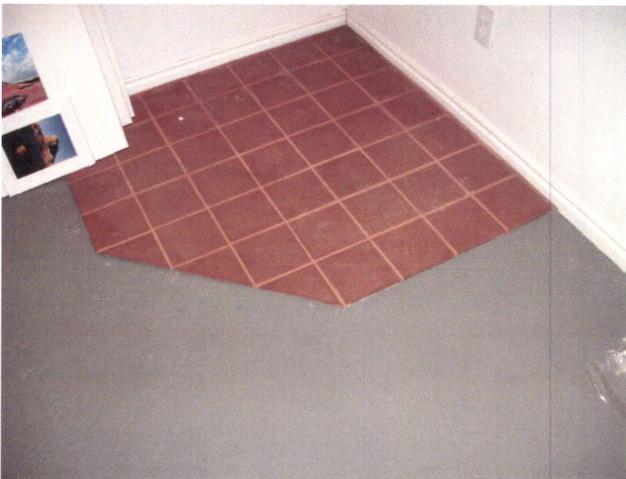
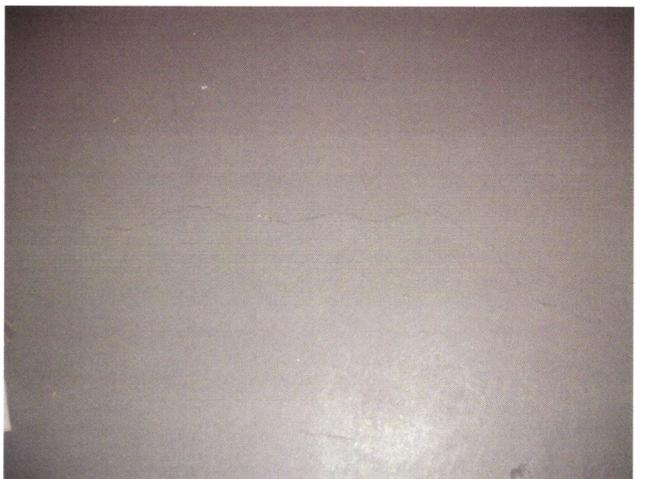
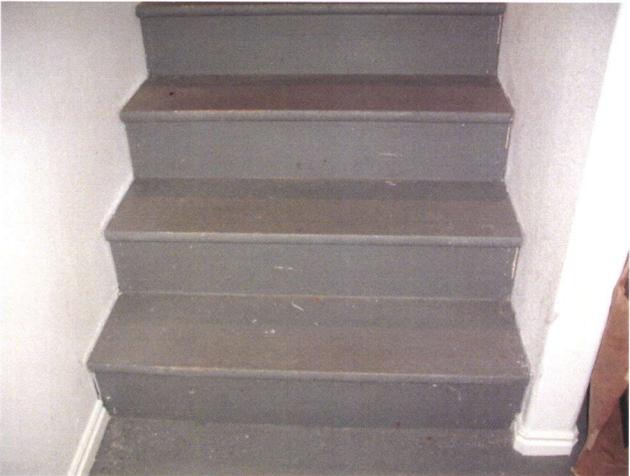
The kitchen area has a wood floor and textured and painted sheetrock walls and ceiling. The living room also has a wooden floor and sheetrock ceiling which is taped and ready to paint. The walls are mostly covered with paneling; however, a portion of the original wood wall is exposed near the doorway. Some of the original wallpaper covering the wood walls is also evident at this location. There is also a wood burning stove in the living room. The area beneath and around the stove is tiled. A large bay window has been added on the north side of the living room. A remodeled stairway leads from the living room to the upstairs attic area. There are 3 small

bedrooms in the upstairs area. The bedrooms are covered with painted sheetrock with sloping ceilings and each is carpeted. The smaller bedroom does have one small area with water damage on the ceiling. The addition on the south side of the house has a concrete floor with some wood laminate covering. The walls and ceiling are sheetrock. There is also a garage door on the north end. The area is primarily used as a utility room. As mentioned earlier, the original porch on the east side of the house has now been enclosed, with a small covered porch added to the north.

The house has been modernized over the years, and overall, appears to be in good condition, considering its age. There were no stability issues noted, and no obvious problems other than the small water damage area in the upstairs bedroom mentioned above, and some cracking in the concrete as shown in the photos. The house interior is shown on Plates 6 through 12.

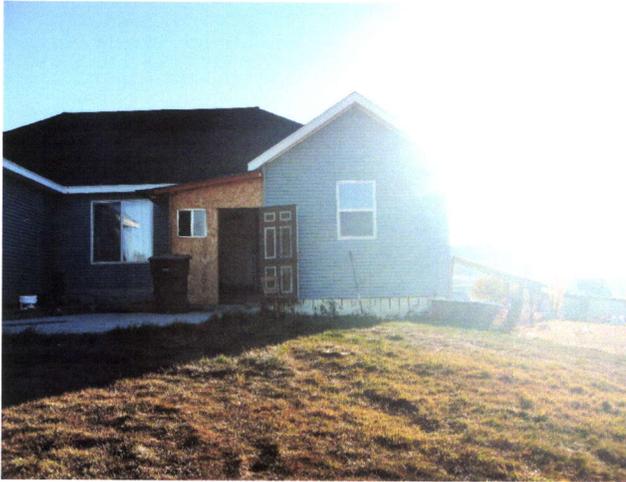
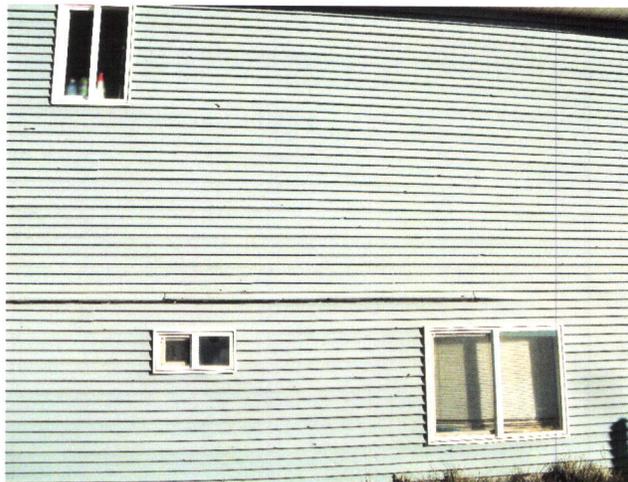
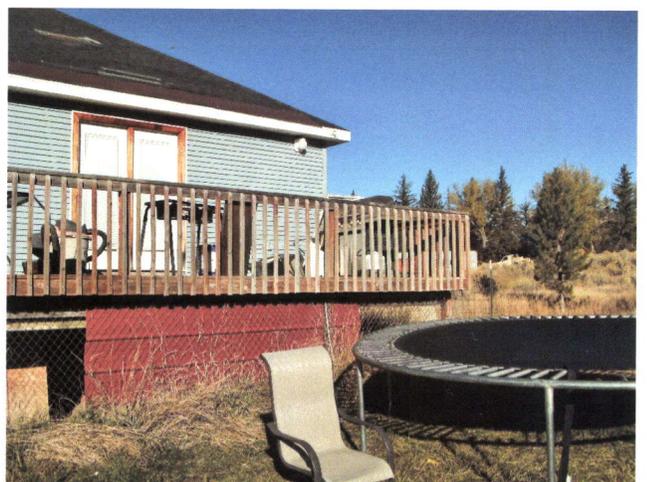
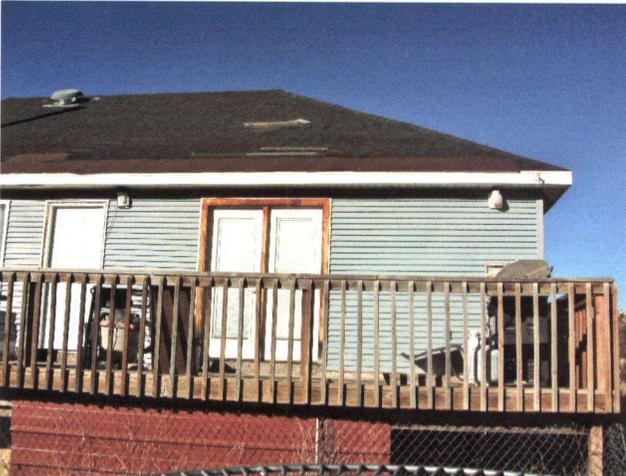
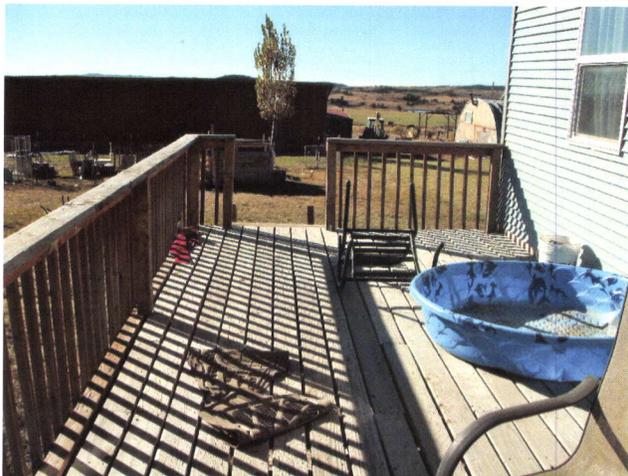
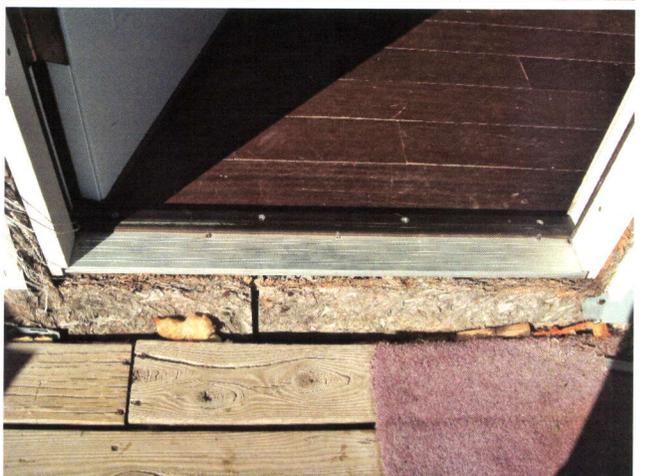
The exterior of the house is covered with a vinyl siding and an asphalt shingled roof. There are some pits in the siding on the south side of the house apparently from hail, and there are some damaged or missing shingles on the roof resulting from wind and storms. There is also a raised wooden deck along the east side of the house. The deck is supported with 4"x4" wooden posts on concrete. The house exterior is shown on Plates 3 through 6 of this report.

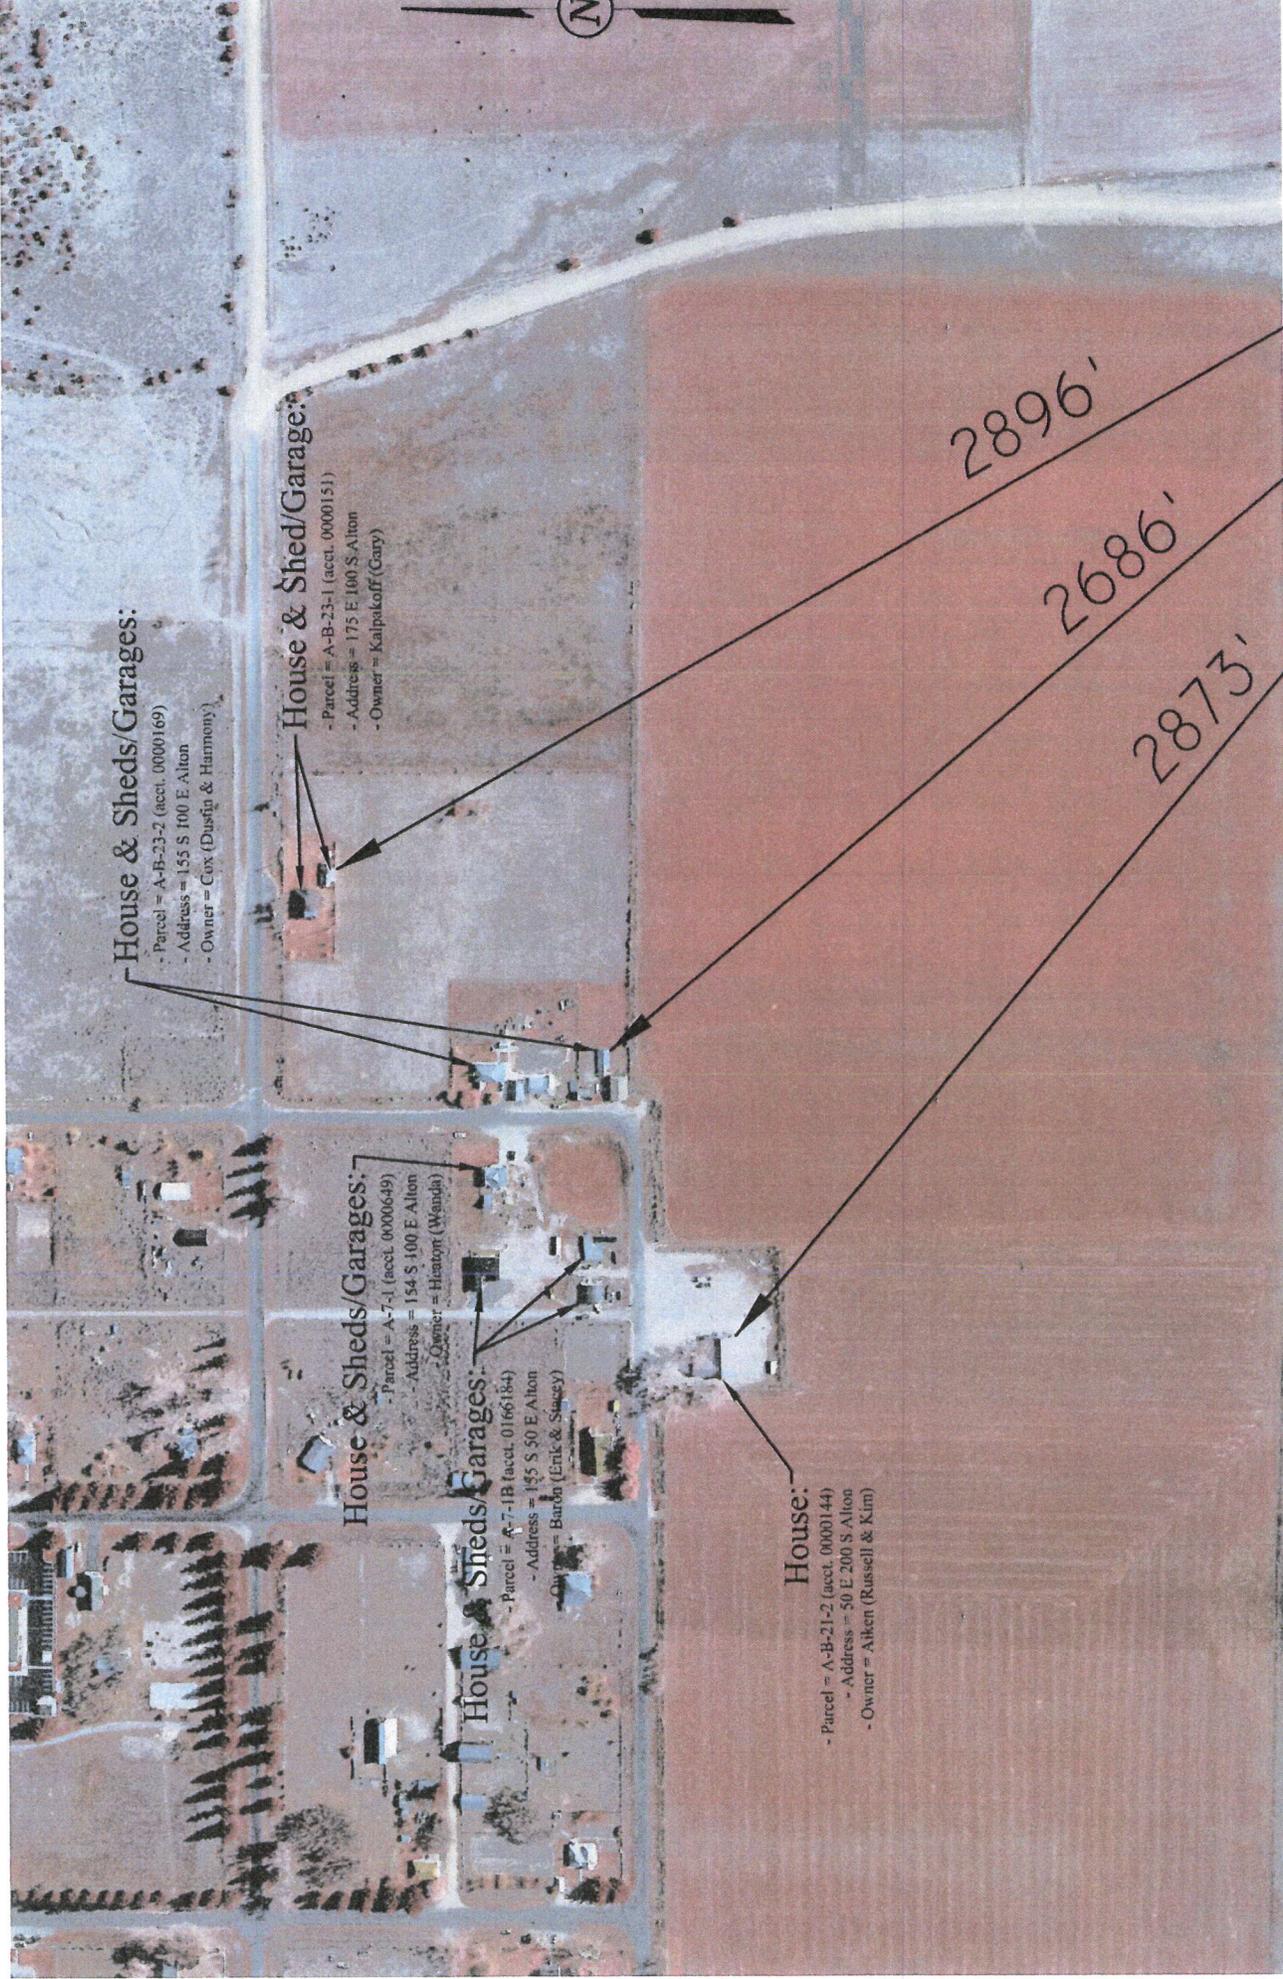
House & Sheds/Garages:

- Parcel = A-B-23-2 (acct. 0000169)
- Address = 155 S 100 E Alton
- Owner = Cox (Dustin & Harmony)

The structures are shown on Plate 2 of this report. The home and other structures are located in an open, gentle-sloping area, which minimizes the potential for damage from slides or falling objects. The house was built in 1933, with additions in 1947. A basement was added in 1957, and the house

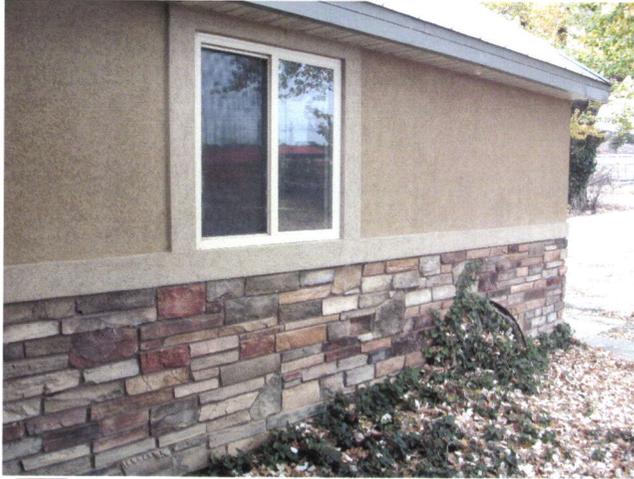
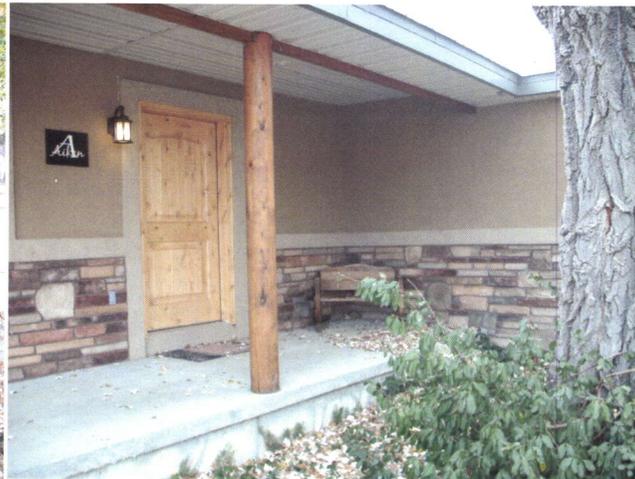
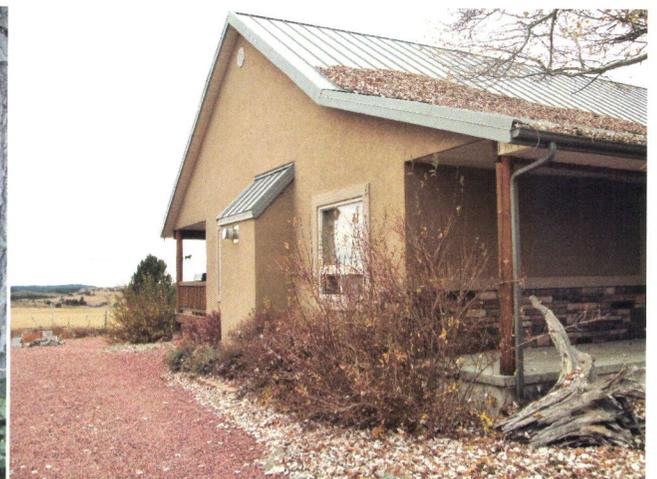
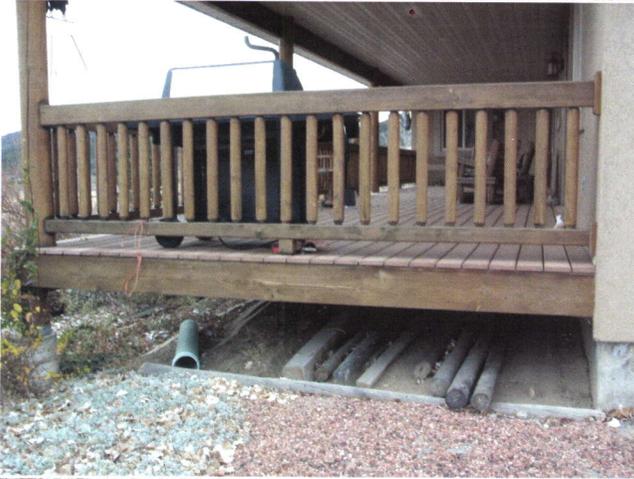
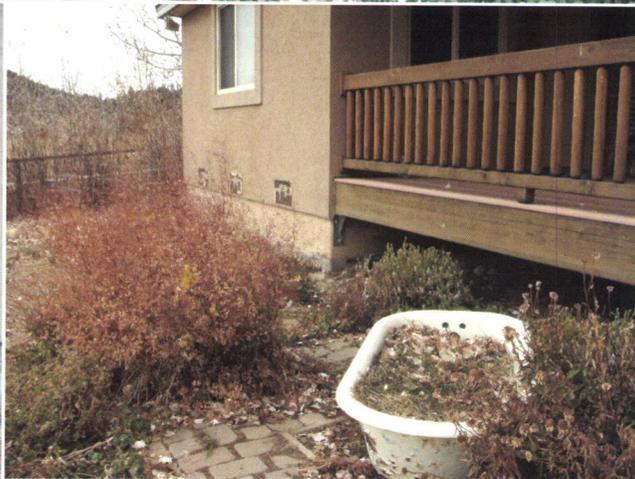
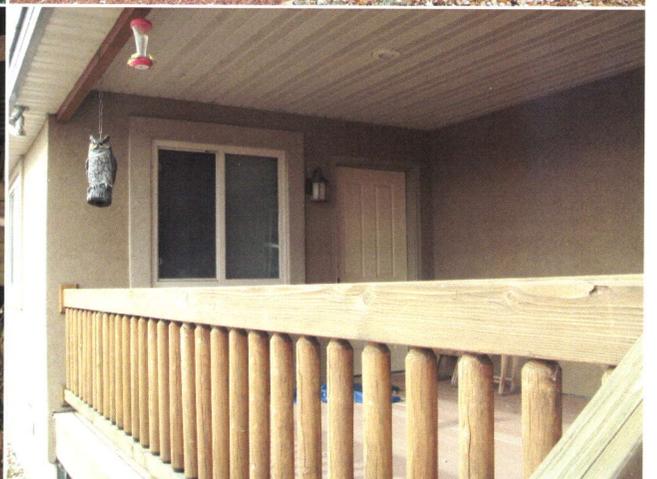
House – The house is basically wood frame construction with concrete footers over a compacted base and concrete stem walls with a crawlspace. The house exterior is finished with stucco all around and a rock facia on the front. The roof is metal with overhangs and aluminum soffit all around. There is a raised, covered concrete front porch with timber post supports. There is also a covered, raised deck in the rear of the house with composite decking and timber post supports. The only issues noted with the house exterior were 2 transverse cracks in the concrete on the front porch. There were no obvious offsets of the concrete, and these were likely just stress cracks since there were no joints on the porch. There is a small chunk of concrete out of the stem wall near the rear of the house, but it doesn't appear to have affected the integrity of the wall. There is also a small, open hole near the end of the driveway and garage. It appears to be an animal burrow, and hasn't caused any damage or stability issues as yet. Each of the above mentioned areas were photographed and are included with this report. The house exterior is shown on Plates 3 through 7 of this report.
