**Subject: 2018 Coal Mining Annual Report; Alton Coal Development LLC, Coal Hollow Mine, C/025/0005**

# 2018 ANNUAL REPORT

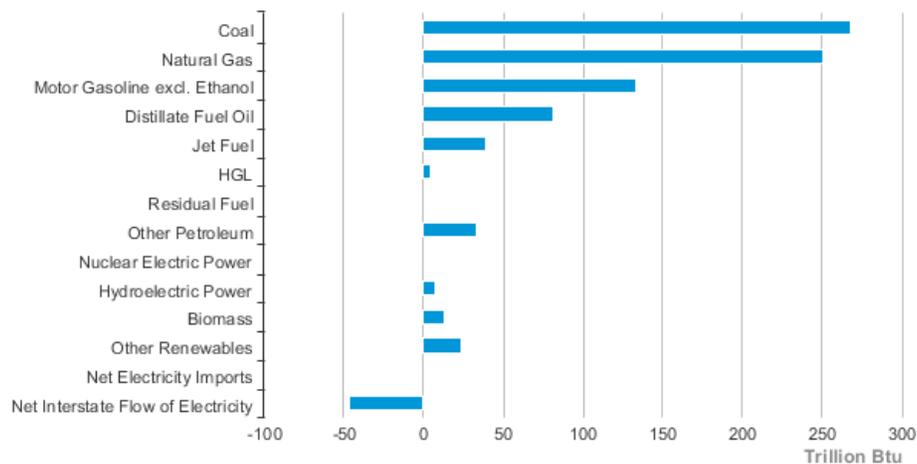
Figure 1. Estimates of energy sources used in the state of Utah. Coal is the highest, providing approximately 70% of Utah’s total energy demand.

In the state of Utah, coal is mined to provide an important energy source for local and regional electrical power generation. In 2016, coal and natural gas combined produced 90% of Utah’s net electricity, with coal responsible for nearly 70% of that total (Figure 1, USEIA 2018). In Alton, coal is currently mined 2.7 km south of town, supporting local industry and providing employment for neighboring communities. In addition to coal, this region also provides important habitat for a diversity of plant and animals species. Of significant importance is the sagebrush habitats that sustain a sustained local population of sage-grouse (Petersen et al. 2016), hereafter referred to as sage-grouse. To ensure the long-term conservation and management of this sage-grouse population. The purpose of this report is to provide an assessment of the habitat conservation accomplishments from fall 2017 to fall 2018 within the Alton and Sink Valley region. Specifically, it will describe the status of the sage-grouse population, habitat improvements implemented in the past year (including post-disturbance habitat reclamation and pinyon-juniper tree removal), and predator control (i.e. ravens and coyotes).

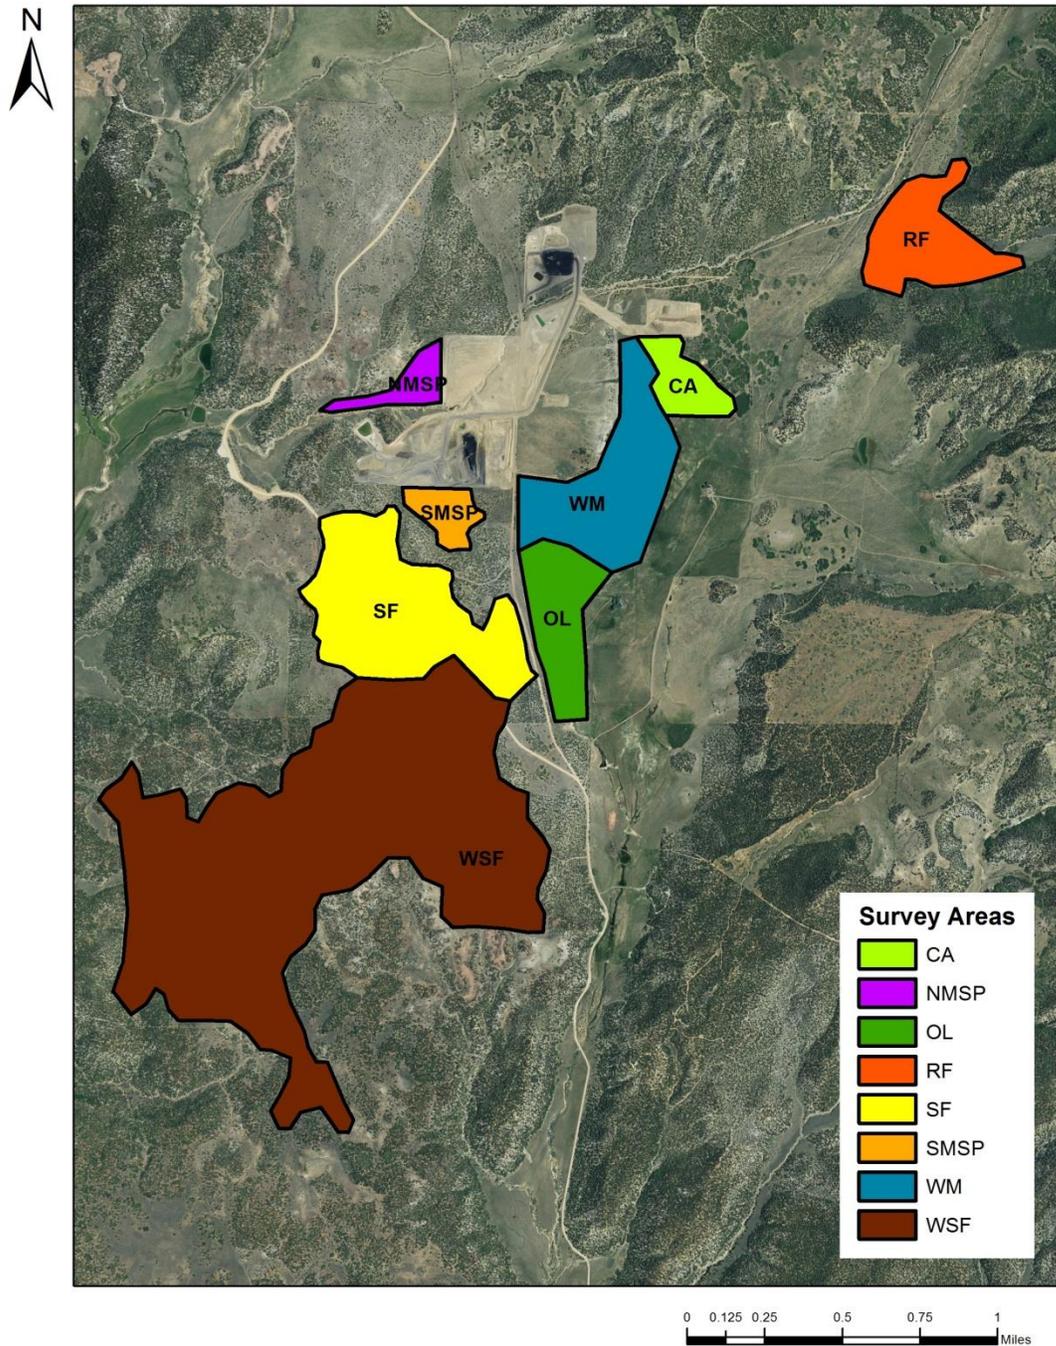
Figure 1. Location of survey areas for sage-grouse during the 2012-2018 monitoring seasons. CA = Conservation area, NMSP = North mine sagebrush patch, OL = Original lek, RL = Rabbitbrush field, SF = Sagebrush flat, SMSP = South mine sagebrush patch, WM = Wet meadow, and WSF = West sagebrush fields. Additional sites not shown above include the corridor (C) and the alfalfa fields (AF) east and south of the town Alton, respectively.

Sage-grouse observations are recorded for the specific flush location (Figure 1). The specific areas that are searched include

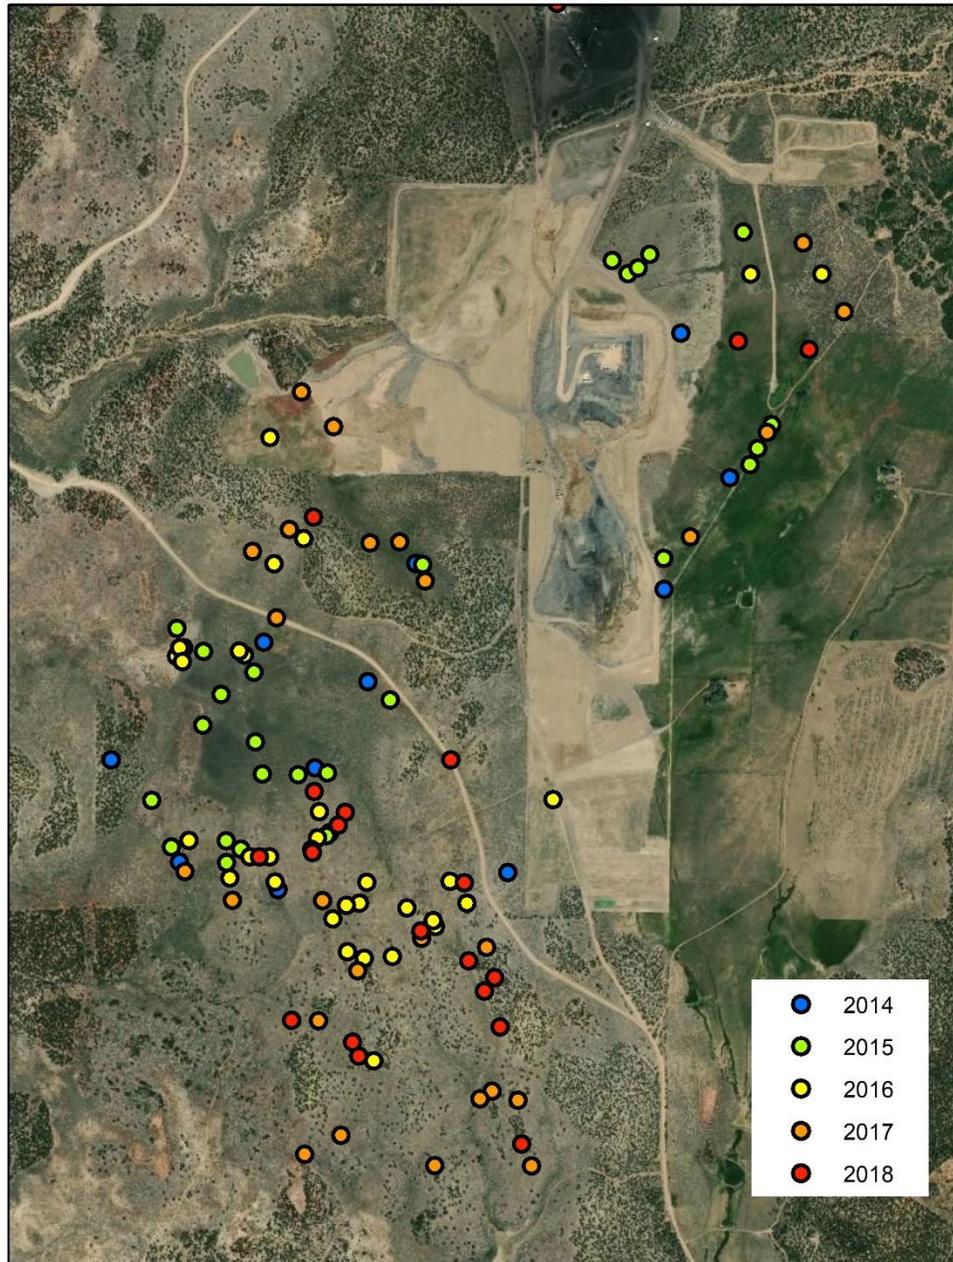
Figure 2. Distribution of sage-grouse flush locations by year. Birds were flushed during monthly surveys within non-breeding time periods (July-Feb).

Nelson) and mountain big sagebrush (*Artemisia tridentata* Nutt. ssp. *vaseyana* (Rydb.) Beetle). There is also scattered rubber rabbitbrush (*Ericameria nauseosa*) with relatively high density Utah juniper (*Juniperus osteosperma*) and pinyon pine (*Pinus edulis*) seedlings. Figure 2 displays the location of birds where they have been flushed during monthly surveys within the non-lekking or nesting time periods (July-Feb) and Figure 3 depicts the number of birds included in each flushed flock.

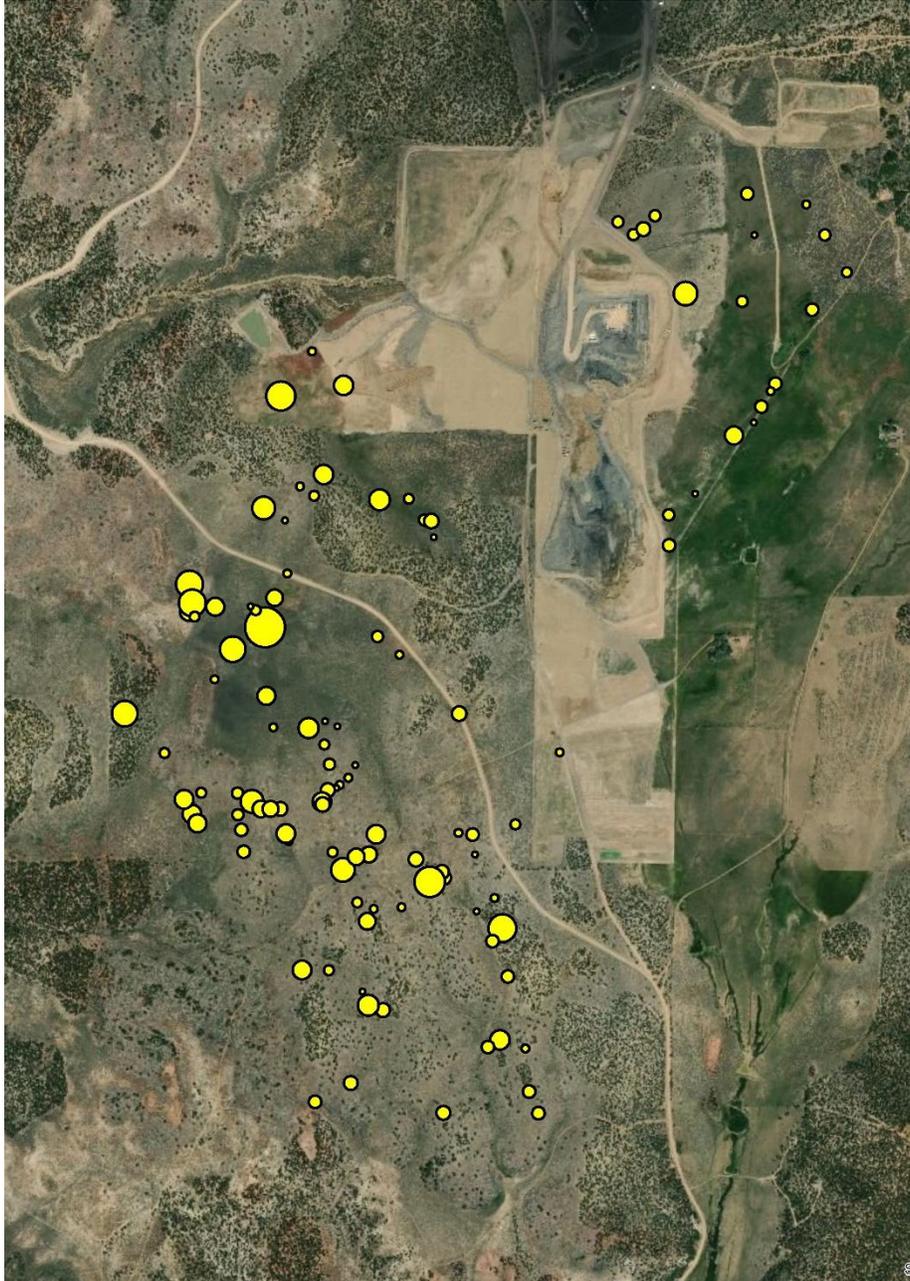
Figure 3. Flock size of birds that were flushed during monthly surveys during the 2014-18 time period.

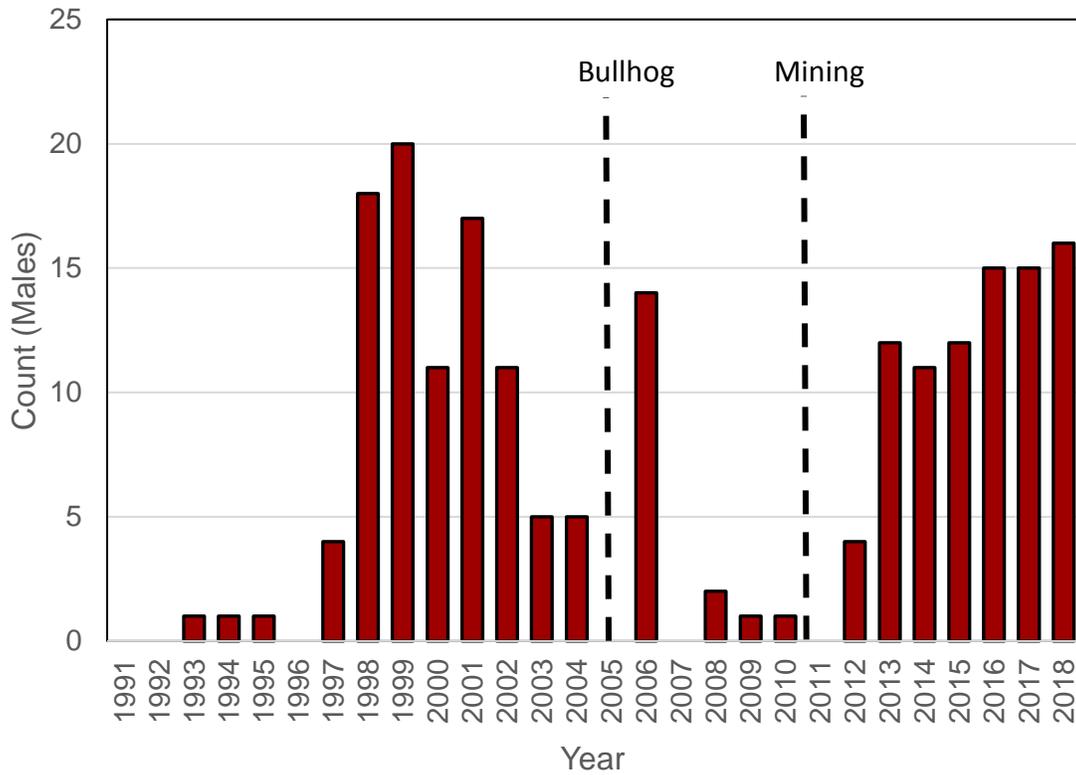
Figure 4. Male sage-grouse lek attendance at the Sink Valley lek, located south of Alton, Utah. All males were observed during morning hours strutting on the primary lek.

During the breeding season, male sage-grouse primarily strut at NL or at several locations in WSF-SB. Over the past 6 years, counts have been relatively consistent with a maximum count of 10-16 birds, with the highest occurring in 2018 (16; Figure 4). The most accurate estimates of bird densities in this region are provided by lek counts conducted annually by wildlife biologists with the Utah Division of Wildlife Resources (UDWR) with contribution from observations made by ACD employees and consultants. In Figure 2, Observations between 1991-2016 were provided by Utah DWR, based on surveys during lekking periods (February – April). For 2017-18, observations were made by Petersen (ACD consultant) and ACD employees (Kirk N and Josh) from surveys in the lekking period. UDWR was unable to provide 2017-18 count data. Both 2005 and 2007, no males were observed at the lek. Similarly, in 2011 no males were counted at the historic lek (HL), however, it may have been that birds were displaying at NL and were not detected. Observations from 1991-2011 were of birds lekking at HL only.

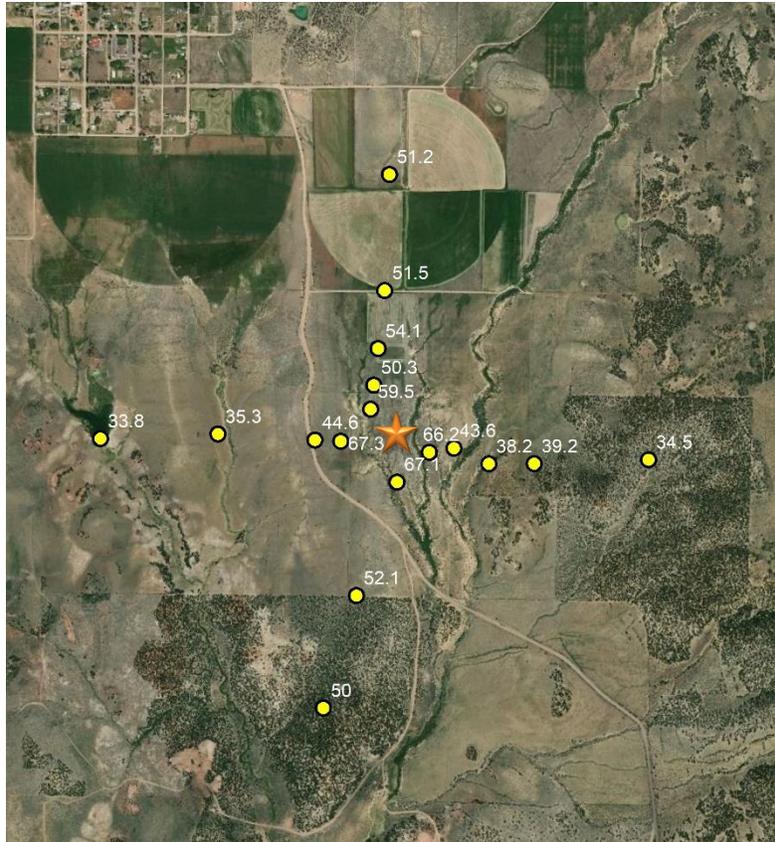
Figure 5. Sound measurements (db) in relation to the north lease mining area (orange star). Measurements were recorded at the disturbance edge, 100m, 500m, and 1000m distant.

The influence of sound (noise pollution) on sage-grouse was measured this year to determine the influence of mining activity in the North Lease area. Sound monitoring is conducted by determining maximum decibel levels using an Extech 407735 Sound Level Meter. Sound measurements were recorded at increasing distances from the mining activity at the North Lease area. In each cardinal direction, sound was recorded at the edge of the immediate mining activity, and then at 100, 500, and 1000m away. The results of all sound measurements is shown in Figure 5.

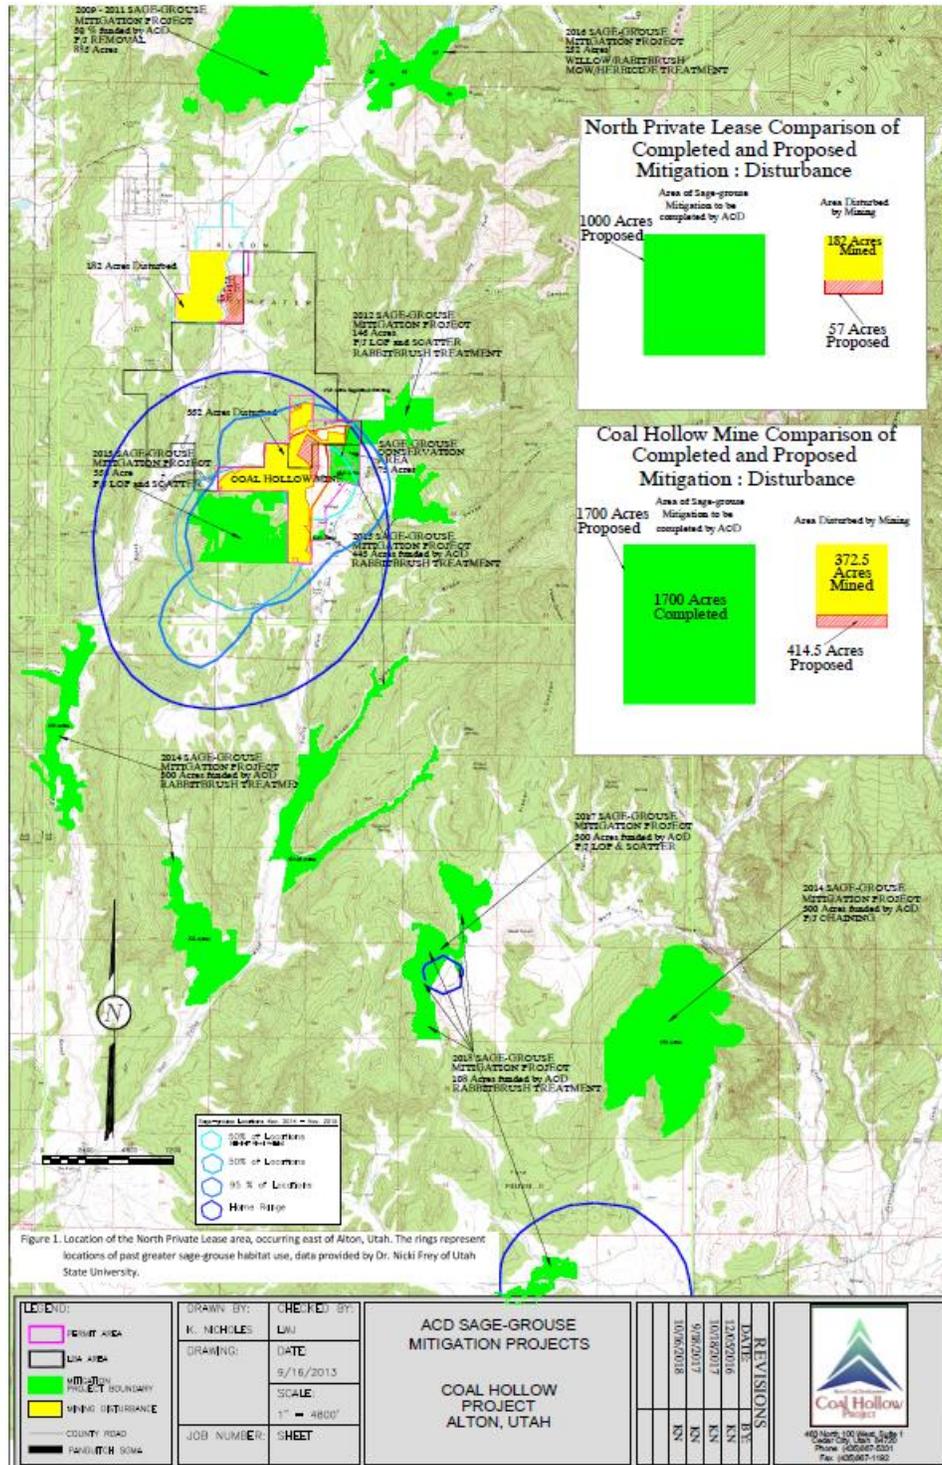
Figure 6. Total sage-grouse habitat mitigation completed through November 2018. Habitat improvements totaled 1,000 acres for the North Private Lease and 1,700 acres in the South Private Lease.

Following mining, ACD implements habitat improvement through soil preparation and seeding adapted species that stabilize soils and establish a functional plant community (Figure 6). These land improvement activities focus on planting seeds using a rangeland drill followed by covering the soil with shredded straw to protect soils and enhance seed microsite conditions (Petersen et al. 2004).

To date, a total of 2,700 acres have been treated by ACD (Figure 6). This includes bullhogging, chaining, and lop-and-scatter of PJ woodlands, reduction of rabbitbrush, mowing and treating willow with herbicide, and disking and reseeding sagebrush to improve sage-grouse habitat in the Conservation Area.

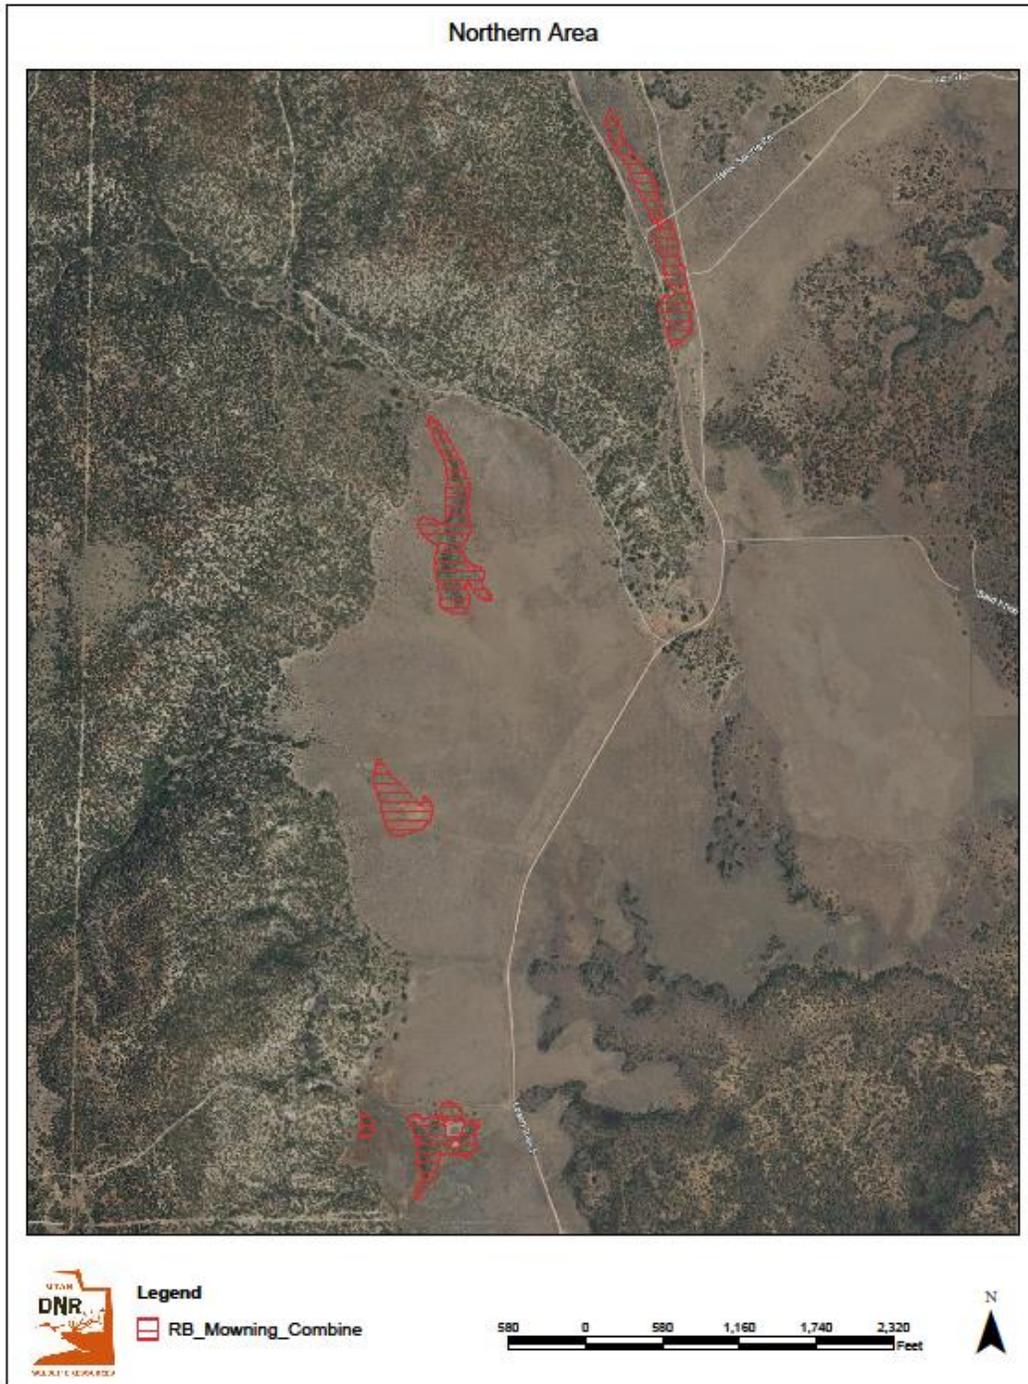
Figure 7. Rabbitbrush treatment using a combine mowing operation in the northern area.

Other projects that are being implemented to improve the habitat for sage-grouse surrounding the Alton/Sink Valley area which involves mowing rabbitbrush using a combine mower in the area north of the mine (Figure 7), the area south of the mine located at the Fords Pasture area 10km south of the mine area (Figure 8). At each site, rabbitbrush will be mowed up to 6 ft. in height and then Tordon 22K herbicide will be applied in a single application to prevent regrowth or resprouting. ACD will fund Utah DWR up to \$14,040.00 to complete this habitat improvement work at the Ford Pasture area.

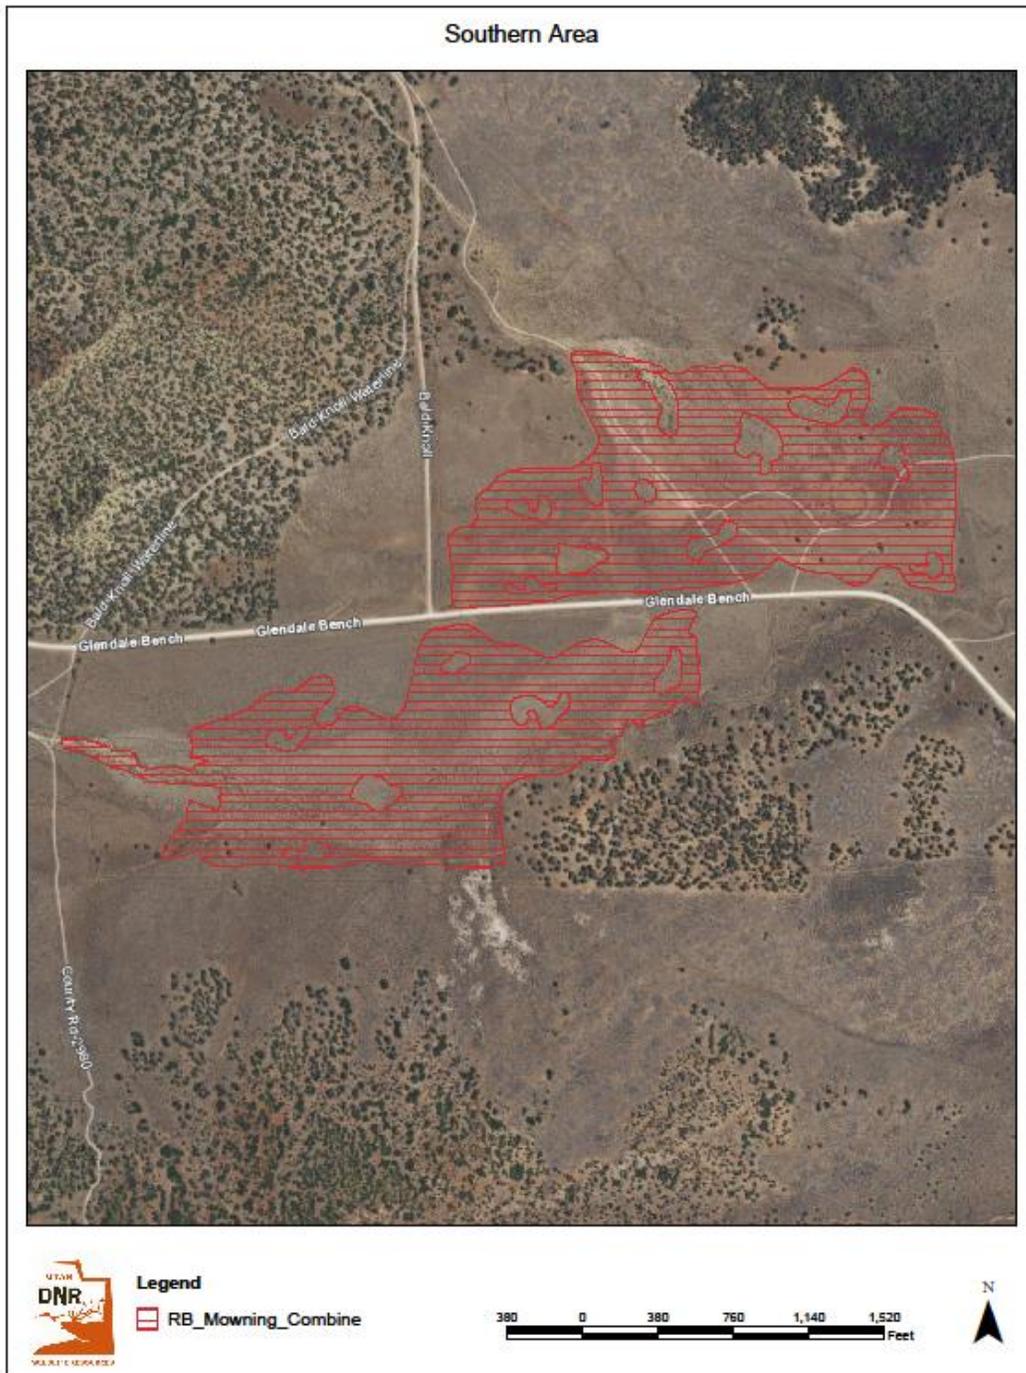
Figure 8. Proposed treatment plan designed to enhance sage-grouse habitat in the Fords Pasture region. Rabbitbrush will be mowed to open soils allowing for greater plant community diversity, including sage-grouse cover and food plant and insect species.

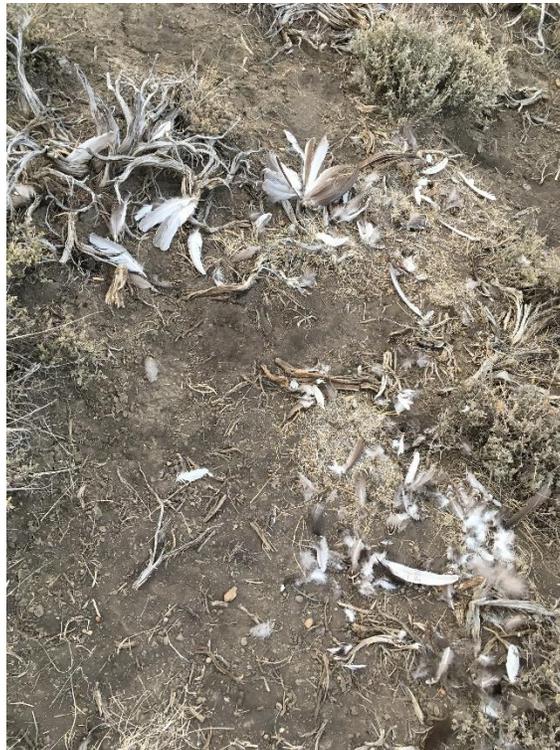
Figure 9. Sage-grouse feathers found at a site where a bird had been killed by a predator. Feathers were found in the sage-brush flat, an area dominated by black sagebrush that has been primary habitat for sage-grouse in this area.

Sage-grouse are impacted by predators in the Alton/Sink Valley area. In 2018, the remains of one sage-grouse was found within a primary habitat, exhibiting characteristic traits of being killed by a predator (Figure 9). The bird was observed on February 10, a killed bird was found in the sagebrush flat area (370334 E 4139169 N). At this site, feathers were spread within the immediate area, located next to many roost piles.

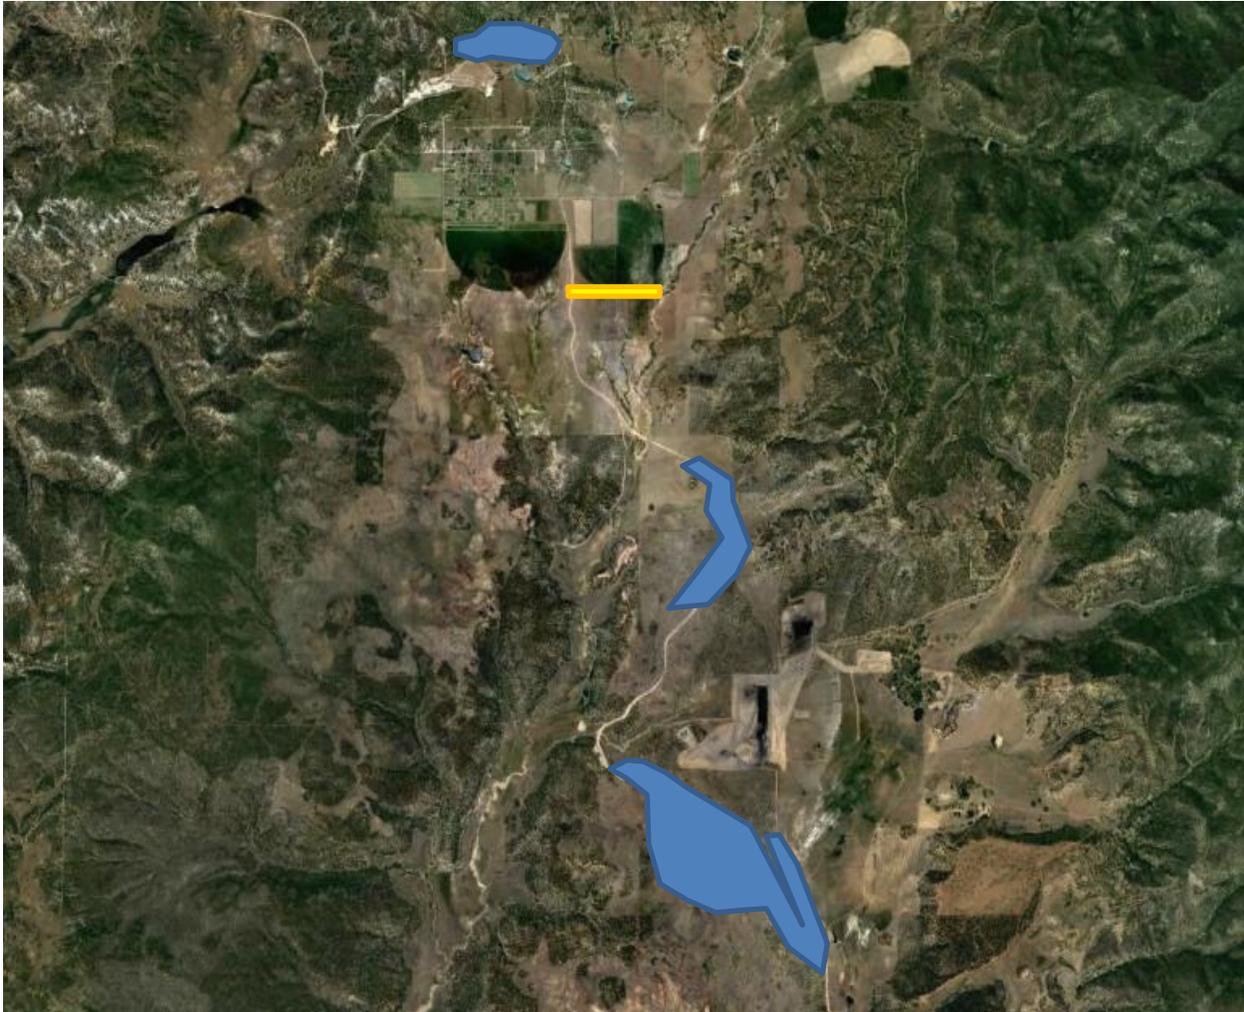
Figure 10. According to Teresa Wright, USDA Wildlife Services biologist, distributed eggs in the same general areas where eggs have been distributed over the past several years. This map portrays that area, with blue polygons indicating sites where poison eggs were distributed. This includes roadsides near critical habitat and the stock yard near Alton where birds congregate. The yellow polygon represents the location where coyote snares are set and trapped.

During the treatment period, a total of 1000 hard-boiled treated eggs were distributed within the mine site and surrounding Alton area (Figure 10). Ravens cache eggs at a ratio of 1 kill for every 6 eggs distributed. Therefore the total number of ravens killed during the reporting window is 167 birds.

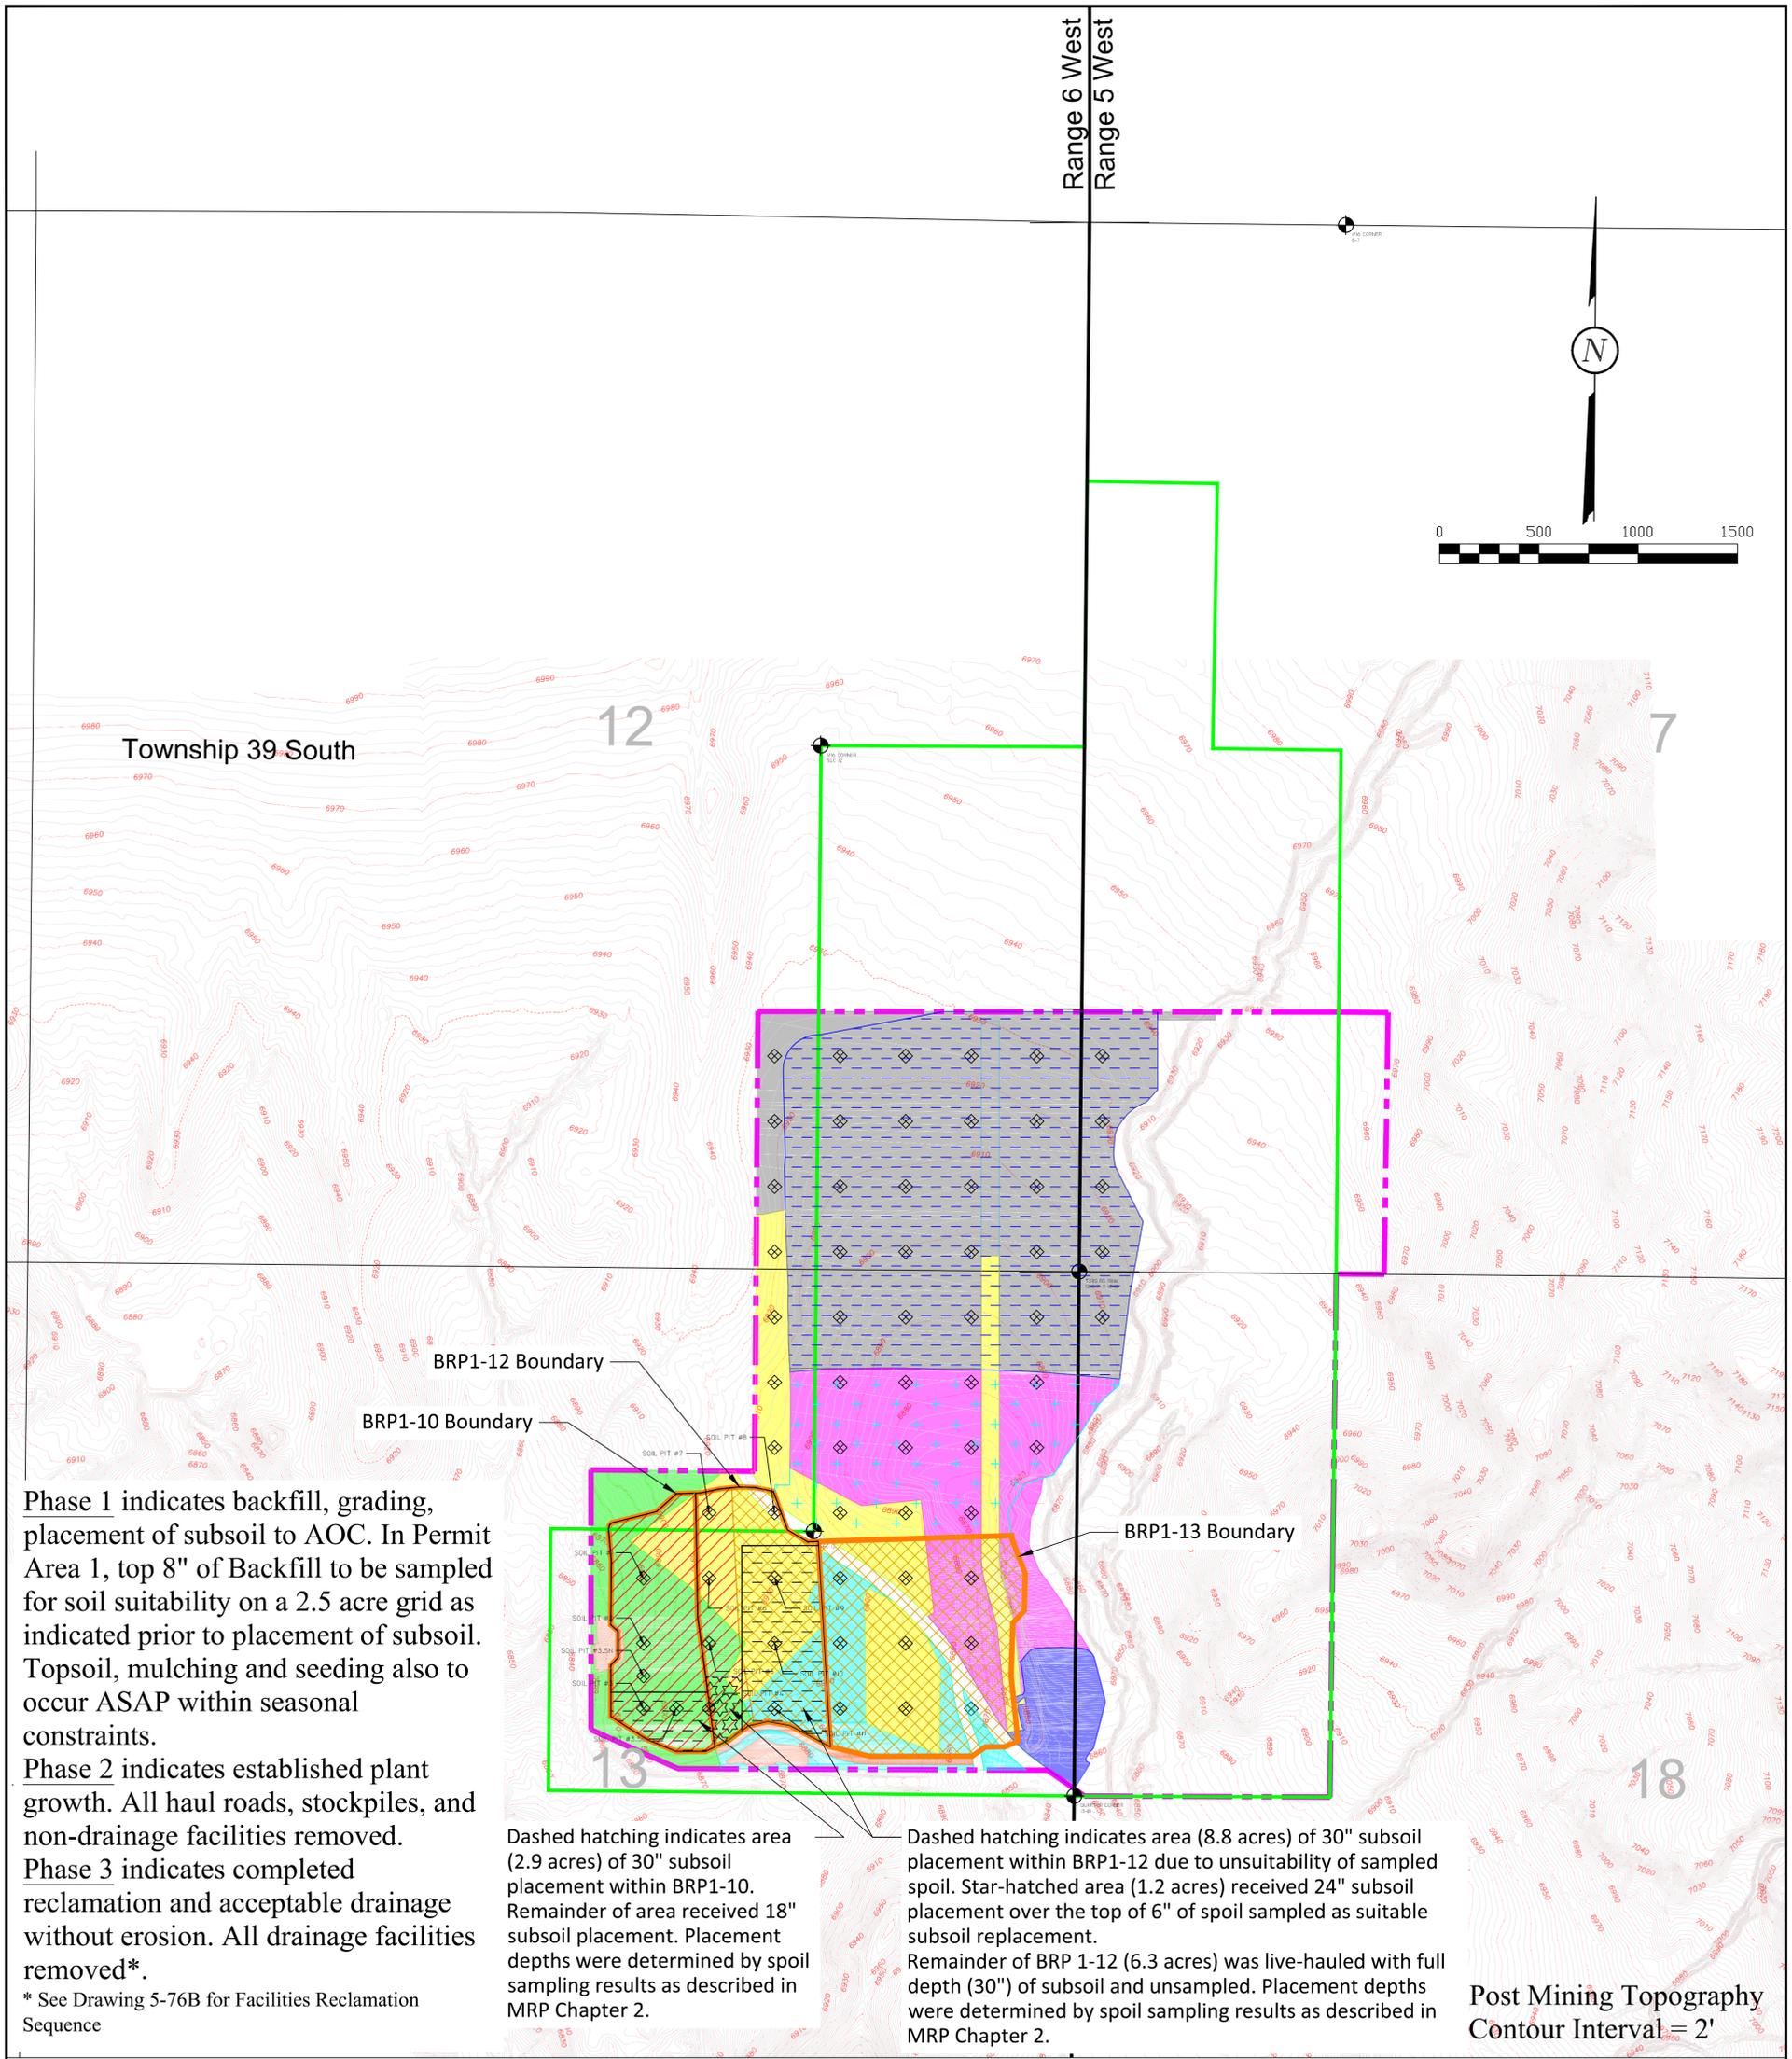
**Phase 1** indicates backfill, grading, placement of subsoil to AOC. In Permit Area 1, top 8" of Backfill to be sampled for soil suitability on a 2.5 acre grid as indicated prior to placement of subsoil. Topsoil, mulching and seeding also to occur ASAP within seasonal constraints.

**Phase 2** indicates established plant growth. All haul roads, stockpiles, and non-drainage facilities removed.

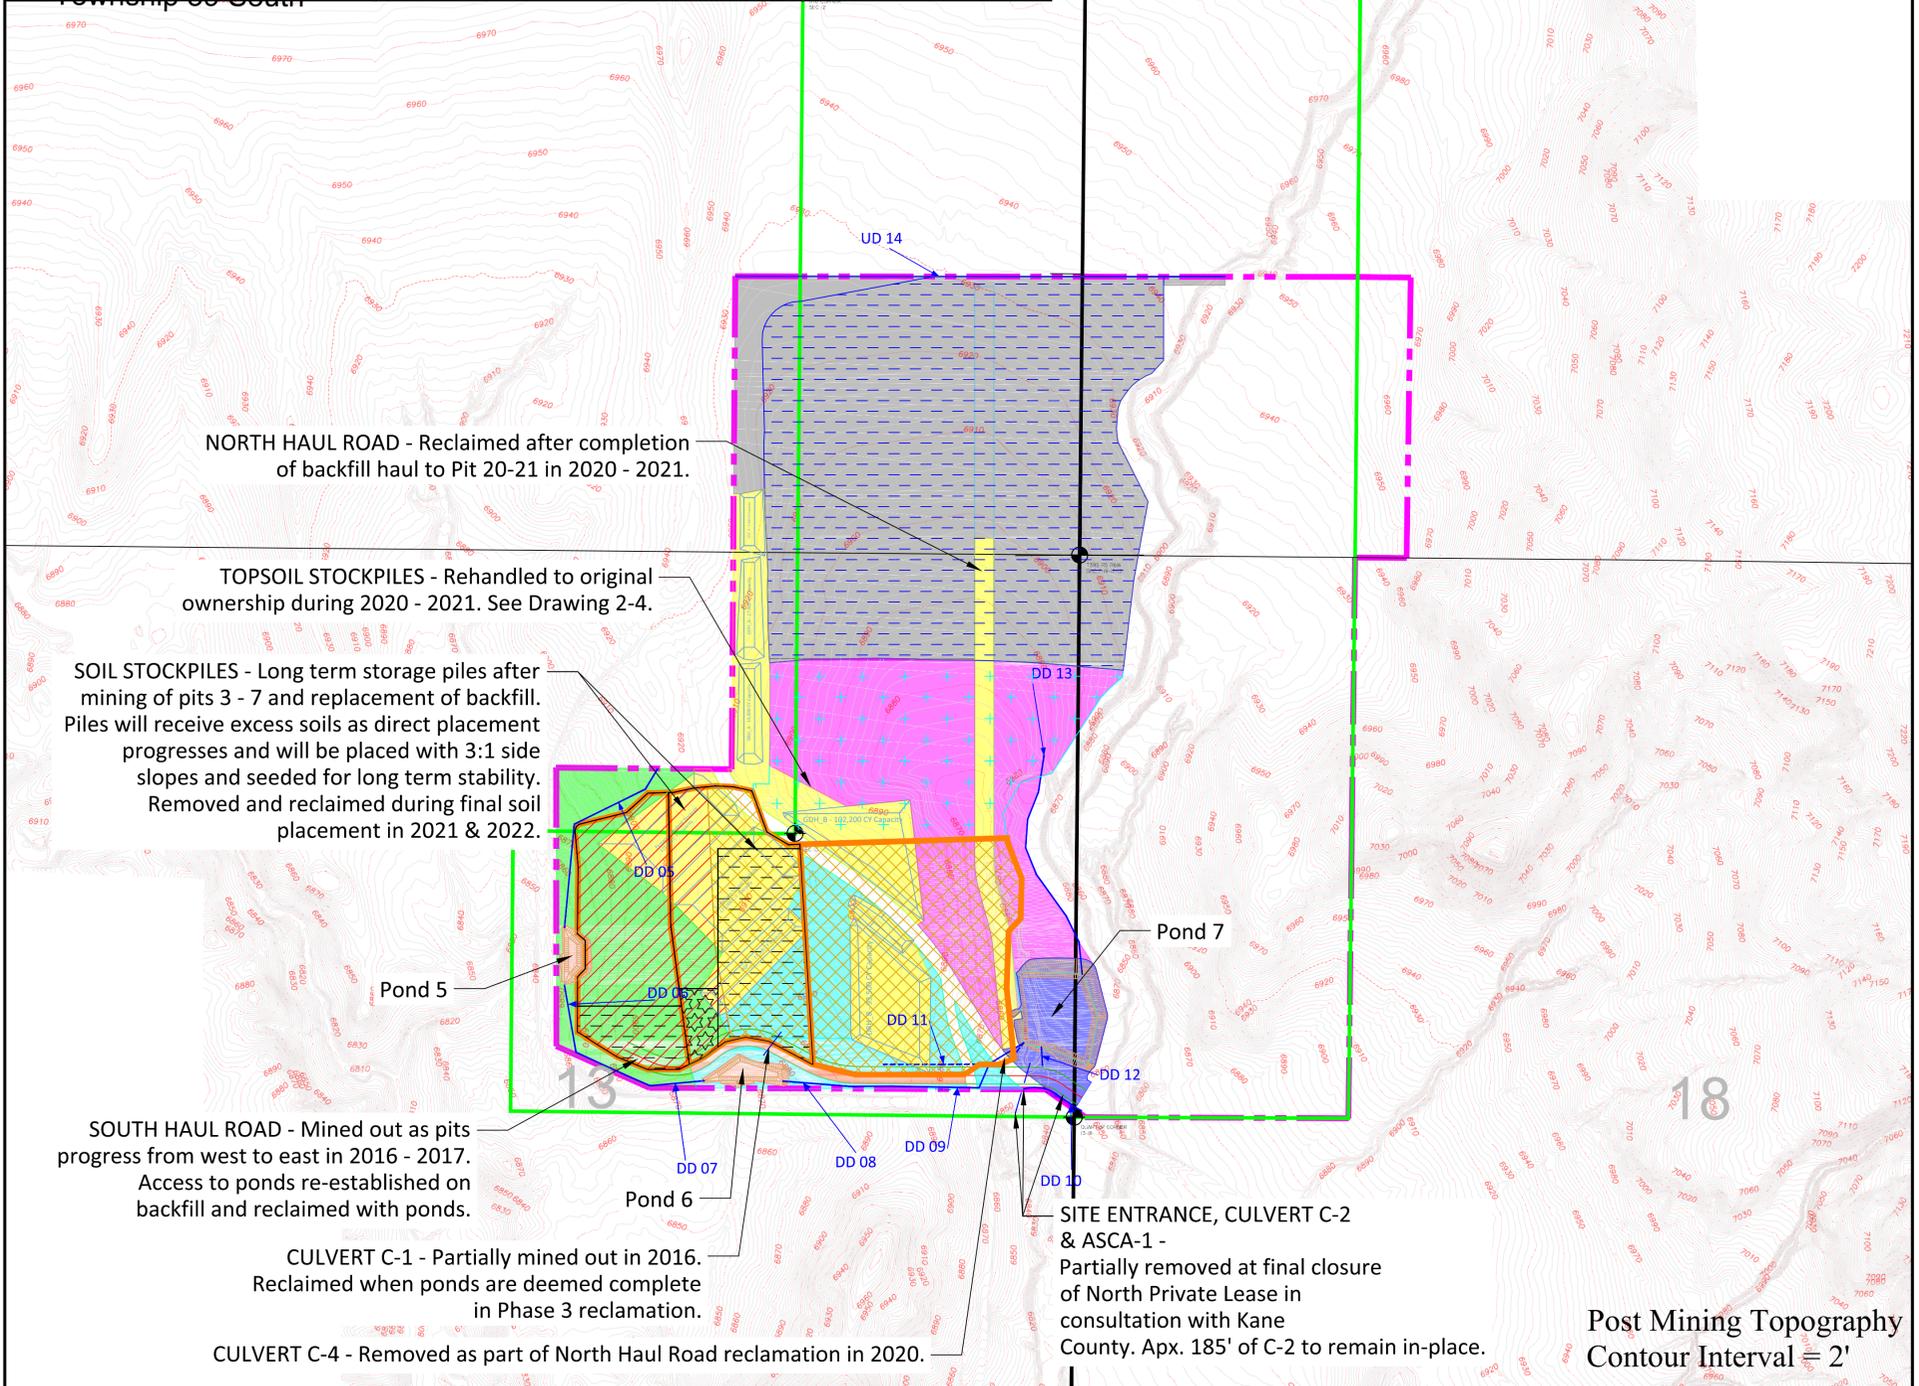
Phase 1 Reclamation:		Phase 2/Surface Mulch & Seeding:	
	2016 Reclaim = 17.9 Acres		2016 Seeding = 18.4 Acres
	2017 Reclaim = 34.7 Acres		2017 Seeding = 11.9 Acres
	2018 Reclaim = 0.0 Acres		2018 Seeding = 0.0 Acres
	2019 Reclaim = 26.8 Acres		2019 Seeding = 30.0 Acres
	2020 Reclaim = 71.9 Acres		2020 Seeding = 75.6 Acres
	2021 Reclaim = 0.0 Acres		2021 Seeding = 33.6 Acres
	2022 Reclaim = 0.0 Acres		2022 Seeding = 2.9 Acres
	2023 Reclaim = 0.0 Acres		2023 Seeding = 5.5 Acres
	2024 Reclaim = 0.0 Acres		2024 Seeding = 0.0 Acres
			Unseeded Road = 3.9 Acres
<b>Total Ph. 1 Reclamation = 151.3 Acres</b>		<b>Total Ph. 2 Reclamation = 181.8 Acres</b>

Phase 3 Reclamation to be completed and released within the 10 year timeframe from Phase 1. **Ponds, culverts and ditches (except Area 1 extension)** to be assessed and reclaimed as Phase 3 nears completion. Area 1-A structures will be removed as mining advances.
