**Subject: 2018 Coal Mining Annual Report; Alton Coal Development LLC, Coal Hollow Mine, C/025/0005**

# 2018 ANNUAL REPORT

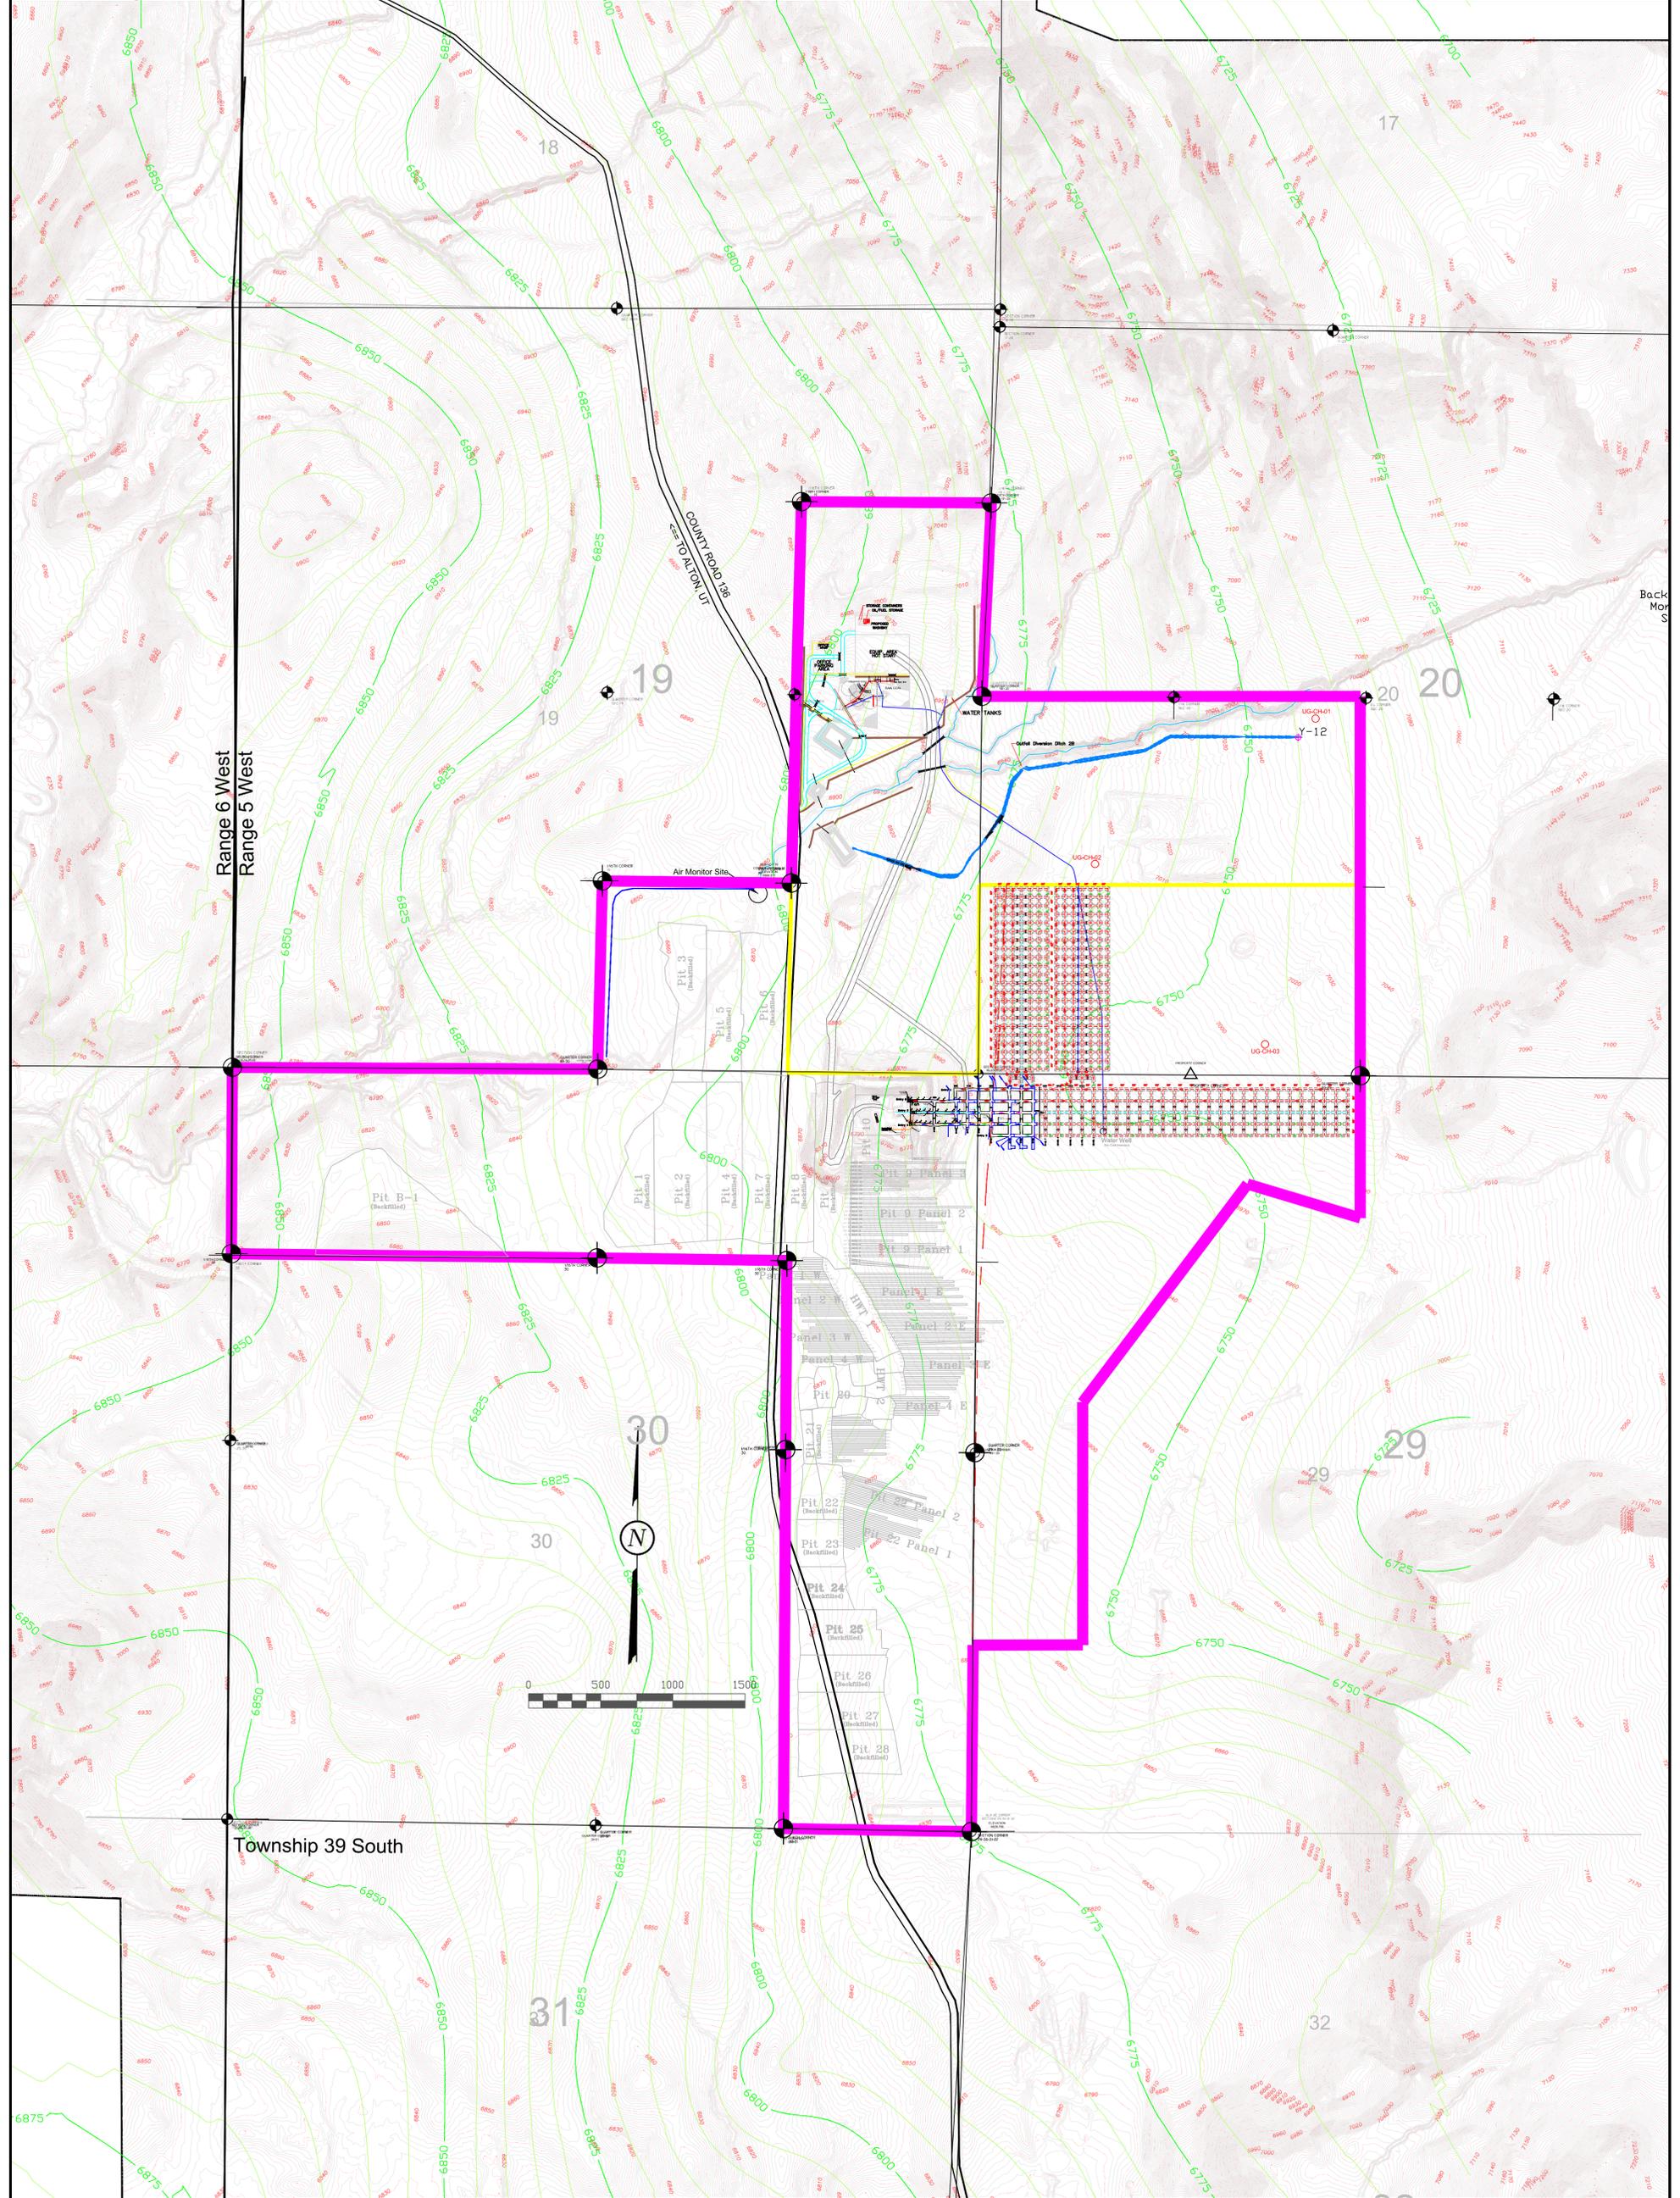
**COAL HOLLOW PROJECT**  
 2060 S. ALTON ROAD  
 ALTON, UTAH  
**DRAWING: 1 of 2**

PERMIT BOUNDARY
	PRIVATE COAL OWNERSHIP
	TOP OF COAL CONTOUR
	SURFACE CONTOUR
	SECTION LINE
	FOUND SECTION CORNER
	FOUND PROPERTY CORNER

**MINE MAP**  
**Coal Hollow Mine**  
 MSHA ID - 42-02519

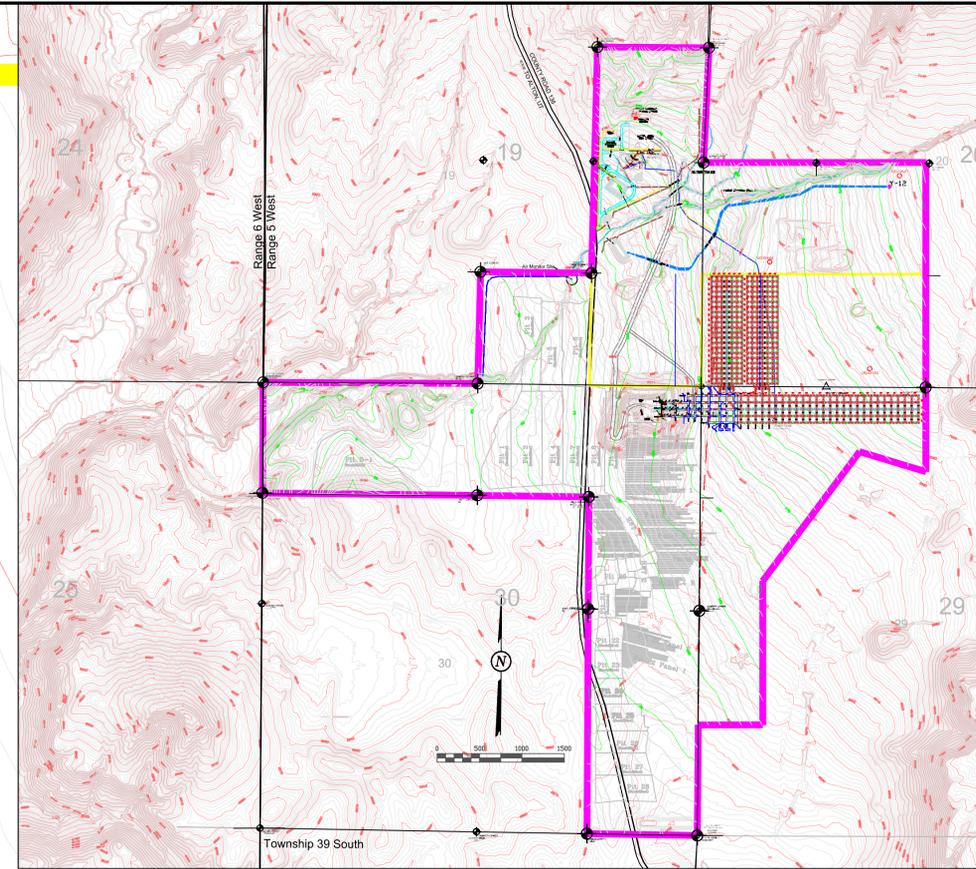
Scale of 1" = 1000'

**Coal Hollow Mine Permit Area Overview**

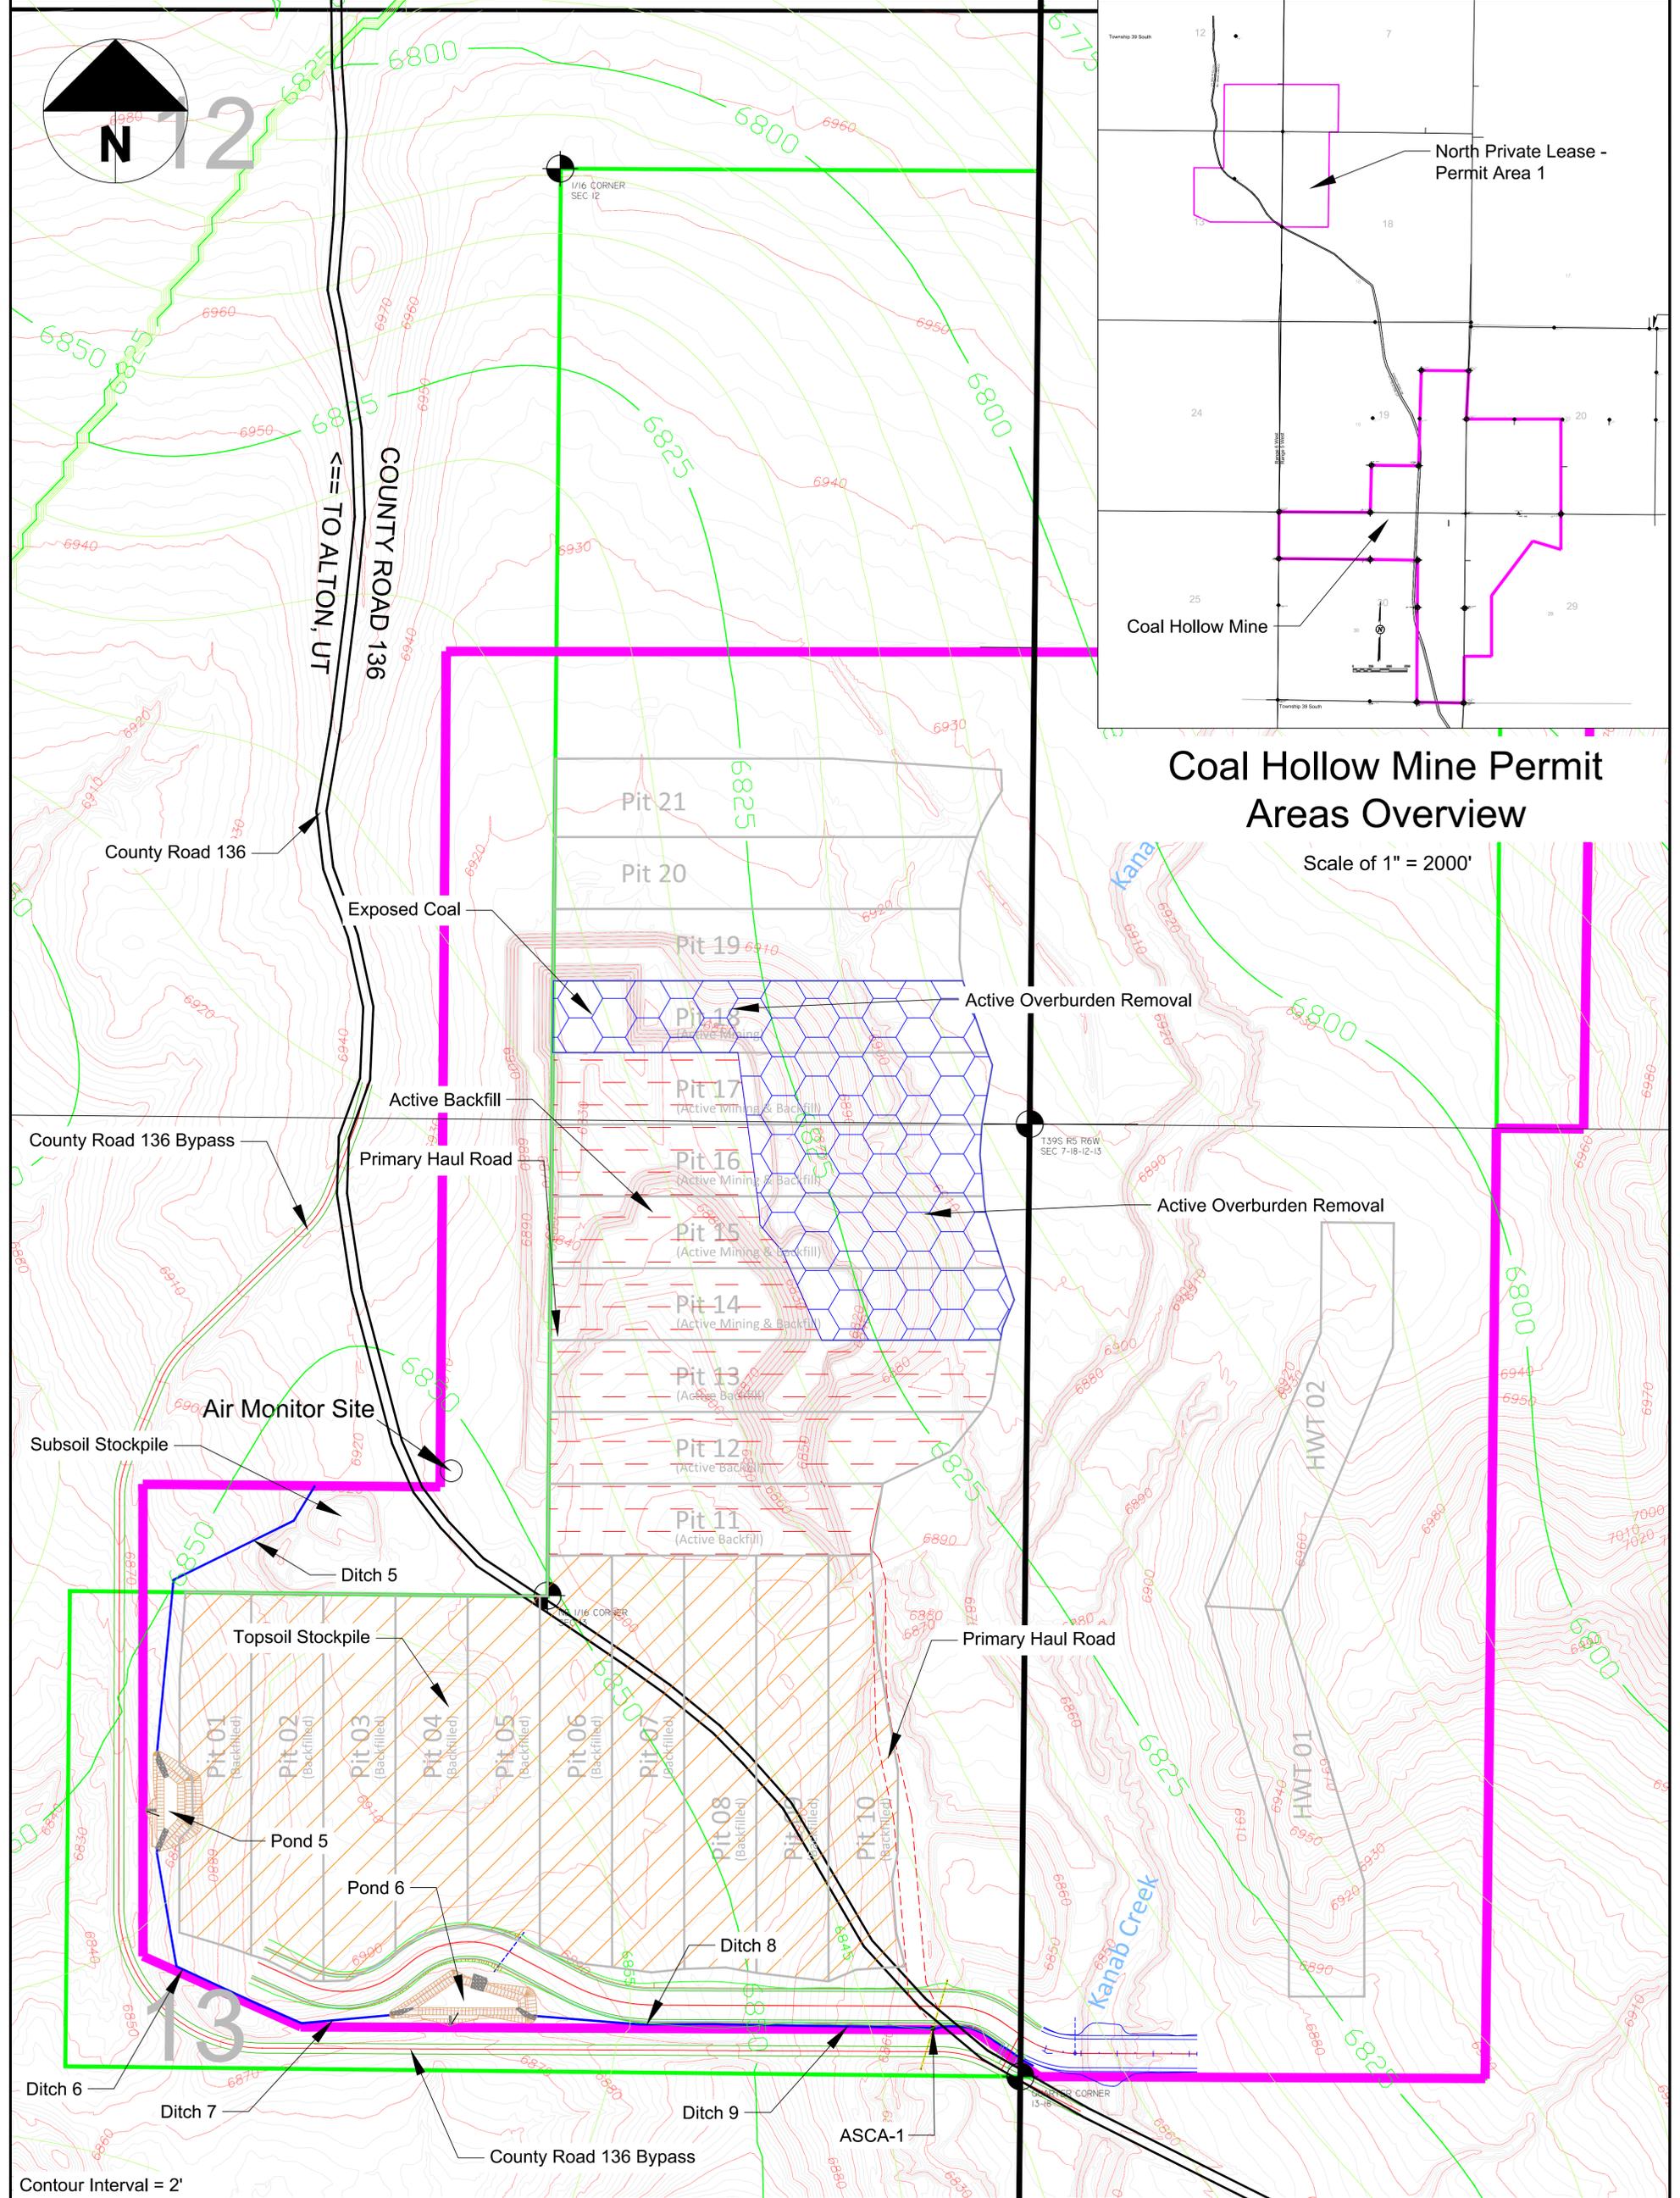
**COAL HOLLOW PROJECT**  
 2060 S. ALTON ROAD  
 ALTON, UTAH  
**DRAWING: 2 of 2**

**MINE MAP**  
**Coal Hollow Mine**  
**North Private Lease**  
 MSHA ID - 42-02519

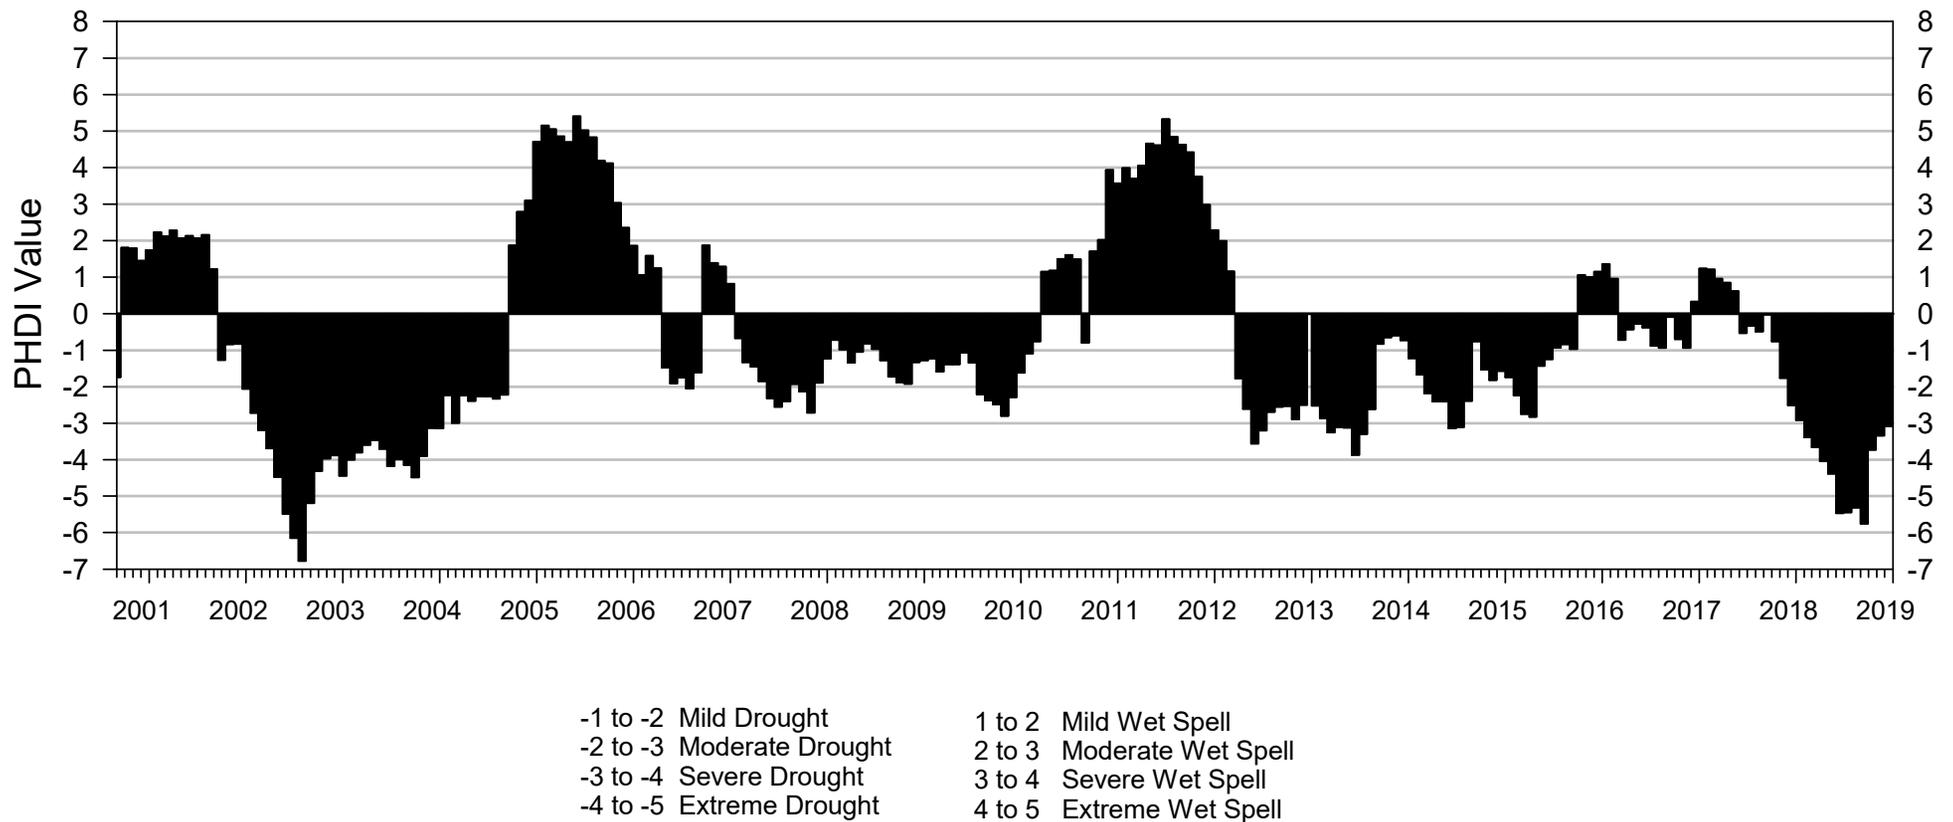
Figure 1 Plot of Palmer Hydrologic Drought Index for Utah Region 4.

It is noted here that severe to extreme drought conditions prevailed in the region during 2018. This is reflected in a plot of the Palmer Hydrologic Drought Index (PHDI) data for 2018 for Utah Region 4 (Figure 1). The PHDI is a monthly value generated by the National Climatic Data Center using a variety of hydrologic parameters that indicates wet and dry spells. The PHDI is calculated from several hydrologic parameters including precipitation, temperature, evapotranspiration, soil water recharge, soil water loss, and runoff. Consequently, it is a useful tool for evaluating the relationship between climate and groundwater and surface-water discharge data. It is noteworthy that the PHDI values measured during September of 2018 indicate the second deepest drought conditions ever measured in the region during the 124-year period of record for the PHDI (1895-2018).
